Inspection Photos
Location Name: Givan #1
API: 05-087-07712
Inspection Date: March 22, 2018

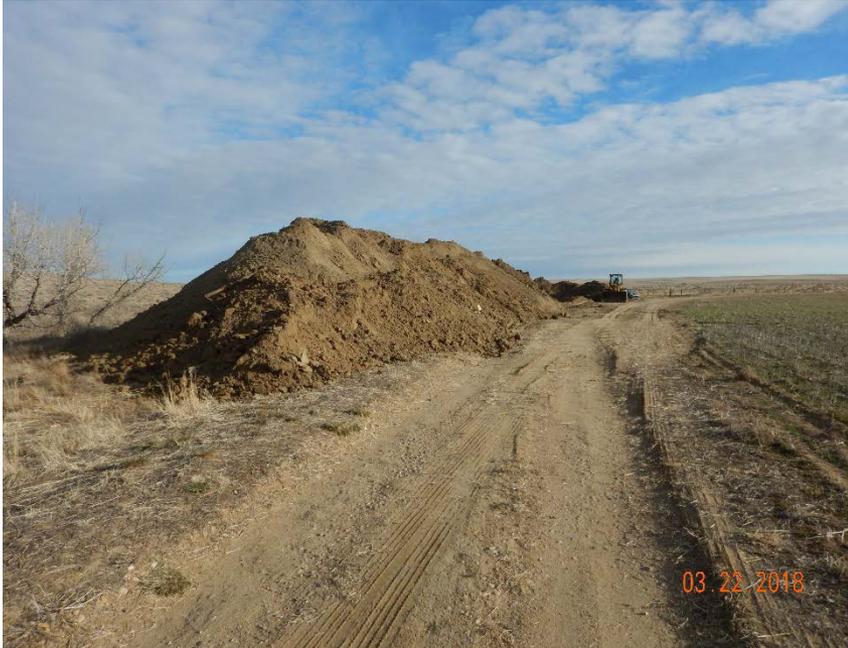
Photo #1 – View from southeast of stockpiled soil resulting from remediation efforts at historical release (Spill ID #454434).

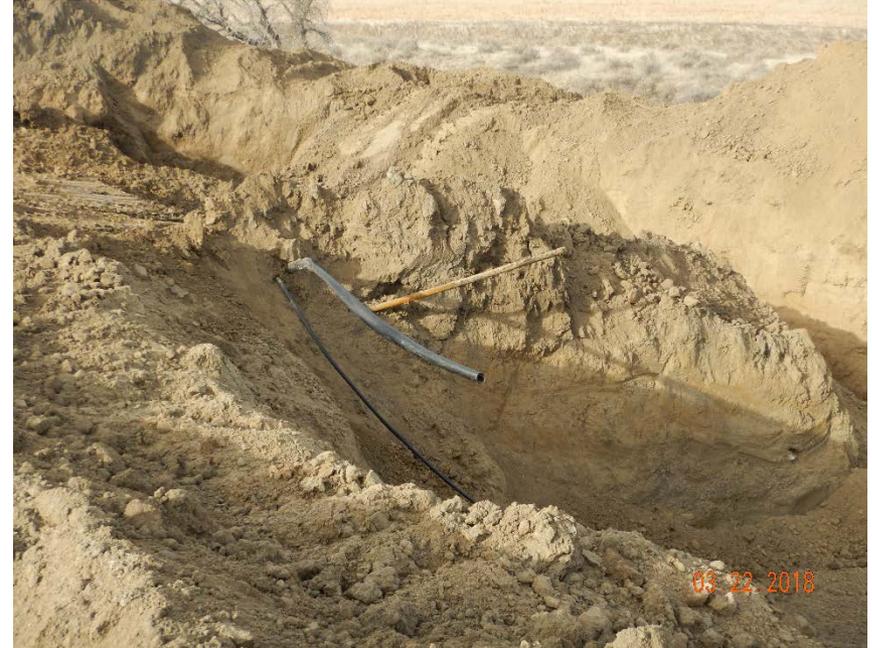
Photo #2 – Exposed flowlines inside of historical release excavation.

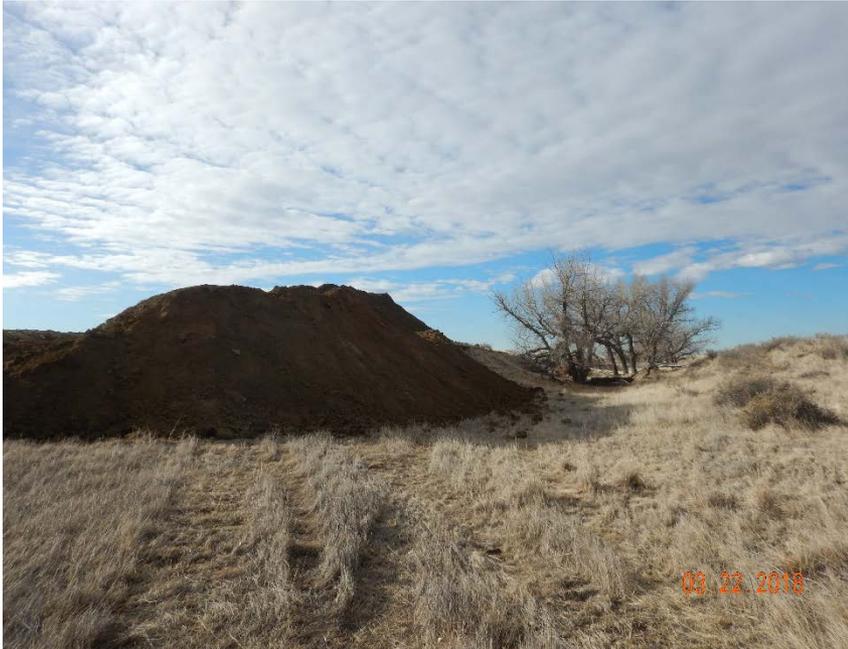
Photo #3 – View from north of stockpiled soil encroaching into adjacent drainage. Note absence of stormwater BMPs.

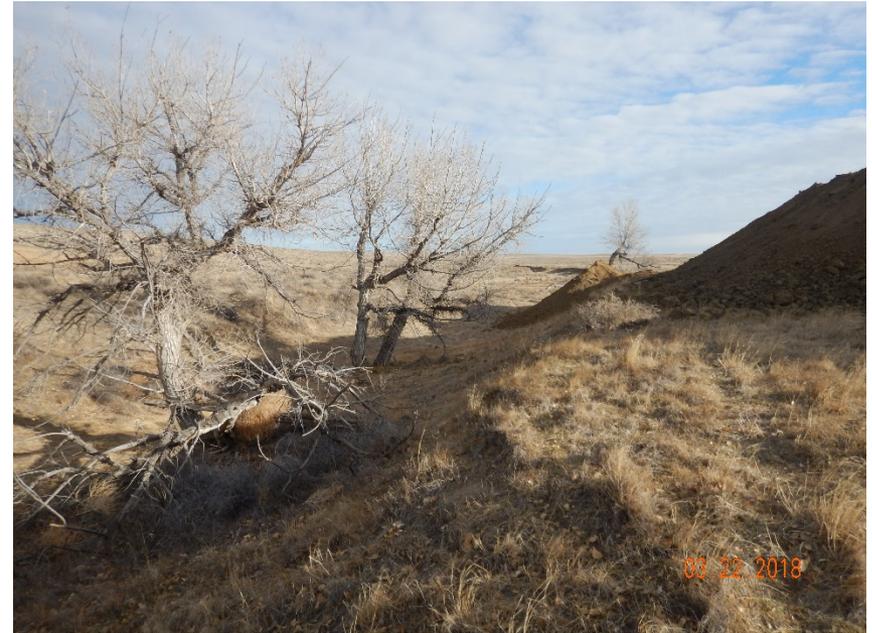
Photo #4 – View from southern extent of soil stockpile, looking NW into adjacent drainage. Note absence of stormwater BMPs.
