Final Reclamation Inspection

March 30, 2018

API: 05-123-07046

Inspection Photos
Location Name: LONG #1
API: 05-123-07046

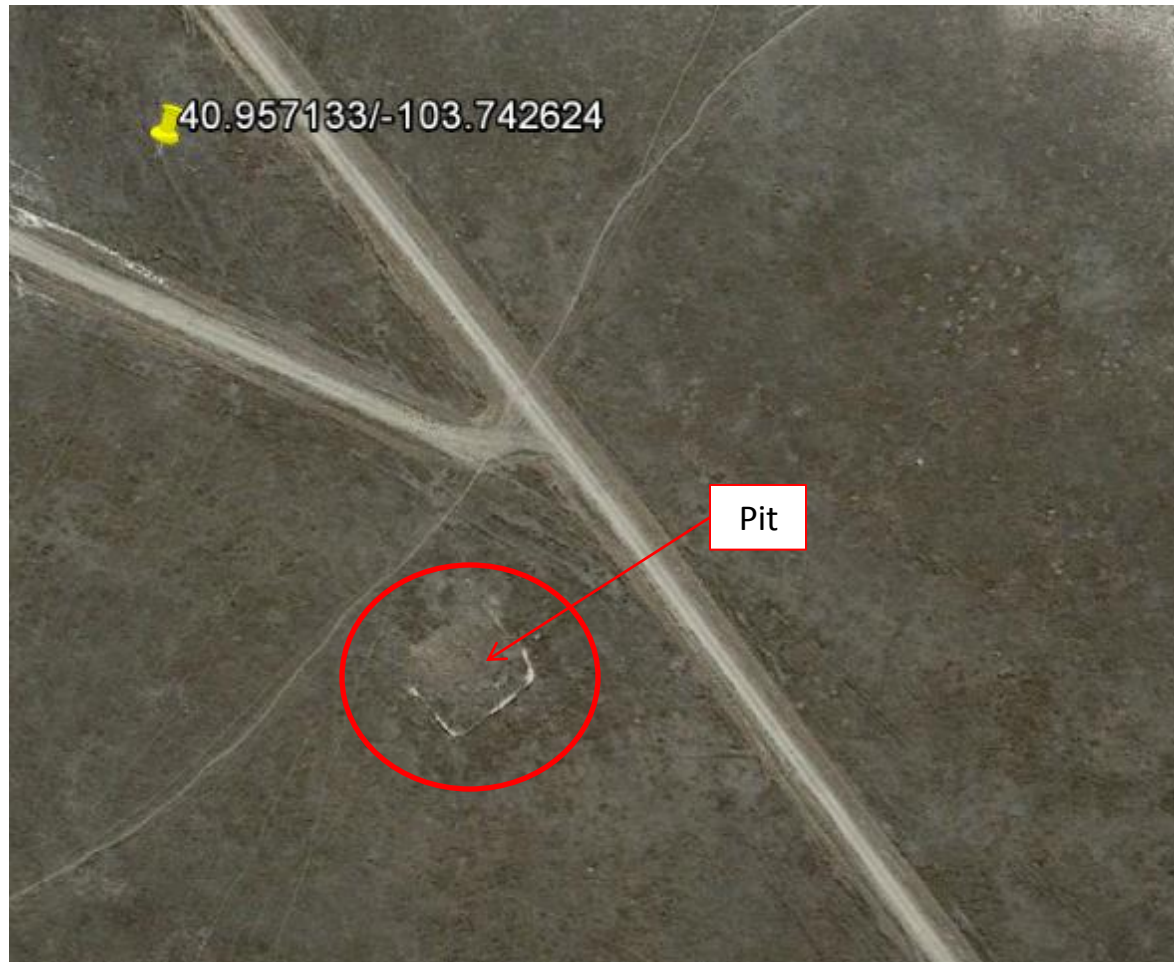
Google Earth aerial imagery taken October 15, 2015 appears to indicate surface disturbance from a pit, approximately 375 feet southeast of the well location (Lat/Long in above image).

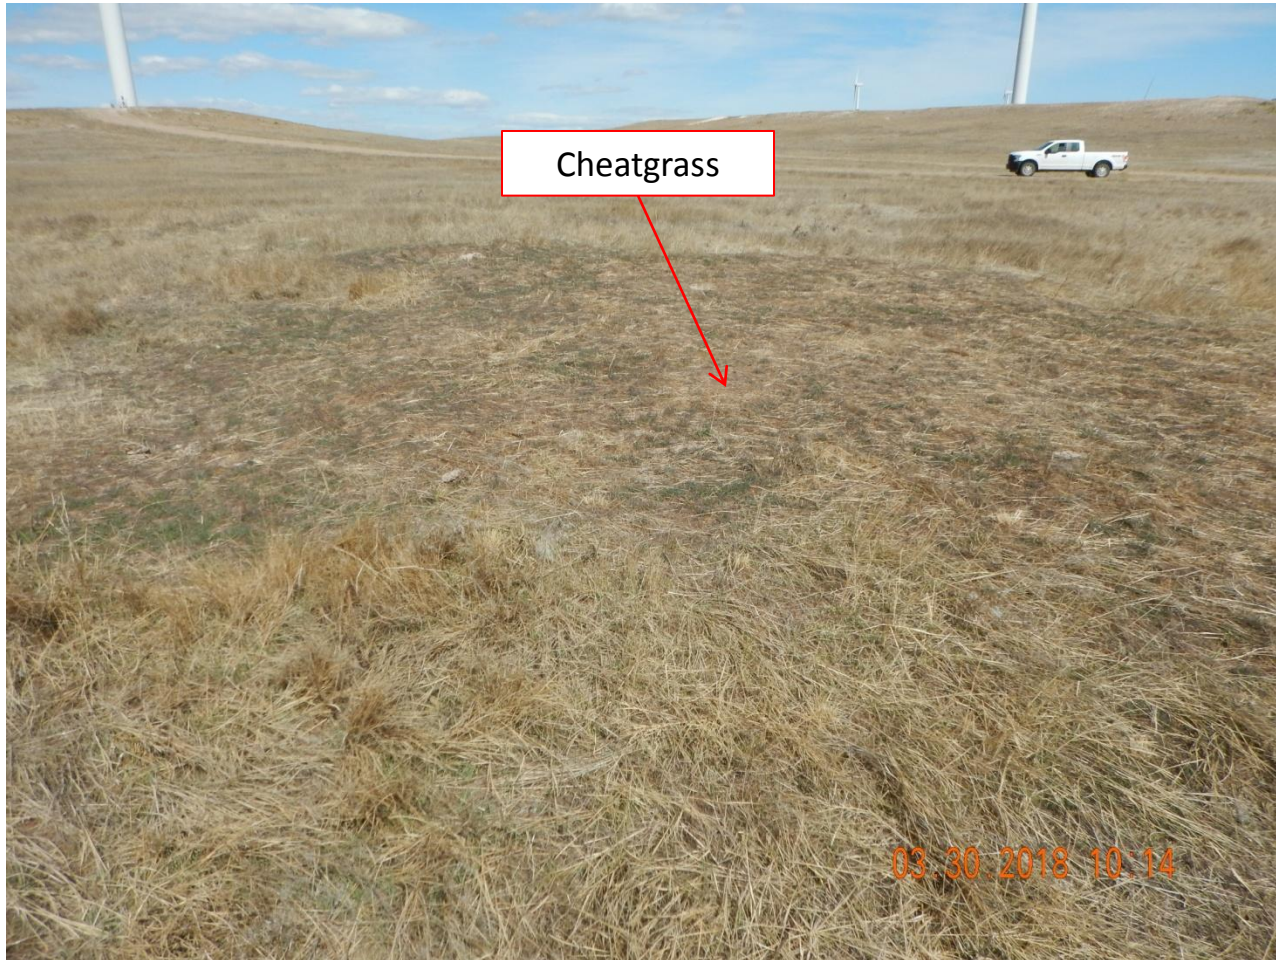
Photo 1. Photo taken from the approximate pit, facing North. Appears the pit has been backfilled but vegetation is not reflective of reference area vegetative levels. The vegetative growth in the central area of the pit consists of Cheatgrass (*Bromus tectorum*). Other areas of the pit are not reflective of reference area vegetative levels.

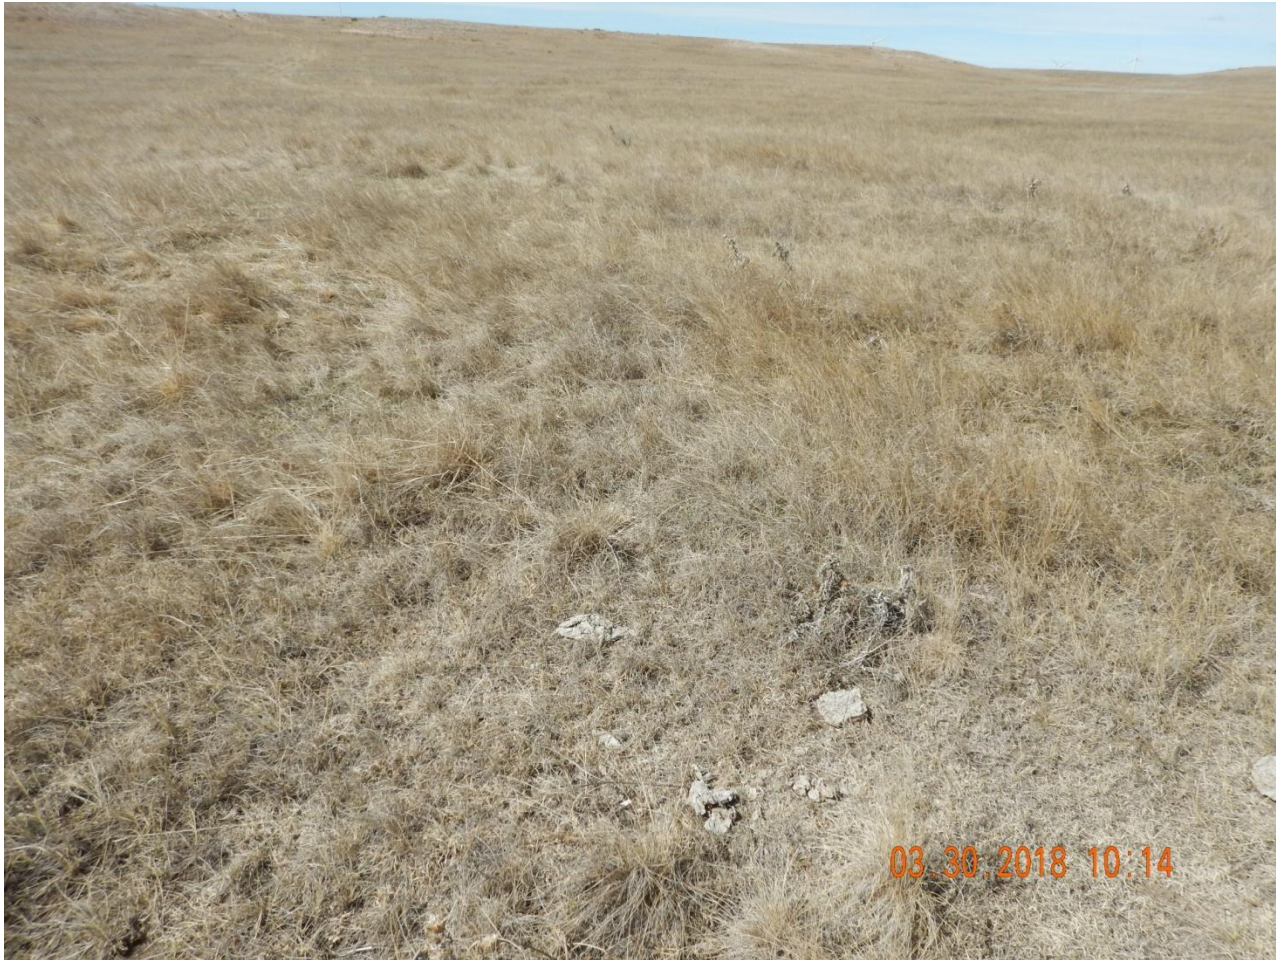
Photo 2. Reference photo taken west of the pit, facing West. Reference area vegetative growth consists of, but not limited to, Blue grama (*Bouteloua gracilis*).

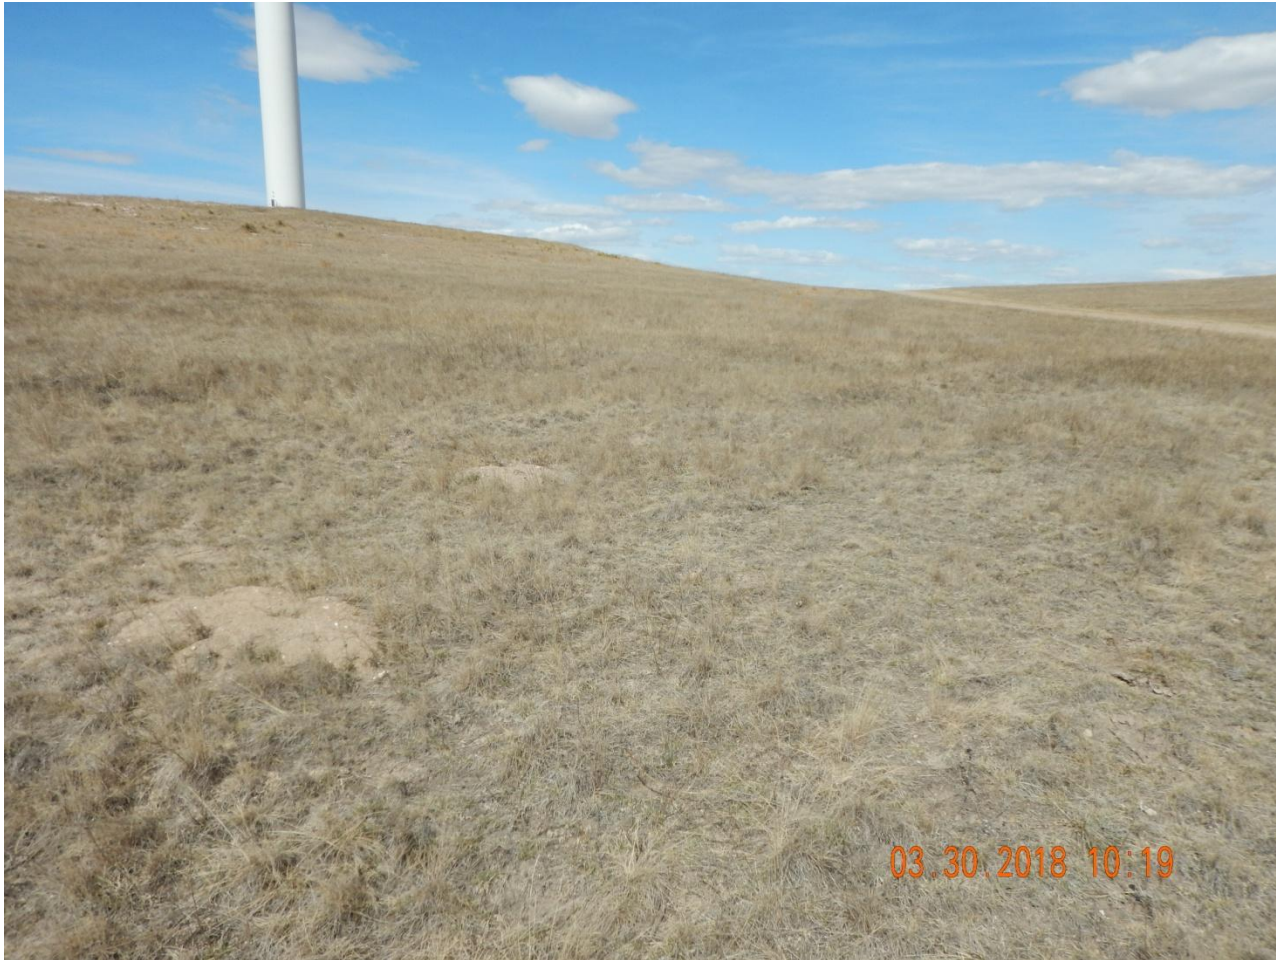
Photo 3. Photo taken from the approximate well location, facing North. Well location appears reflective of reference area vegetative levels.

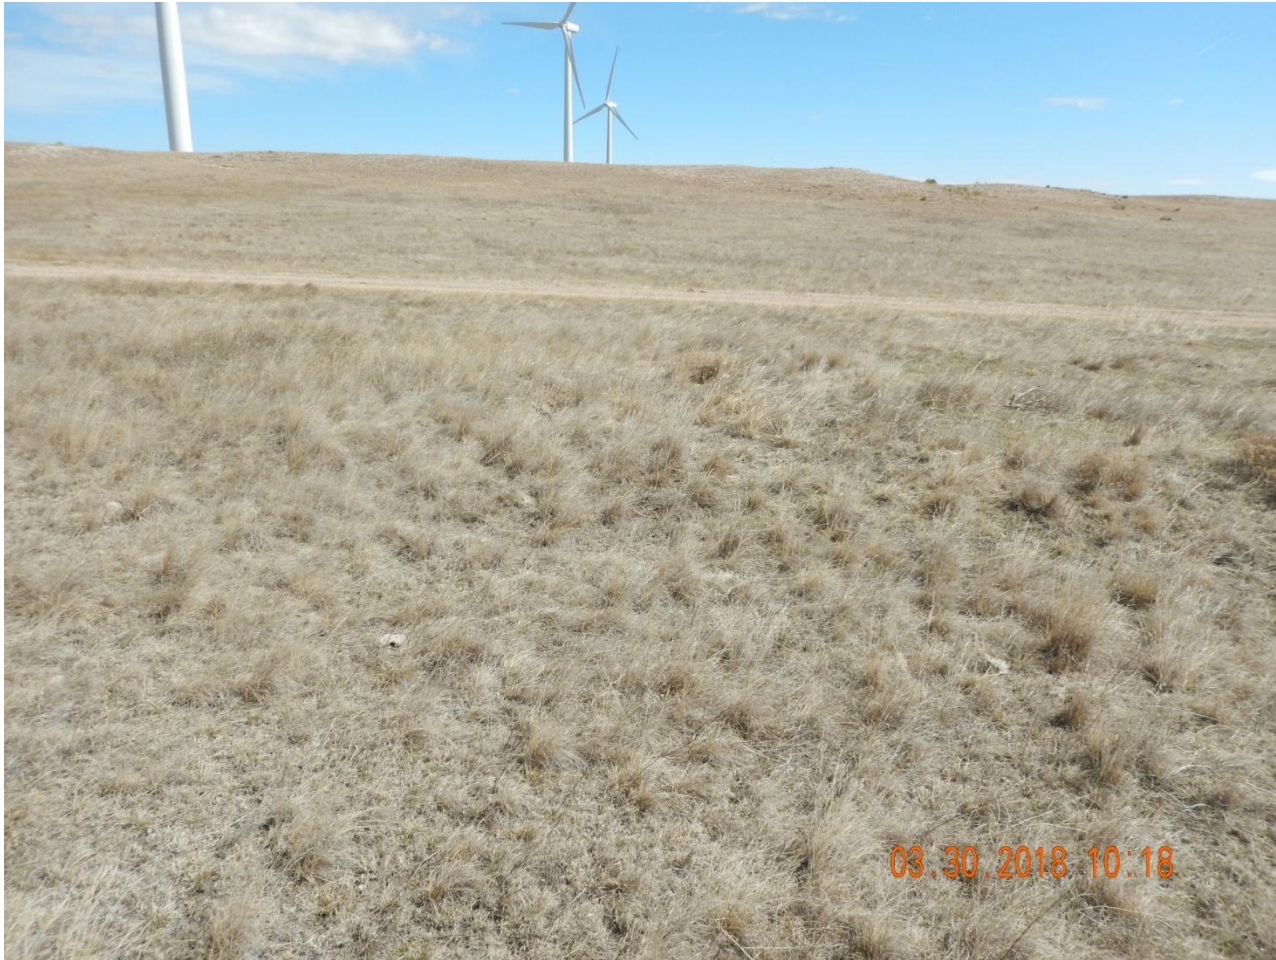
Photo 4. Photo taken from the approximate well location, facing East. Well location appears reflective of reference area vegetative levels.
