# Inspection Photos

Operator: HRM RESOURCES II LLC - 10548

Location ID: 317081

Inspection Doc. Number: 682503318

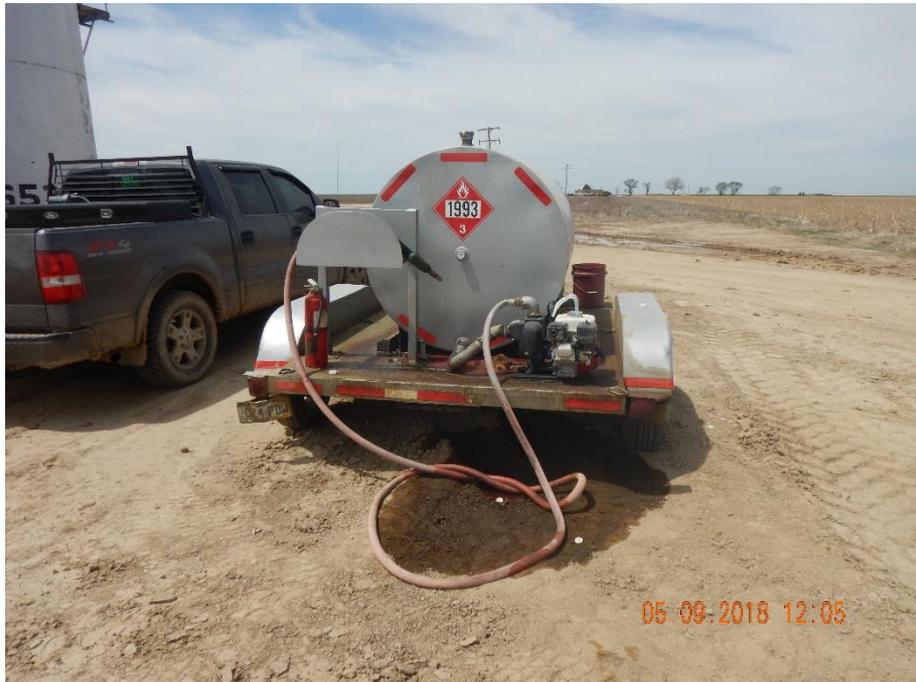
**Photo 1:** Photo taken from the north end of the location, facing west. Photo shows what looks to be a fuel tank w/ pump containing diesel fluids appears to be leaking onto the pad. Fluids can be found over the trailer as well as ponding beneath.

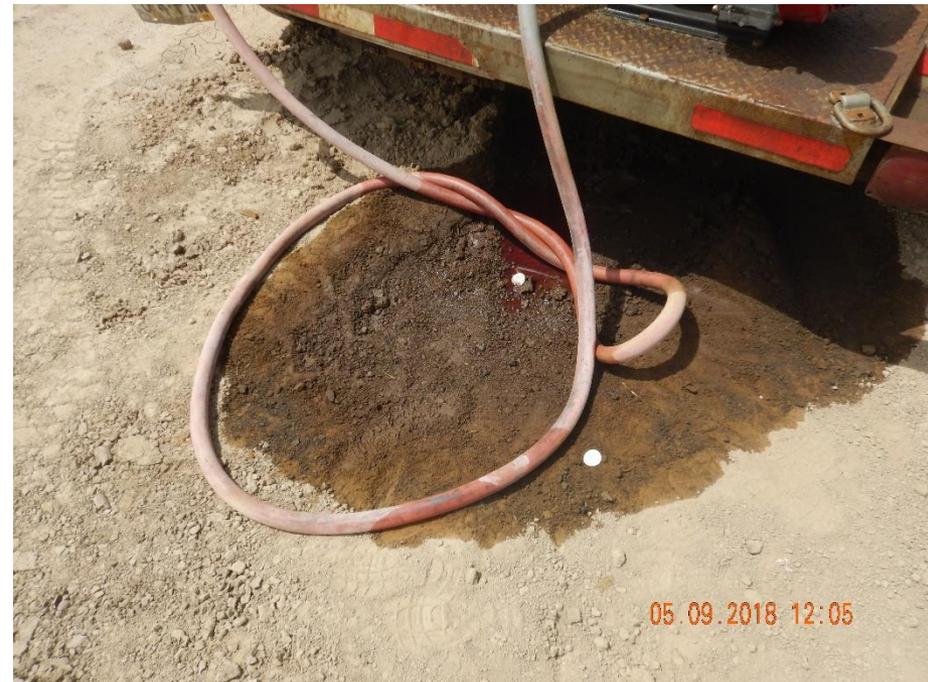
**Photo 2:** Photo taken from the north end of the location. Photo shows what looks to be a fuel tank w/ pump containing diesel fluids appears to be leaking onto the pad. Fluids can be found over the trailer as well as ponding beneath.

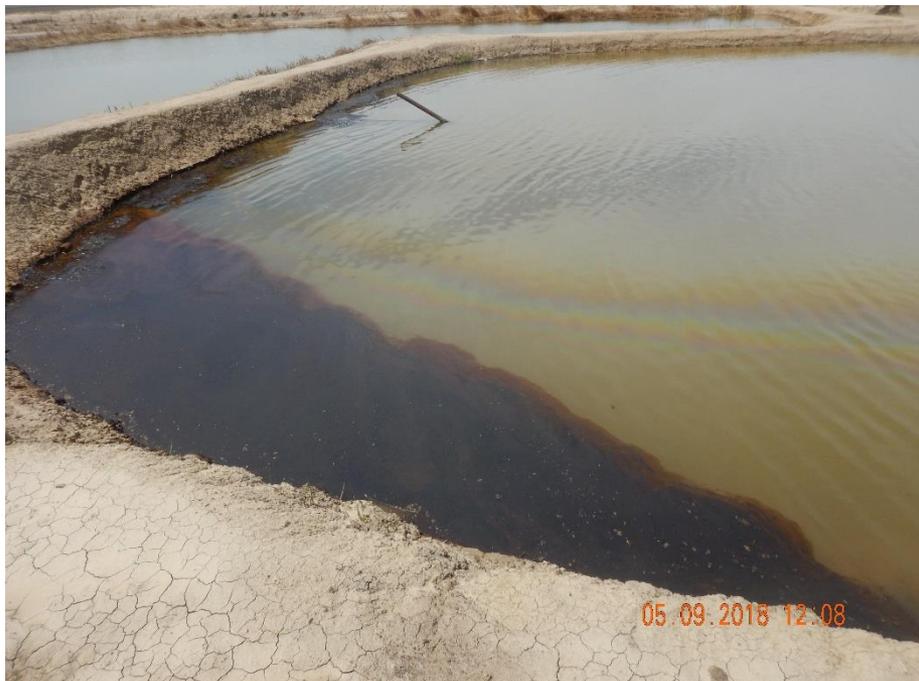
**Photo 3:** Photo taken from the southeast corner, of the north-central produced water pit. Photo shows hydrocarbons in the produced water pit.

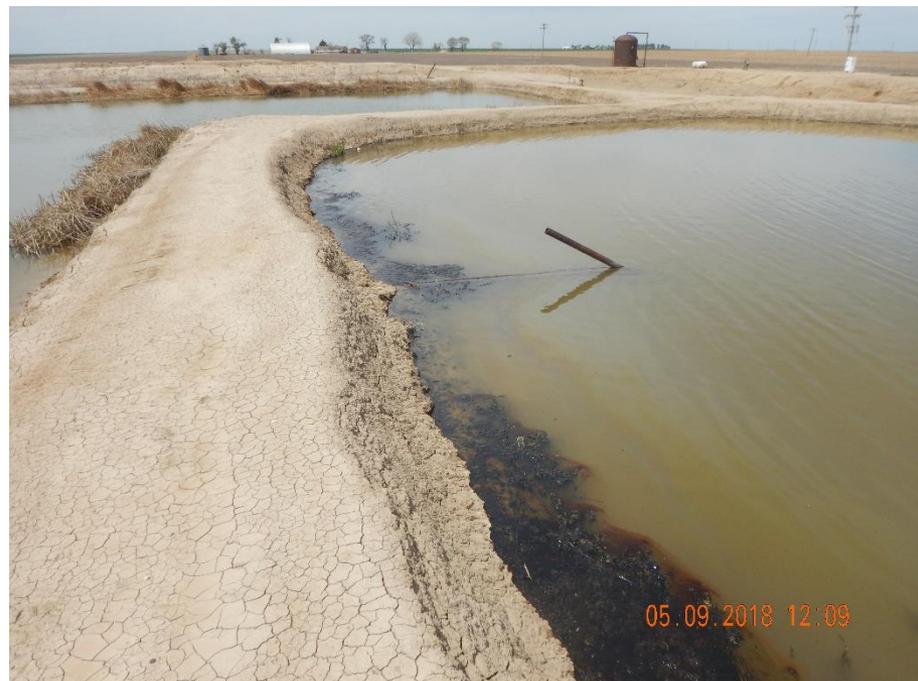
**Photo 4:** Photo taken from the south end, of the north-central produced water pit. Photo shows hydrocarbons in the produced water pit.
