Inspection Photos

Operator: PRONGHORN OPERATING LLC - 10422

Location ID: 387156

Inspection Doc. Number: 682503359

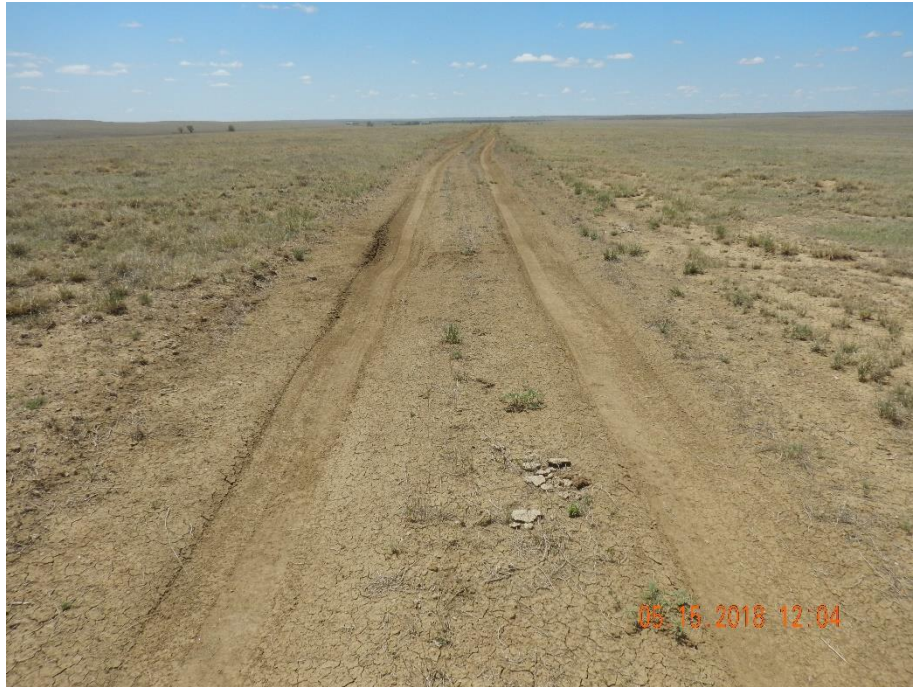
Photo 1: Photo taken from the south of the location, facing south. Photo shows access road. Operator has submitted a 502.b variance request to no reclaim access road.

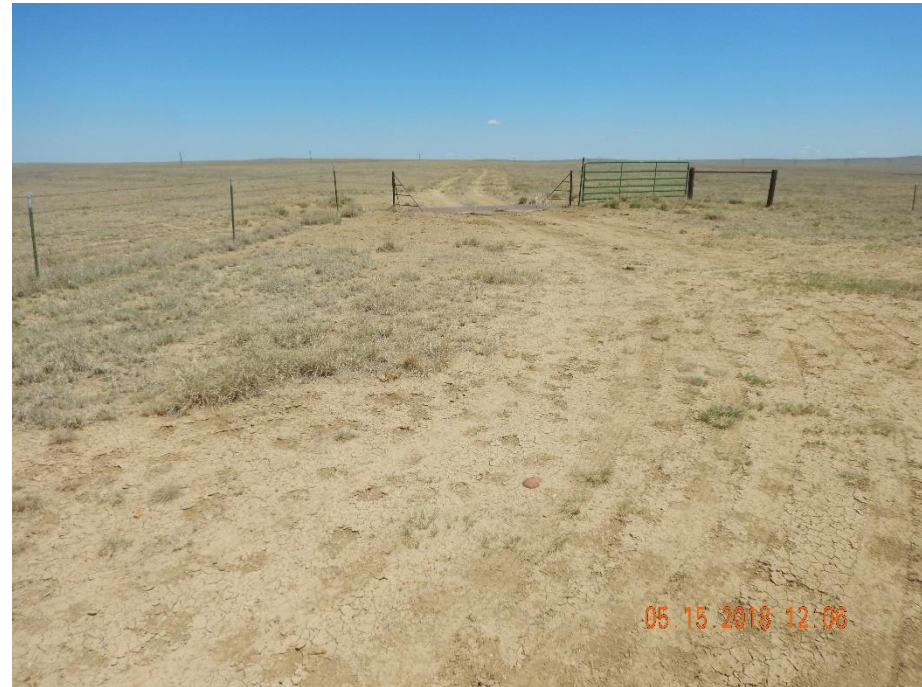
Photo 2: Photo taken from the access road entrance, facing north. Photo shows cattle guard and access road.

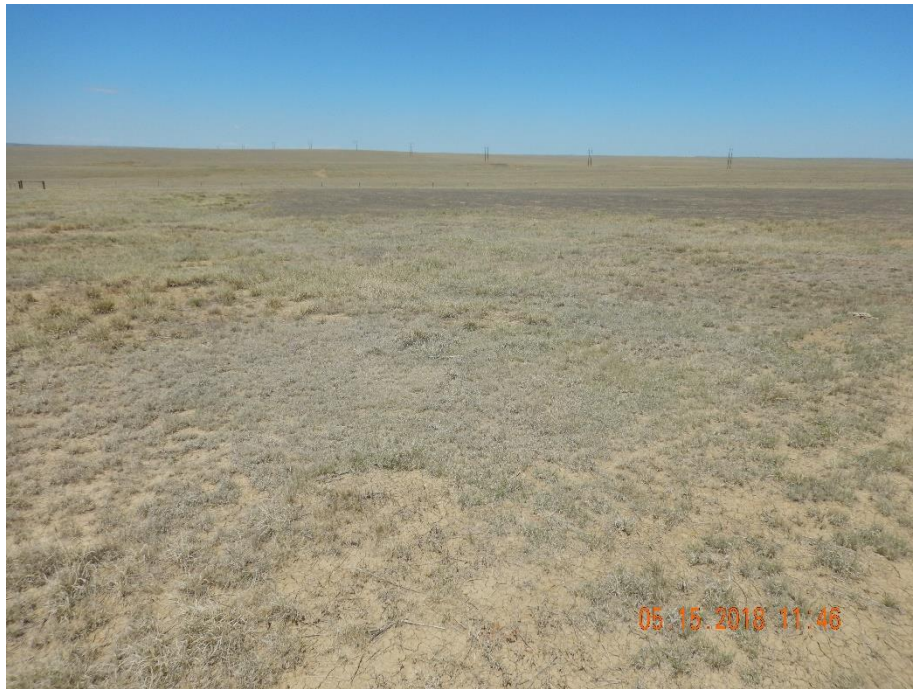
Photo 3: Photo taken from the south end of the location, facing northwest. Photo shows overview of the location.

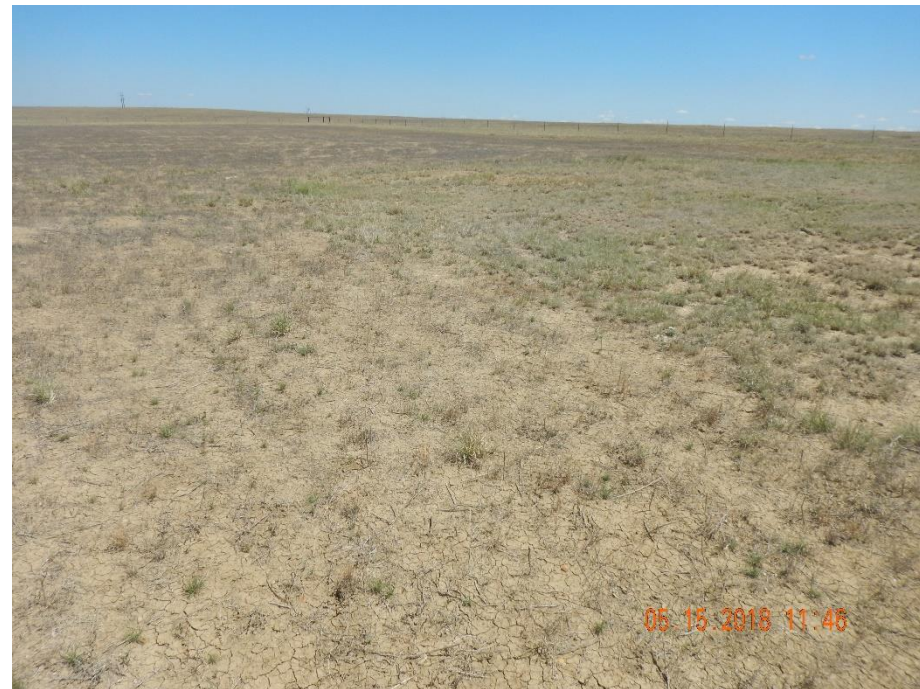
Photo 4: Photo taken from the south end of the location, facing northeast. Photo shows overview of the location.

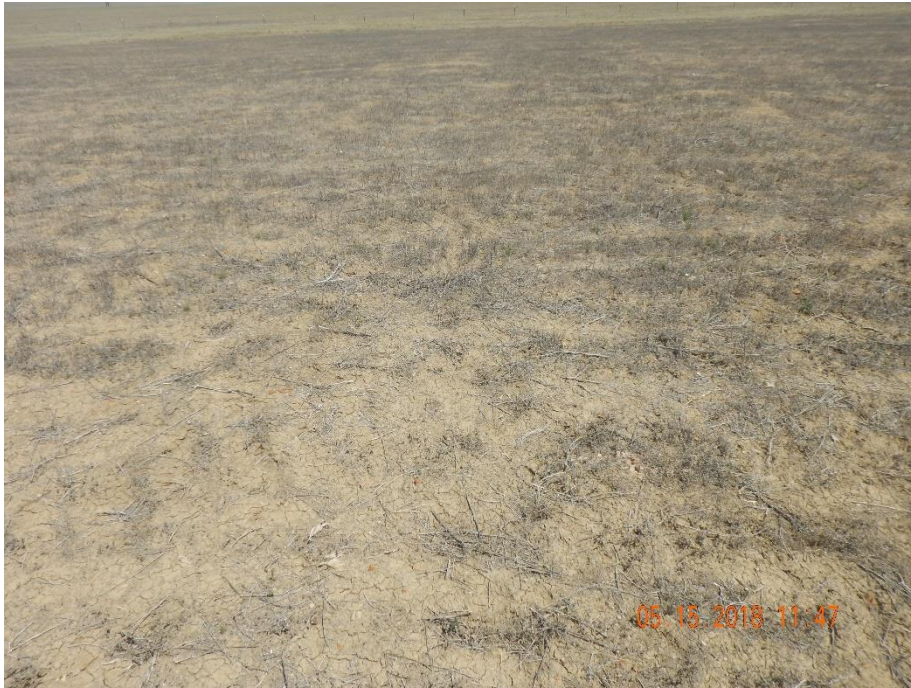
Photo 5: Photo taken from the center of the location, facing north. Photo shows vegetation on the location is predominantly undesirable weedy plant species, or is bare and exposed soil. Unable to find desirable perennial vegetative establishment or germination evident on the location.

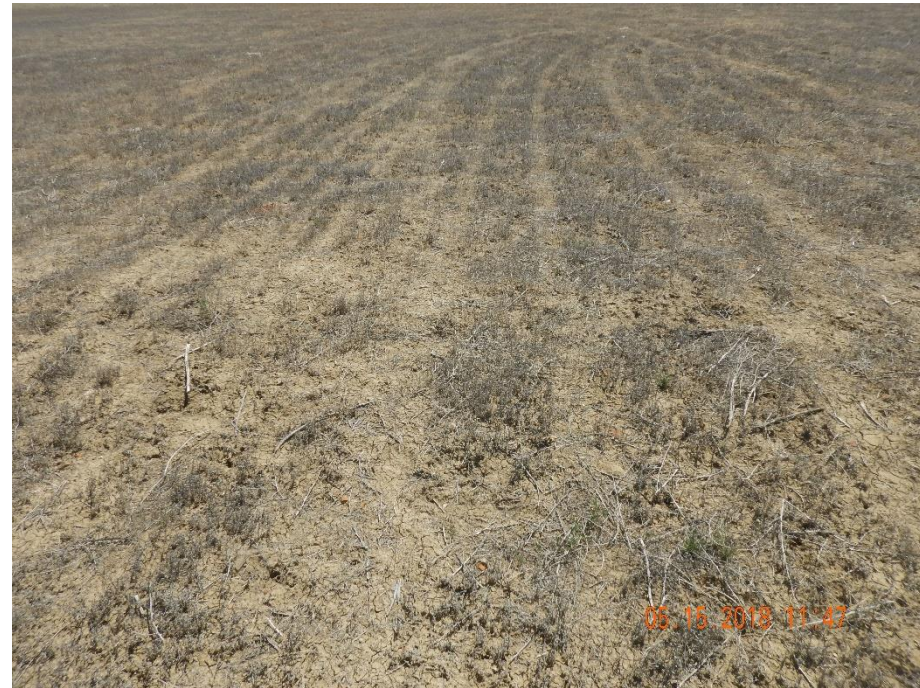
Photo 6: Photo taken from the center of the location, facing east. Photo shows vegetation on the location is predominantly undesirable weedy plant species, or is bare and exposed soil. Unable to find desirable perennial vegetative establishment or germination evident on the location.

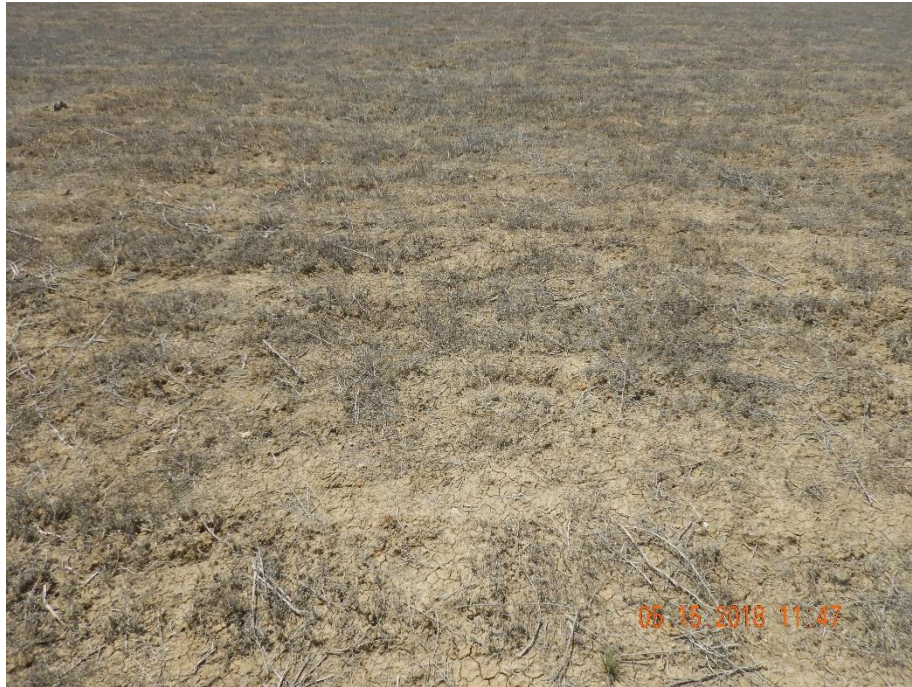
Photo 7: Photo taken from the center of the location, facing south. Photo shows vegetation on the location is predominantly undesirable weedy plant species, or is bare and exposed soil. Unable to find desirable perennial vegetative establishment or germination evident on the location.

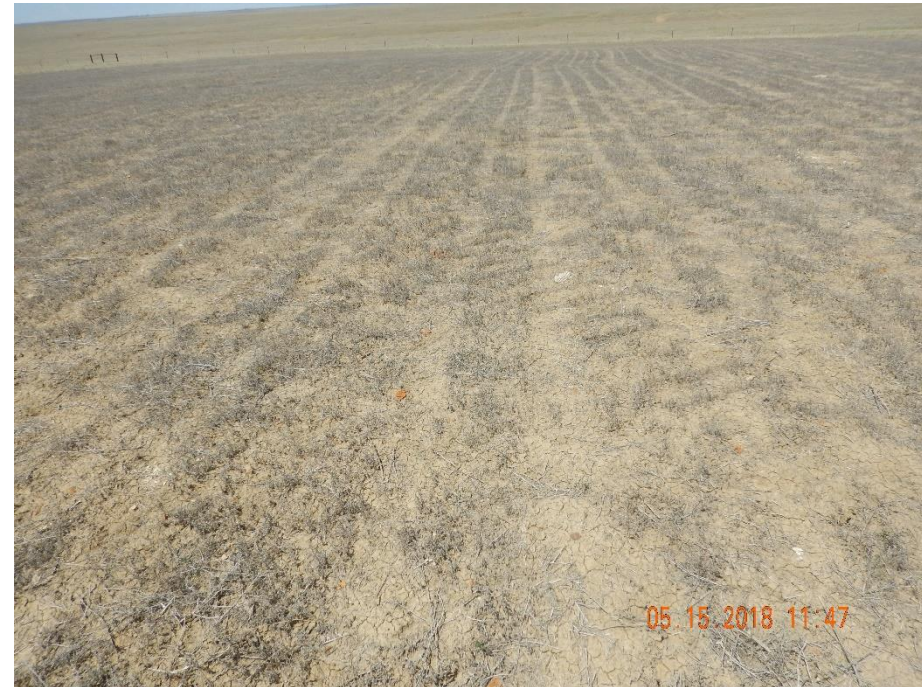
Photo 8: Photo taken from the center of the location, facing west. Photo shows vegetation on the location is predominantly undesirable weedy plant species, or is bare and exposed soil. Unable to find desirable perennial vegetative establishment or germination evident on the location.

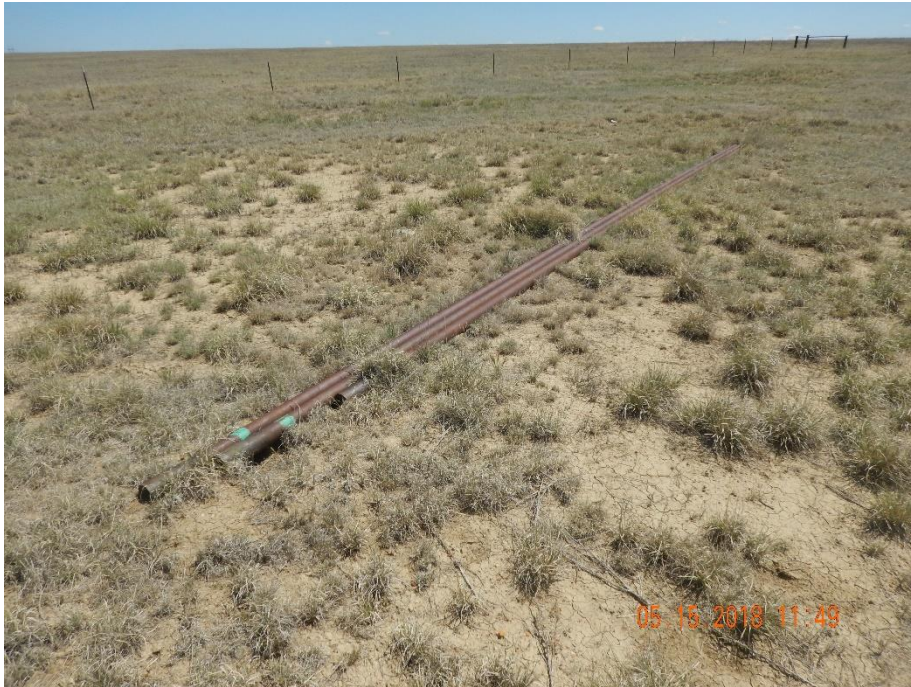
Photo 9: Photo taken from the north end of the location. Photo shows pipe remaining.

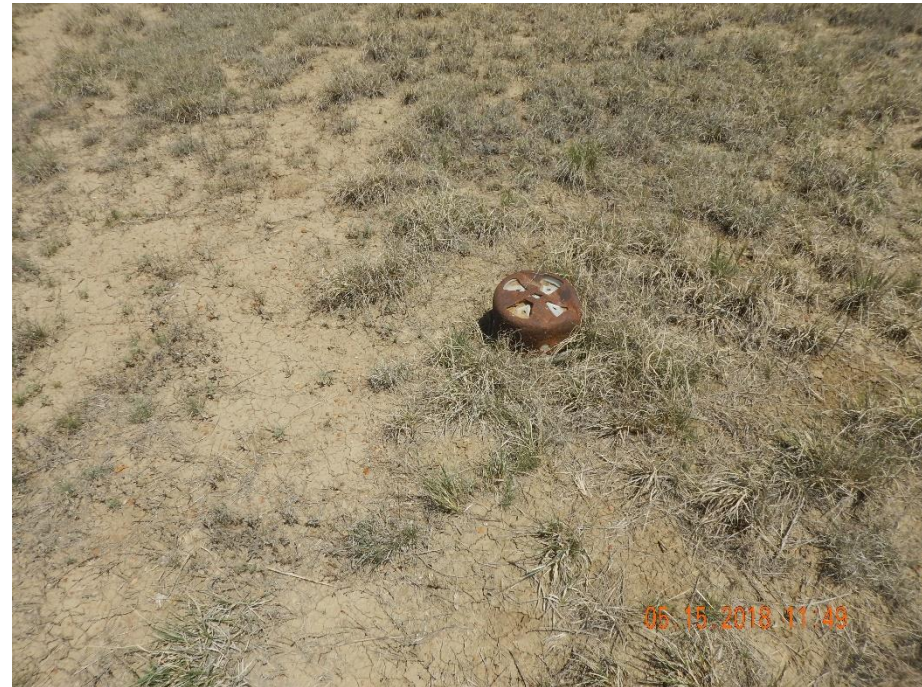
Photo 10: Photo taken from the north end of the location. Photo shows debris remaining.
