Interim Reclamation Inspection

Operator: PDC ENERGY INC - #69175

API: 05-123-23409

Inspection Photos
Location Name: JEFFERS #21-35
API: 05-123-23409

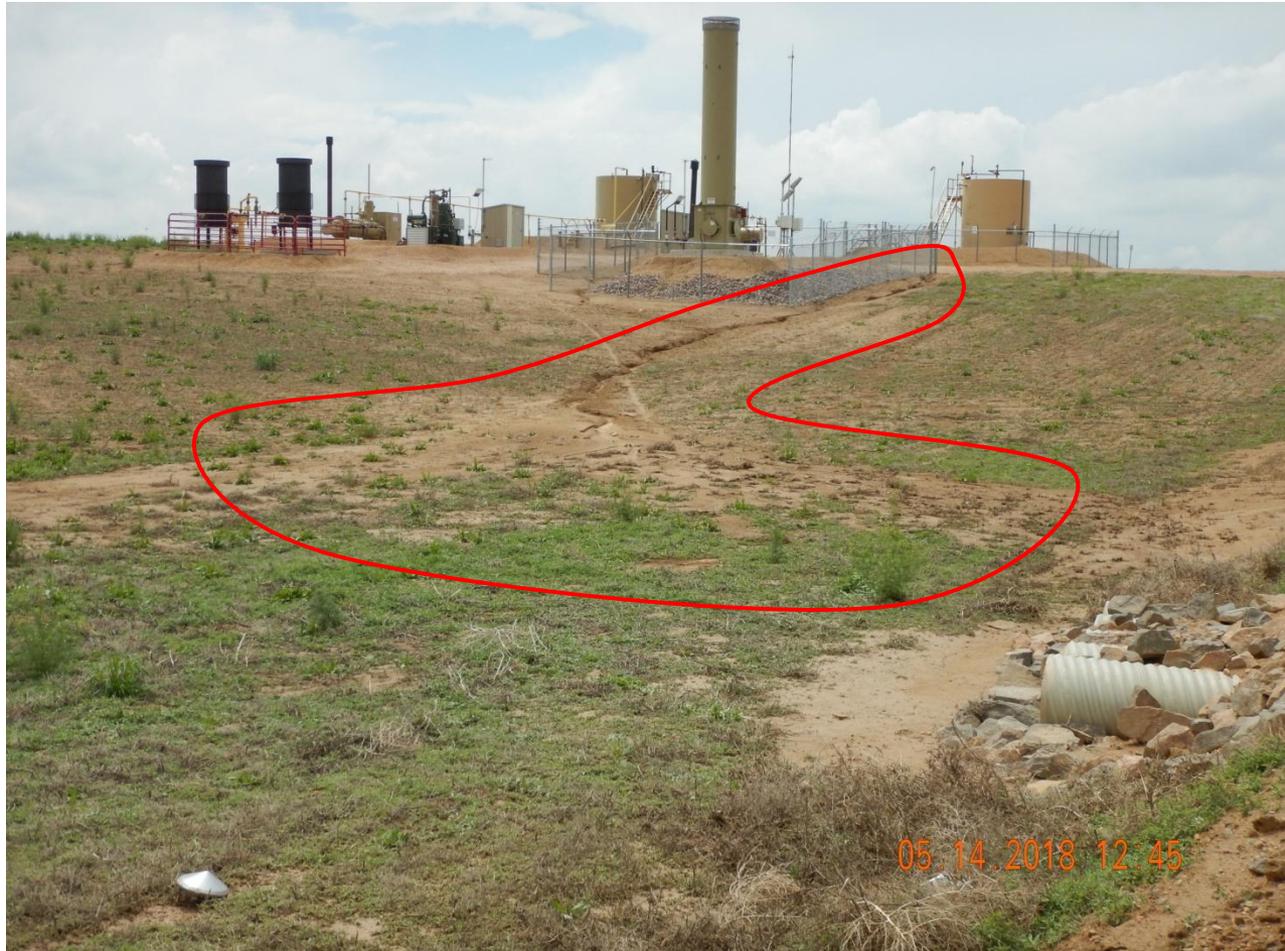
Photo 1. Photo taken of the northeast battery location, facing Southwest. Appears stormwater runoff from the battery location is causing rill erosion off location. There were no observed BMPs being implemented along the battery location to minimize erosion.

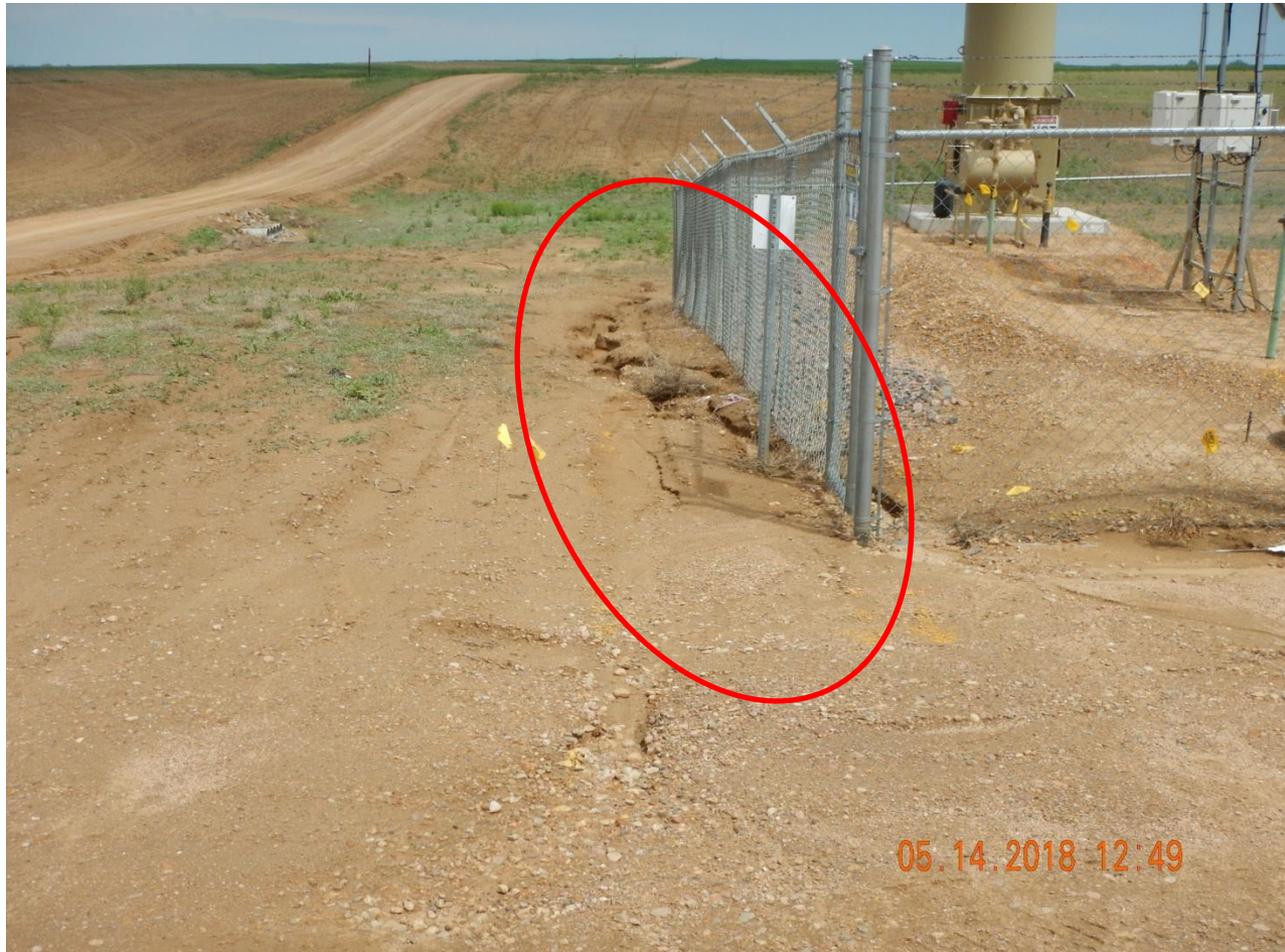
Photo 2. Photo taken from the northern battery location, facing East. See comments under Photo 1.

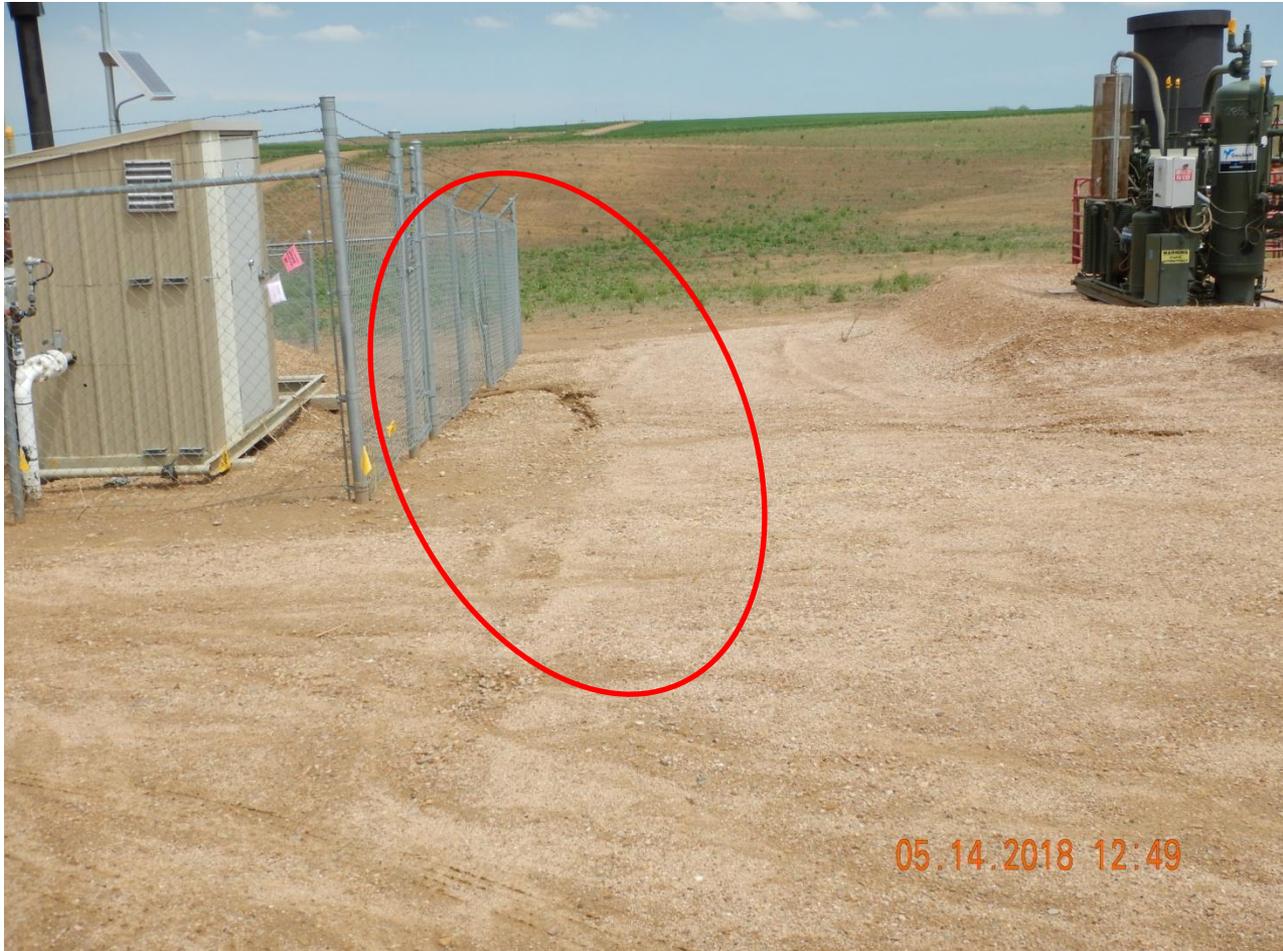
Photo 3. Photo taken from the central battery location, facing East. See comments under Photo 1.
