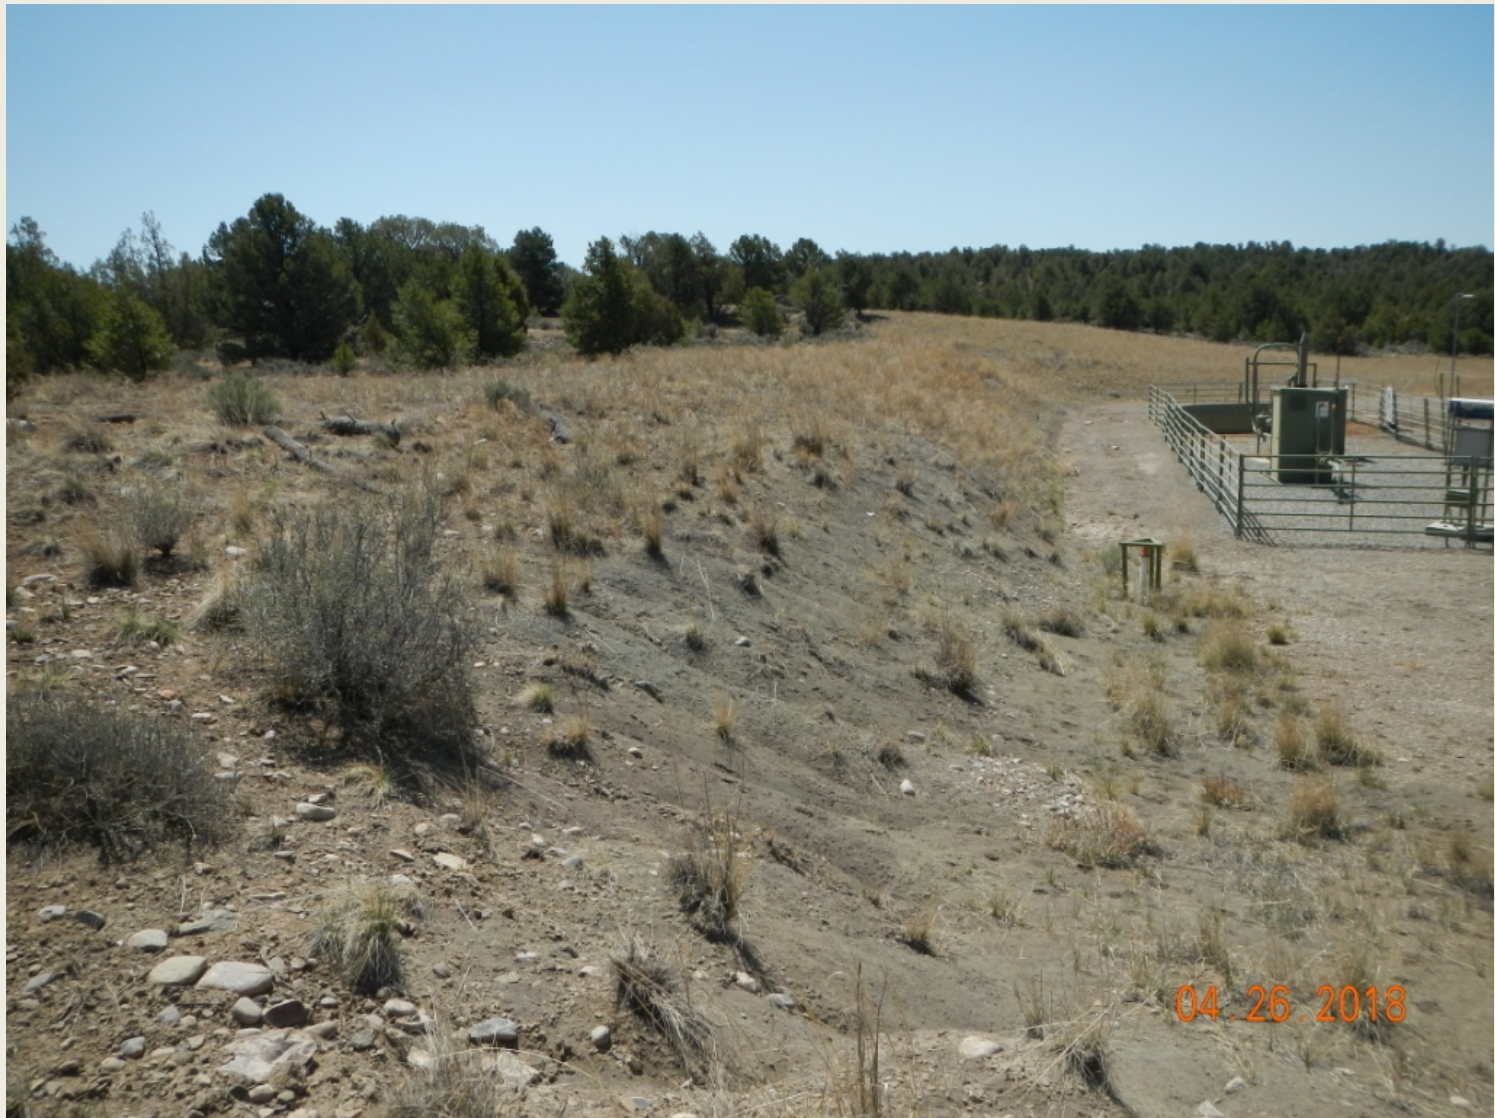
**Photo 2. View of the eastern portion of the project area from the northeastern corner facing southward. Revegetation is progressing on cut-slopes, but sparse on steep areas, with rilling evident.**

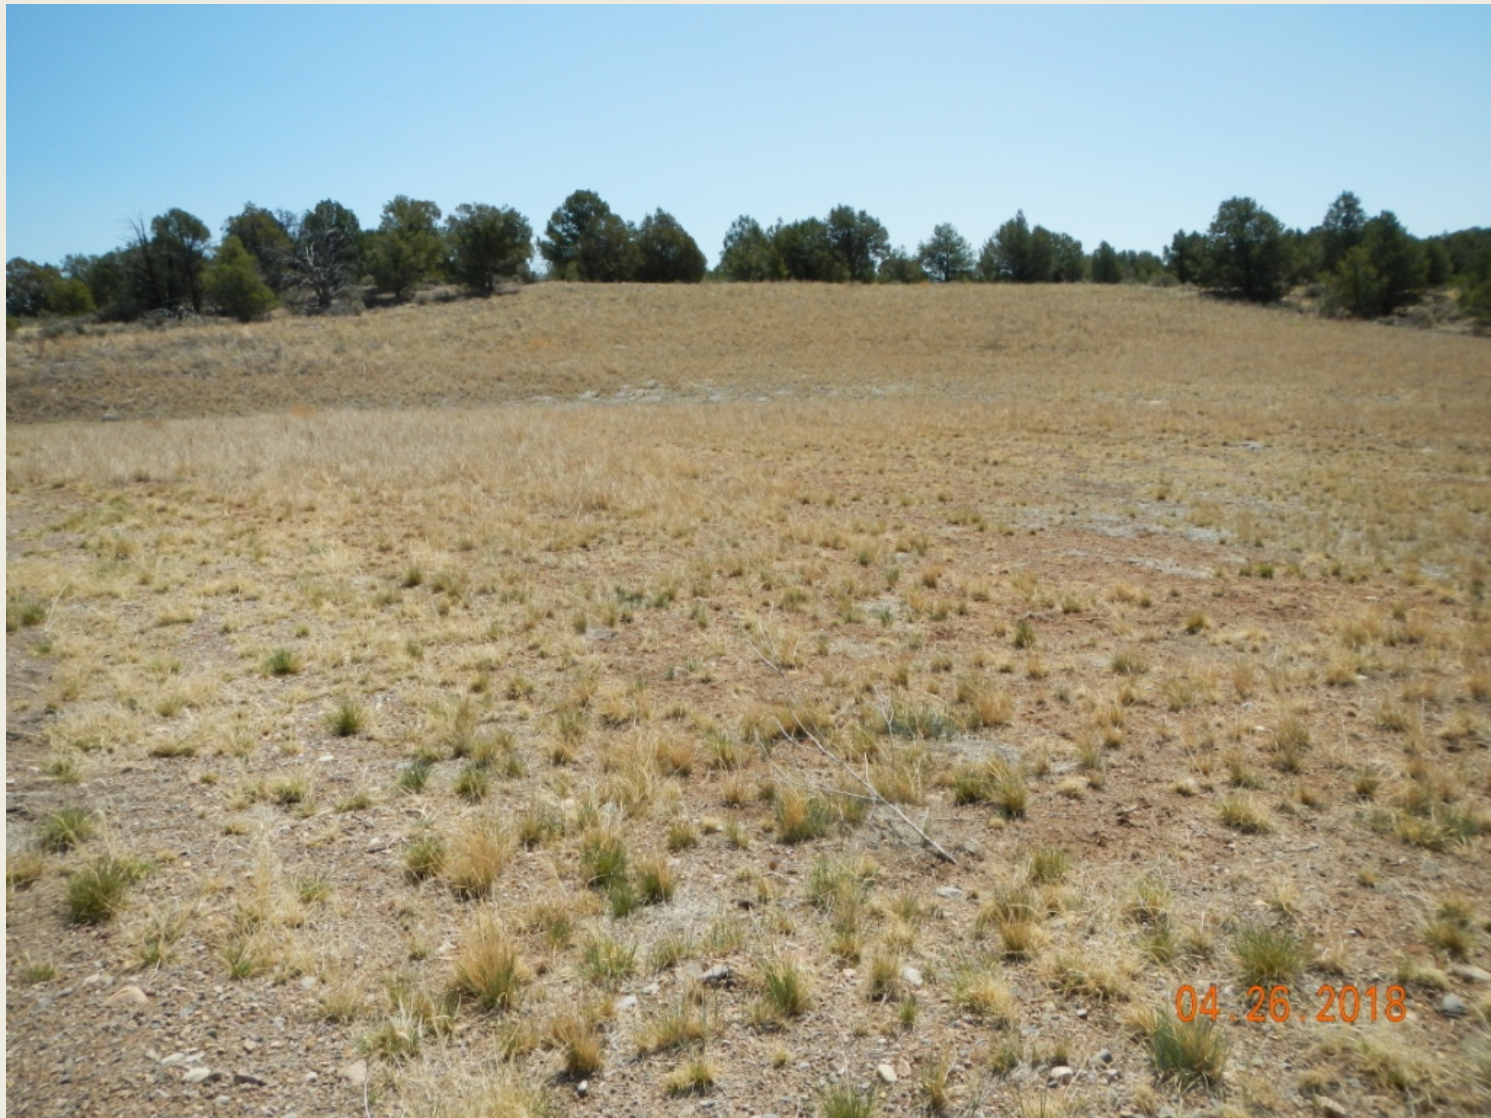
**Photo 3. View of the southern portion of the project area from the southwestern corner facing southeastward. Revegetation is progressing with grasses such as western wheatgrass (*Pascopyrum smithii*), intermediate wheatgrass (*Thinopyron intermedium*), and sand dropseed (*Sporobolus cryptandrus*).**

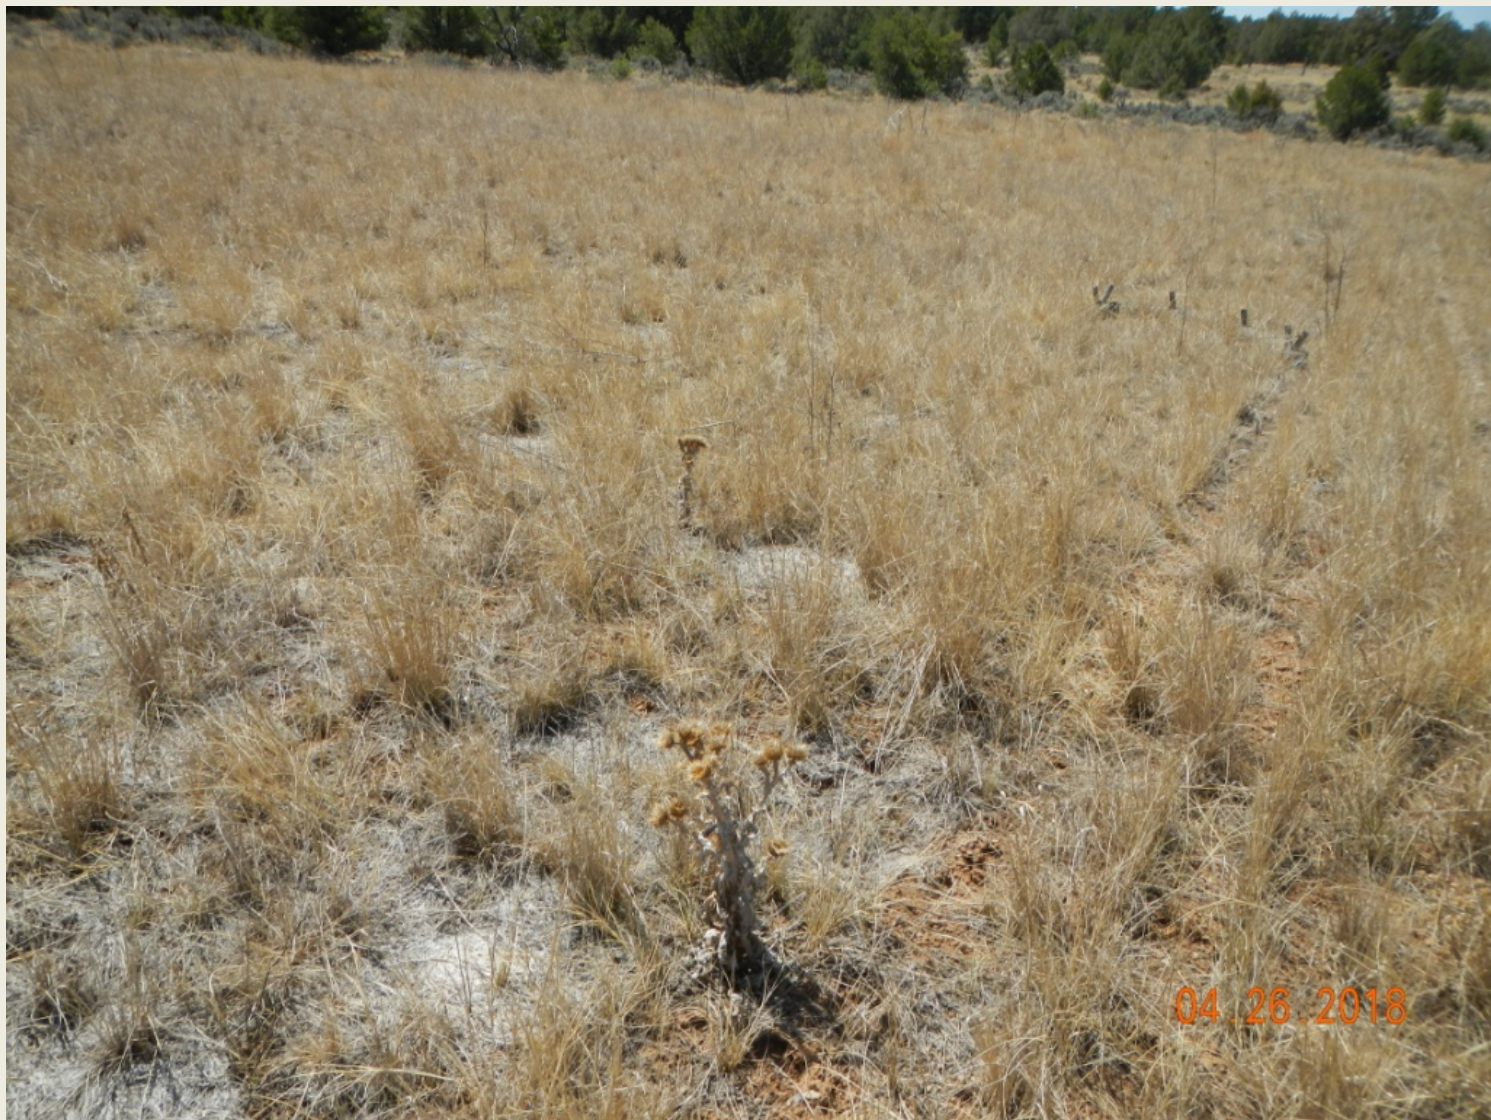
**Photo 4. View of Scotch thistles (*Onopordum acanthium*) within the interim reclamation area.**
