# Construction and Stormwater Inspection

May 23, 2018

Operator: MAGPIE OPERATING, INC- #52530

Location ID: 333081

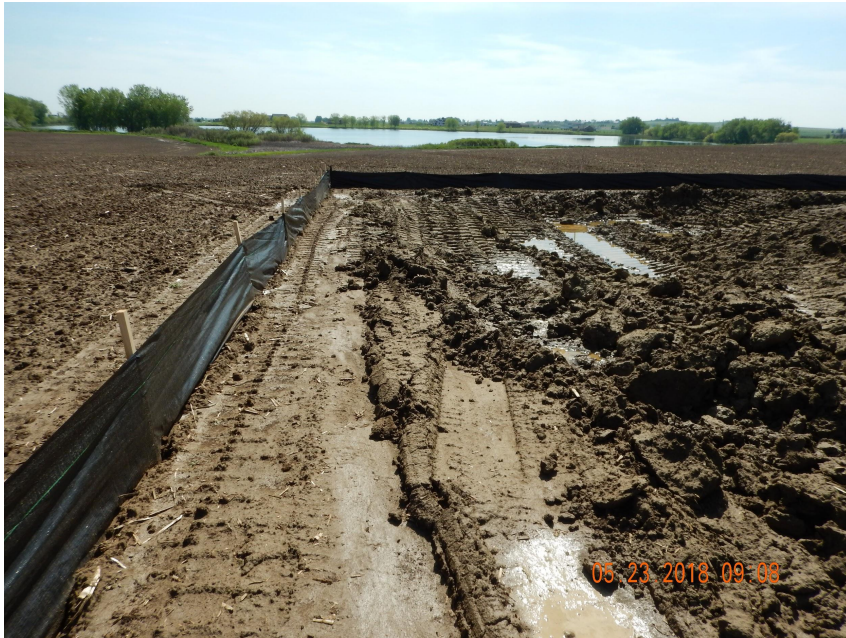
**Photo 1.** Photo taken from the northeastern perimeter of location, facing East. Operator has installed a silt fence BMP around the entire perimeter of the location. Operator still plans to install a sediment trap and make repairs to the ditch and berm BMP.

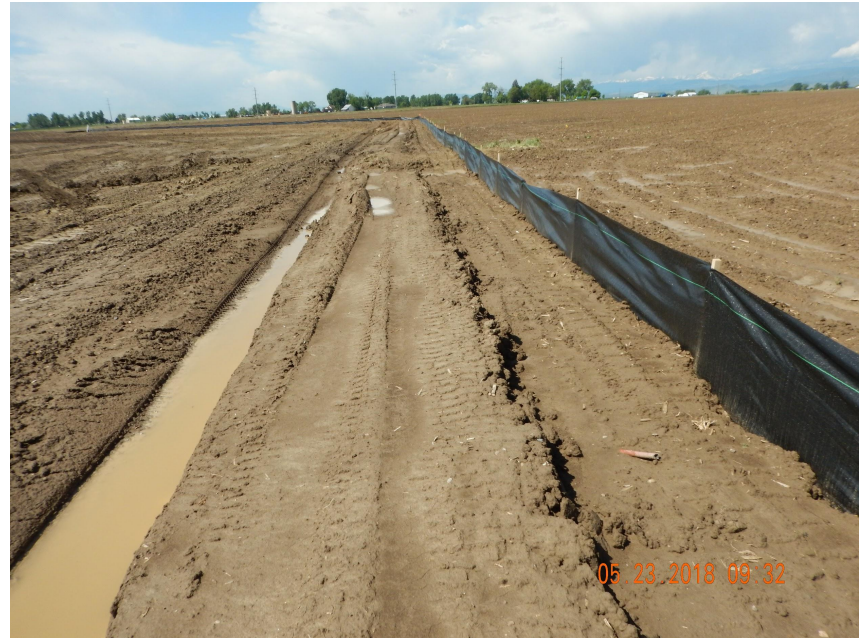
**Photo 2.** Photo taken from the northwestern perimeter of location, facing Southwest. See comments under Photo 1.

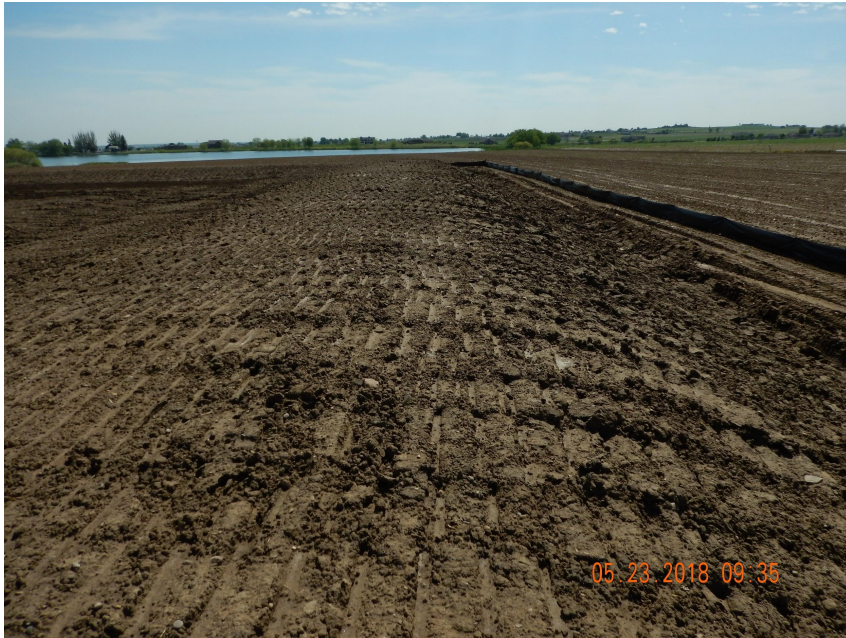
**Photo 3.** Photo taken from the southwestern perimeter of the location, facing East. Photo illustrates the southern topsoil stockpile that has been temporarily stabilized with equipment tracking.

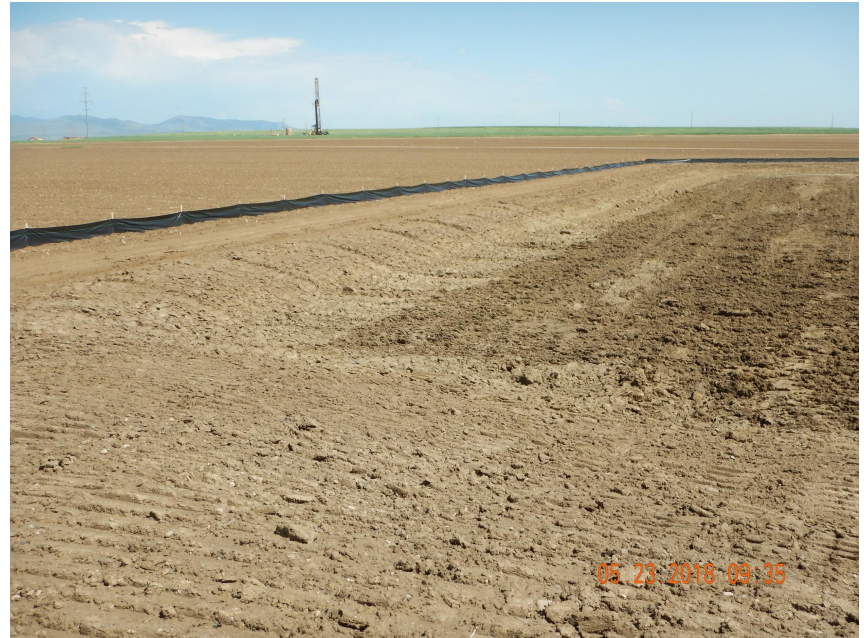
**Photo 4.** Photo taken from the southwestern perimeter of the location, facing North. Photo illustrates the cut from topsoil salvage operations.

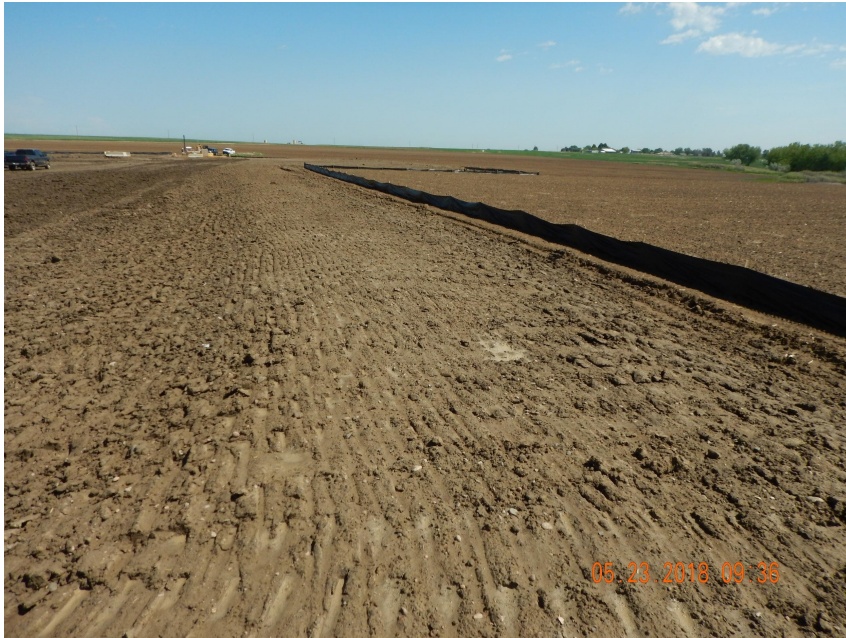
**Photo 5.** Photo taken from the southeastern perimeter of the location, facing North. Photo illustrates the eastern topsoil stockpile that has been temporarily stabilized with equipment tracking.
