# Final Reclamation and Stormwater Inspection

Operator: KERR MCGEE OIL & GAS ONSHORE LP #47120

Location ID: 318780

Inspection Document #: 674902122

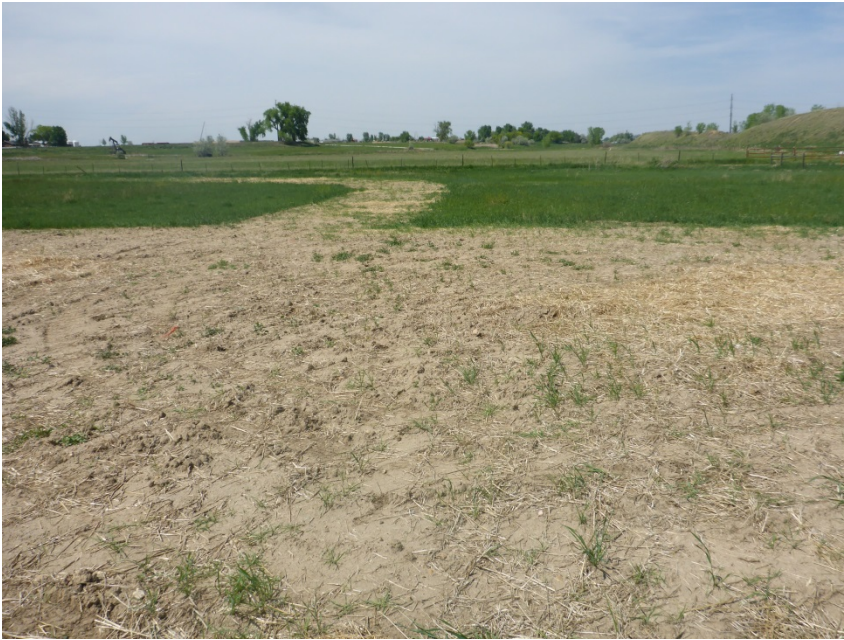
**Photo 1.** Photo taken from the location, facing North. Appears the Operator has performed final reclamation activities, with the evidence of drilling rows, straw crimped mulch, and some perennial grass starting to grow.

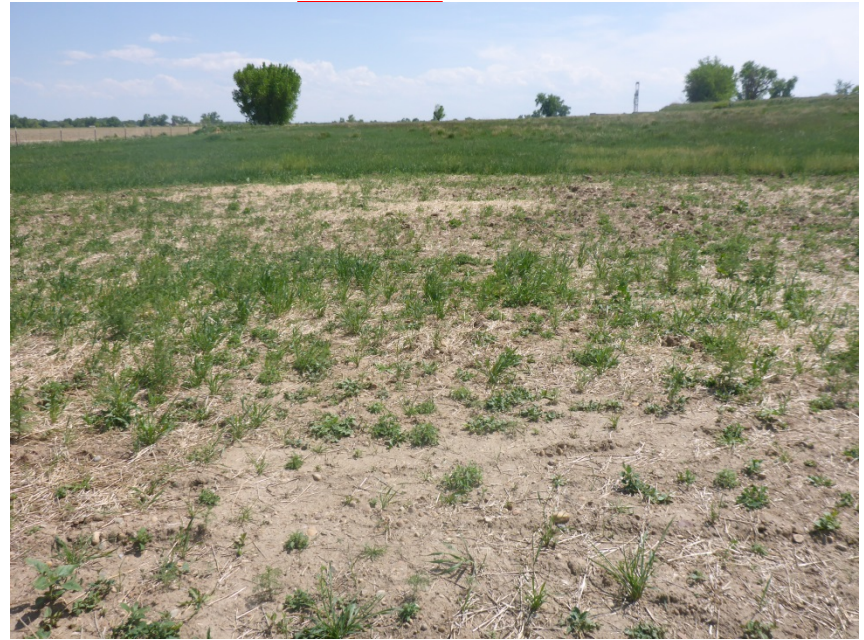
**Photo 2.** Photo taken from the location, facing South. See comments under Photo 1.

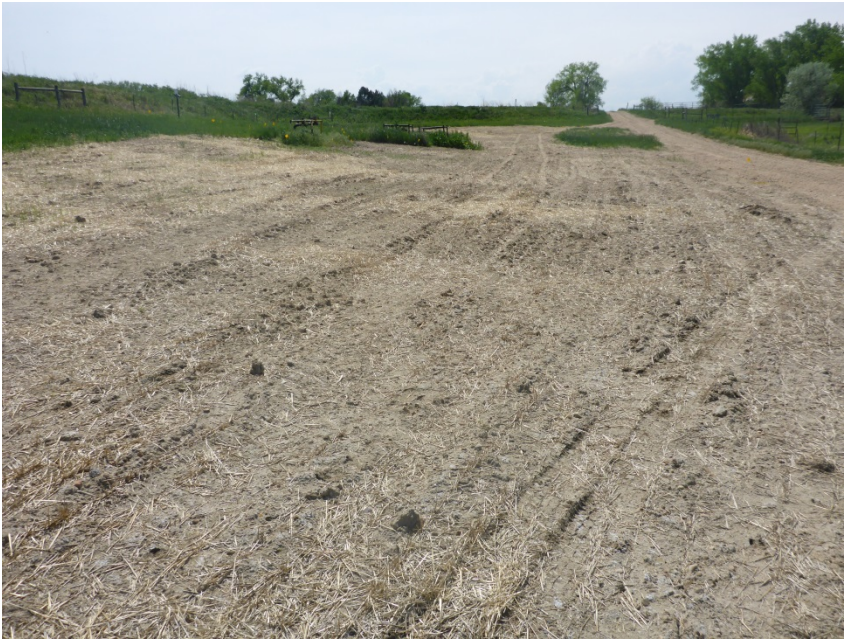
**Photo 3.** Photo taken from the facility area, facing East. along the access road. See comments under Photo 1.

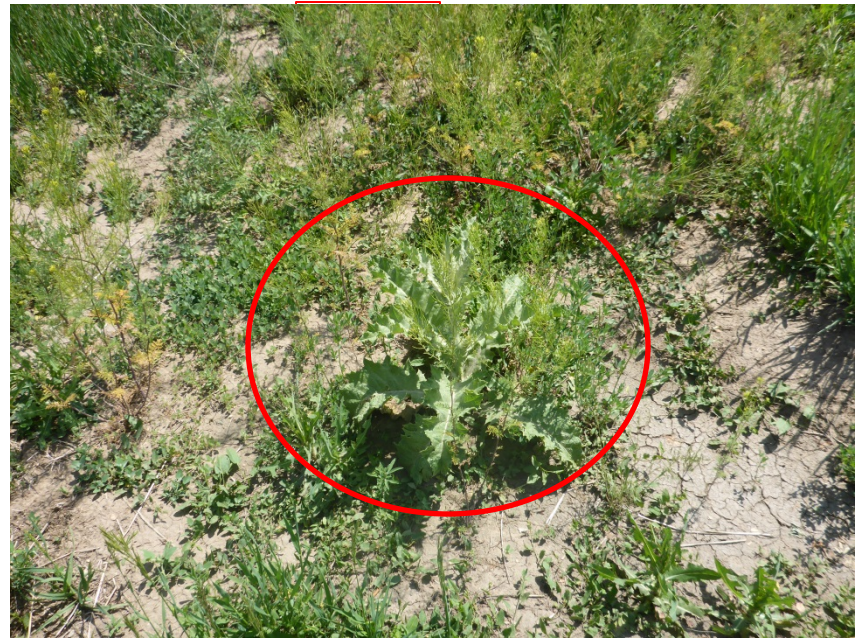
**Photo 4.** Photo taken along east edge of disturbance area, facing North. A List B Colorado Noxious weed species, Scotch thistle (*Onopordum acanthium*), is found at low densities.
