## Inspection Photos

Location Name: Krier 4 Land Application Site, Facility: 454282, Spill ID 455159

Inspection Date: 05/24/2018

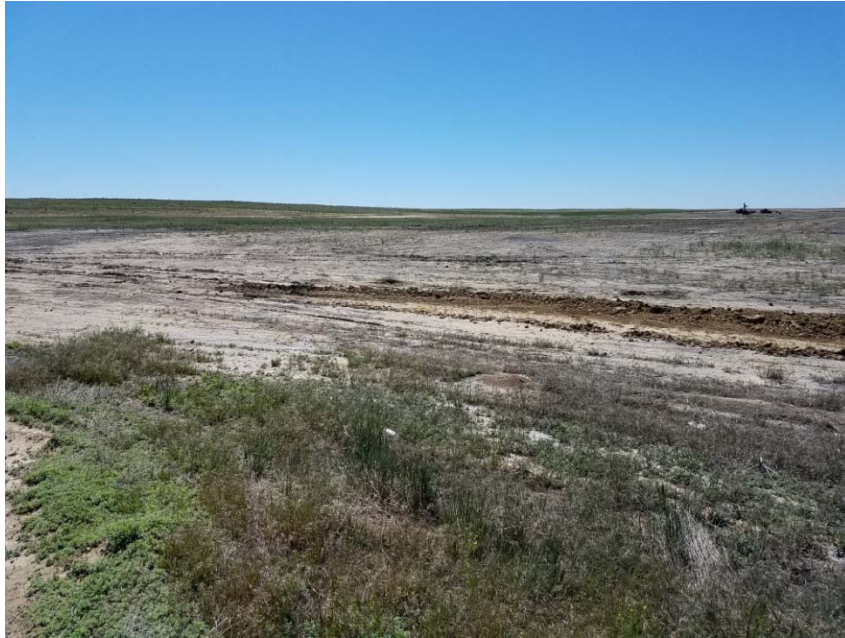
**Photo 1 – From north end of Krier 4 Land Application Area at Carlson 22-1 tank battery looking southeast toward the Carlson 22-1 well.**

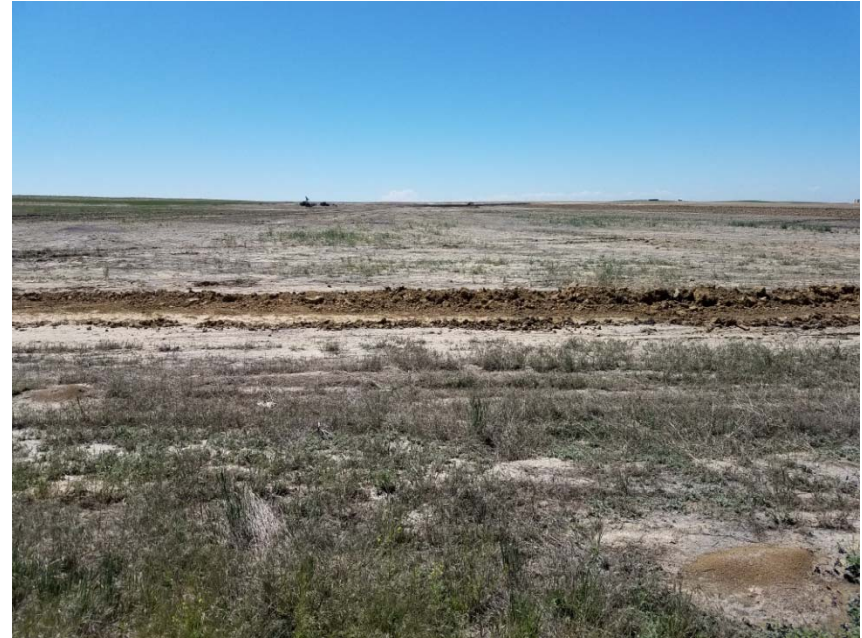
**Photo 2 – From north end of Krier 4 Land Application Area at Carlson 22-1 tank battery looking south. Soil has been roughened in the middle of photo to aid in prevention of offsite liquid migration.**

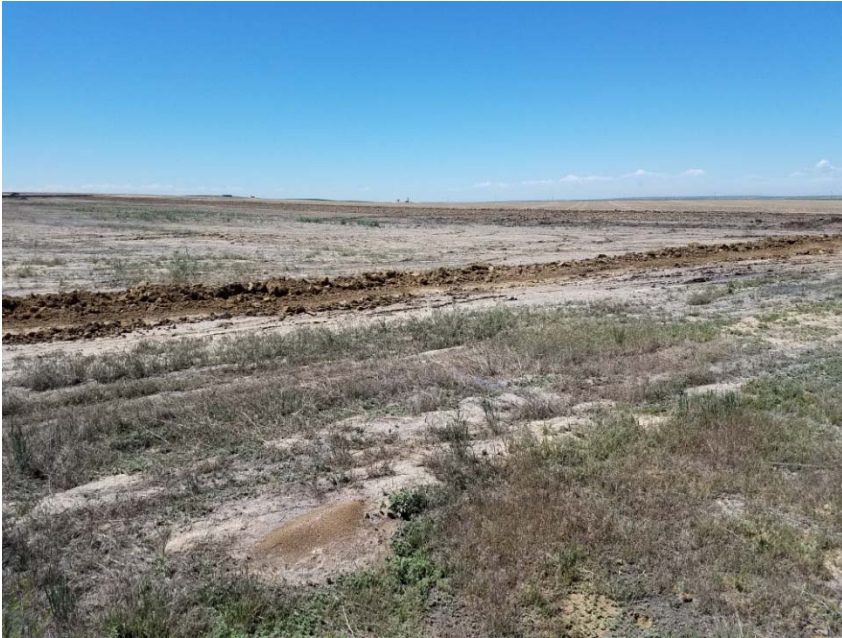
**Photo 3 – From north end of Krier 4 Land Application Area at Carlson 22-1 tank battery looking southwest.**

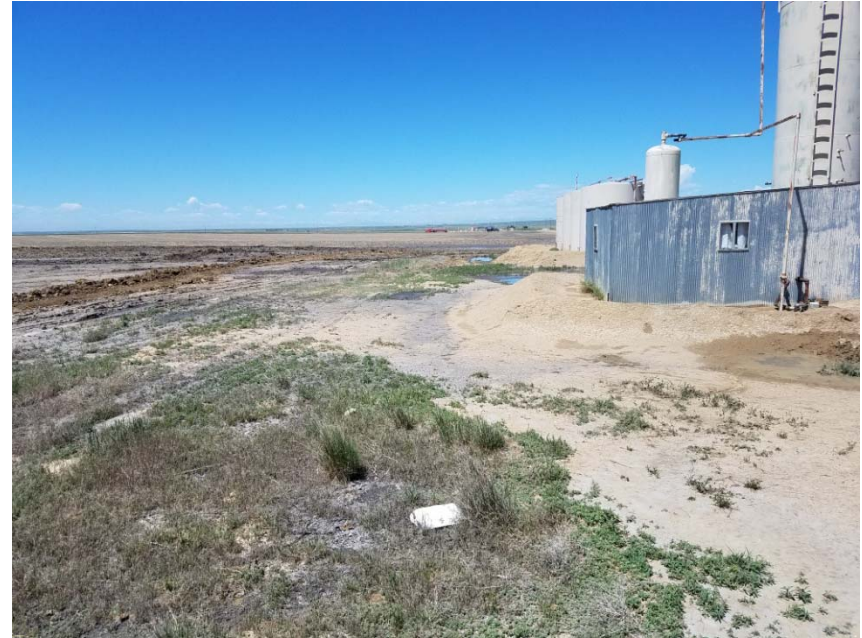
**Photo 4 – On the Carlson 22-1 adjacent to the north end of the Krier 4 land application site. Looking west.**

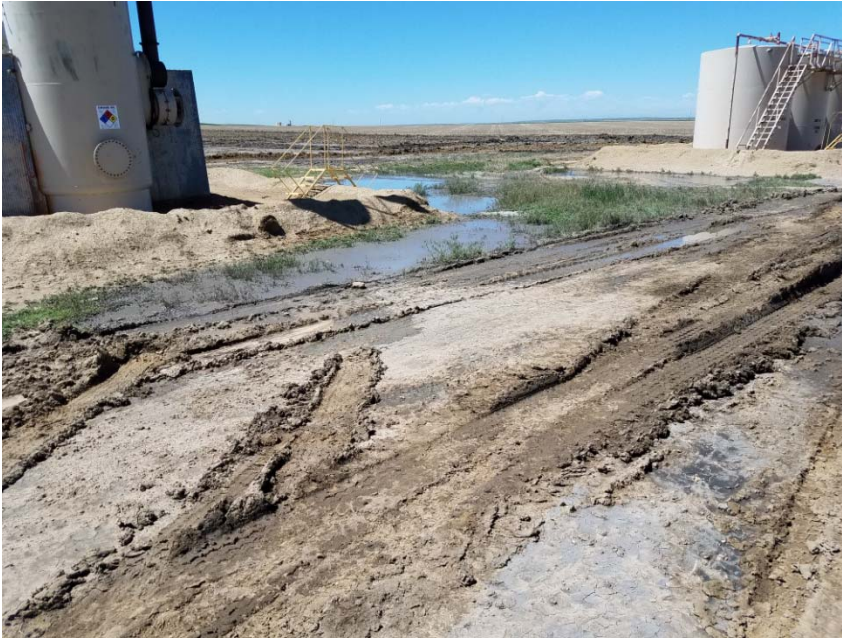
**Photo 5 – On the Carlson 22-1 tank battery, impacted by drilling fluid runoff from the Krier 4 land application site.**

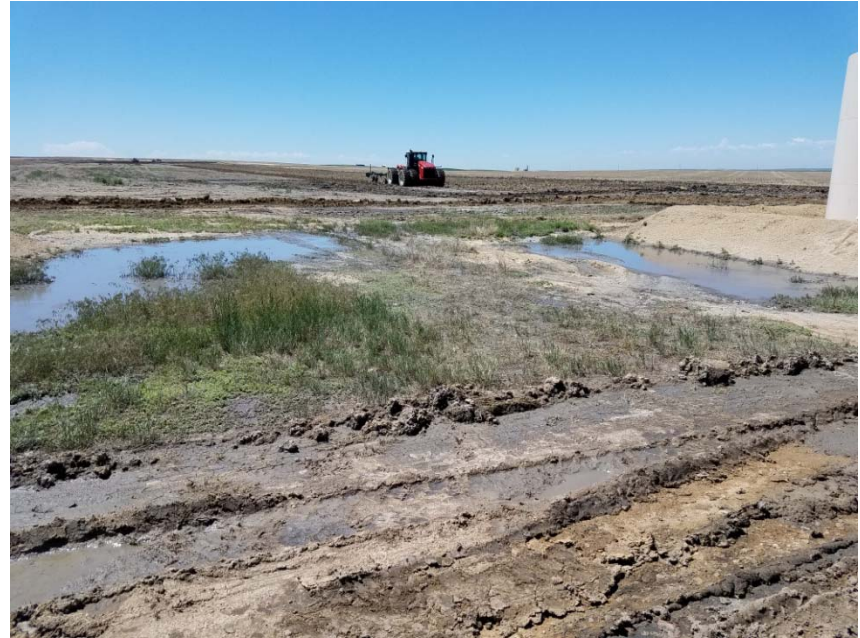
**Photo 6 – On the Carlson 22-1 tank battery, impacted by drilling fluid runoff from the Krier 4 land application site.**

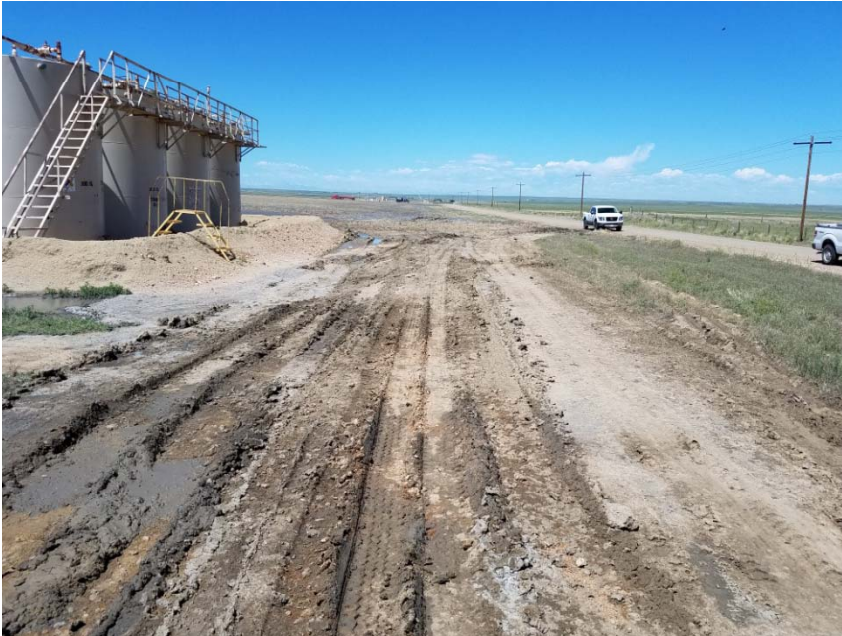
**Photo 7 – On the Carlson 22-1 tank battery, looking west. Weld County Road 68 is on right (north) side of photo.**

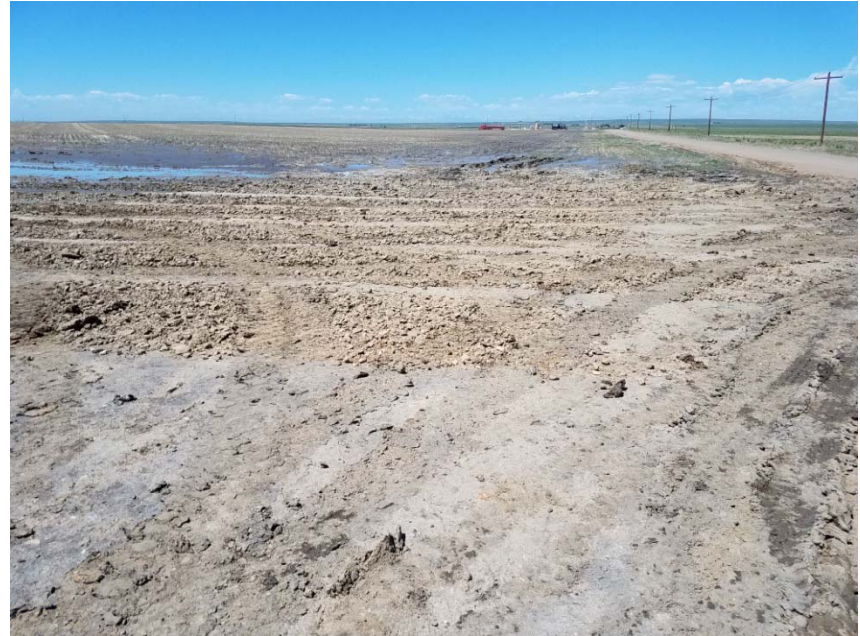
**Photo 8 – Photo from the west side of the Carlson 22-1 tank battery, looking west.**

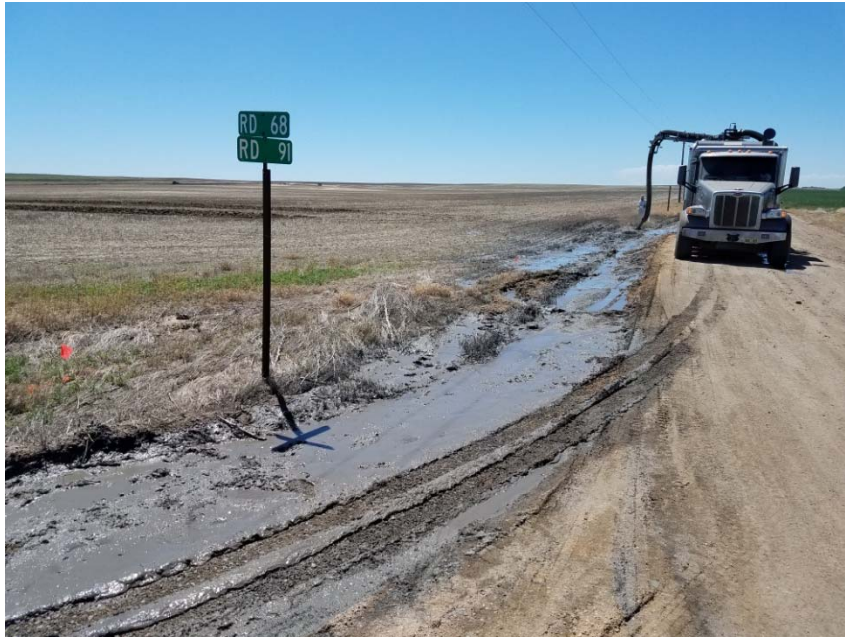
**Photo 9 – Photo at Weld County Roads 68 and 91, looking south. Removal of drilling fluids is underway.**

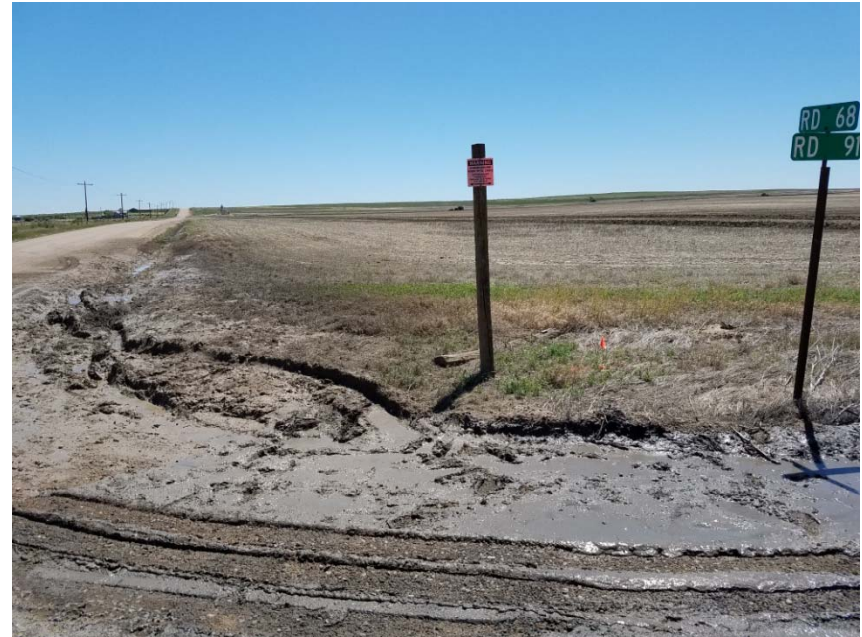
**Photo 10 – Photo at Weld County Roads 68 & 91 looking east down County Road 68.**

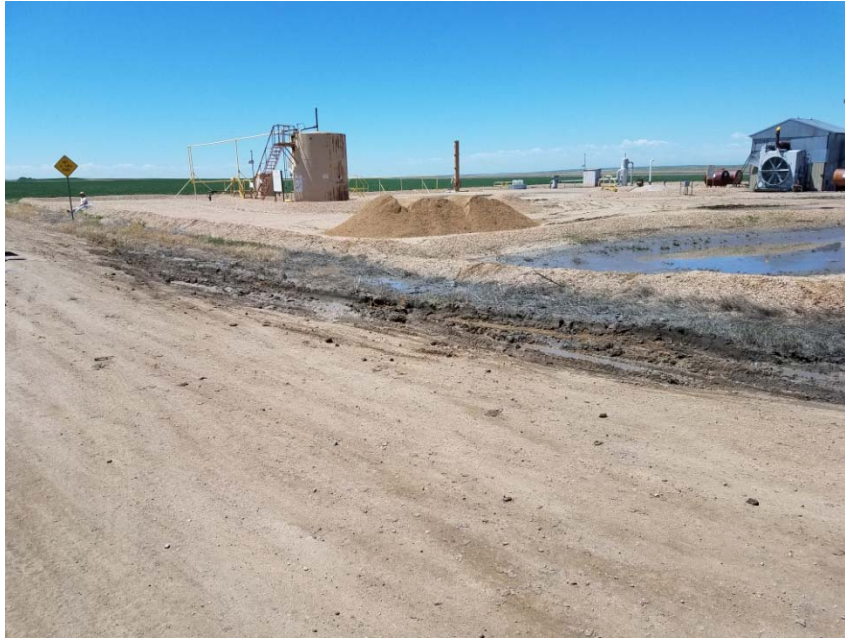
**Photo 11 – Photo at Weld County Roads 68 & 91 looking southwest at DCP Compressor Station impacted by spilled drilling fluids. Drilling fluids and stormwater crossed County Road 91 and impacted the DCP compressor station.**

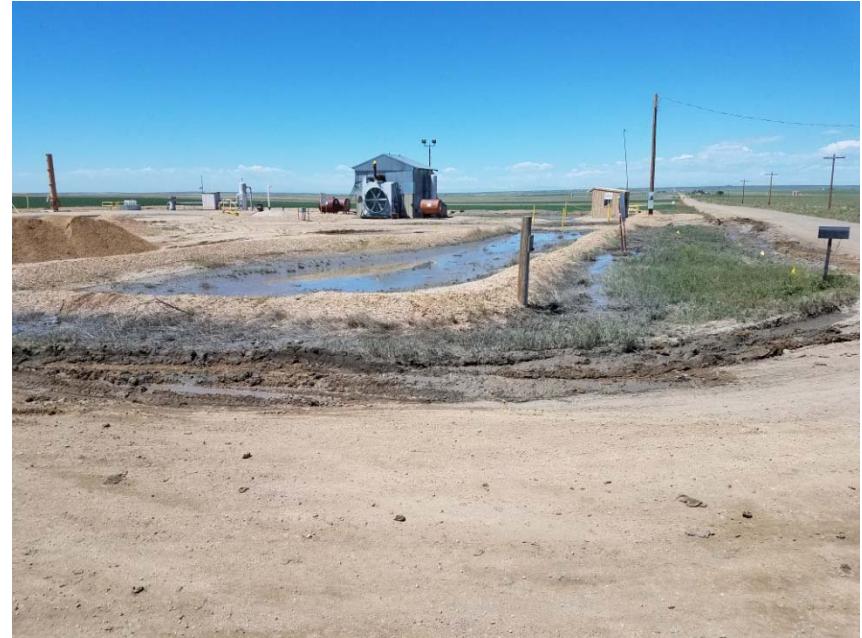
**Photo 12 – Photo at Weld County Roads 68 & 91 looking west at DCP Compressor Station impacted by spilled drilling fluids.**

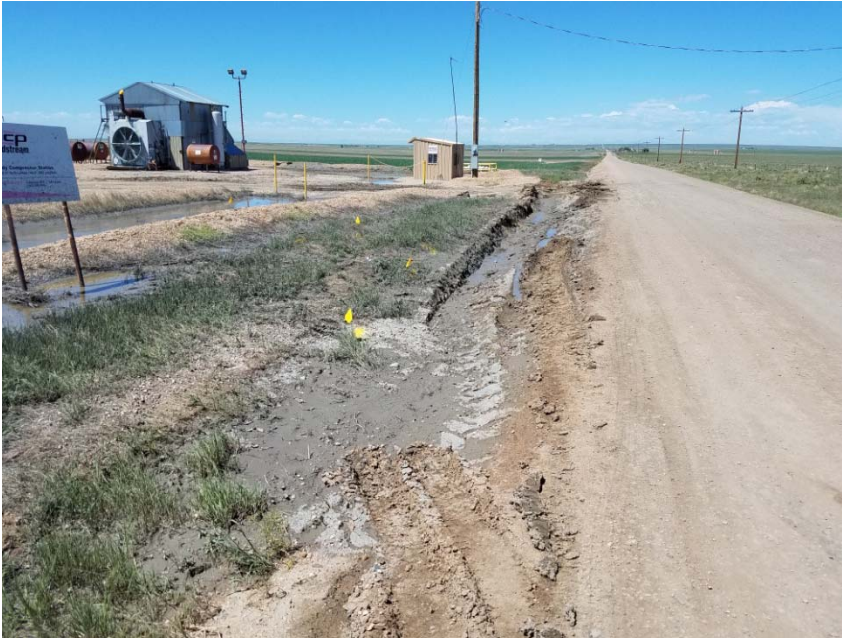
**Photo 13 – Photo looking west along Weld County Road 68. Drilling fluids also flowed along County Road 68 ditch.**

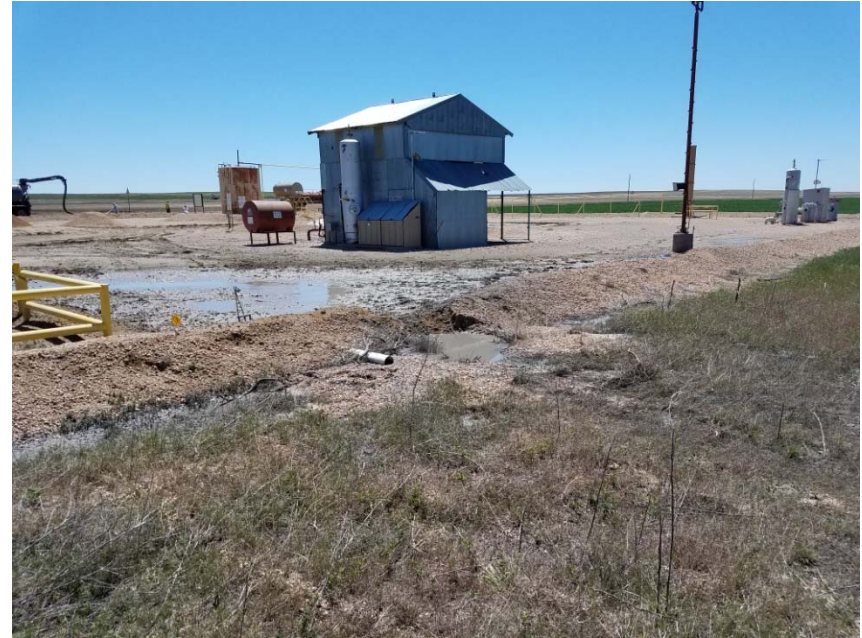
**Photo 14 – Photo from northwest corner of impacted DCP compressor station looking southeast. Compressor station berm was breached by release and stormwater.**

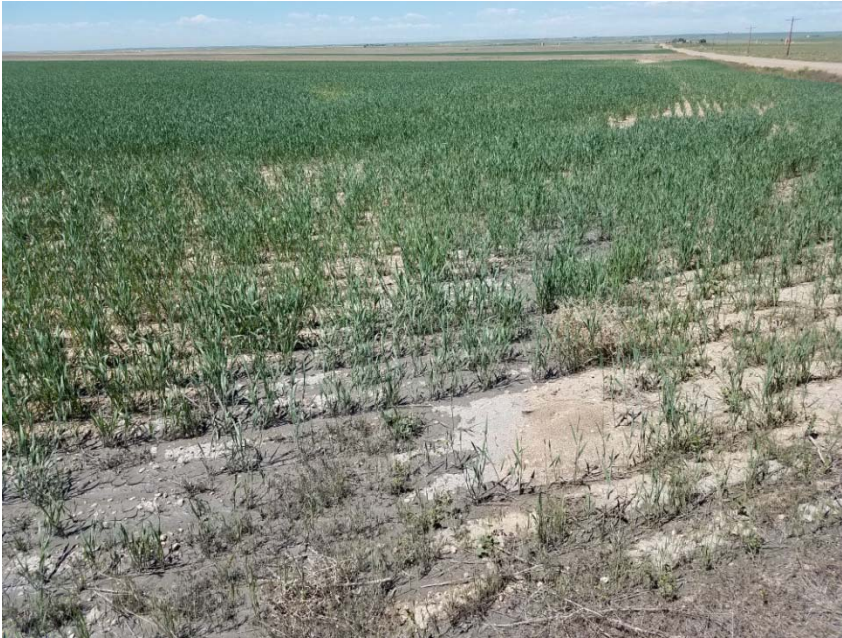
**Photo 15 – Photo from west of DCP compressor station in adjacent wheat field looking west. Drilling fluids impacted dryland wheat west of the DCP compressor station, west of County Road 91.**

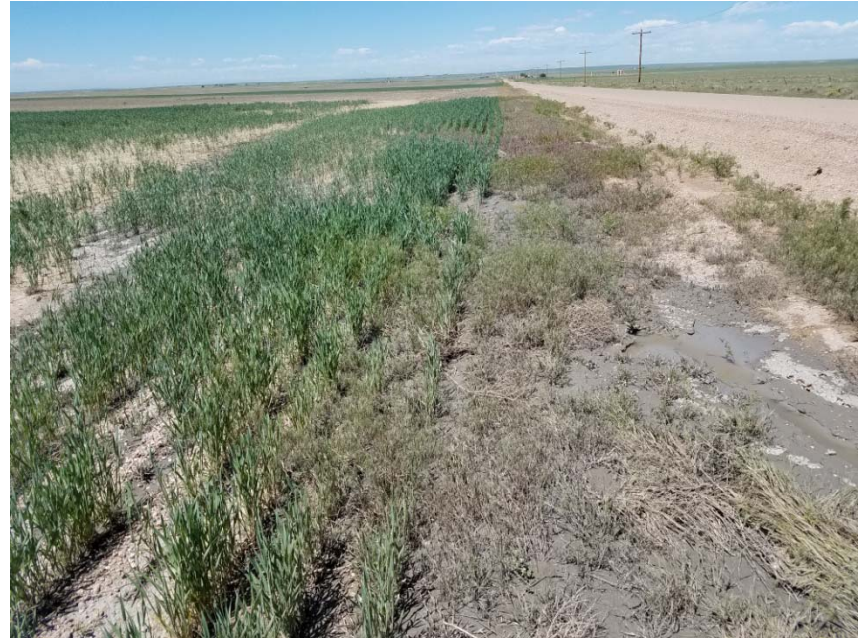
**Photo 16 – Photo from west of DCP compressor station, looking west along County Road 68.**

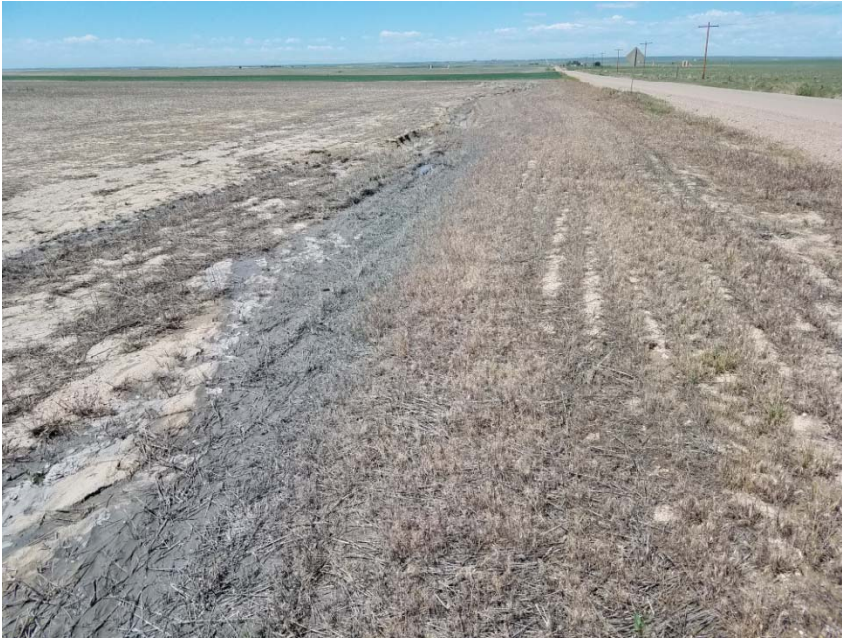
**Photo 17 – Photo further west along County Road 68, looking west.**

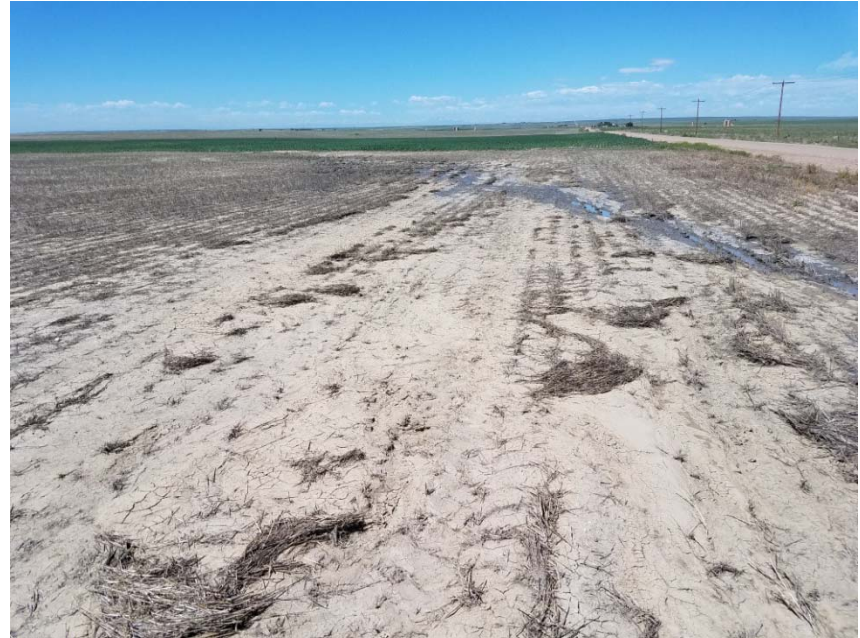
**Photo 18 – Photo in fallowed dryland wheat field west of County Road 91, looking west.**

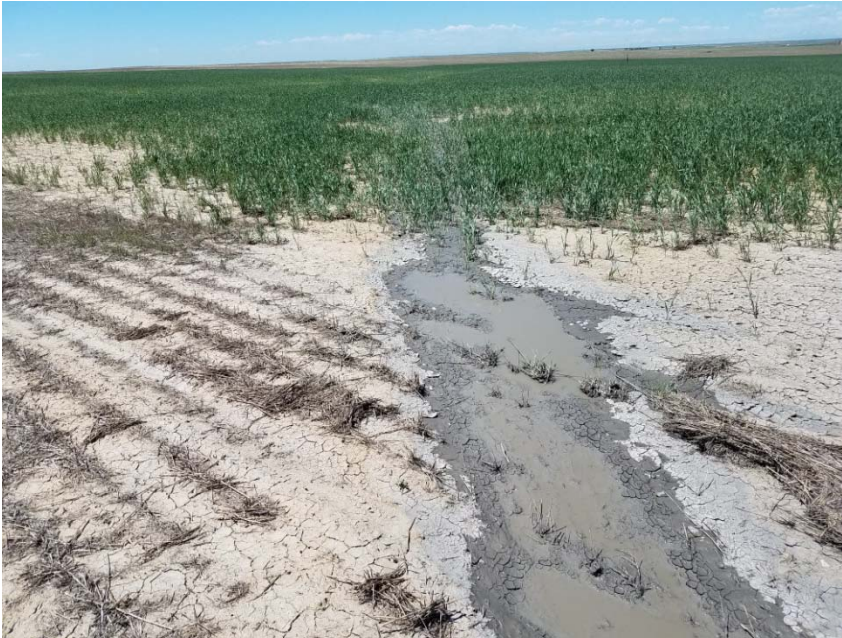
**Photo 19 – Drilling fluids continued to migrate across dryland wheat field west of County Road 91, turning toward southwest. Photo is looking southwest.**

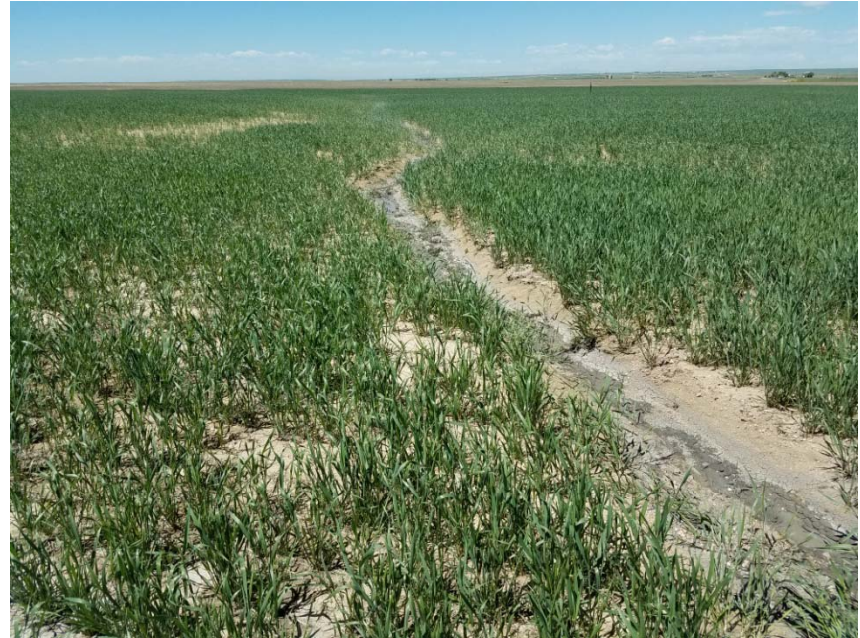
**Photo 20 – Drilling fluids continued to migrate across dryland wheat field west of County Road 91, turning toward southwest. Photo is looking southwest.**

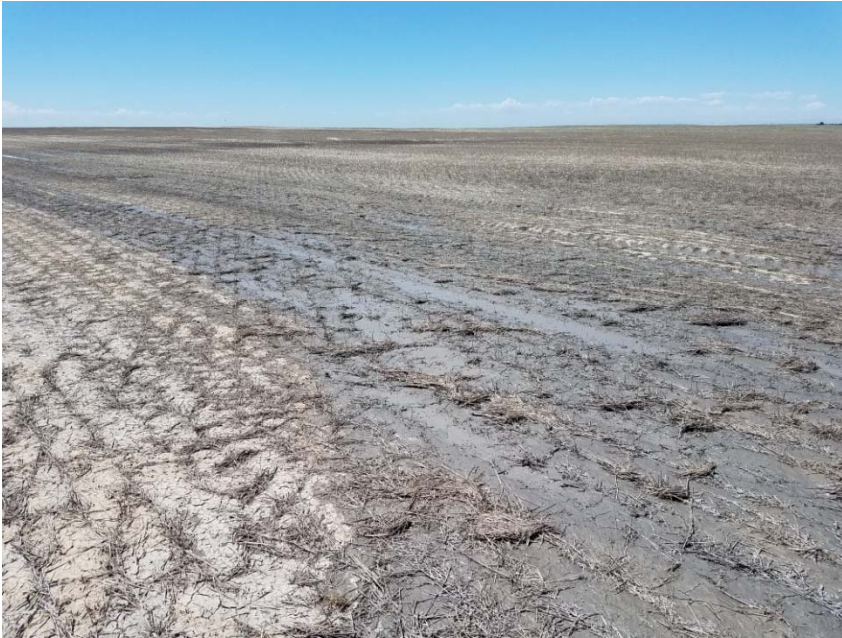
**Photo 21 – Near the termination point in fallowed dryland wheat field approximately 4500 feet west of the Carlson 22-1 tank battery where drilling fluids began to migrate off the Krier 4 land application area. Photo looks southwest.**

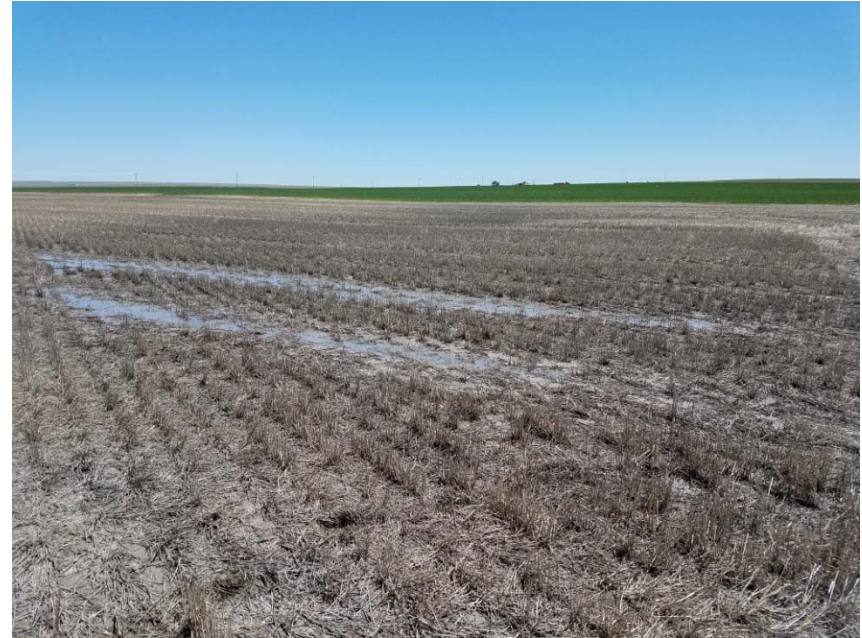
**Photo 22 – The termination point in fallowed dryland wheat field approximately 4500 feet west of the Carlson 22-1 tank battery where drilling fluids began to migrate off the Krier 4 land application area. Photo looks east, northeast at DCP compressor station on horizon.**
