Inspection Photos

Operator: RITCHIE EXPLORATION INC - 74770

Location ID: 309602

Inspection Doc. Number: 682503395

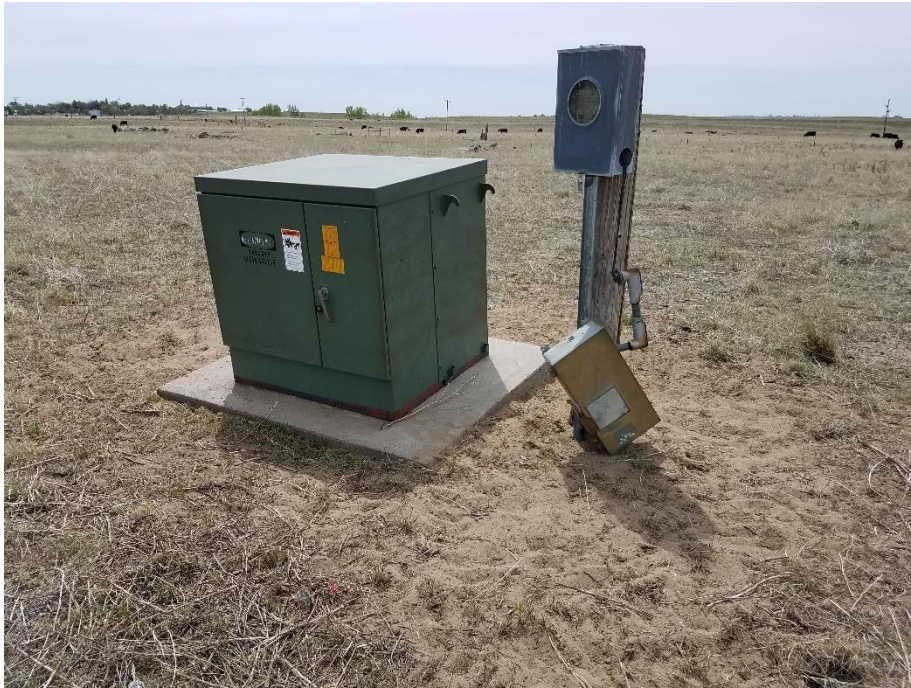
Photo 1: Photo taken from the north end of the well location, facing south. Photo shows utility equipment related to the well remains on location.

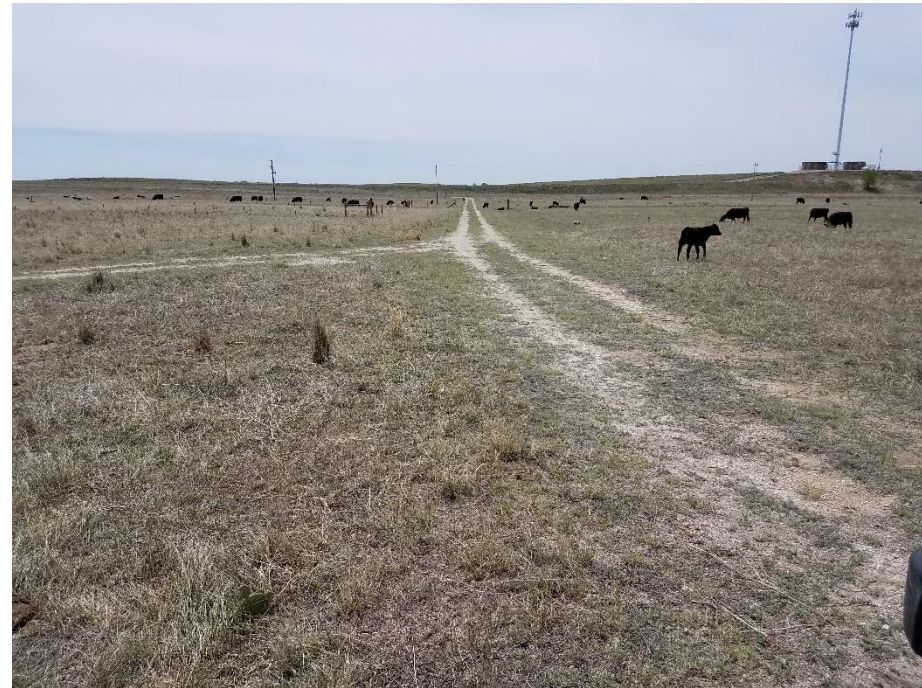
Photo 2: Photo taken from the north end of the location, facing south. Photo shows access road remaining.

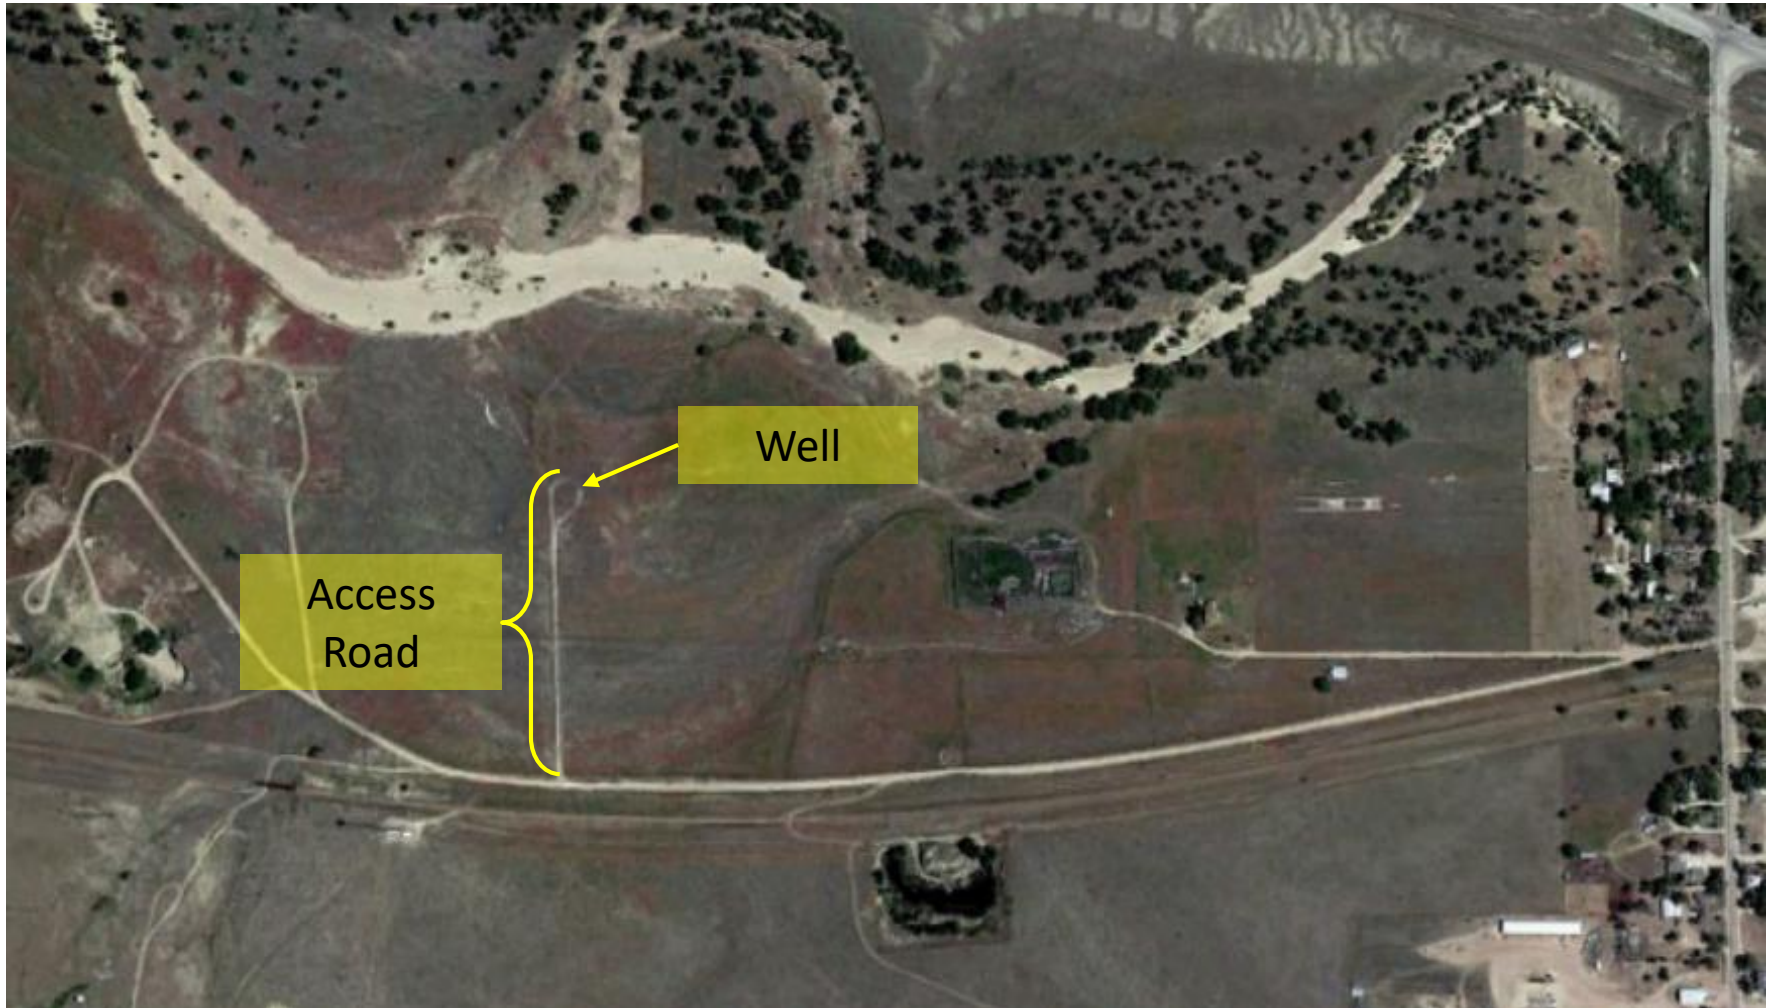
Photo 3: Current available aerial imagery (2017). Photo shows location of well and access road.

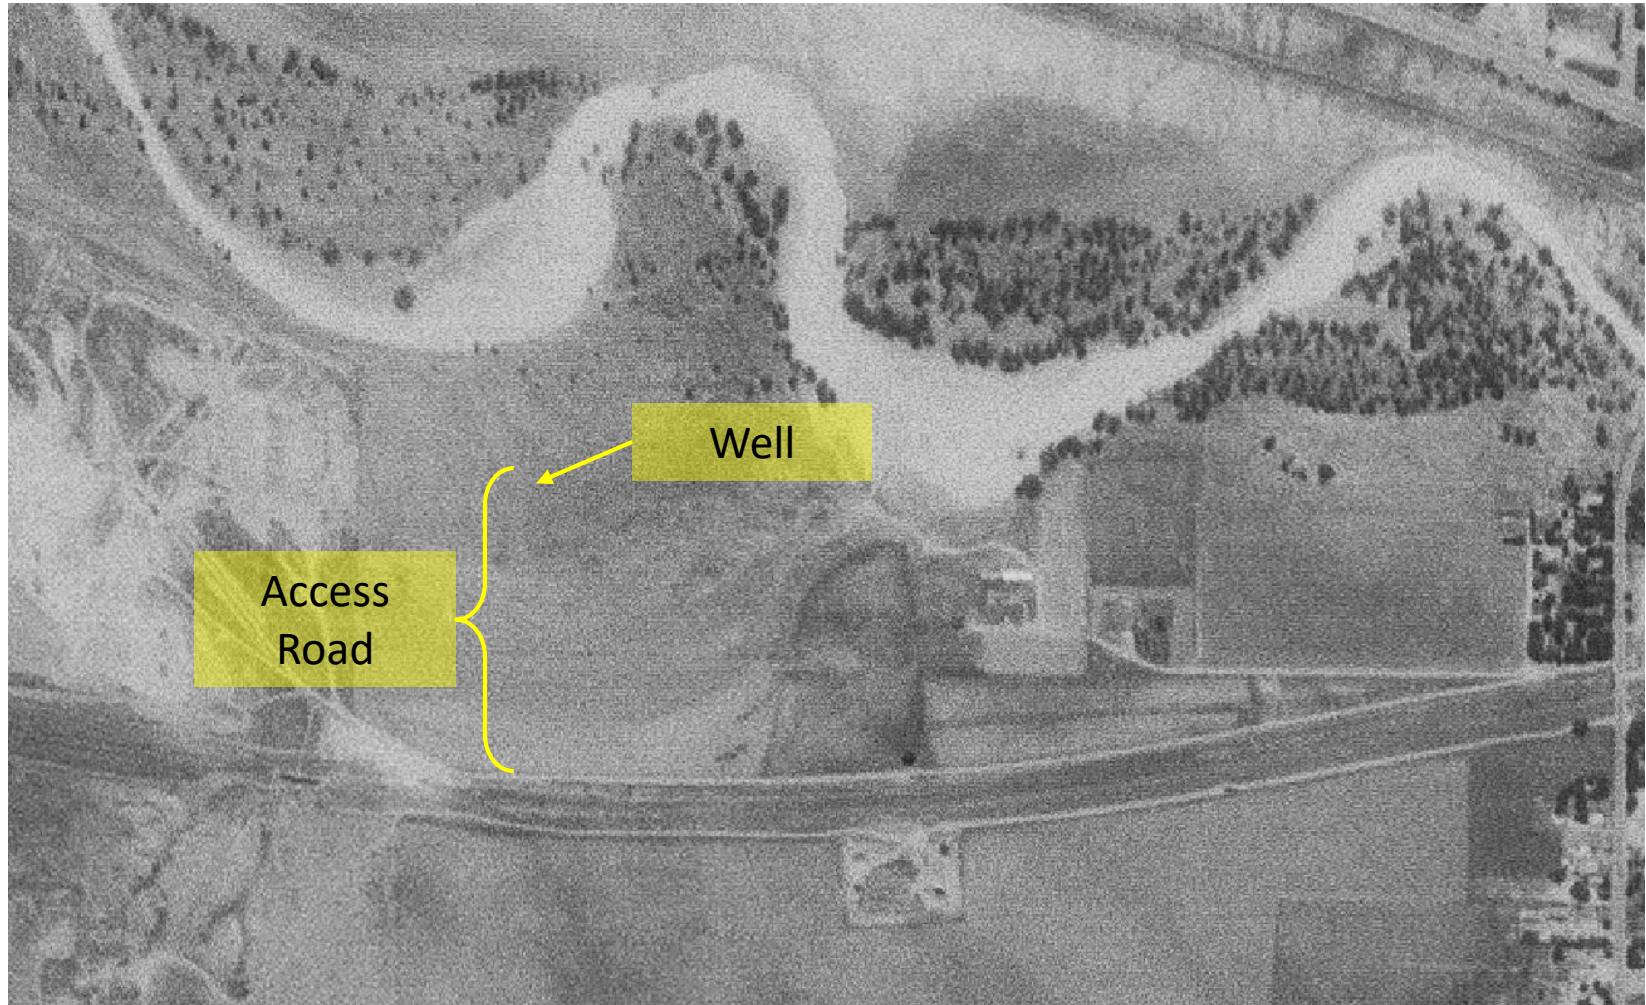
Photo 4: 1975 historic aerial imagery. Records show well was spud 1985. Photo shows access road did not pre-exist the oil and gas location, was constructed for the purpose of oil and gas access, and will require reclamation.
