Final Reclamation and Stormwater Inspection

Operator: PAR PACIFIC HOLDINGS INC # 16800

Location ID: 327424

Inspection Document #: 674902141

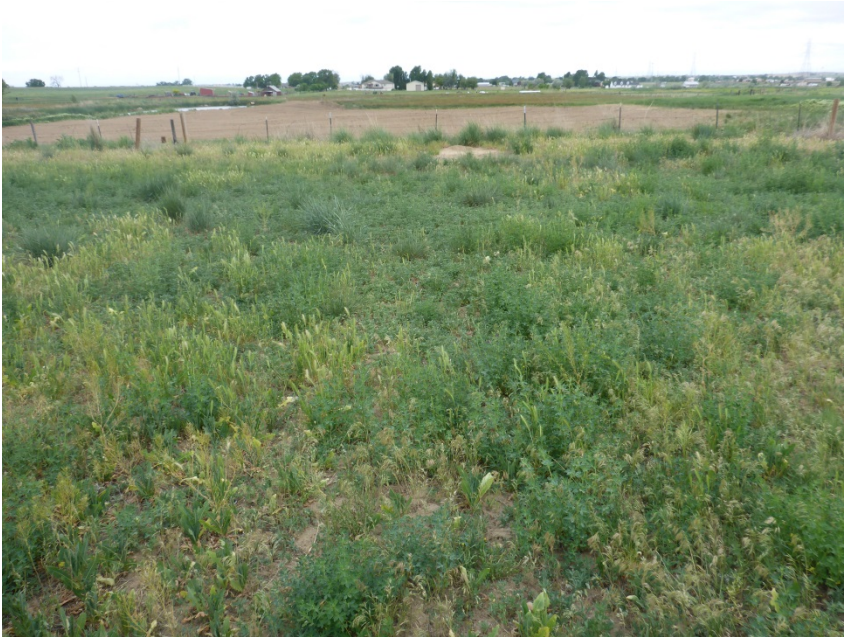
Photo 1. Photo taken from the location, facing West. Appears the Operator has performed final reclamation activities, with all equipment removed, location re-contoured and several years of crop production observed through historical aerial imagery. A List C Colorado Noxious weed species, cheatgrass (*Bromus tectorum*), is found throughout the reclaimed area in moderate to high densities.

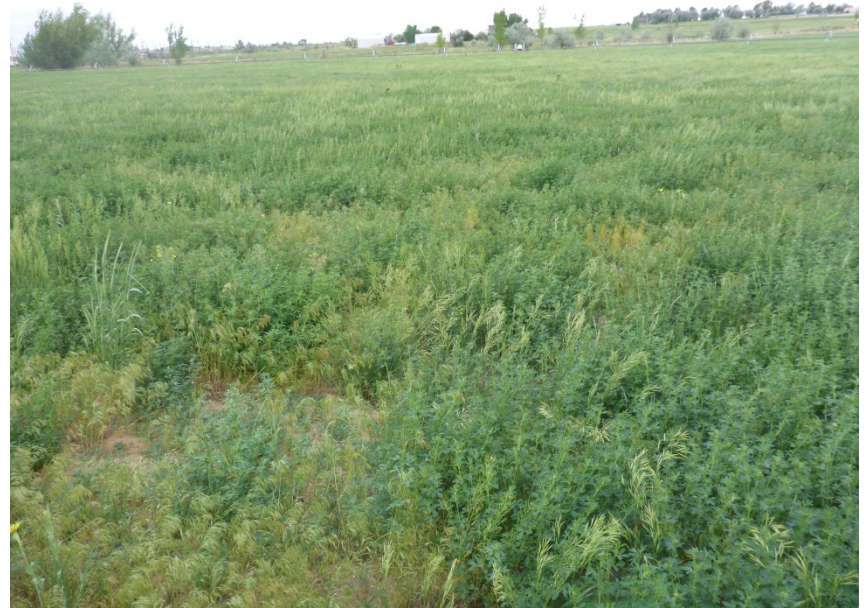
Photo 2. Photo taken from the adjacent reference location, facing East. See comments under Photo 1.

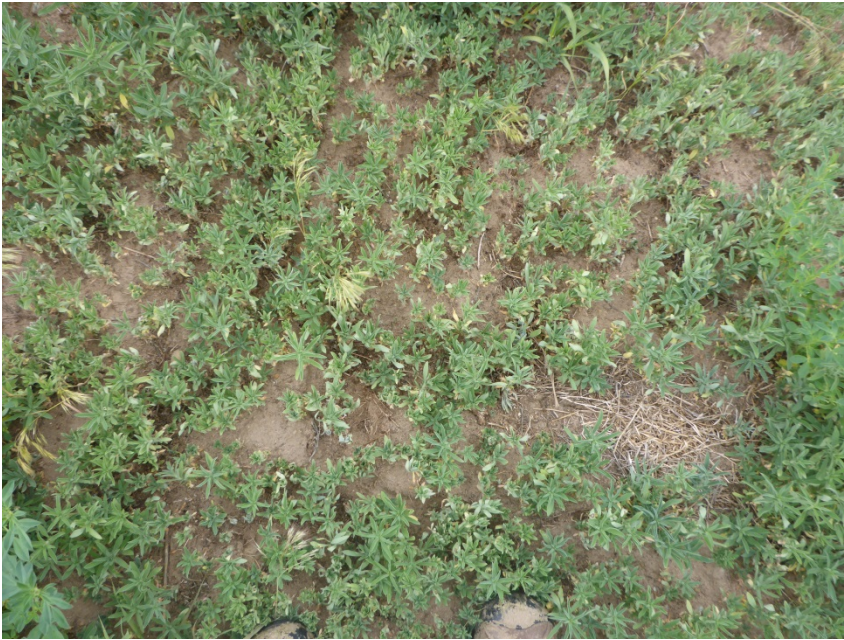
Photo 3. Photo taken from the location. Several large patches of *Kochia scoparia*, a weedy annual, was observed throughout the reclaimed area.

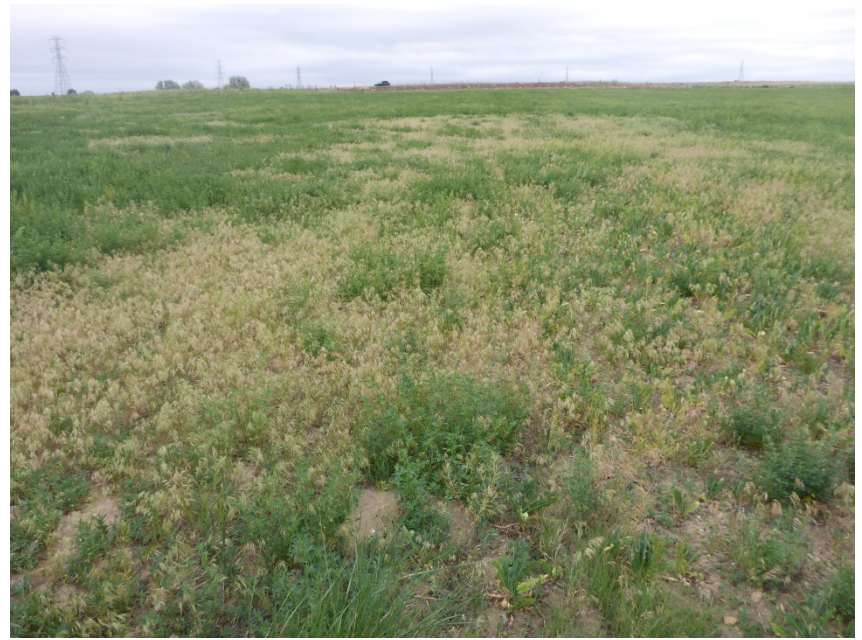
Photo 4. Photo taken from the location, facing East. Several large patches of cheatgrass, a List C Colorado Noxious weed species, was observed throughout the reclaimed area.
