Final Reclamation and Stormwater Inspection

Operator: KERR MCGEE OIL & GAS ONSHORE LP #47120

Location ID: 320377

Adams County, CO

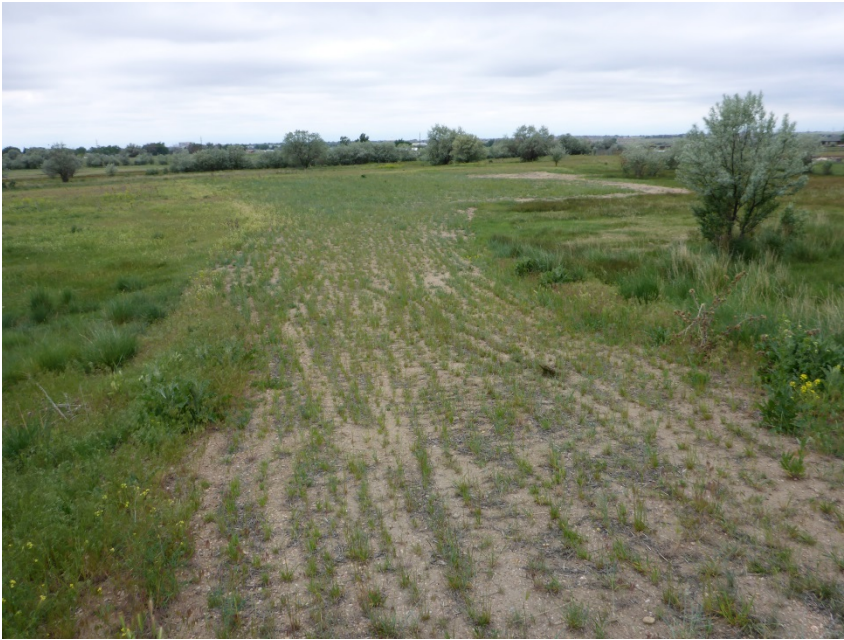
Photo 1. Photo taken from the location entrance, facing West. Appears the Operator has performed final reclamation activities, with the evidence of drilling rows, straw crimped mulch, and perennial grass starting to come in.

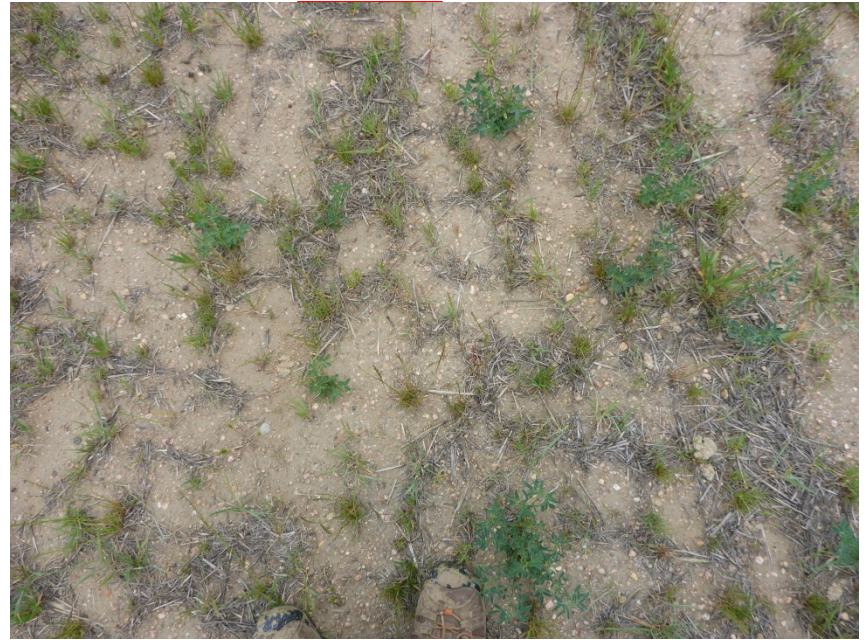
Photo 2. Photo taken from the location along the access road. See comments under Photo 1.

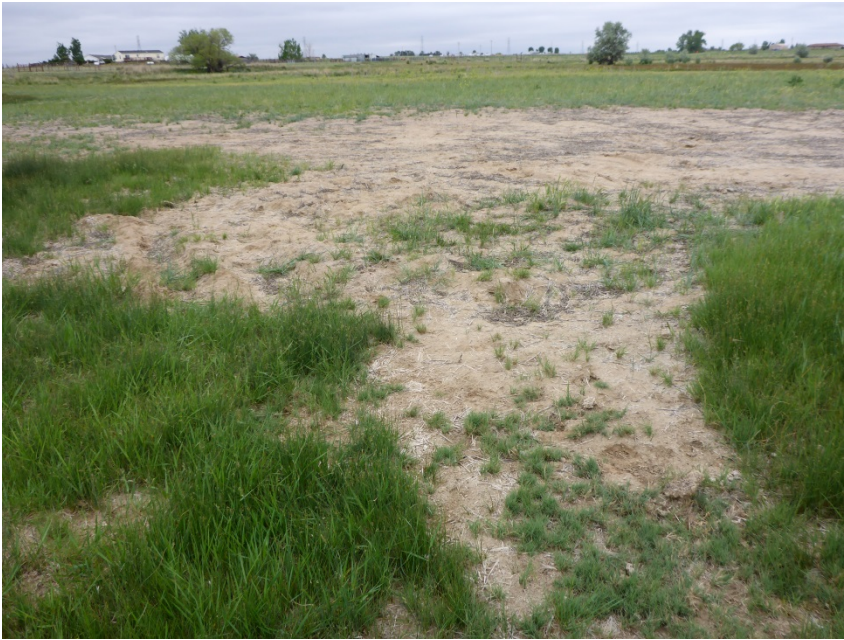
Photo 3. Photo taken from the location, facing North showing a barren patch of the disturbance area where reclamation has failed. See comments under Photo 1.

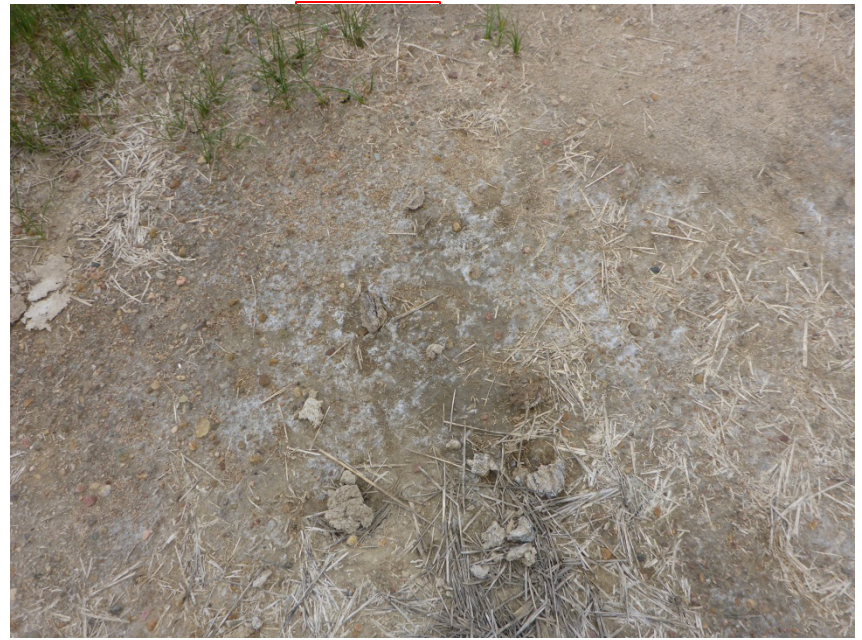
Photo 4. Photo taken along North edge of disturbance area showing the barren ground and potential salt issues.

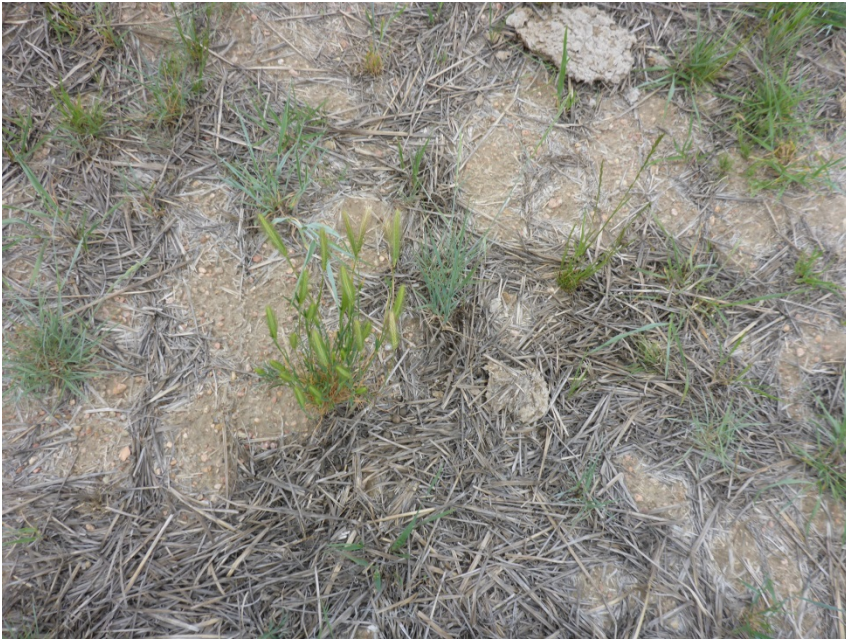
Photo 5. Photo taken from the location. See comments under Photo 1.

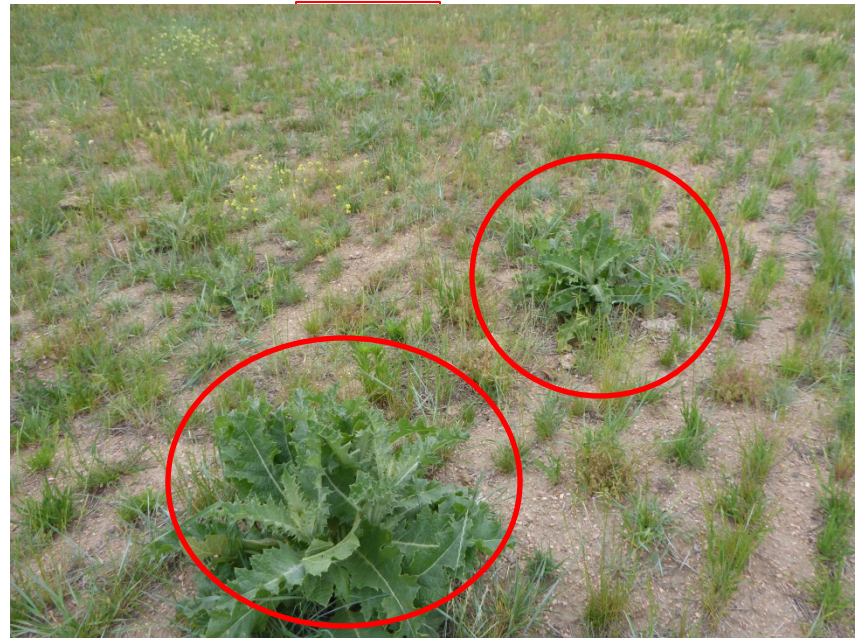
Photo 6. Photo taken within disturbance area. A List B Colorado Noxious weed species, Scotch thistle (*Onopordum acanthium*), is found at low densities.
