# Final Reclamation and Stormwater Inspection

Operator: KERR MCGEE OIL & GAS ONSHORE LP #47120

Location ID: 320364

Inspection Document #: 674902146

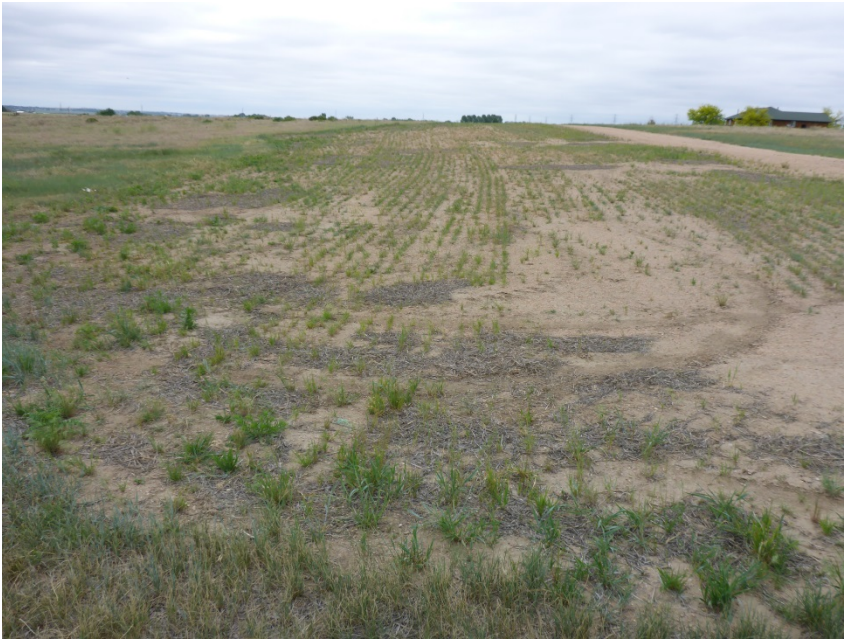
**Photo 1.** Photo taken from the location entrance, facing North showing the facility location. Appears the Operator has performed final reclamation activities, with the evidence of drilling rows, straw crimped mulch, and perennial grass starting to come in.

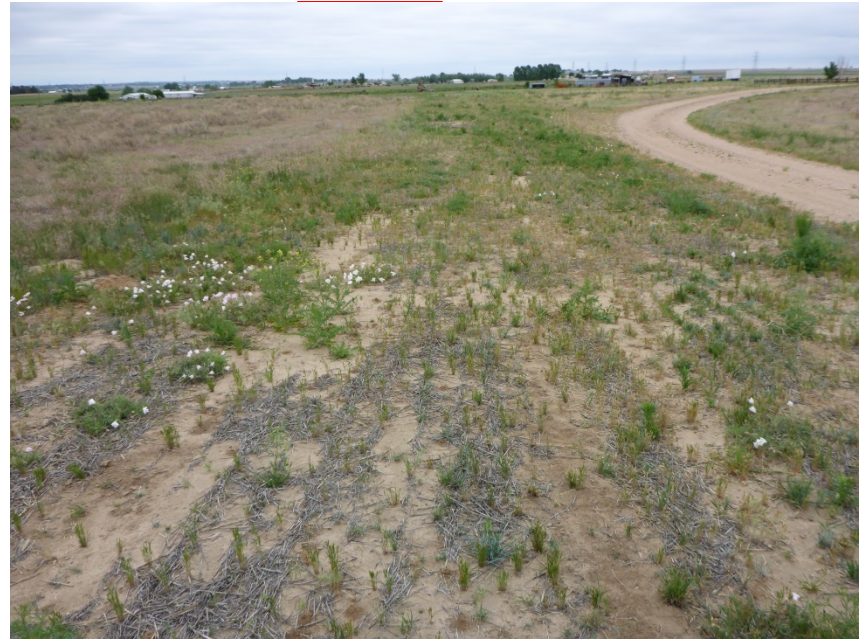
**Photo 2.** Photo taken from the location along the access road, facing North. See comments under Photo 1.

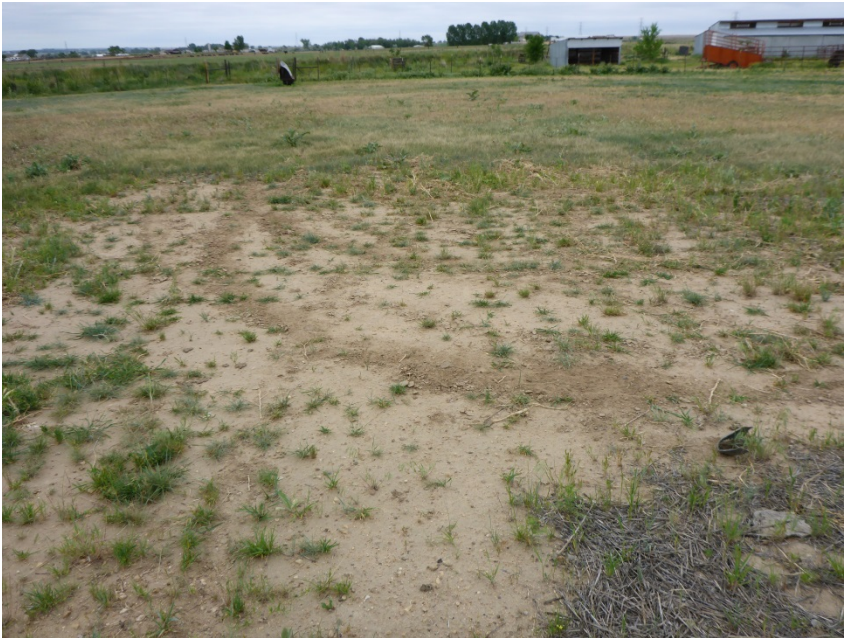
**Photo 3.** Photo taken from the location, facing North showing a barren patch of the disturbance area where reclamation has not been as successful. See comments under Photo 1.

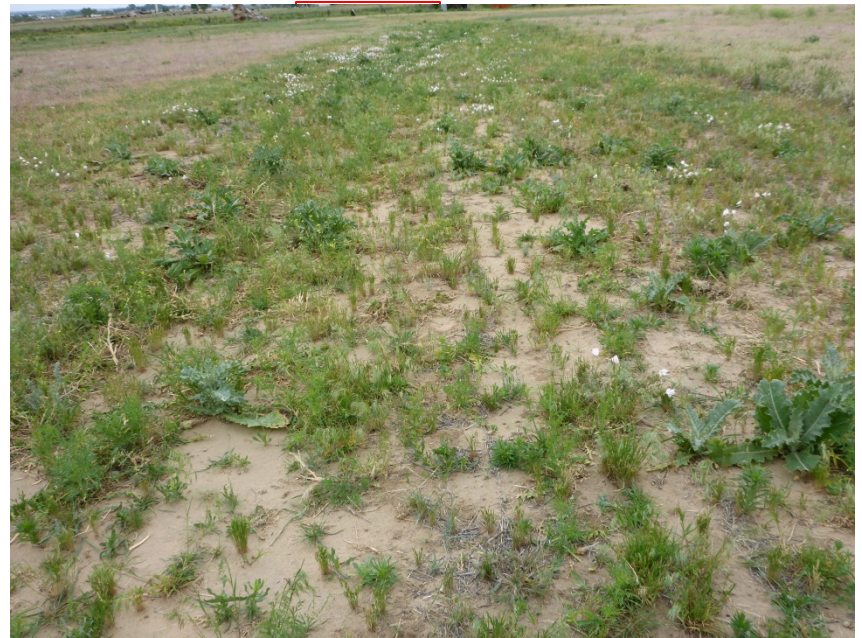
**Photo 4.** Photo taken along access road, facing North. A List B Colorado Noxious weed species, Scotch thistle (*Onopordum acanthium*), is found at high densities along the access road and on location.
