# Final Reclamation and Stormwater Inspection

Operator: KERR MCGEE OIL & GAS ONSHORE LP #47120

Location ID: 320397

Inspection Document #: 674902147

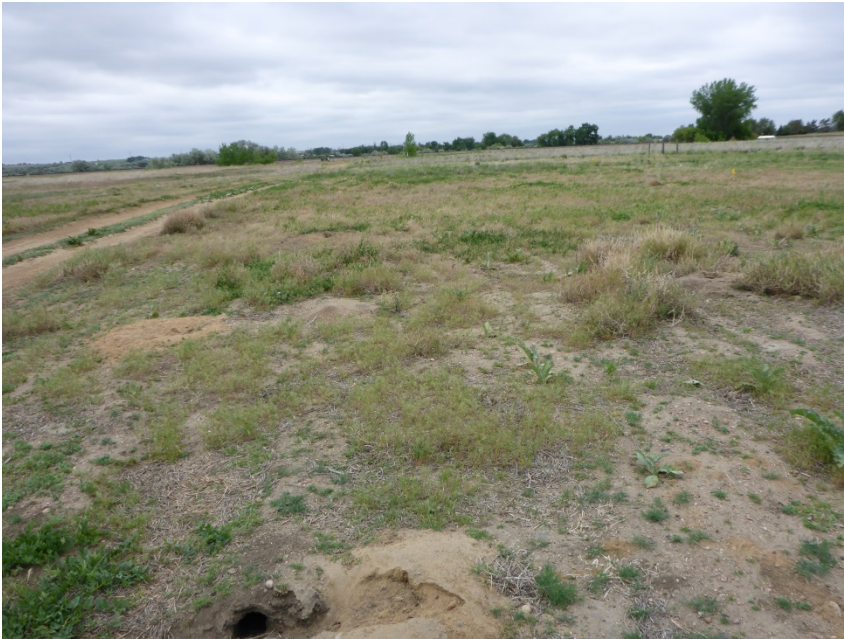
**Photo 1.** Photo taken from the location, facing Southeast. Appears the Operator has performed final reclamation activities on the well location, with the evidence of drilling rows, straw crimped mulch. However, the majority of the site is covered in weedy, annual vegetation which includes but not limited to field bindweed, Russian thistle, cheatgrass and kochia, with little perennial grass cover establishment. A List B Colorado Noxious weed species, Scotch thistle (*Onopordum acanthium*), is found at low densities throughout the site .

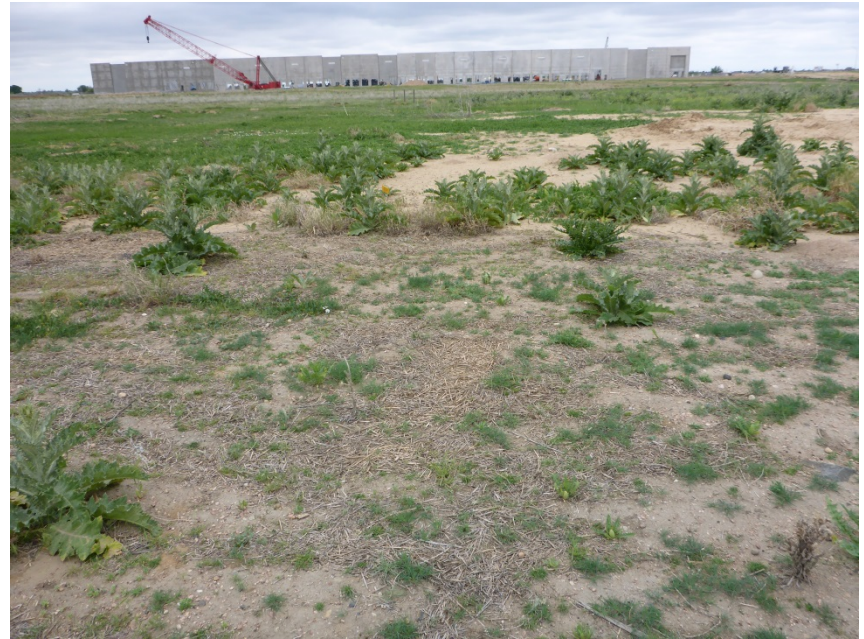
**Photo 2.** Photo taken from the location, facing Southwest. See comments under Photo 1.

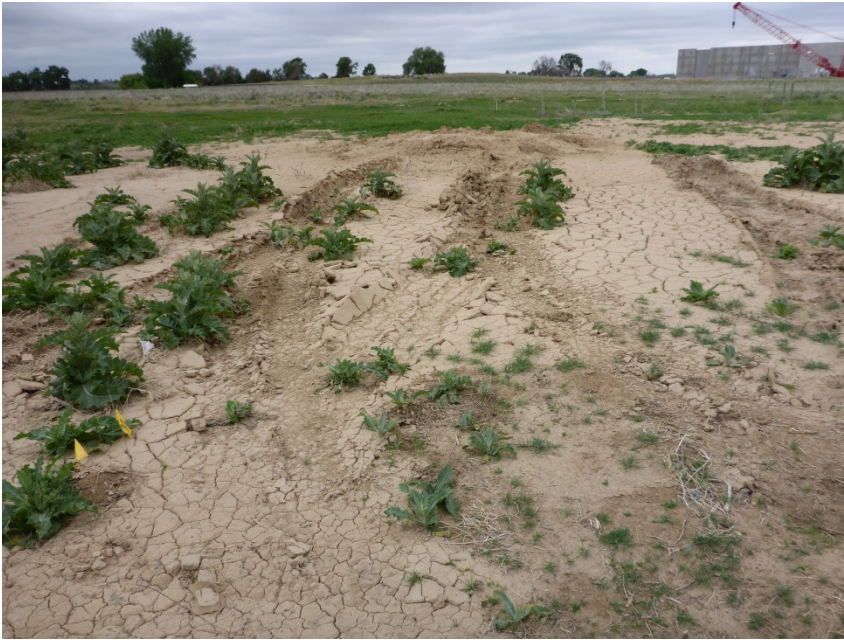
**Photo 3.** Photo taken from the location, facing Southeast showing a barren patch of the disturbance area where reclamation has not been completed and is full of noxious and annual weeds that is adjacent to the location. See comments under Photo 1.

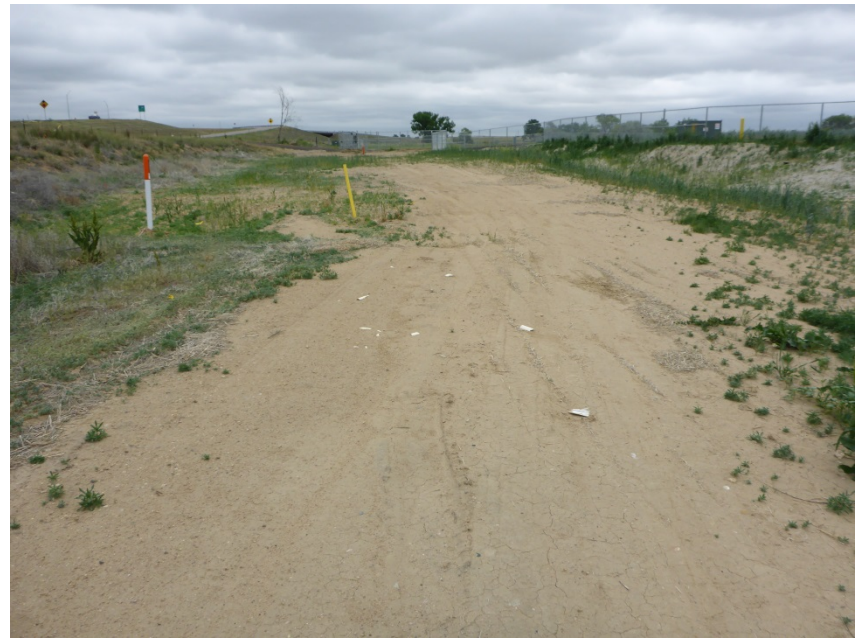
**Photo 4.** Photo taken along access road, facing Northeast. The majority of the access road remains with no reclamation activities.

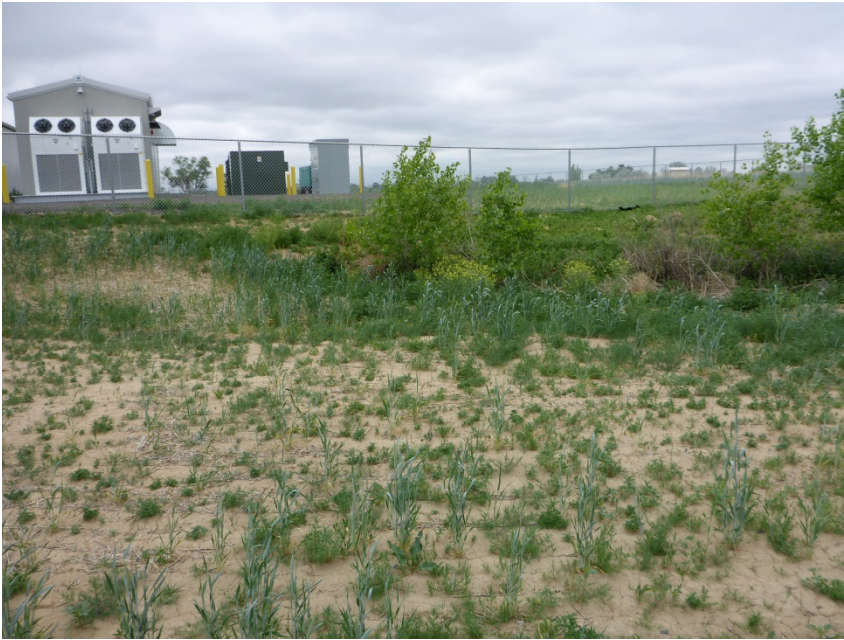
**Photo 5.** Photo taken from the facility location, facing Southeast. Appears the Operator has performed final reclamation activities on the facility location, with the evidence of drilling rows, straw crimped mulch. See comments under Photo 1.

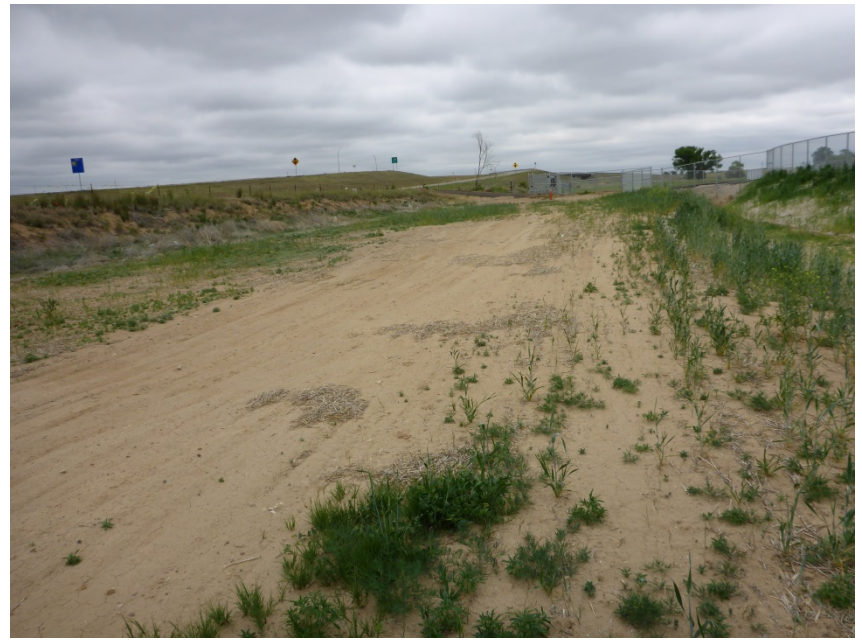
**Photo 6.** Photo taken from the facility location, facing Northeast showing the access road through the facility location has not been reclaimed.
