# Inspection Photos

Operator: BEREN CORPORATION - 7800

Location ID: 317052

Inspection Doc. Number: 682503399

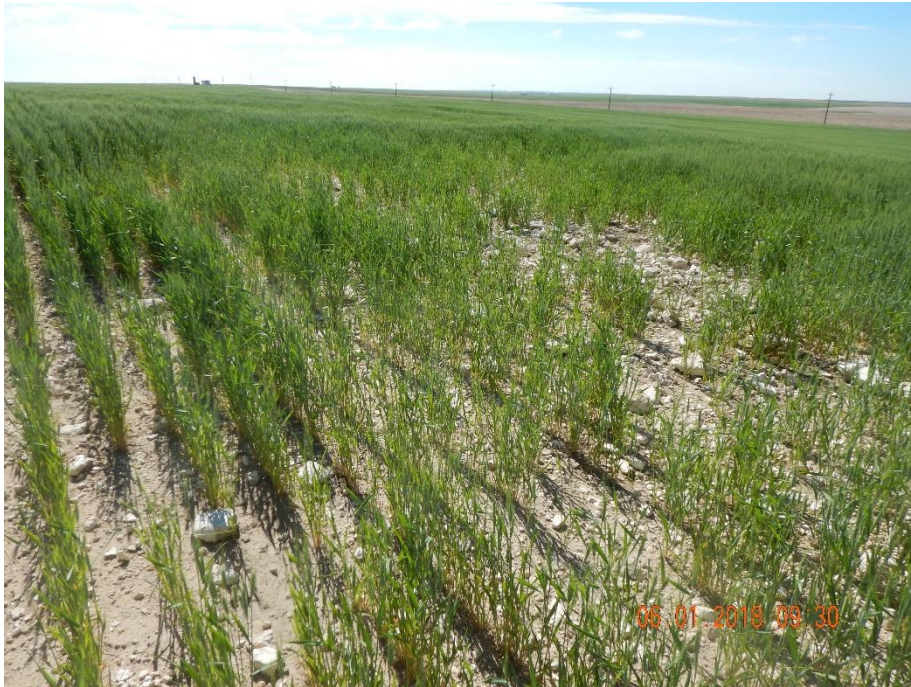
**Photo 1:** Photo taken from the central area of the location, facing east. Photo shows crop over the reclamation area appears stunted compare to crop on the reference (see photos 10-13); vegetation establishment on the location does not appear to be uniform/reflective of the reference area.

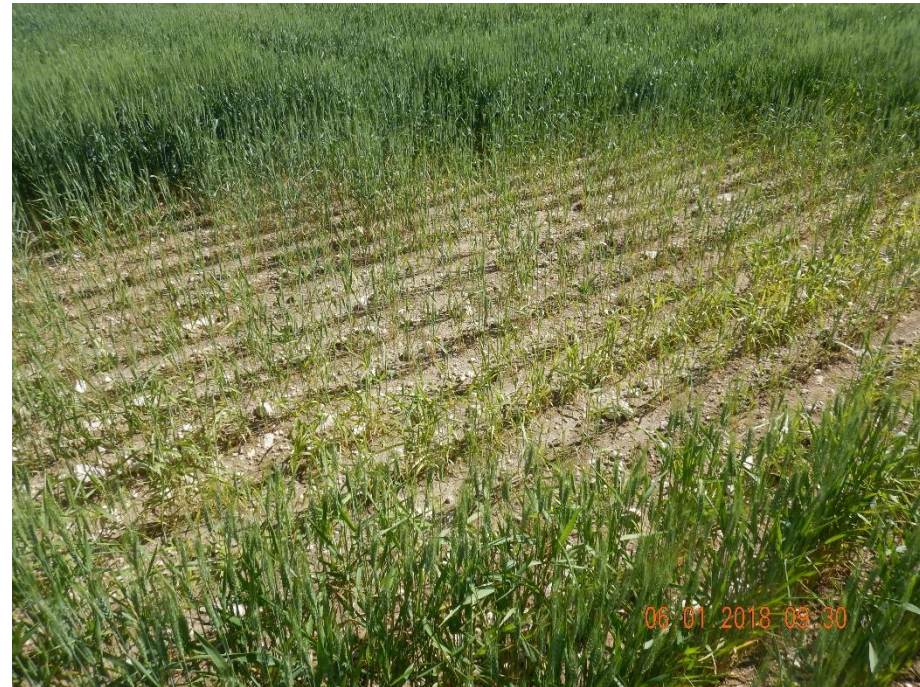
**Photo 2:** Photo taken from the location. See comments under photo 1.

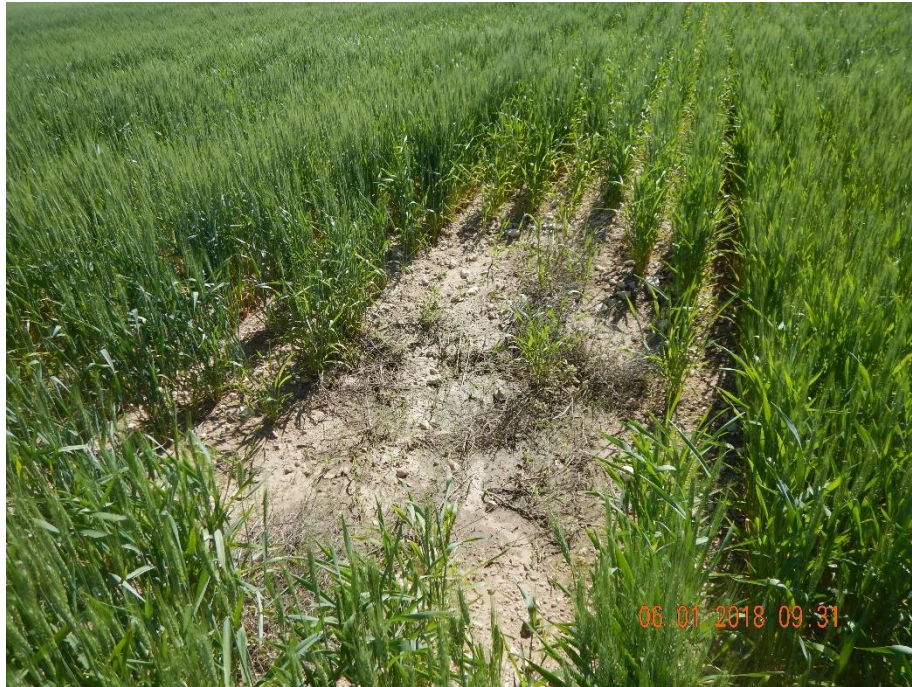
**Photo 3:** Photo taken from the well location. Photo shows vegetation at the well has failed to establish uniformly. Subsidence also evident at the well.

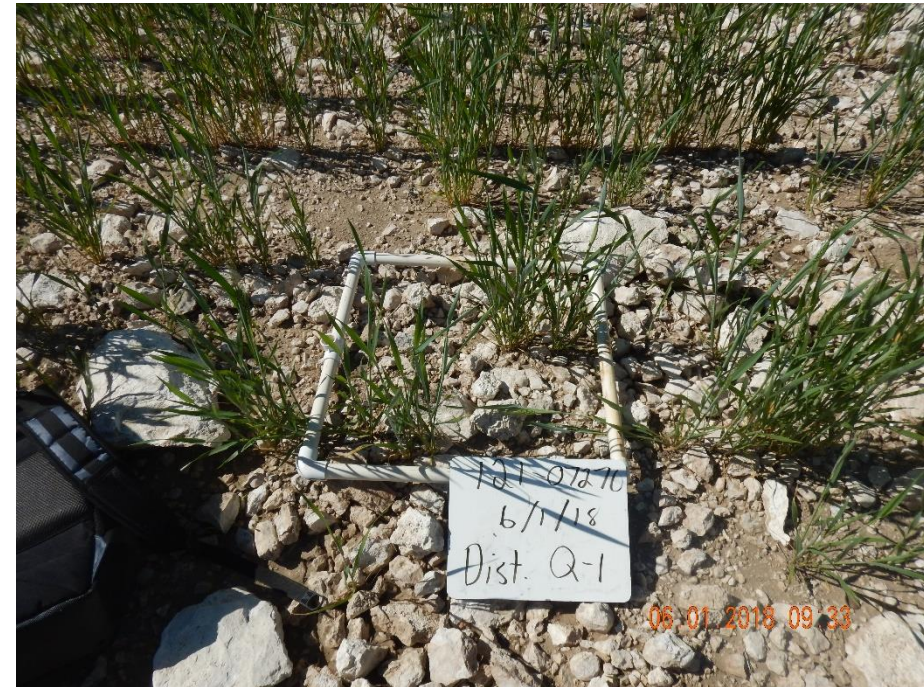
**Photo 4:** Photo taken from the location. Photo shows disturbance quadrat #1 and crop establishment over the disturbance area (location). Refer to data sheet.

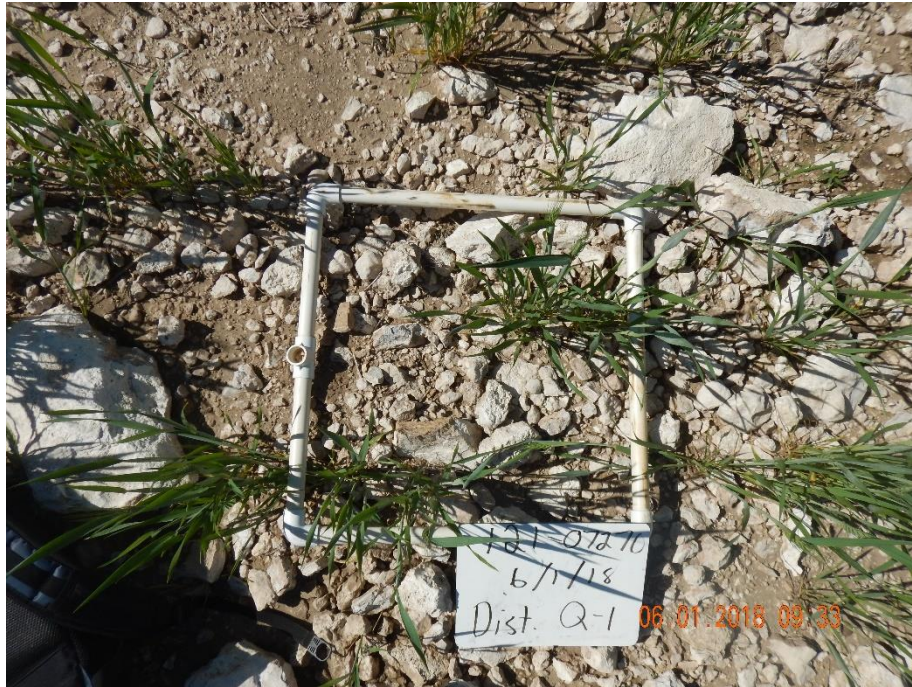
**Photo 5:** Photo taken from the location. Photo shows disturbance quadrat #1 and crop establishment over the disturbance area (location). Refer to data sheet.

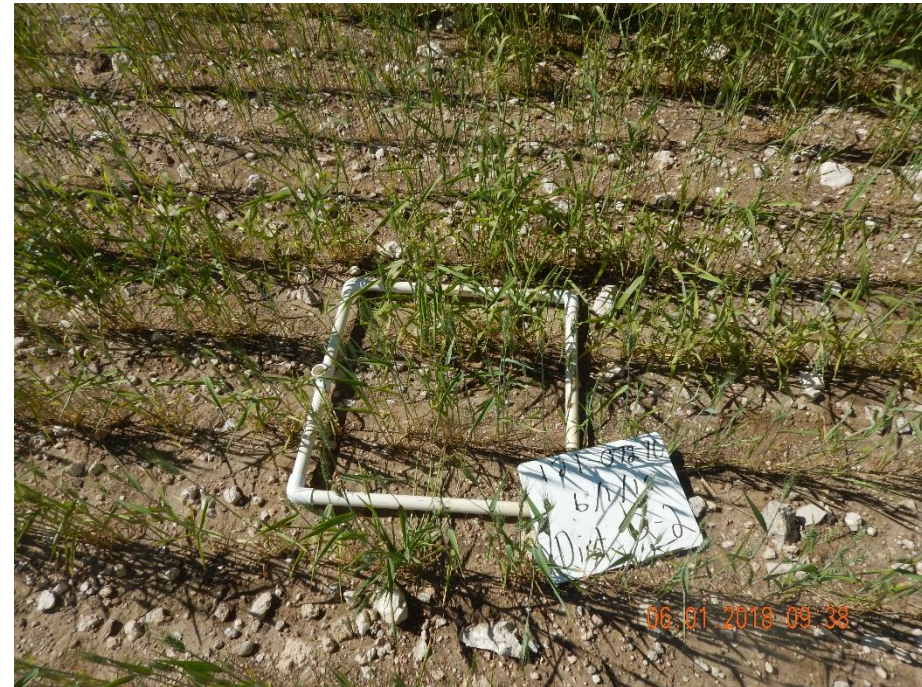
**Photo 6:** Photo taken from the location. Photo shows disturbance quadrat #2 and crop establishment over the disturbance area (location). Refer to data sheet.

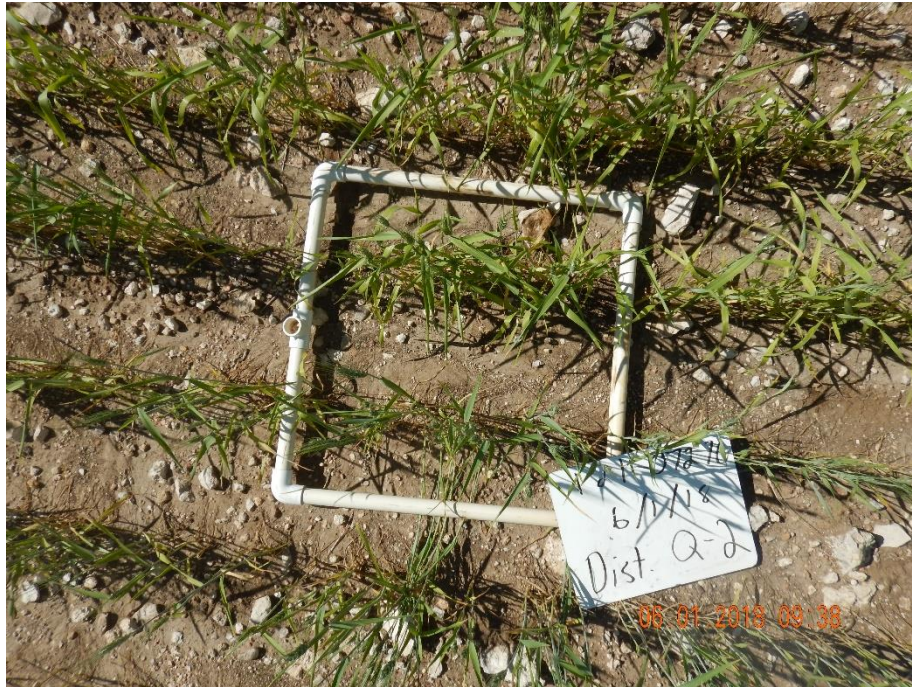
**Photo 7:** Photo taken from the location. Photo shows disturbance quadrat #2 and crop establishment over the disturbance area (location). Refer to data sheet

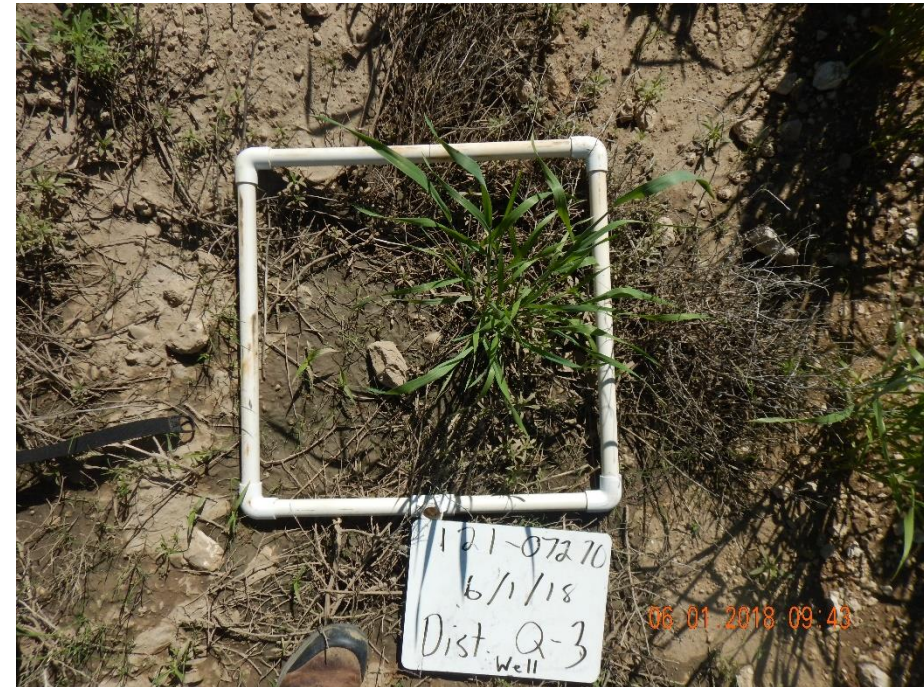
**Photo 8:** Photo taken from the well location. Photo shows disturbance quadrat #3 and crop establishment over the disturbance area (well). Refer to data sheet

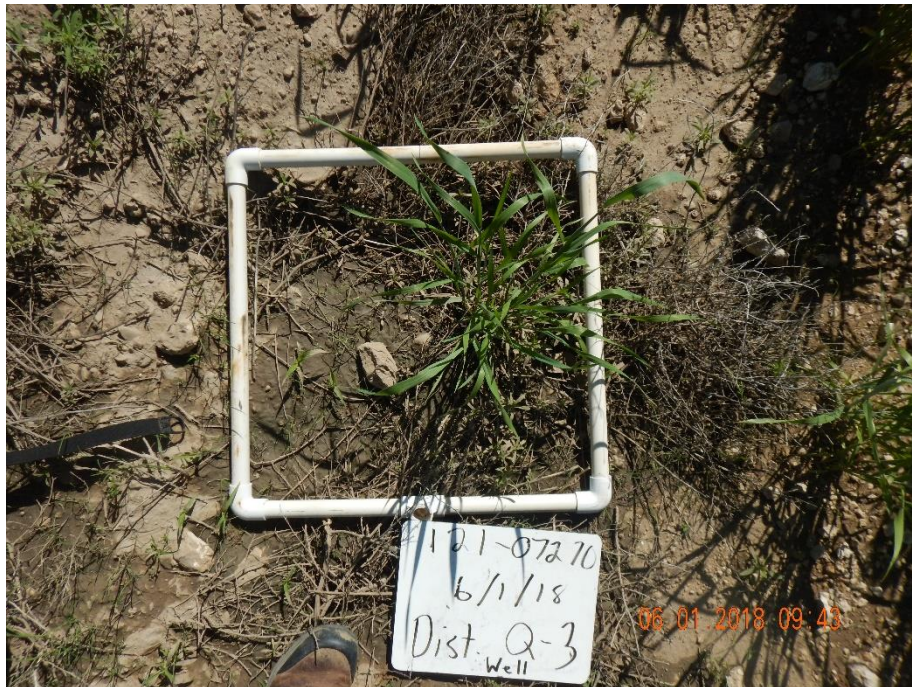
**Photo 9:** Photo taken from the well location. Photo shows disturbance quadrat #3 and crop establishment over the disturbance area (well). Refer to data sheet

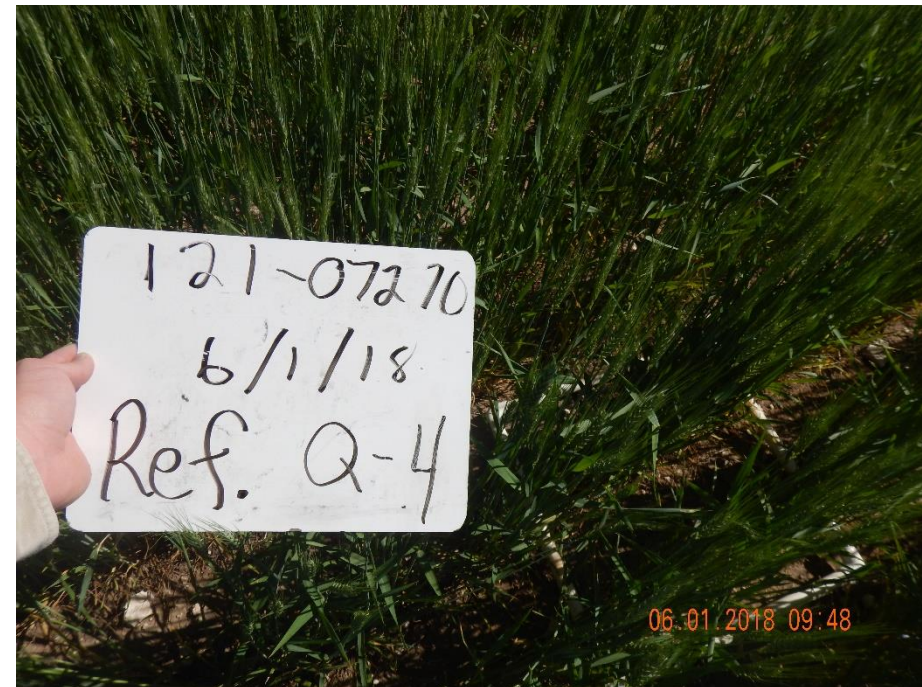
**Photo 10:** Photo taken from the reference area. Photo shows reference area, quadrat #4, and crop establishment over the reference area. Refer to data sheet.

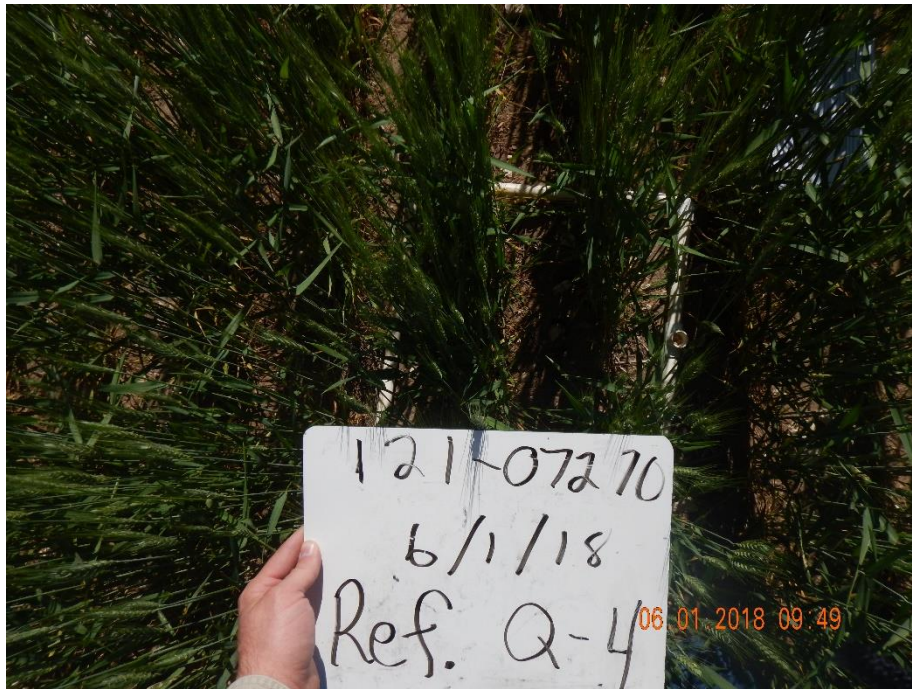
**Photo 11:** Photo taken from the reference area. Photo shows reference area, quadrat #4, and crop establishment over the reference area. Refer to data sheet.

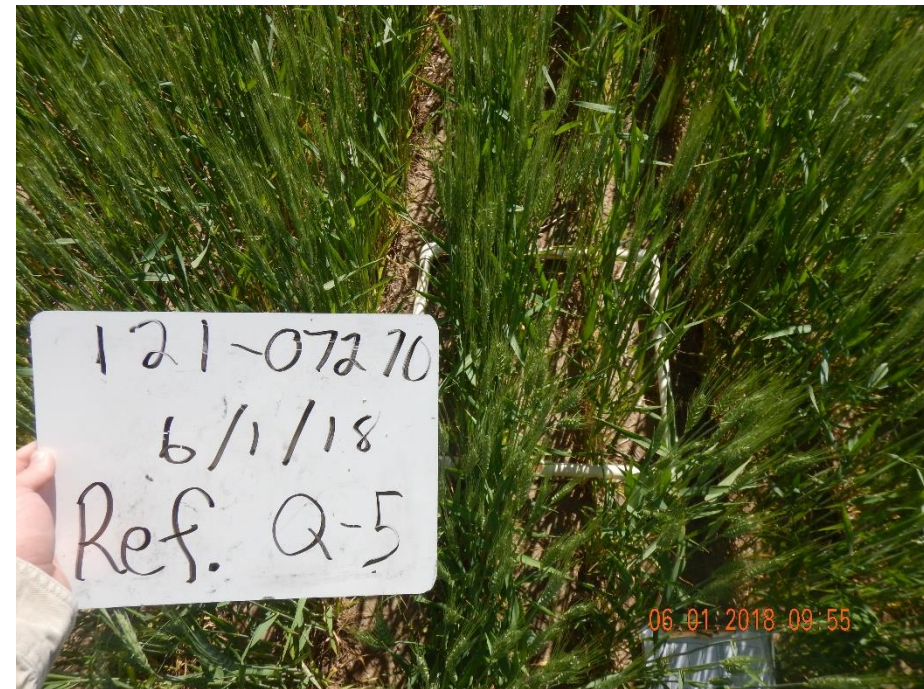
**Photo 12:** Photo taken from the reference area. Photo shows reference area, quadrat #5, and crop establishment over the reference area. Refer to data sheet.

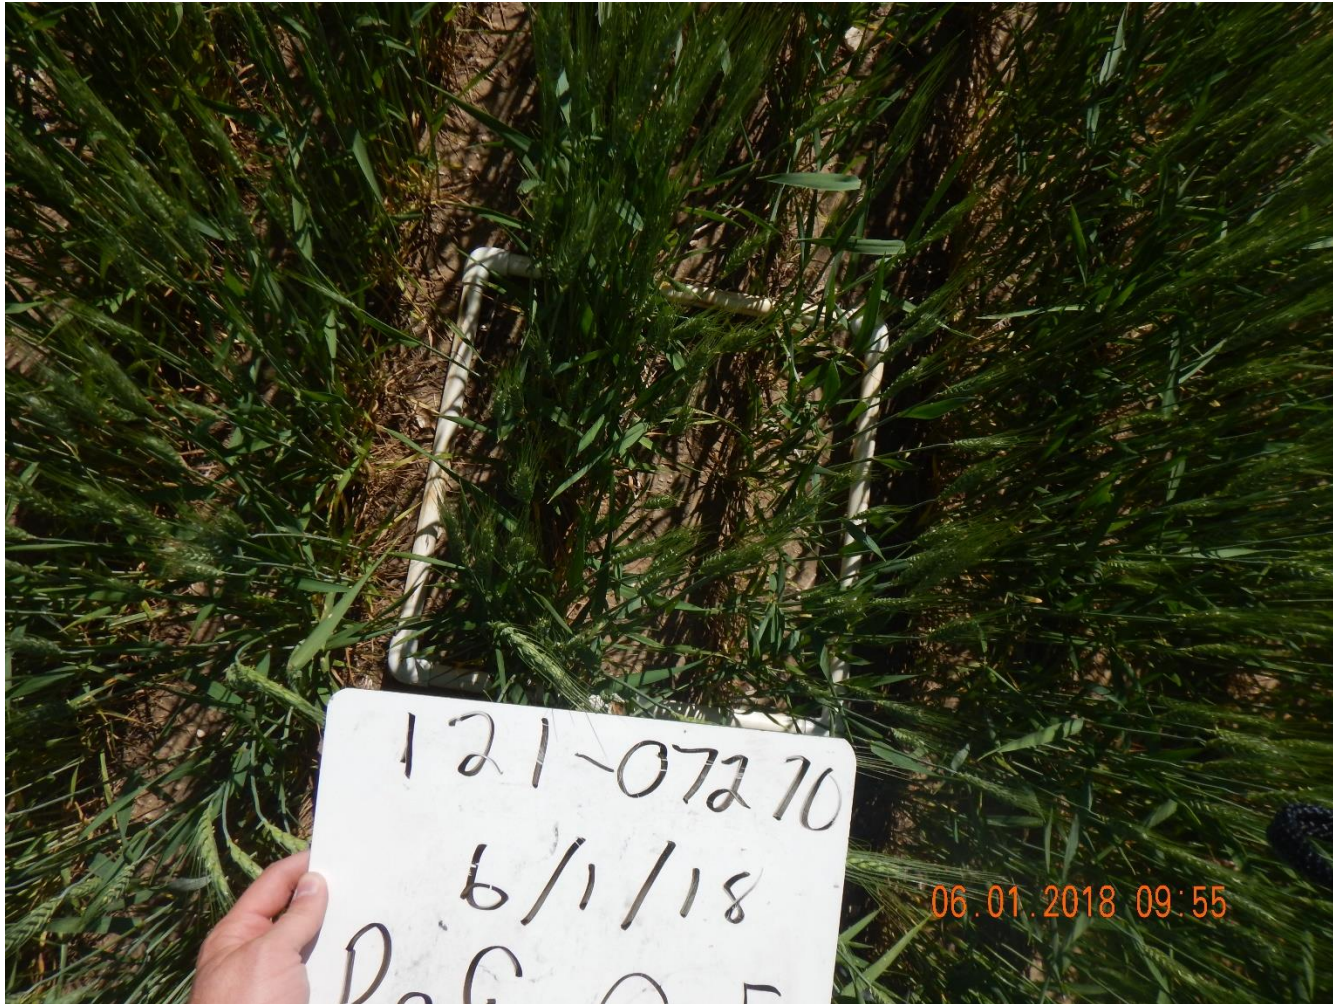
**Photo 13:** Photo taken from the reference area. Photo shows reference area, quadrat #5, and crop establishment over the reference area. Refer to data sheet.
