# Final Reclamation and Stormwater Inspection

Operator: KERR MCGEE OIL & GAS ONSHORE LP #47120

Location ID: 320405

Inspection Document #: 674902144

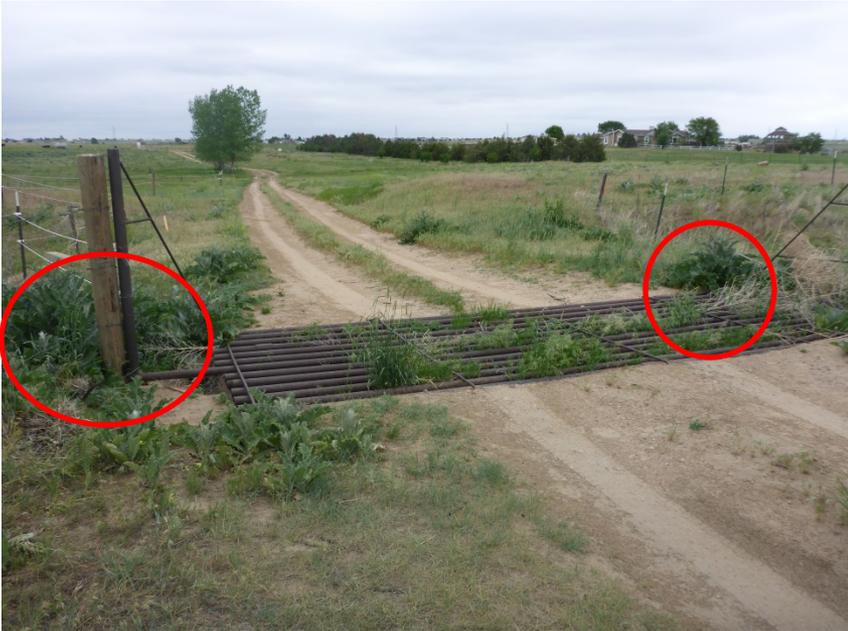
**Photo 1.** Photo taken from the location entrance, facing North. Appears the Operator has not performed final reclamation activities for the access road, the cattle guard and access road remain on location. A List B Colorado Noxious weed species, Scotch thistle (*Onopordum acanthium*), is found at high densities along the access road and on location.

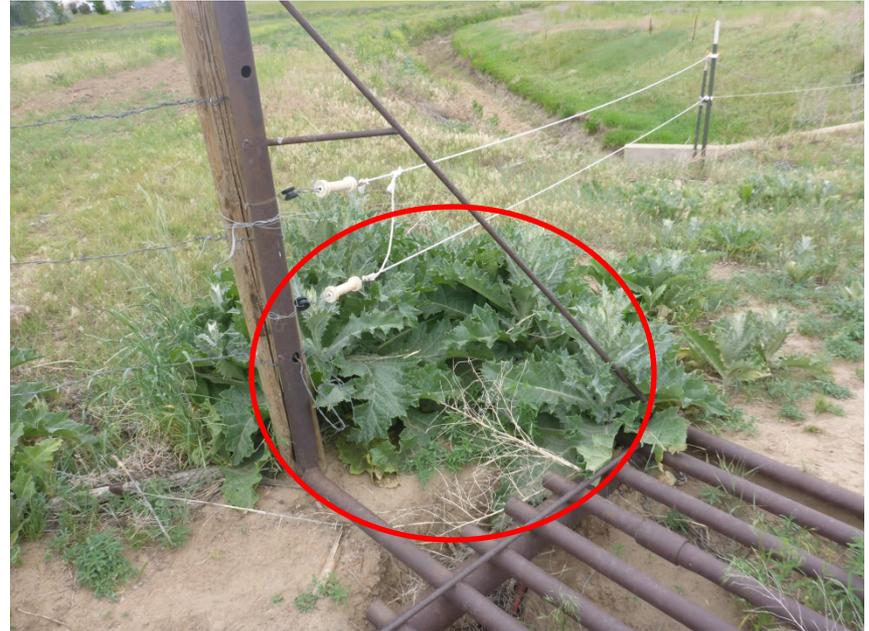
**Photo 2.** Photo taken from the location, facing South. See comments under Photo 1.

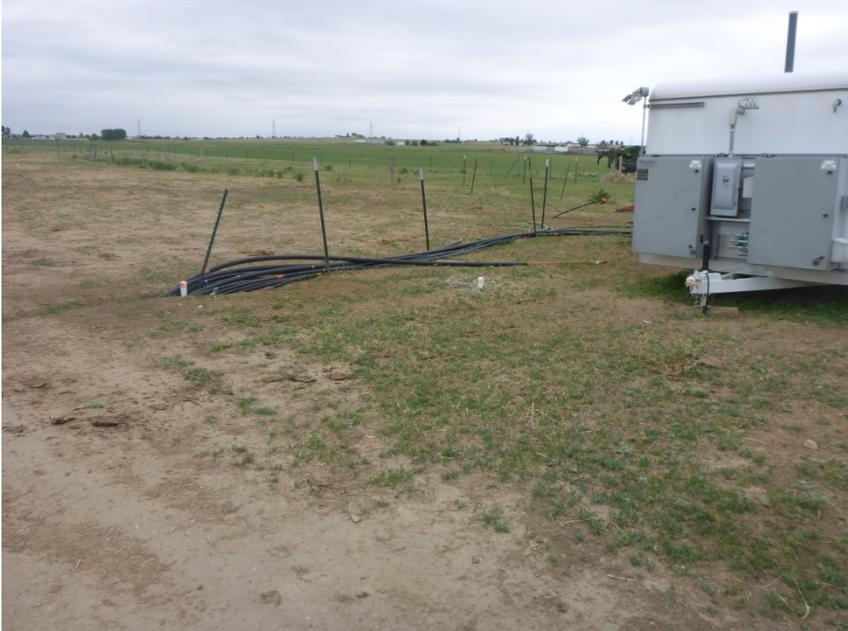
**Photo 3.** Photo taken from location, facing Southeast. Equipment is still on location. Appears the Operator has performed final reclamation activities, with the evidence of drilling rows and straw crimped mulch. However, the majority of the site is either barren or covered in weedy, annual vegetation which includes but not limited to cheatgrass and kochia.

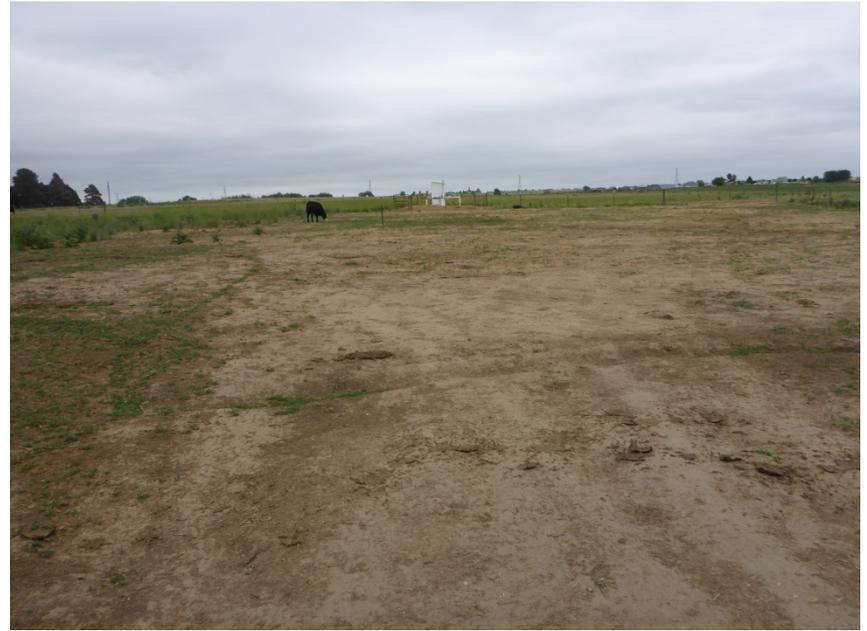
**Photo 4.** Photo taken from location, facing East. See comments under Photo 3.

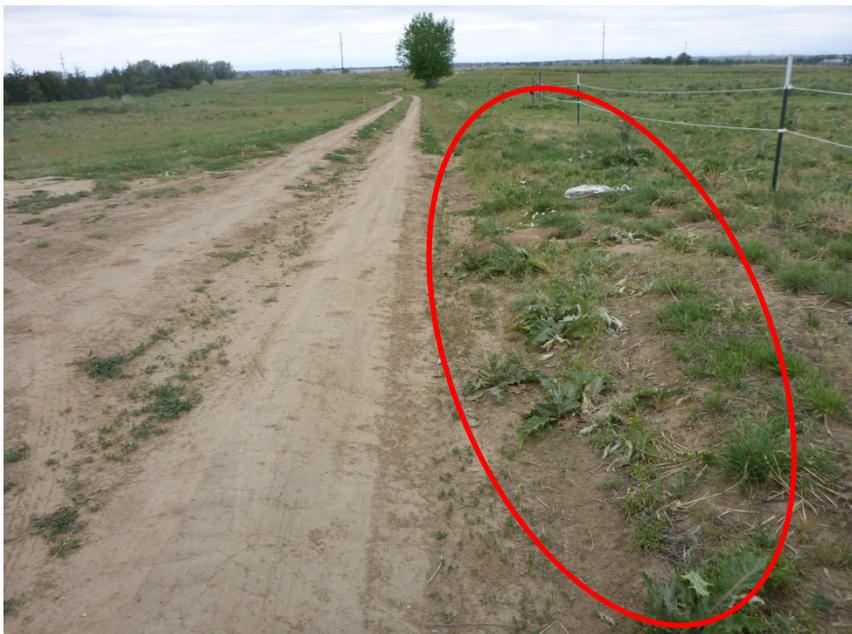
**Photo 5.** Photo taken from the facility area, facing West along the access road. See comments under Photo 1.

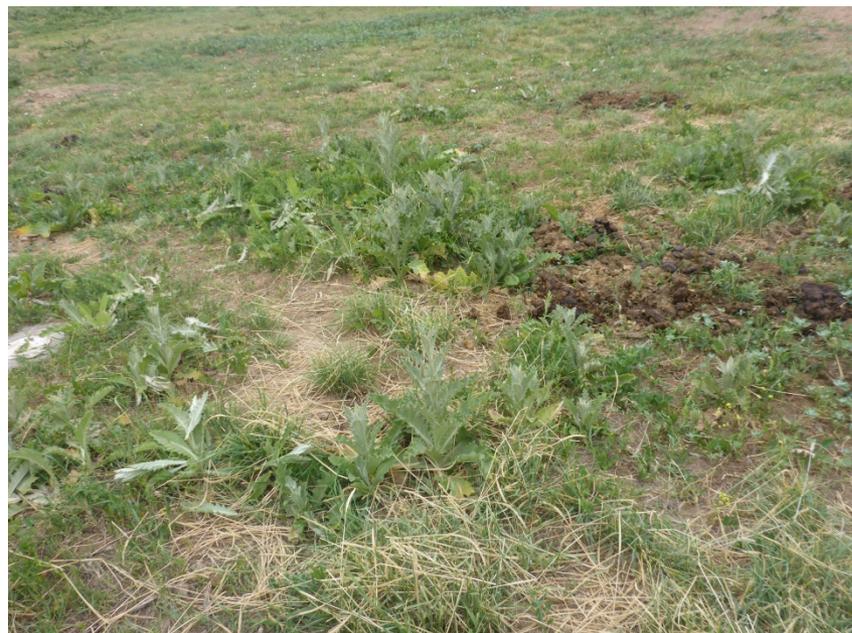
**Photo 6.** Photo taken North of the access road, facing North showing the high density of scotch thistle on the adjacent property. See comments under Photo 1.
