# Final Reclamation and Stormwater Inspection

Operator: EXTRACTION OIL & GAS INC - 10459

Location ID: 323243

SESE Section 23 T2N R68W

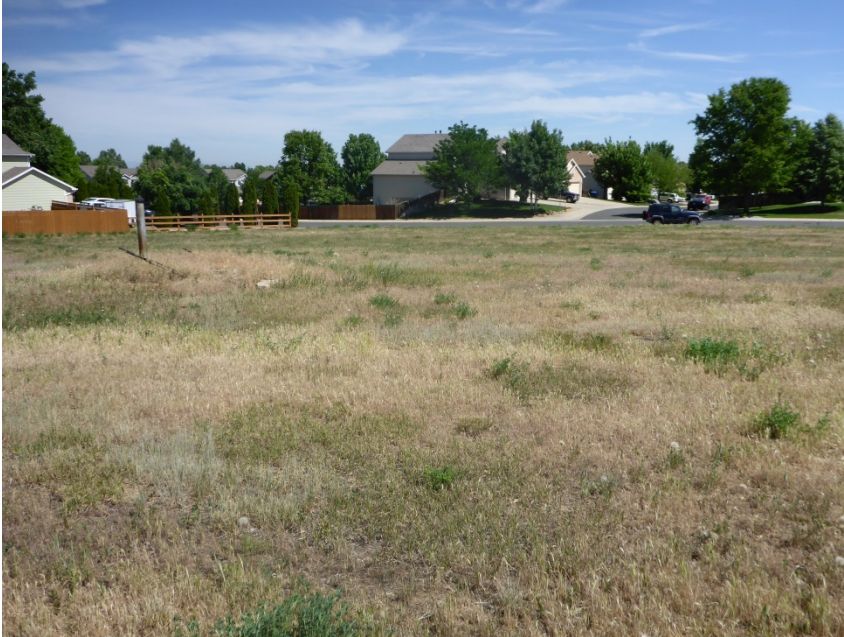
**Photo 1.** Photo taken from the well location, facing East. Appears the Operator has performed reclamation activities. Equipment and debris remain.

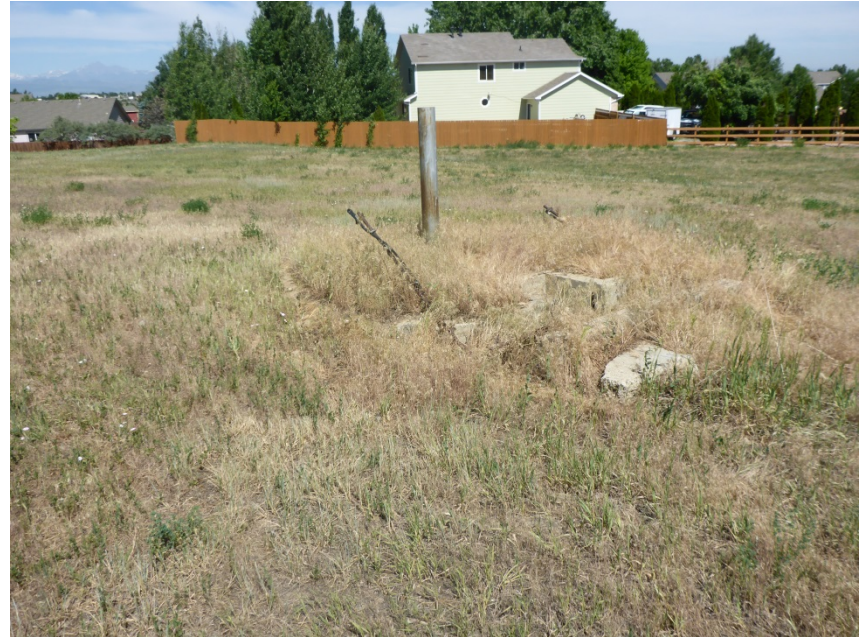
**Photo 2.** Photo taken from location, facing West. See comments from Photo 1.

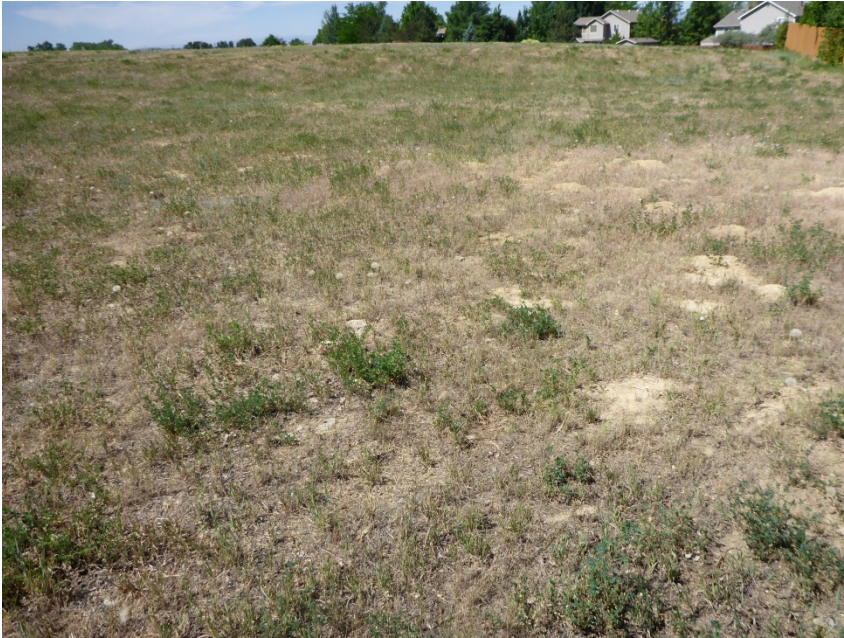
**Photo 3.** Photo taken from location, facing Southwest. Appears the Operator has performed final reclamation activities, with the evidence of drilling rows and straw crimped mulch. However, the portions of the site are covered in weedy, annual vegetation which includes but not limited to cheatgrass, field bindweed and kochia, with little perennial grass cover establishment. A List B Colorado Noxious weed species, musk thistle (*Carduus nutans*), is found at low densities throughout the site .

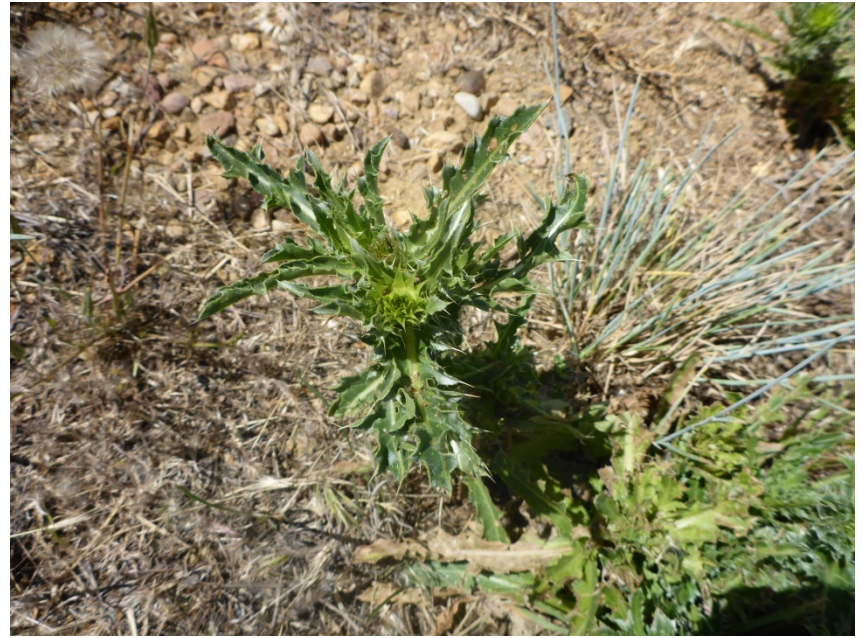
**Photo 4.** Photo taken within facility area. Note the musk thistle. See comments from Photo 3.
