# Final Reclamation Inspection

Operator: HOMESTEAD OIL INC - #41050

API: 05-123-16272

Inspection Photos  
Location Name: BOULTER #15-24  
API: 05-123-16272

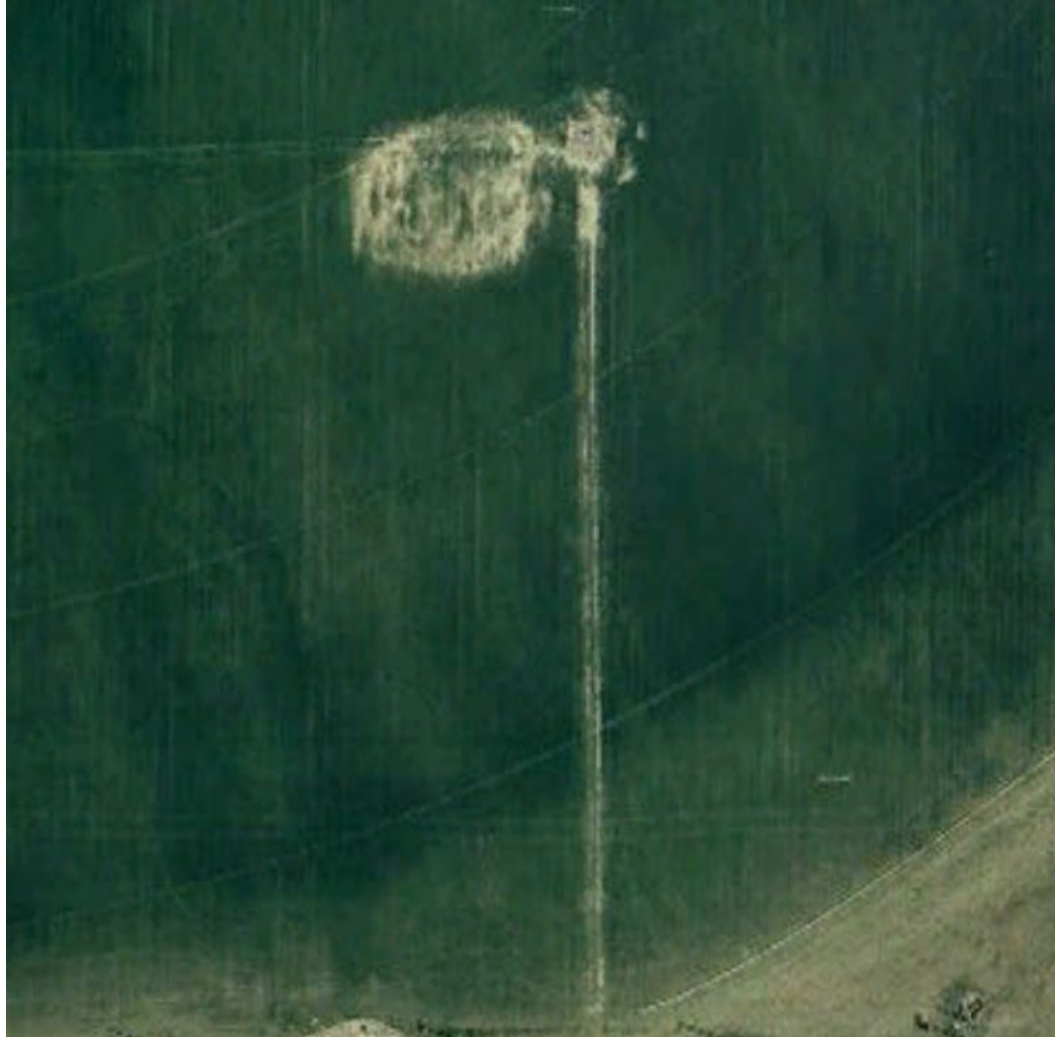
Google Earth aerial imagery taken February 29, 2008 of the well location and access road during active operations. Appears there was a disturbance between June 30, 2006 and August 30, 2006, located just west of the location.

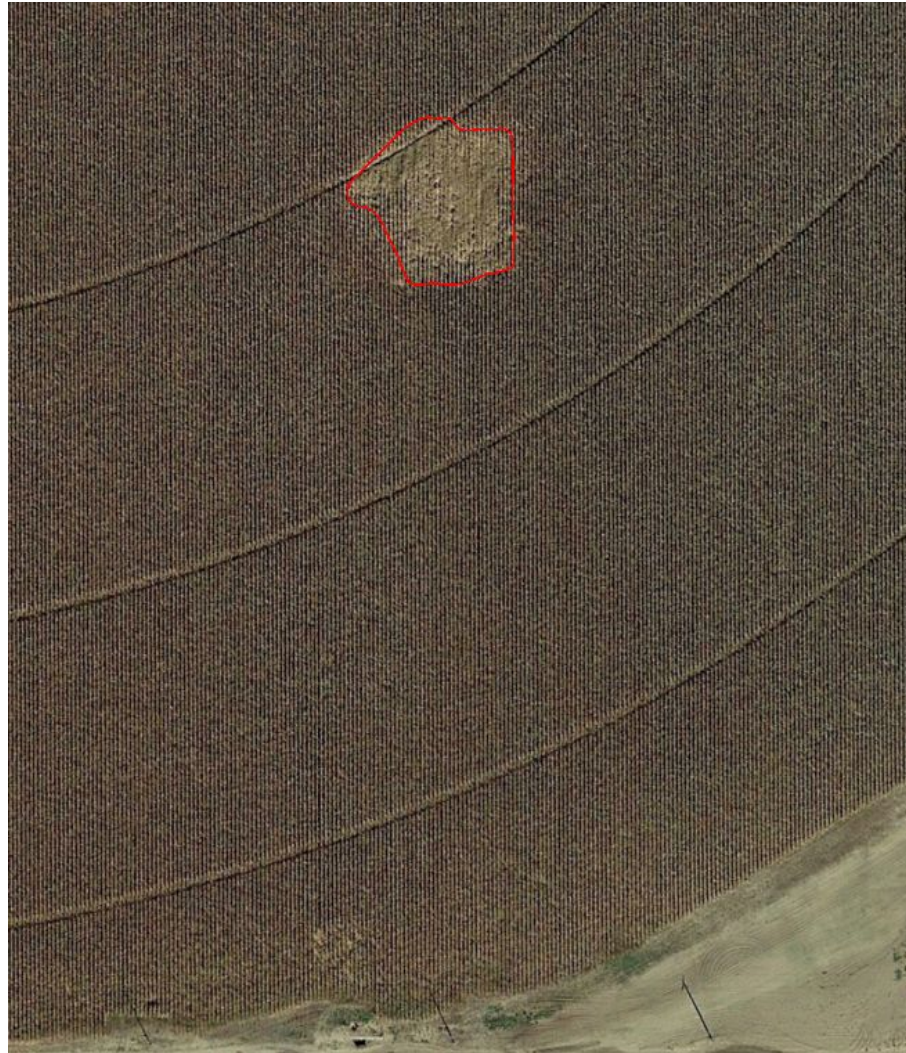
Google Earth aerial imagery taken October 14, 2017 post plugging operations. On June 11, 2018, Staff mapped the approximate area of stunted growth (line red). Other disturbance areas appeared to meet Rule 1004 standards.

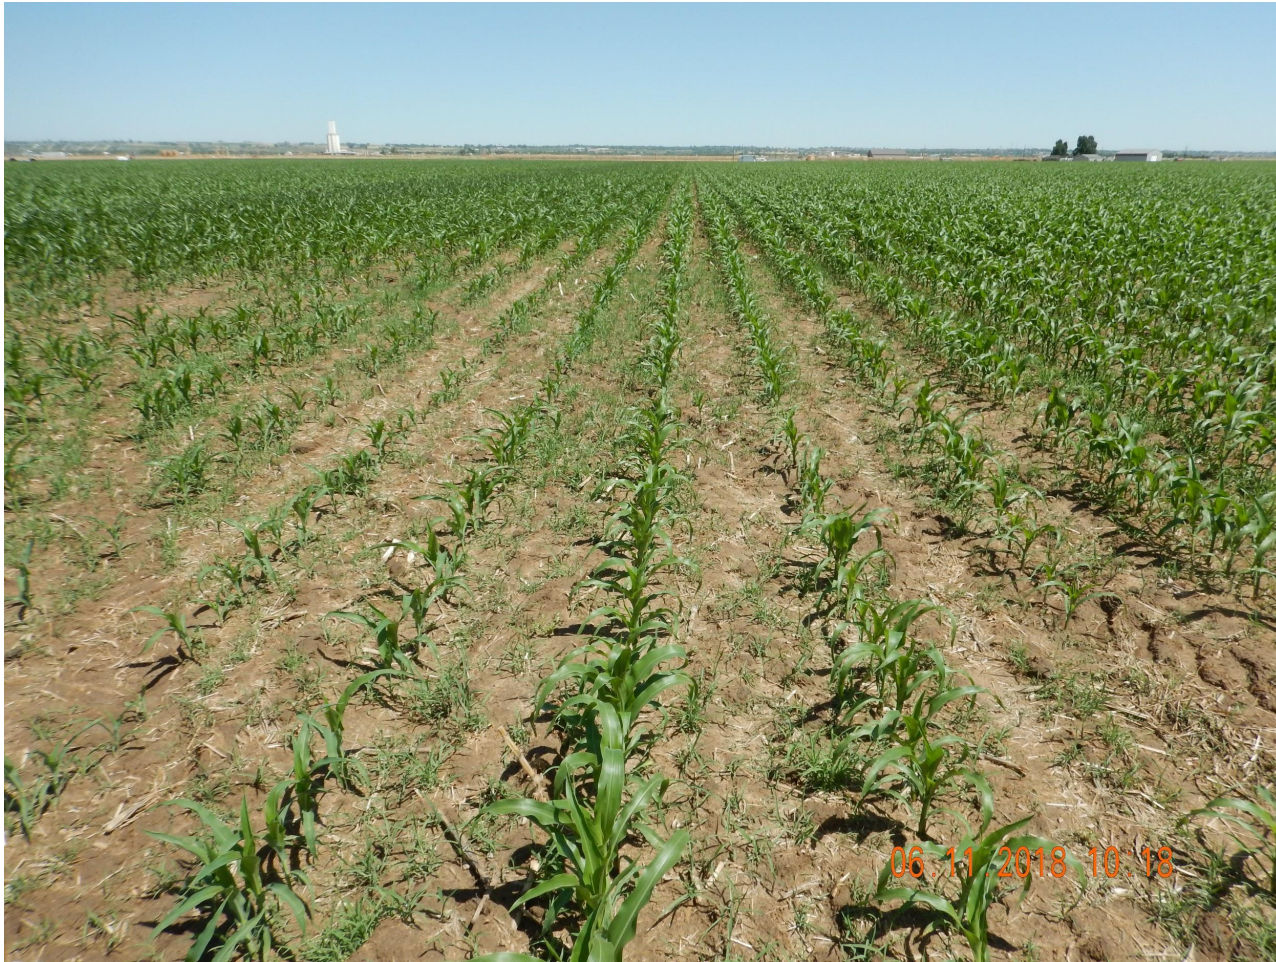
**Photo 1.** Photo taken from just west of the well location, facing North. Photo illustrates an area of stunted corn growth which is not reflective of reference area crop levels.

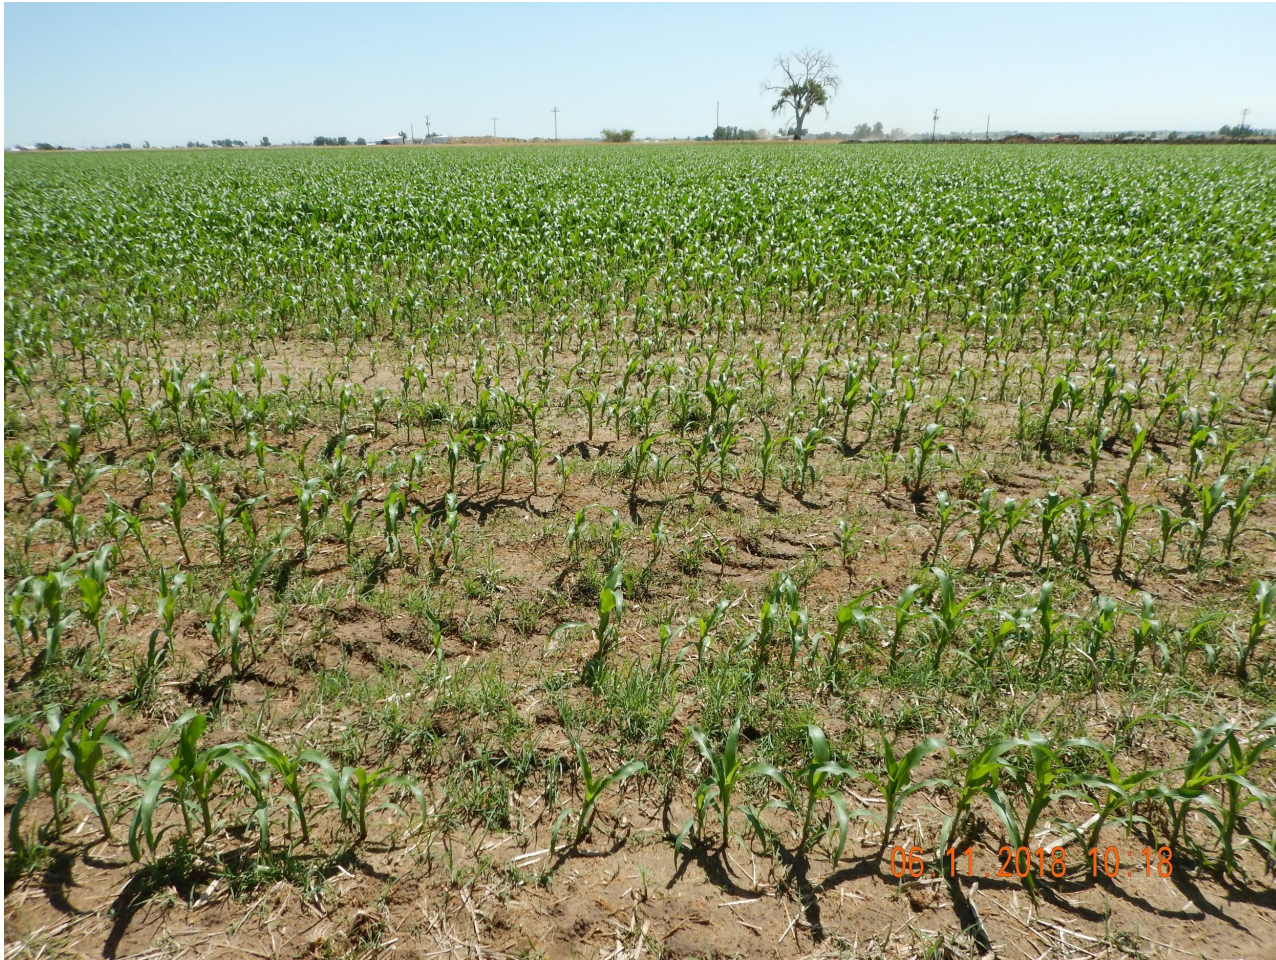
**Photo 2.** Photo taken from the central area of stunted corn growth, facing East. See comments under Photo 1.

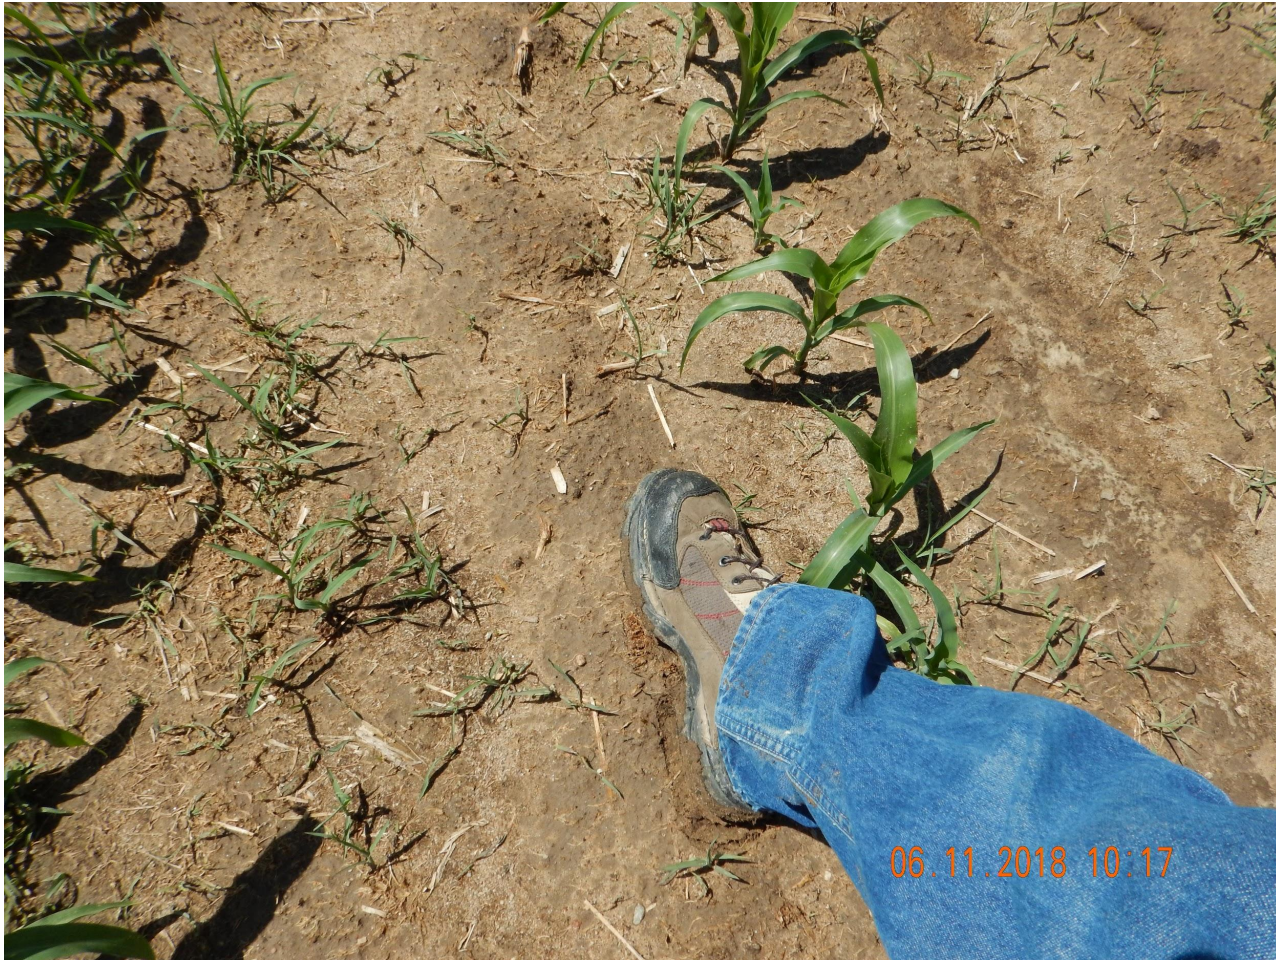
**Photo 3.** Photo taken of the approximate height of stunted corn which was approximately ankle height.

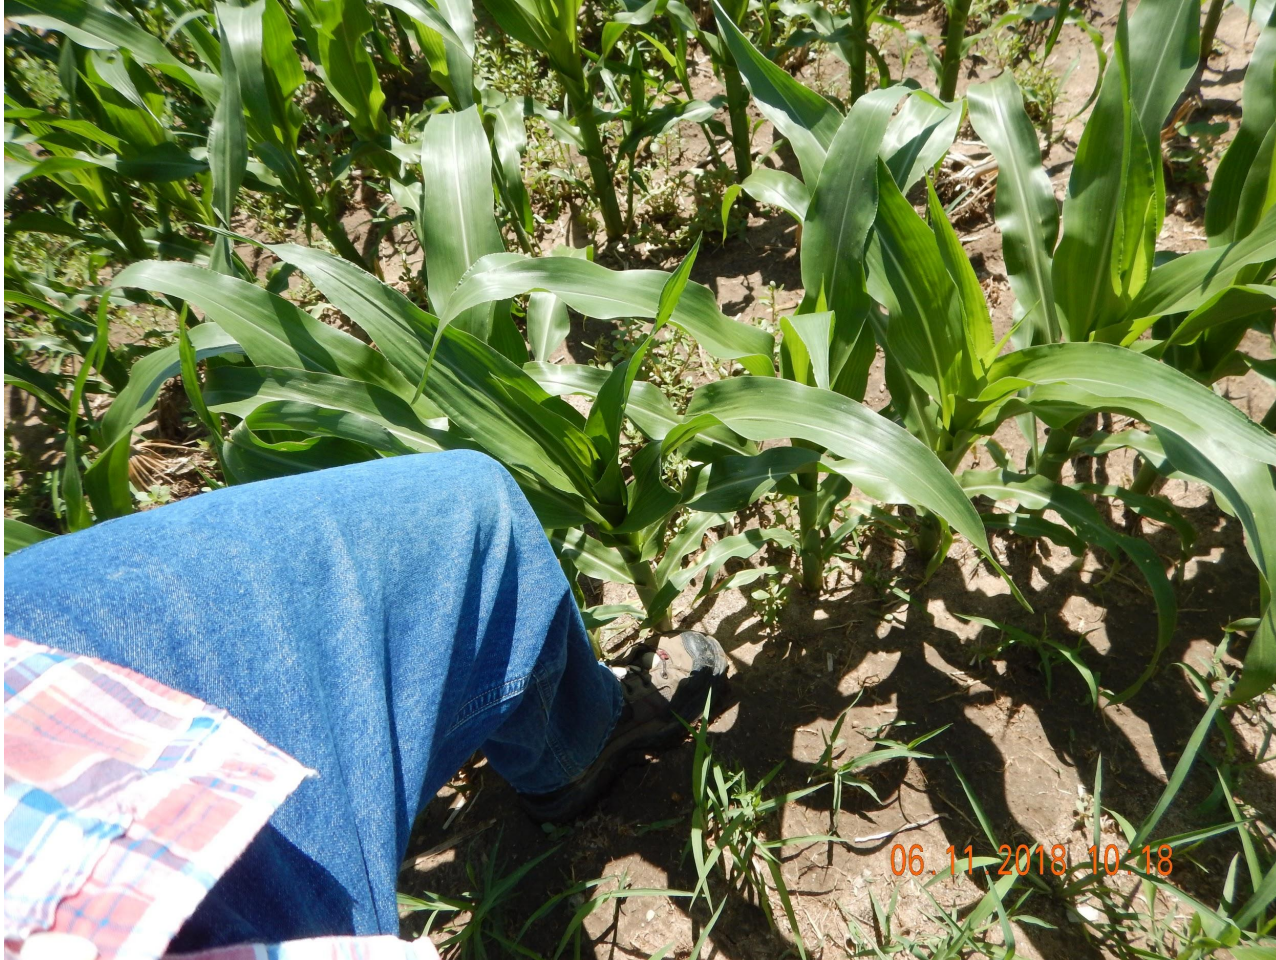
**Photo 4.** Photo taken of the approximate height of reference corn which was approximately knee height.

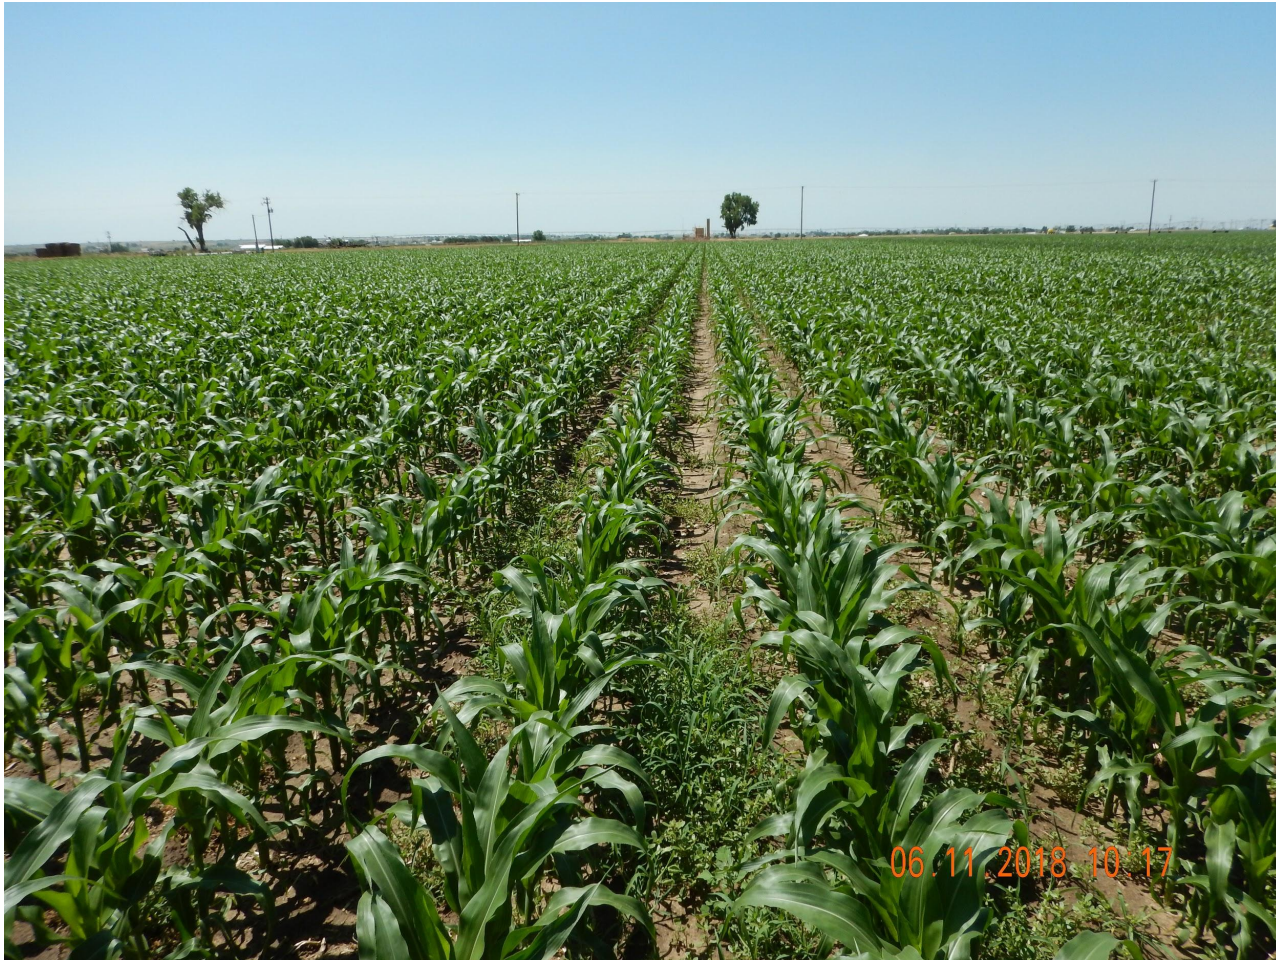
**Photo 5.** Photo taken along a portion of the access road, facing South. Access road appears reflective of reference area crop levels.
