# *Inspection Photos*

*API#077-07361*

*Operator: Caerus*

*Inspection Number: 674104467*

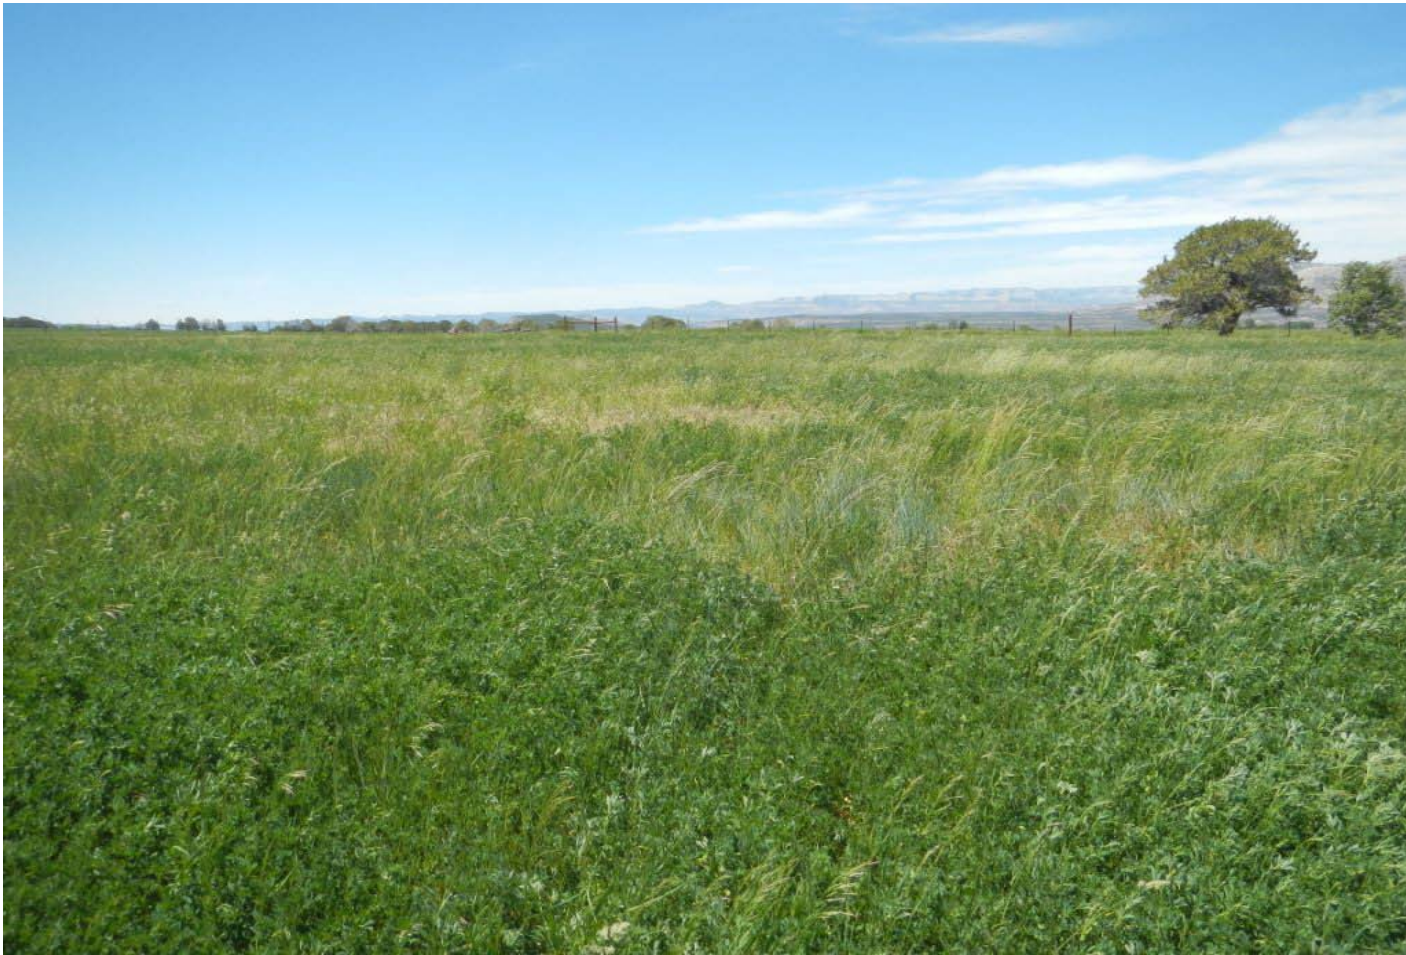
Photo#1:  
Overview of Location to Northwest.

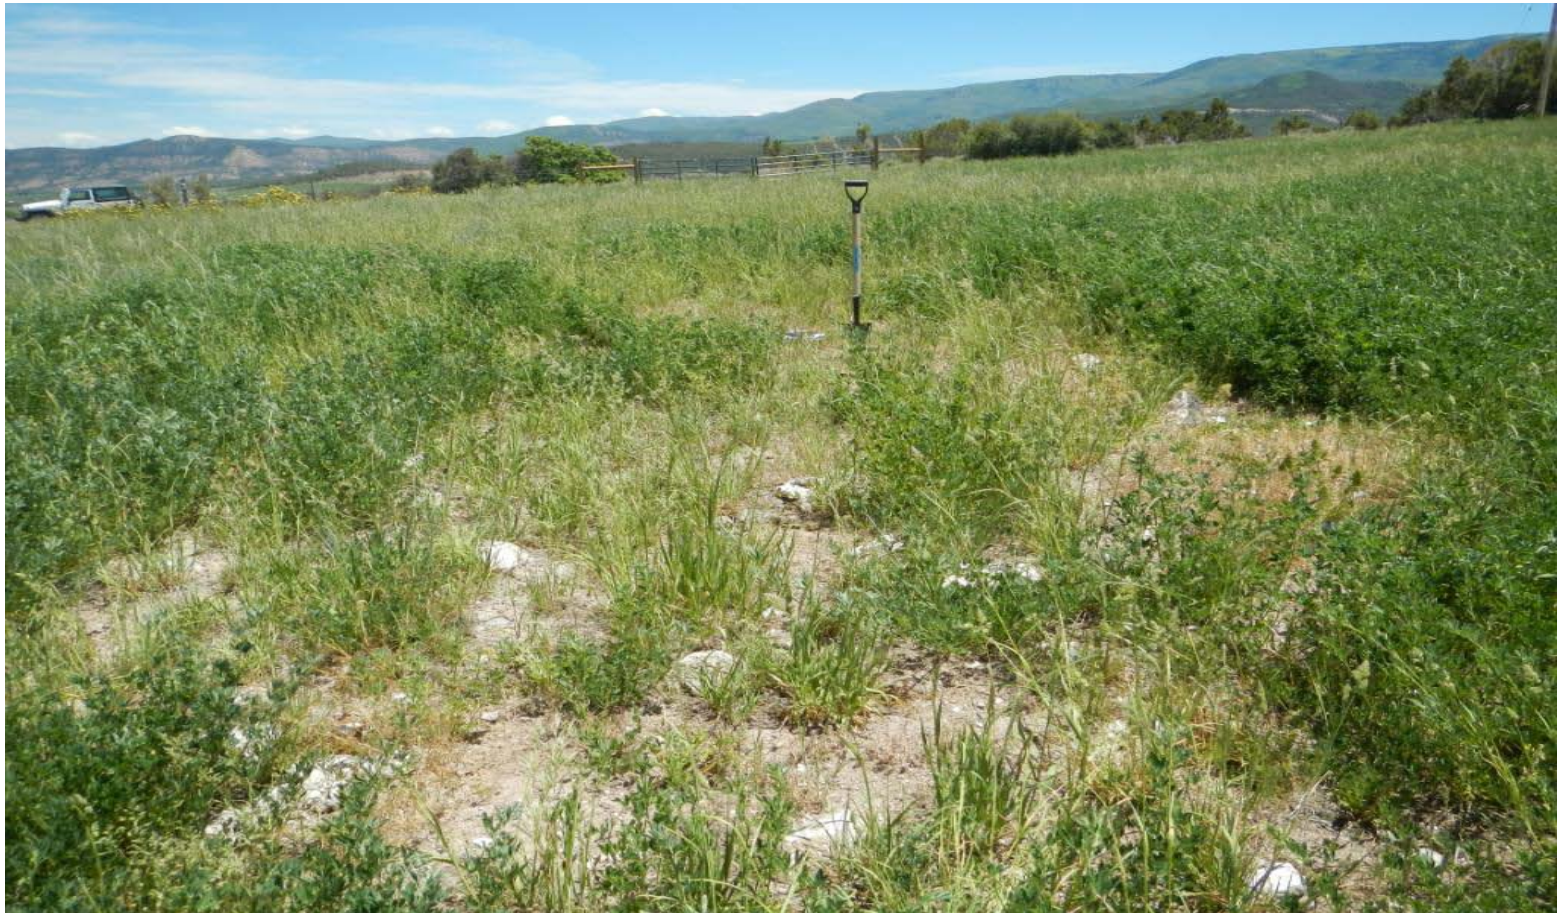
### Photo#2:

Several areas of Location have less vegetation and are more compacted than surrounding soils; these areas appear to be where Facilities were located when looking at historical aerial imagery.

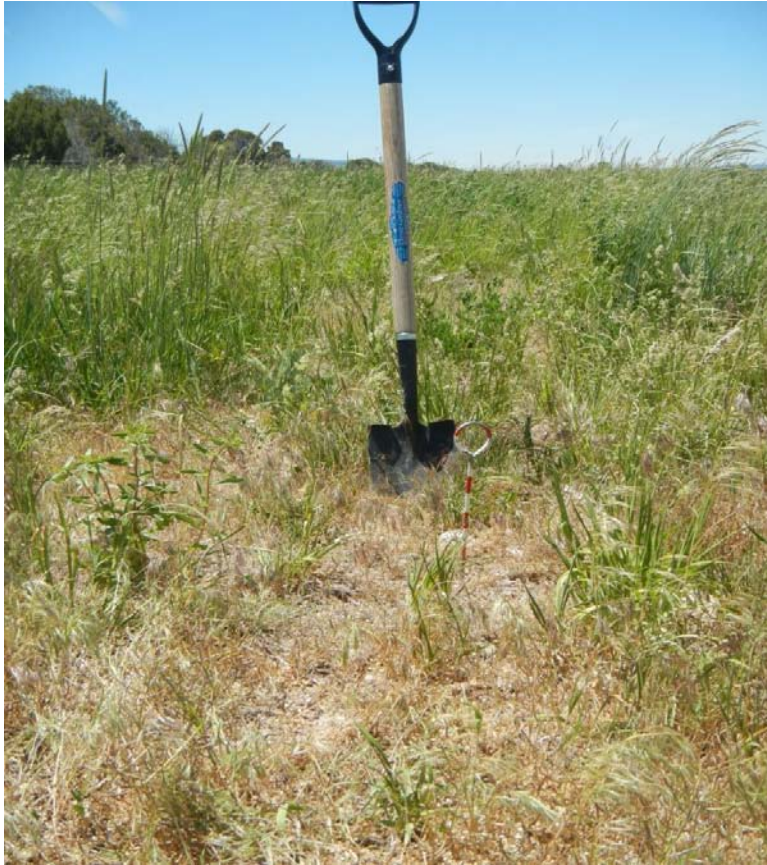
Photo#3:

Several areas of Location have less vegetation and are more compacted than surrounding soils; these areas appear to be where Facilities were located when looking at historical aerial imagery.
