# Final Reclamation and Stormwater Inspection

Operator: PAR PACIFIC HOLDINGS INC – 16800

Location ID: 409710

Weld County, CO

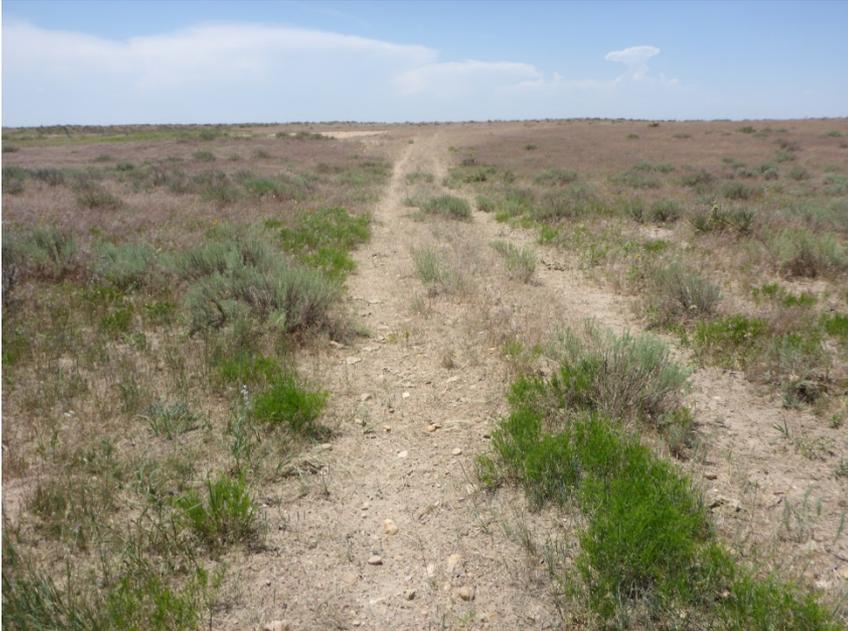
**Photo 1.** Photo taken from the access road looking towards the well location, facing Southwest. Appears the Operator has not performed any reclamation activities on the access road itself but has on the well pad location.

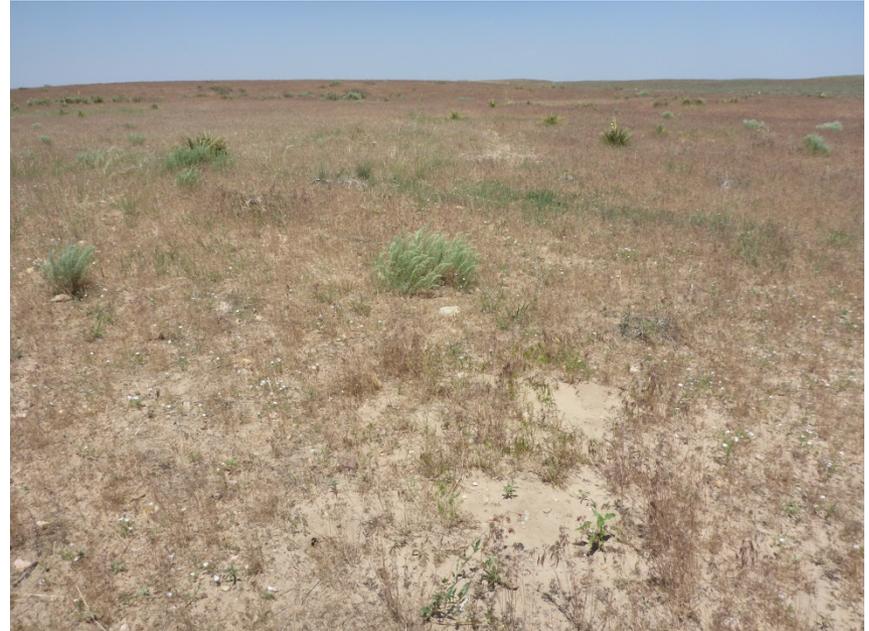
**Photo 2.** Photo taken from the well location, facing North. The reclamation operations have failed to generate perennial vegetation cover. Disturbance area is currently dominated by the annual List C Colorado Noxious Weed cheatgrass.

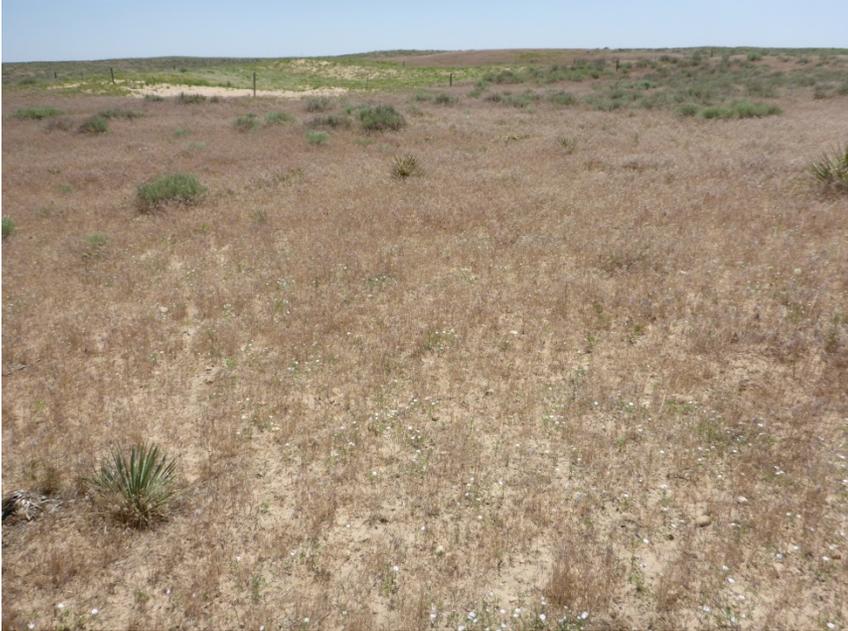
**Photo 3.** Photo taken from the facility, facing South. See comments from Photo 2.

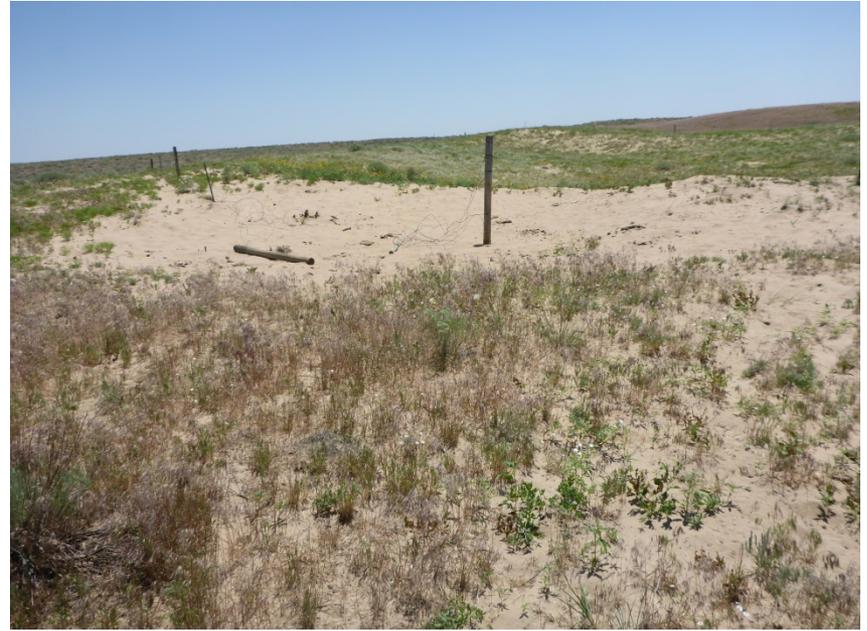
**Photo 4.** Photo taken from the south end of the location, facing East. There is a fenced in pit area remaining on location that will need to be re-contoured and re-graded. See comments from Photo 2.

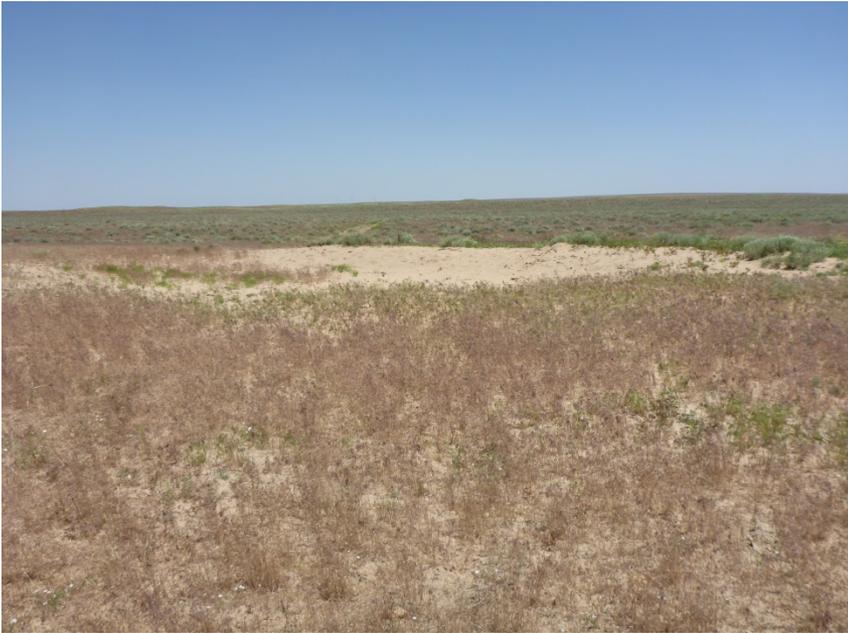
**Photo 5.** Photo taken from the Northeast end of the location. There is an excavated barren area remaining on location that will need to be re-contoured and re-graded.

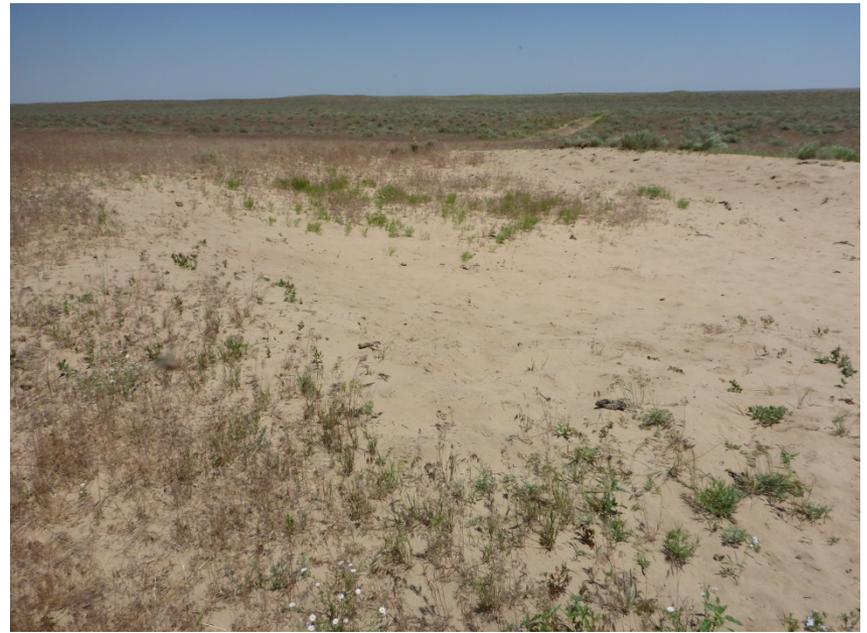
**Photo 6.** Close-up photo taken from the Northeast end of the location. See comments under Photo 5.
