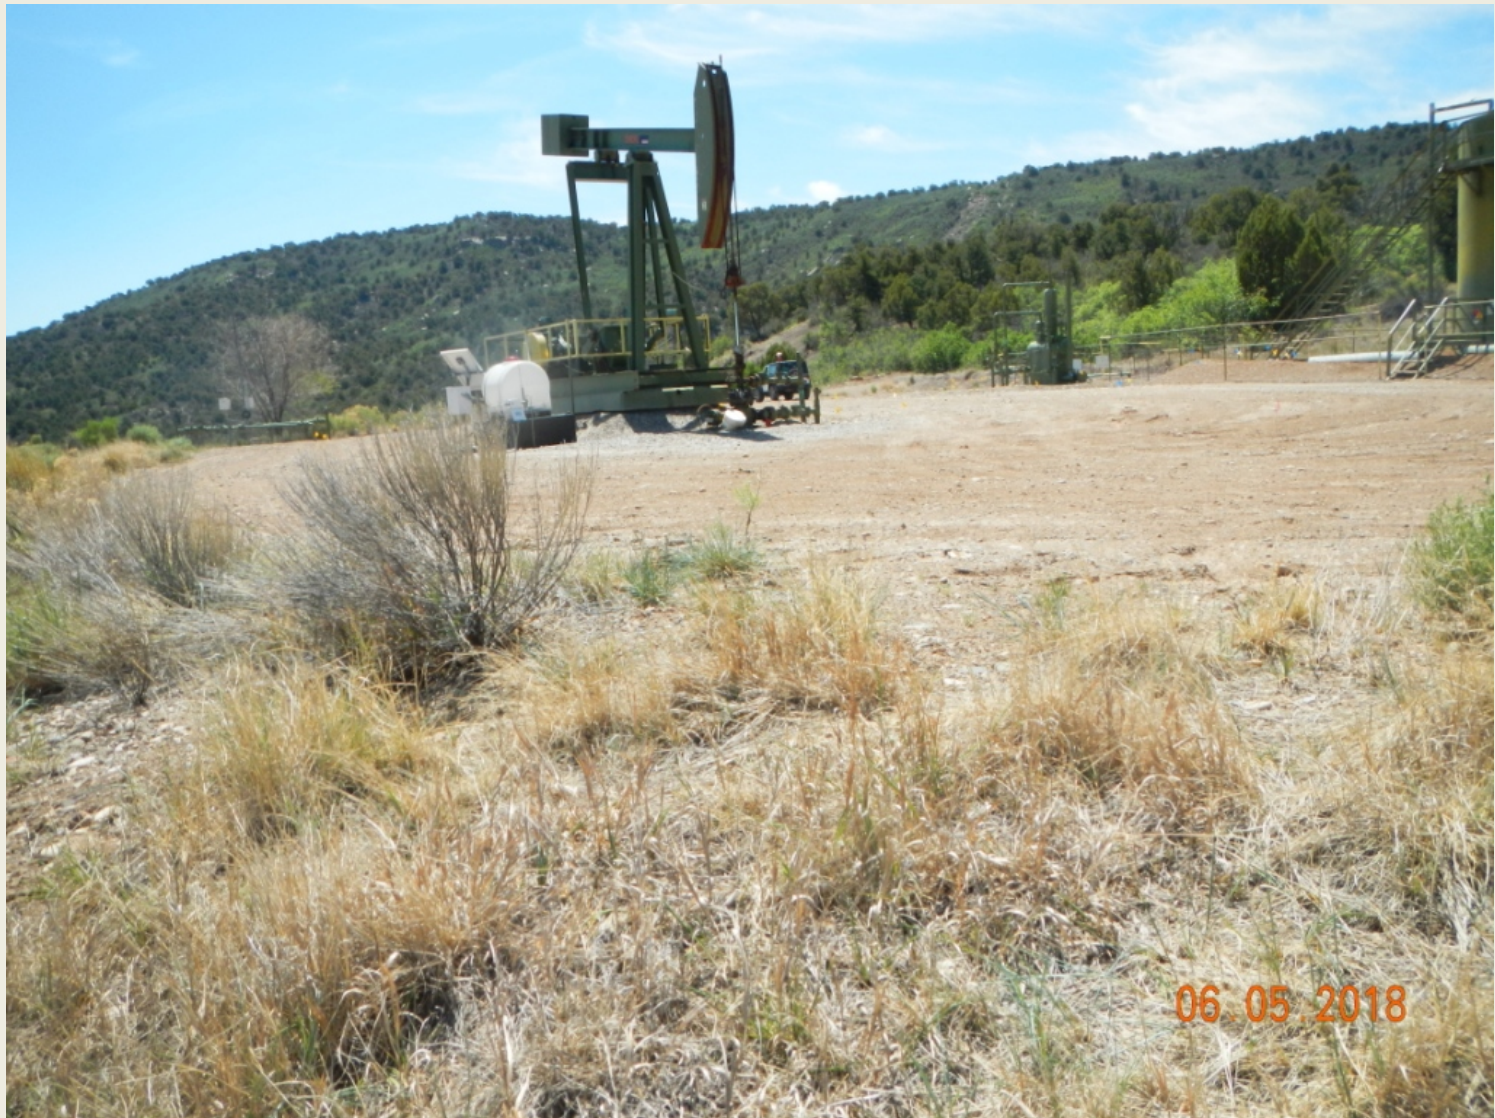
Photo 1. View of the project area from the northwestern corner facing center.

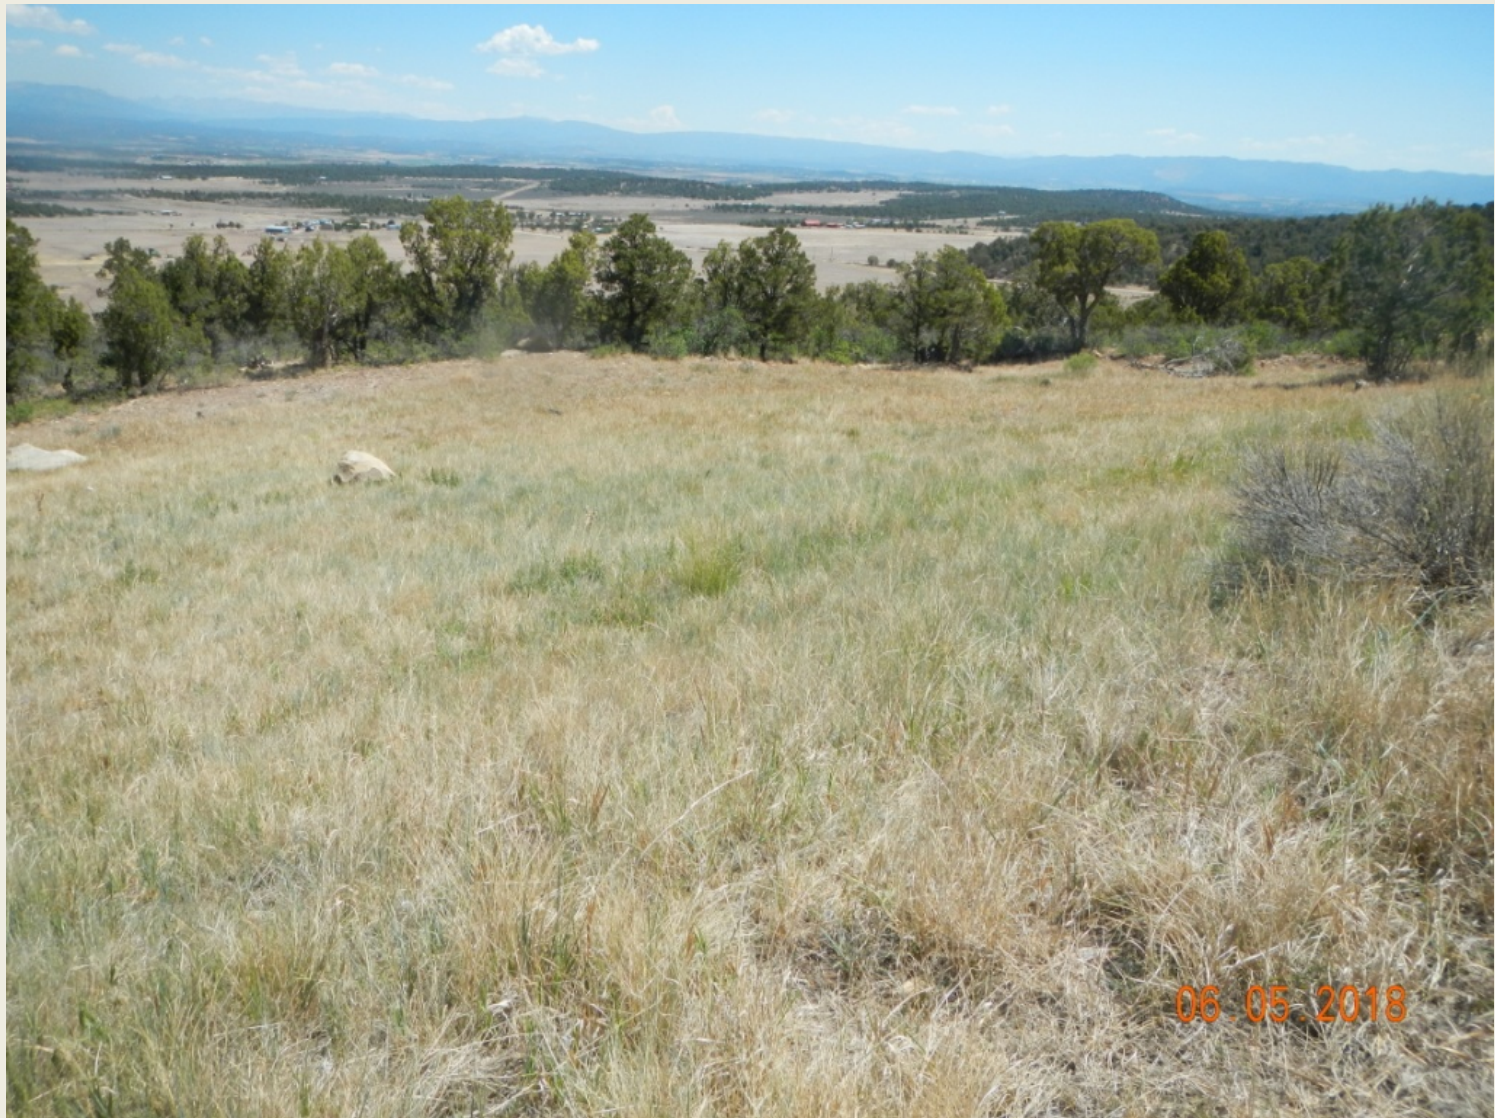
Photo 2. View of the northern portion of the project area from the southwestern corner facing northward. Revegetation is progressing within outer reclamation areas with grasses such as Indian ricegrass (*Achnatherum hymenoides*), smooth brome (*Bromus inermis*), and western wheatgrass (*Pascopyrum smithii*).

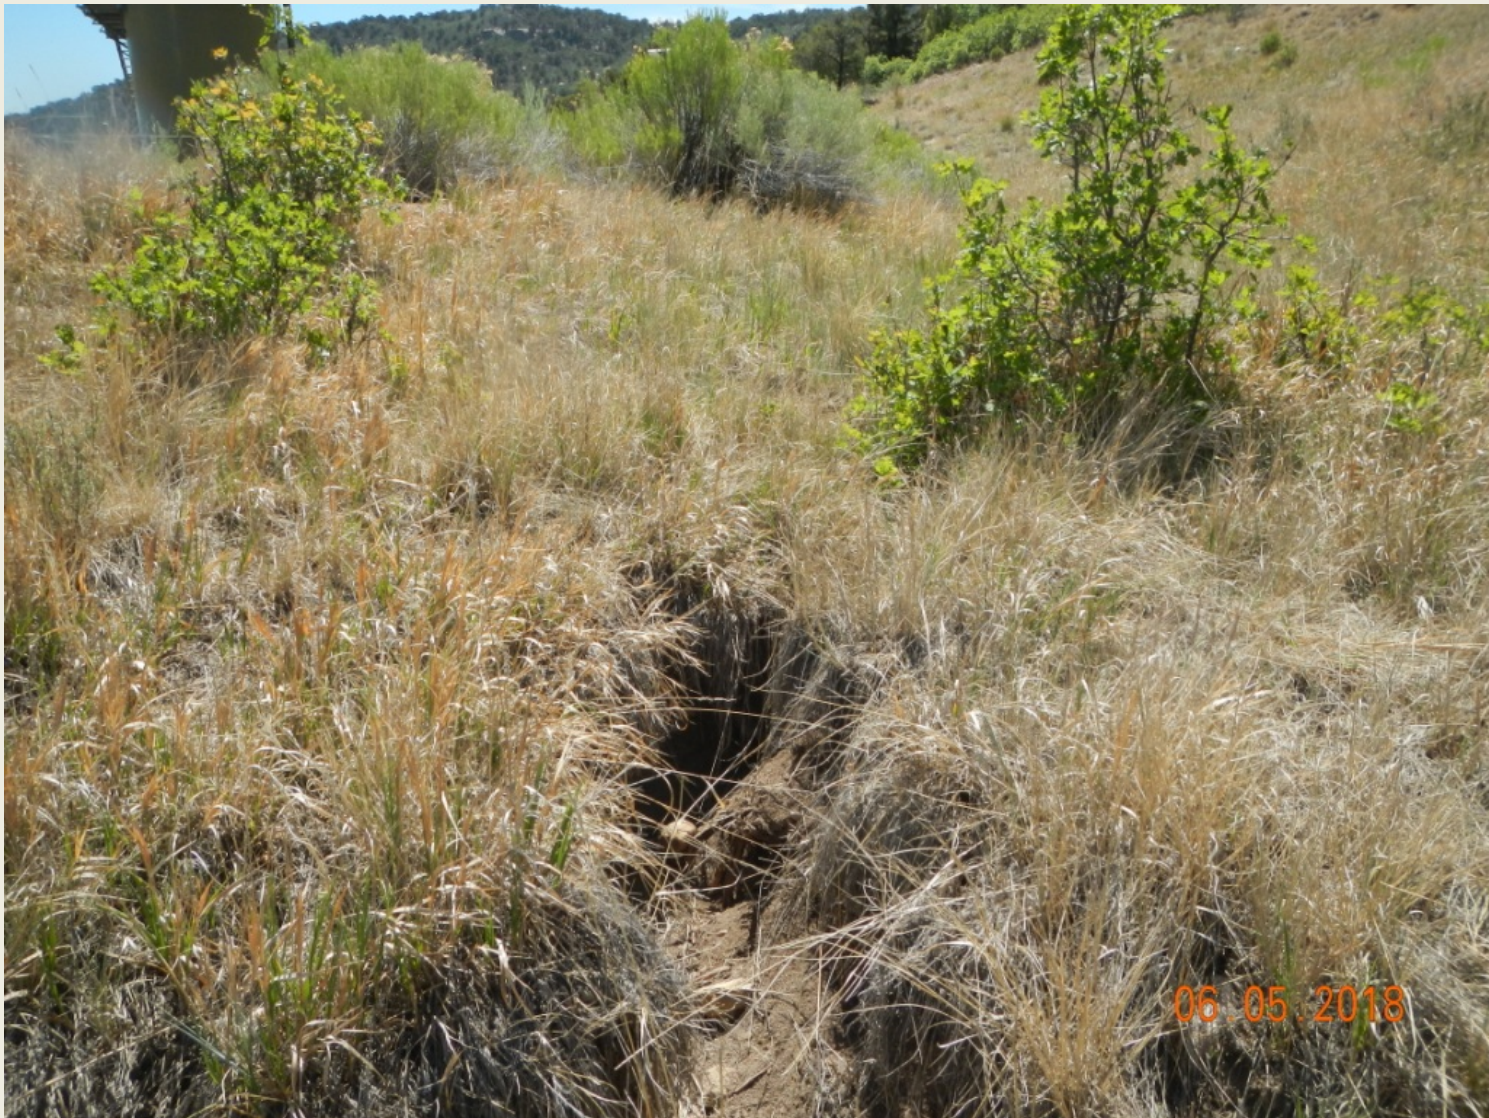
Photo 4. View of erosional channel and tunneling in the southwestern project area, where concentrated stormwater flows down a diversion from the southern edge of the well pad. Photo is facing upstream toward the well pad.

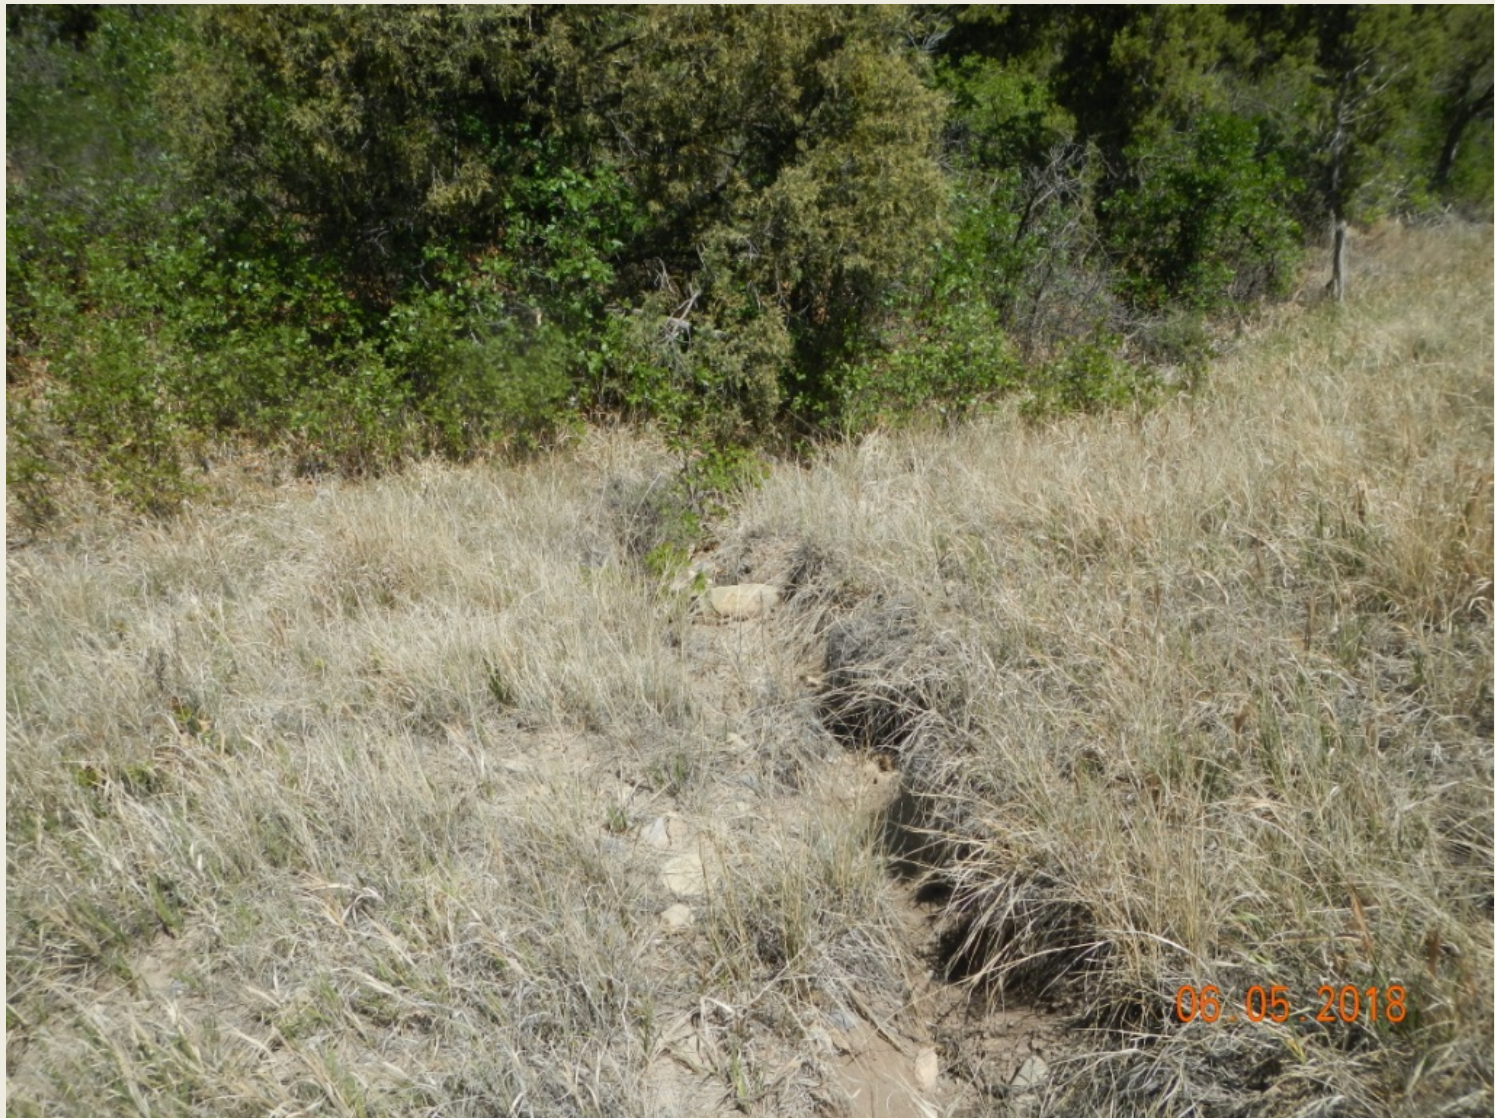
Photo 5. View of erosional channel shown in photo 4, facing downstream. Channel is approximately 2.5 feet wide and deep. Stabilization measures are needed here.

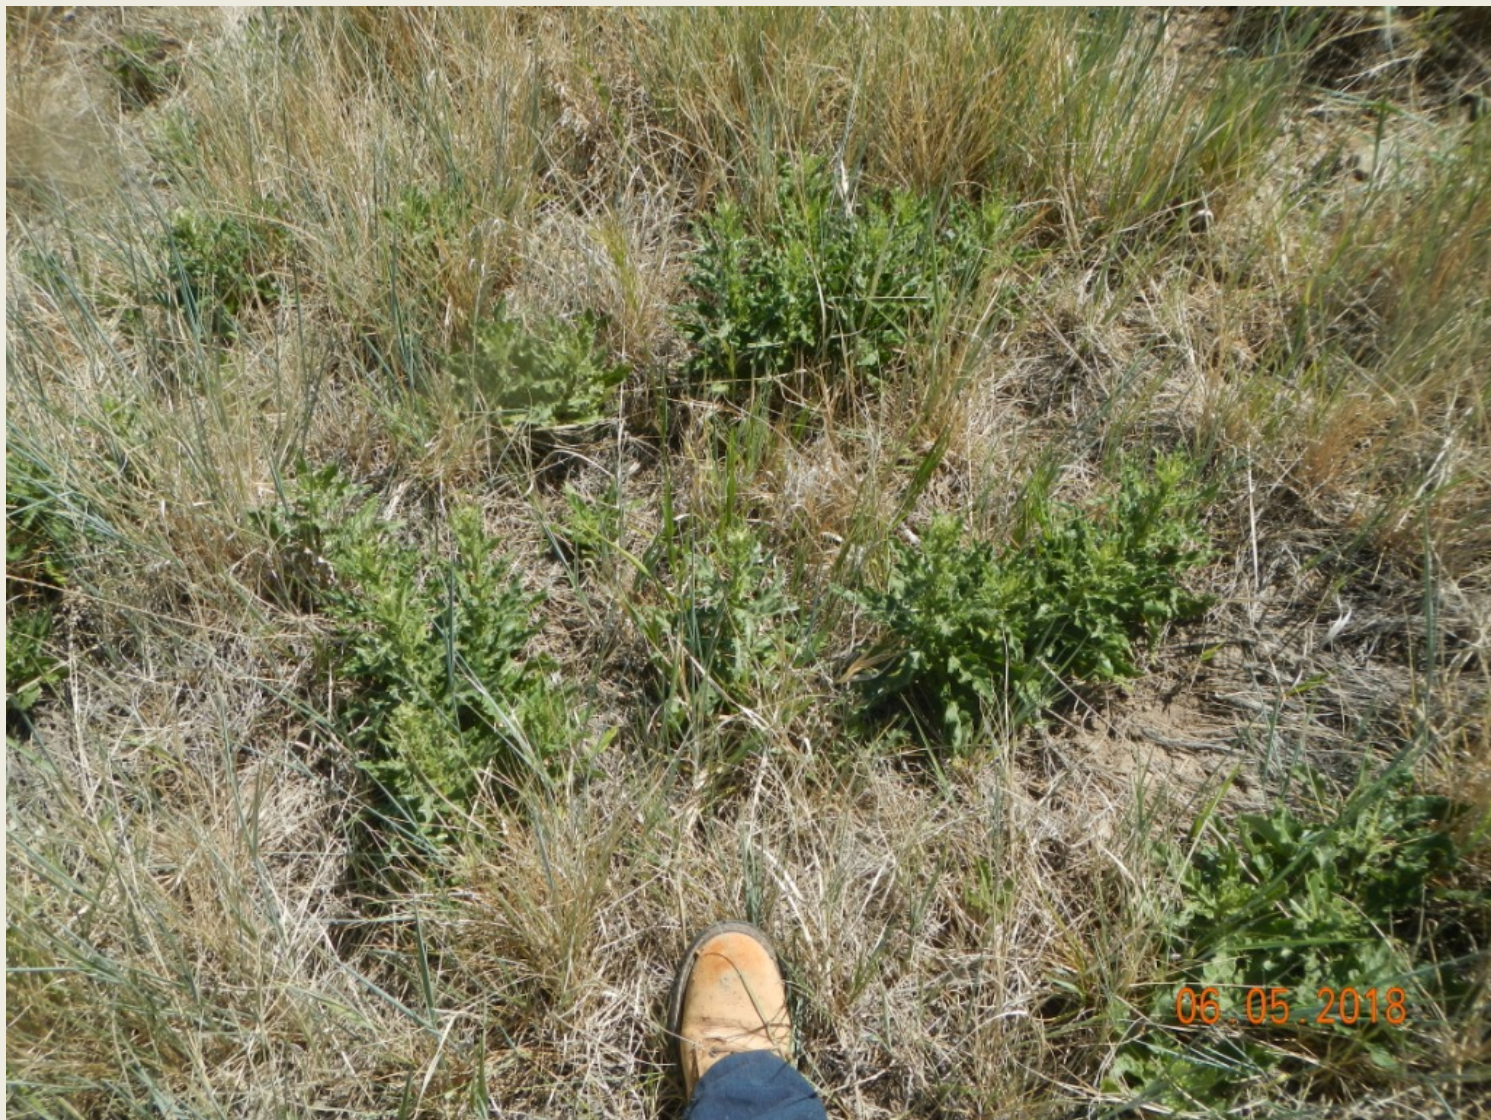
Photo 6. View of Canada thistles (*Cirsium arvense*) within the northwestern interim reclamation area. Approximately 300 Canada and musk thistles observed.
