# Final Reclamation Inspection

Operator: SRC ENERGY INC- #10311

API: 05-123-20035

Inspection Photos  
Location Name: HERTZKE #1-33  
API: 05-123-20035

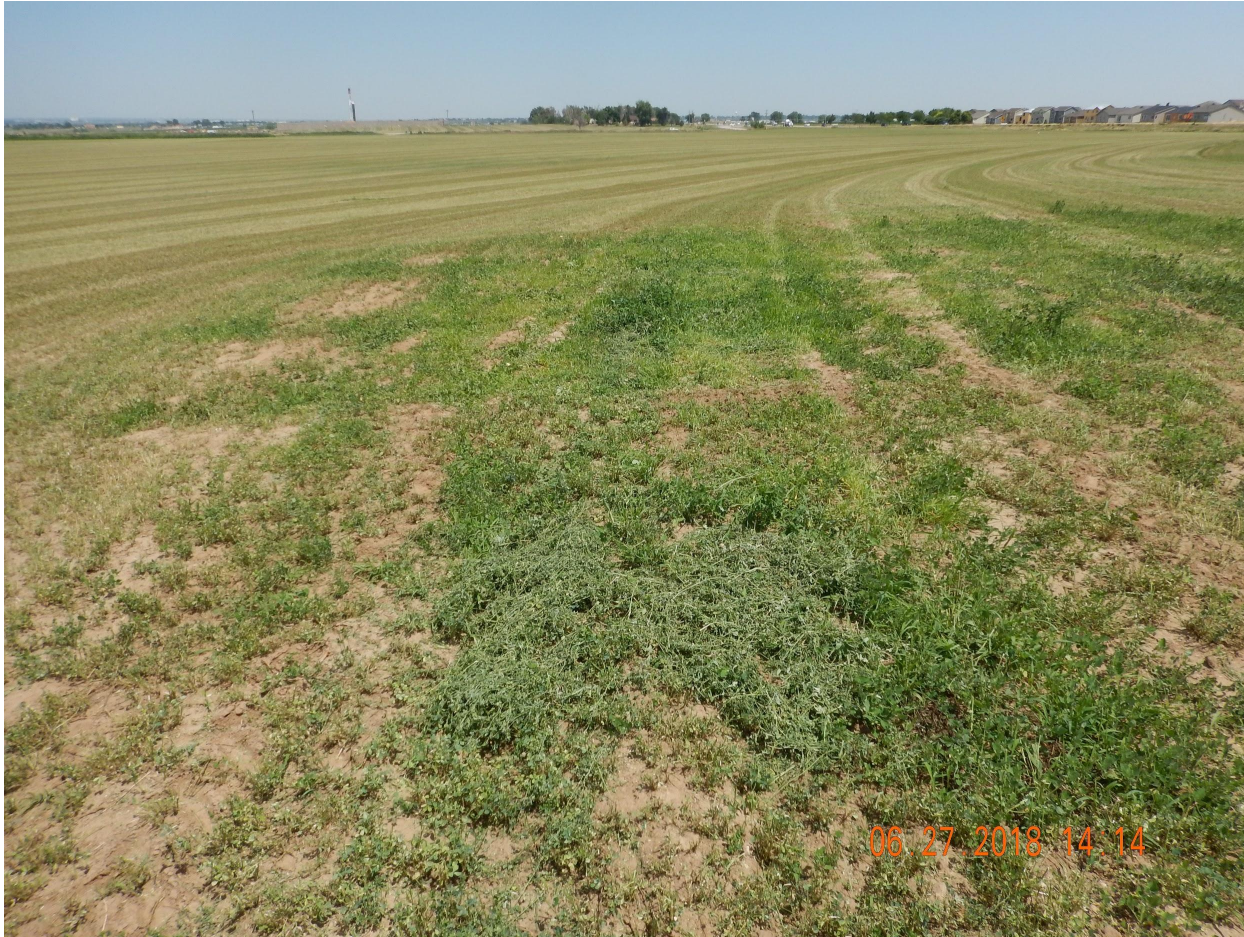
**Photo 1.** Photo taken from the well location, facing East. Photo illustrates that the well location has not been properly contoured and there could also be subsidence issues.

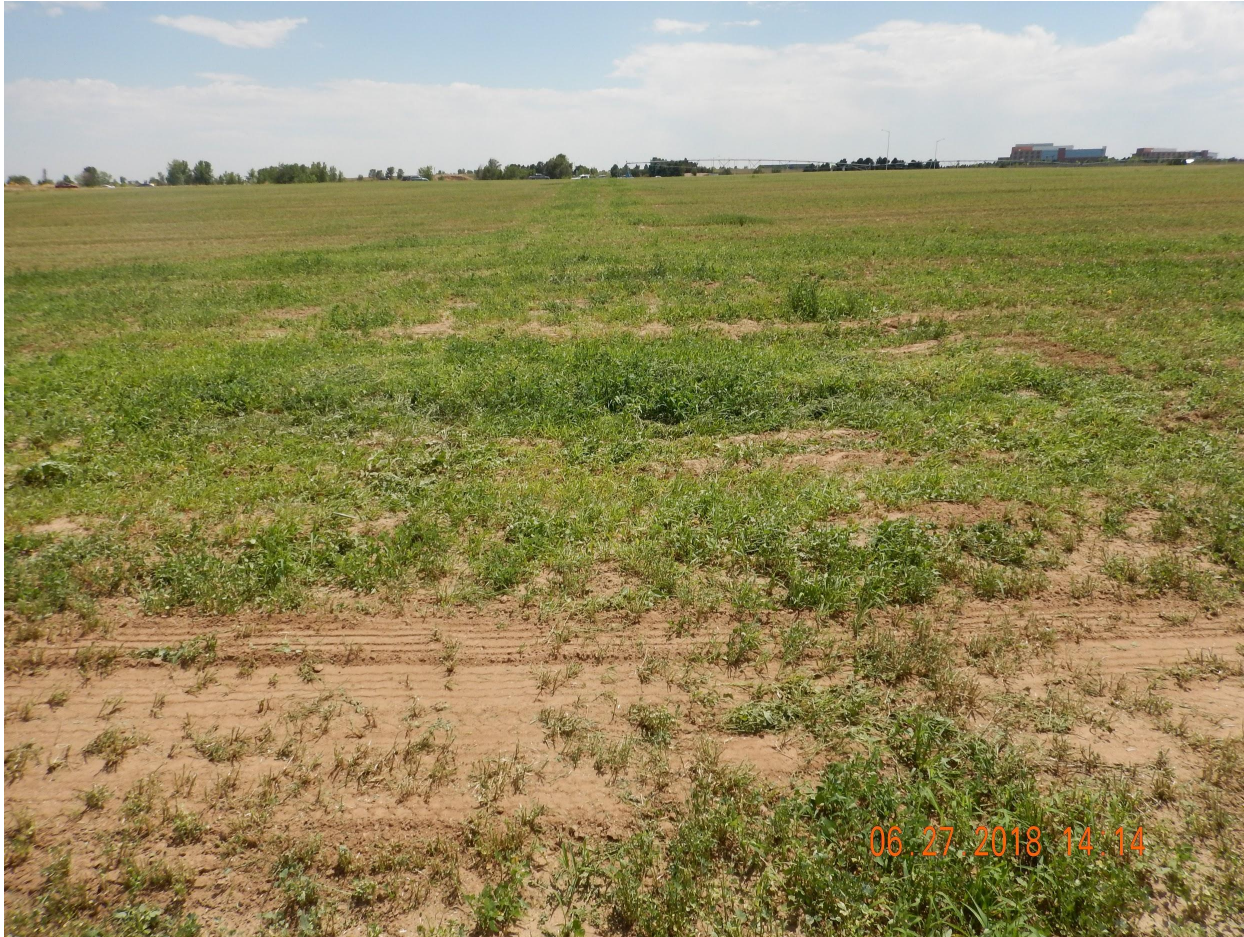
**Photo 2.** Photo taken from the well location, facing South. See comments under Photo 1.

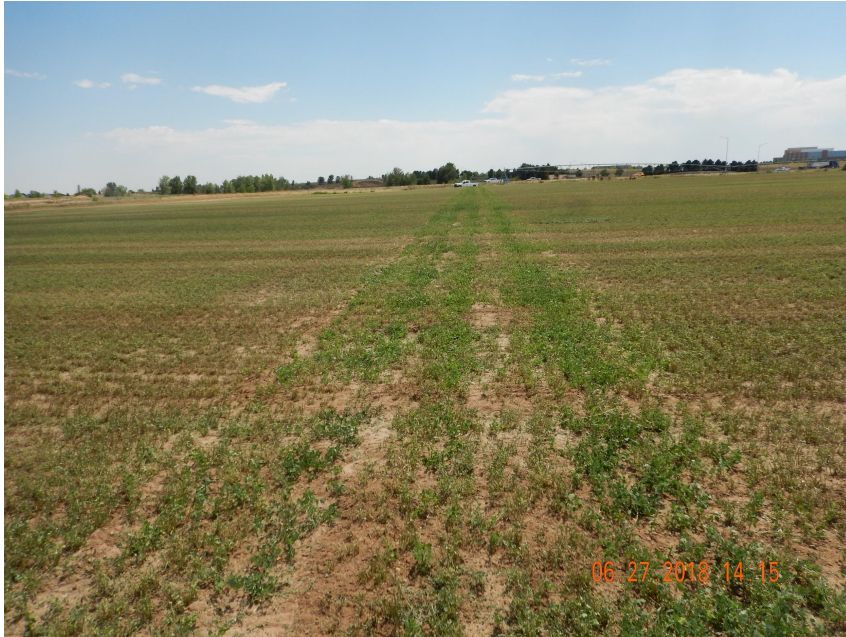
**Photo 3.** Photo taken from a portion of the well location access road, facing South. Access road will remain in-process until it meet Rule 1004 vegetative standards.

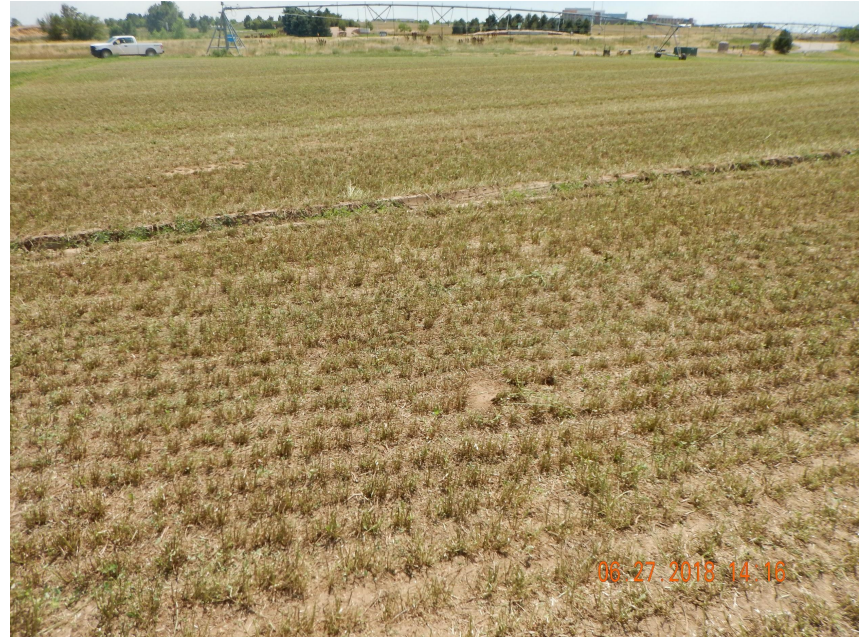
**Photo 4.** Reference photo taken west of the well location access road, facing South. See comments under Photo 3.
