Inspection Photos

Operator: FOUNDATION ENERGY
MANAGEMENT LLC - 10112

Location ID: 323773

Inspection Doc. Number: 682503578
Weld County, CO

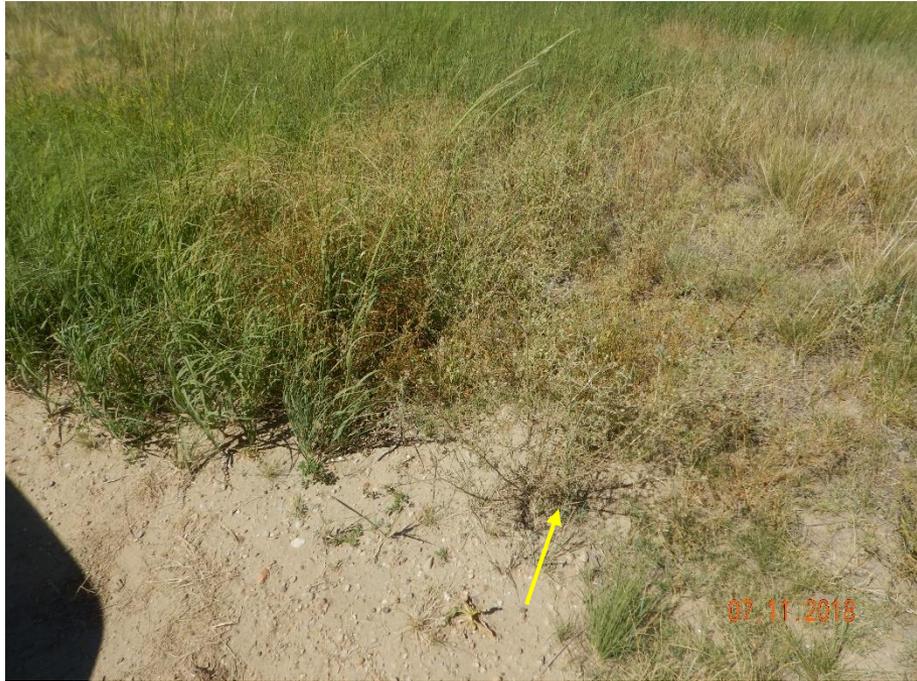
Photo 1: Photo taken from the western interim areas of the location, facing west. Previous inspection required management and removal of noxious weeds.

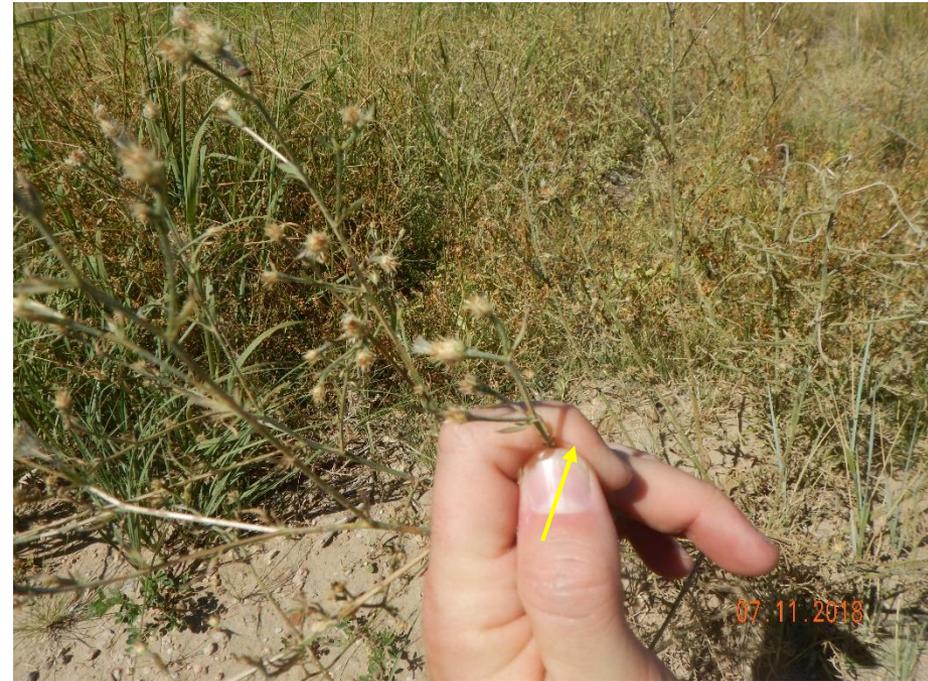
Photo 2: See comments under photo 1.

Photo shows Diffuse Knapweed (lighter, grey-green plants, white colored flowers) remains prevalent on location and access roads. Though there is evidence of herbicide, spraying does not appear to have been sufficient as many plants appear to be viable and have continued to mature/flower

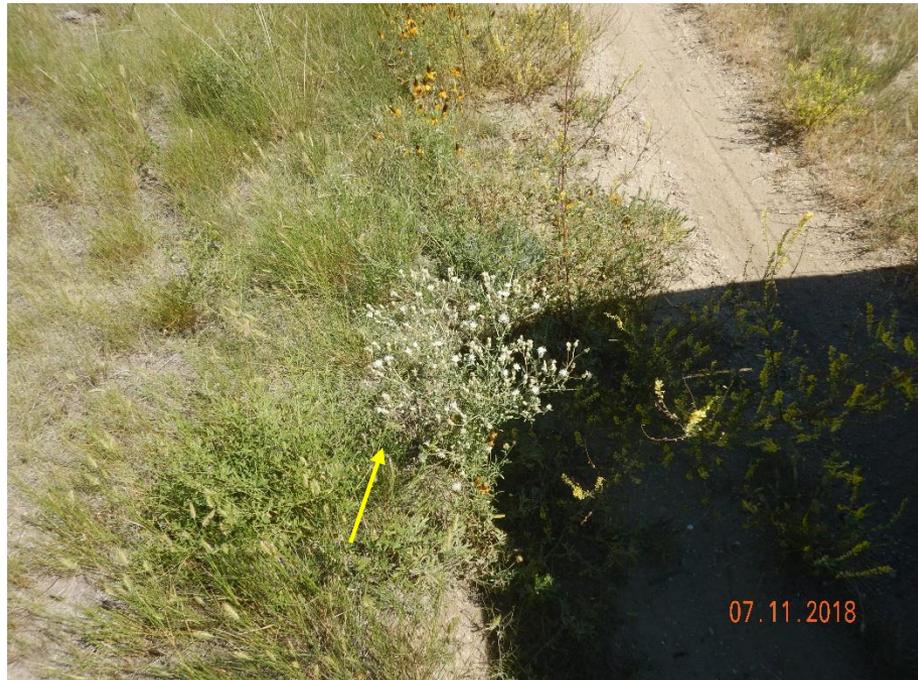
Photo 3: Photo taken from the access road. Previous inspection required management and removal of noxious weeds.

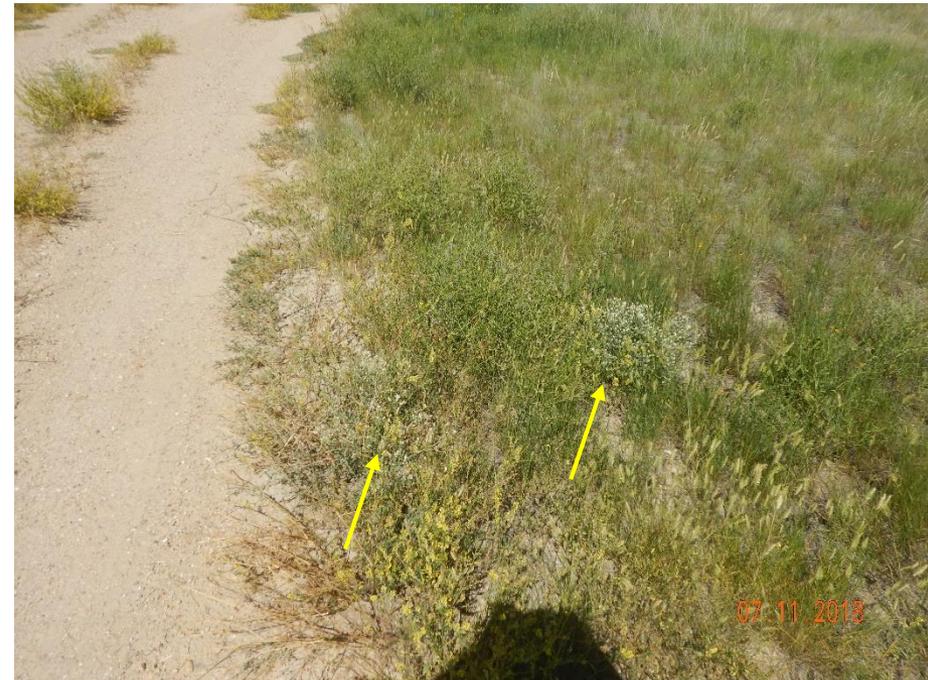
Photo 4: See comments under photo 3

Photo shows Diffuse Knapweed (lighter, grey-green plants, white colored flowers) remains prevalent on location and access roads. Though there is evidence of herbicide, spraying does not appear to have been sufficient as many plants appear to be viable and have continued to mature/flower
