# Inspection Photos

Operator: NOBLE ENERGY INC - 100322

Location ID: 323695

Inspection Doc. Number: 682503583

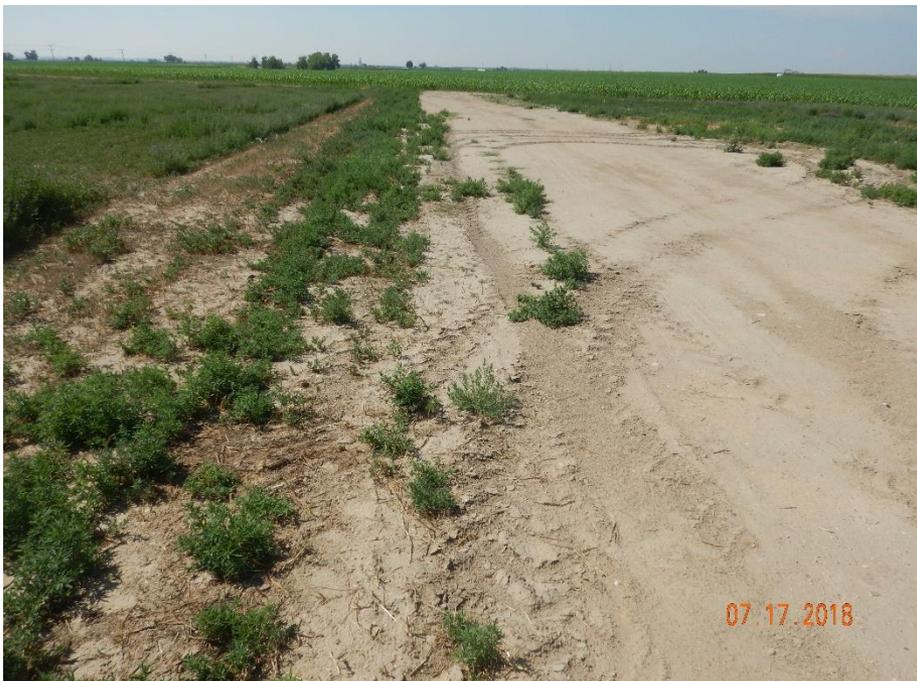
**Photo 1:** Photo taken from the north end of the battery location, facing south. Photo shows battery remains predominantly bare and exposed soil, or vegetated by undesirable weedy plant species. FIRR #401471165 states that corrective action has been addressed, that "location was ripped and cross-ripped, disc and seeded with alfalfa on November 22, 2017". Unable to find evidence of crop establishment.

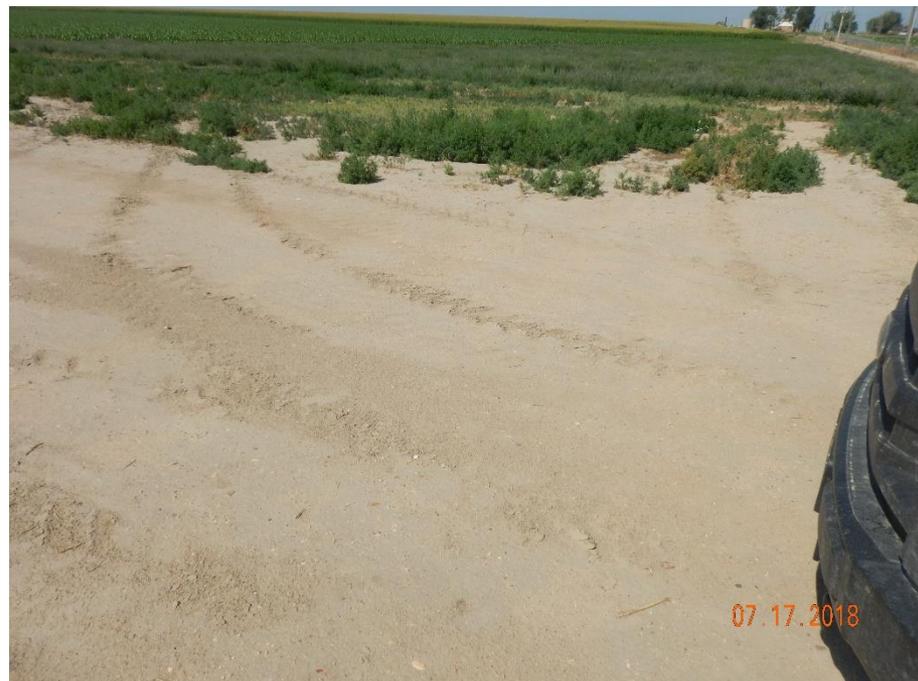
**Photo 2:** Photo taken from the north end of the battery location, facing east. See comments under photo 1.

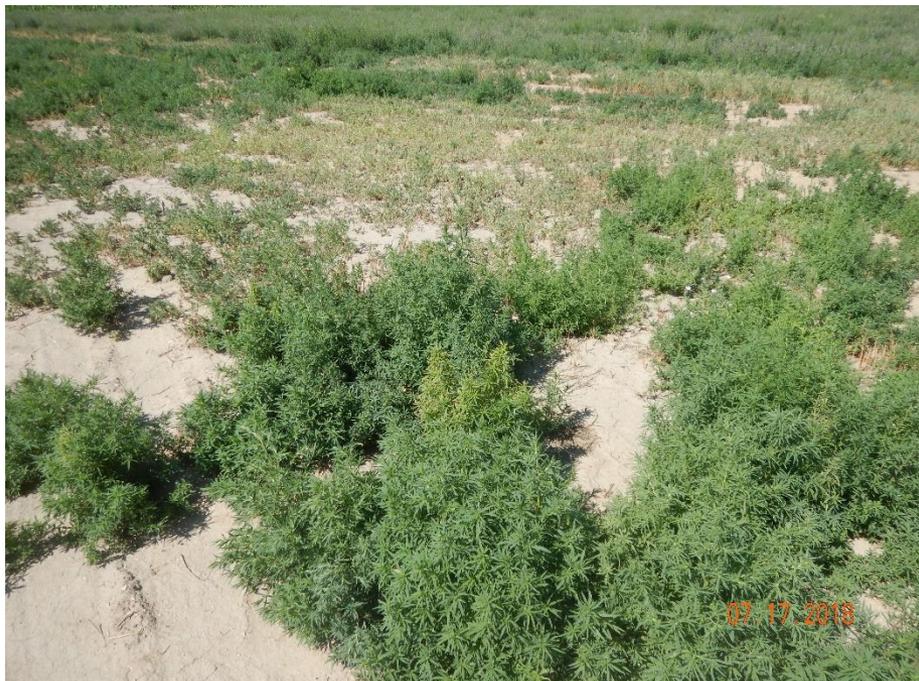
**Photo 3:** Photo taken from the battery location. Photo shows vegetation on the location is predominantly undesirable weedy plant species.

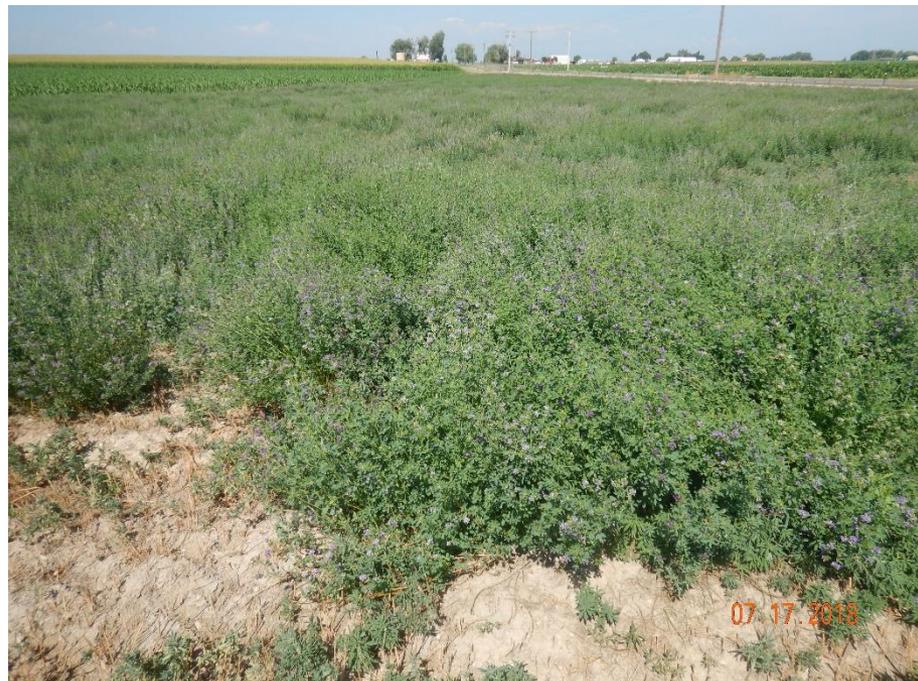
**Photo 4:** Photo taken from the adjacent reference area, facing east. Photo shows alfalfa crop in the reference.
