Inspection Photos

Operator: PCR OPERATING LLC - 10657

Location ID: 313784

Inspection Doc. Number: 682503690

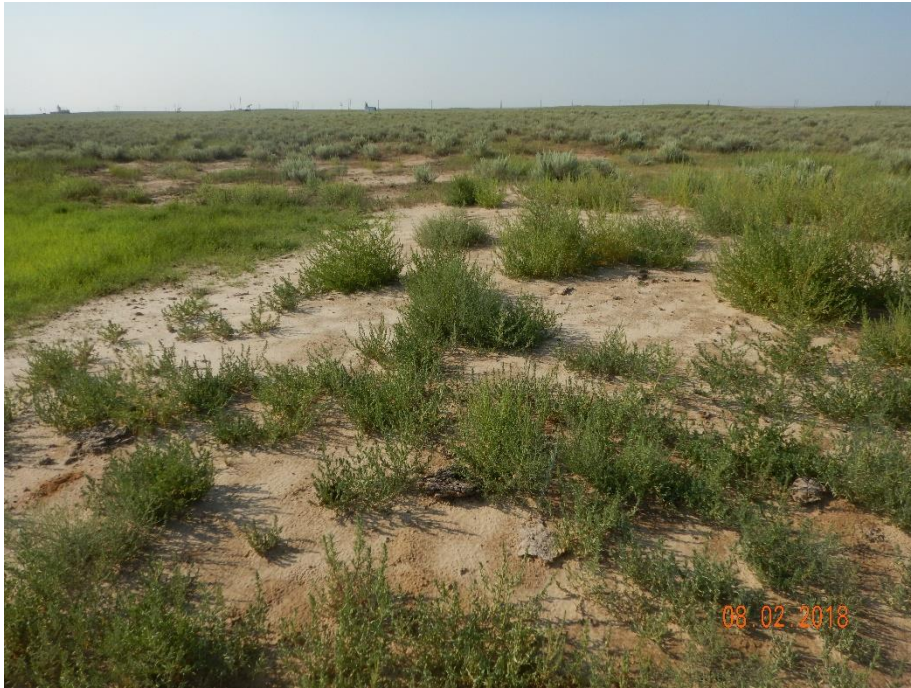
Photo 1: Photo taken from the location facing north. Photo shows the location remains either bare and exposed soil, or vegetation is predominantly undesirable weedy plant species. Unable to find evidence of additional reclamation activities have been conducted.

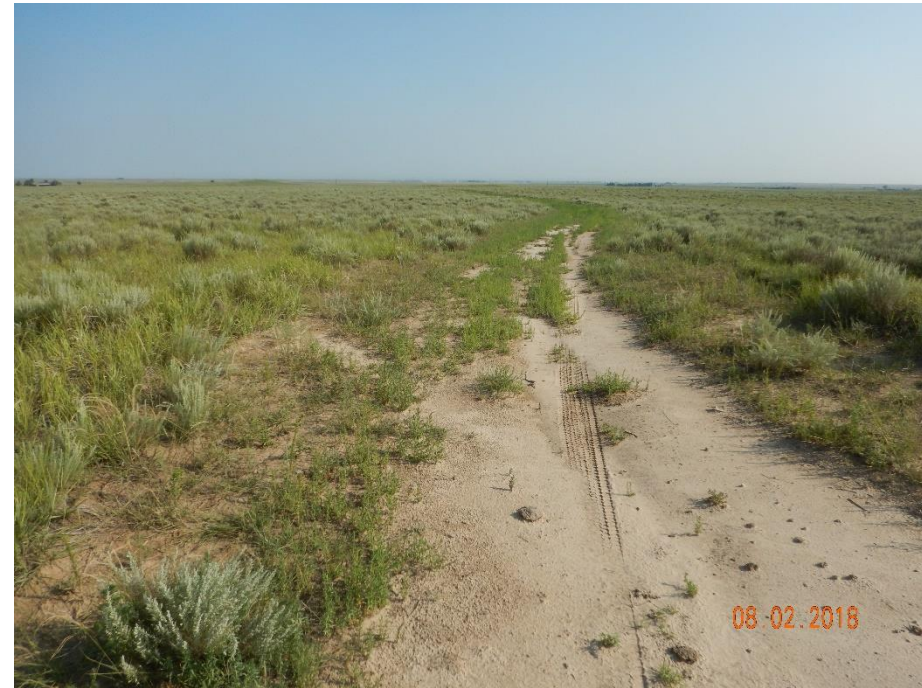
Photo 2: Photo taken from the location facing north. Photo shows access road. Access road has not been recontoured/regraded, and remains either bare and exposed soil, or vegetation is predominantly undesirable weedy plant species. Unable to find evidence of additional reclamation activities have been conducted.

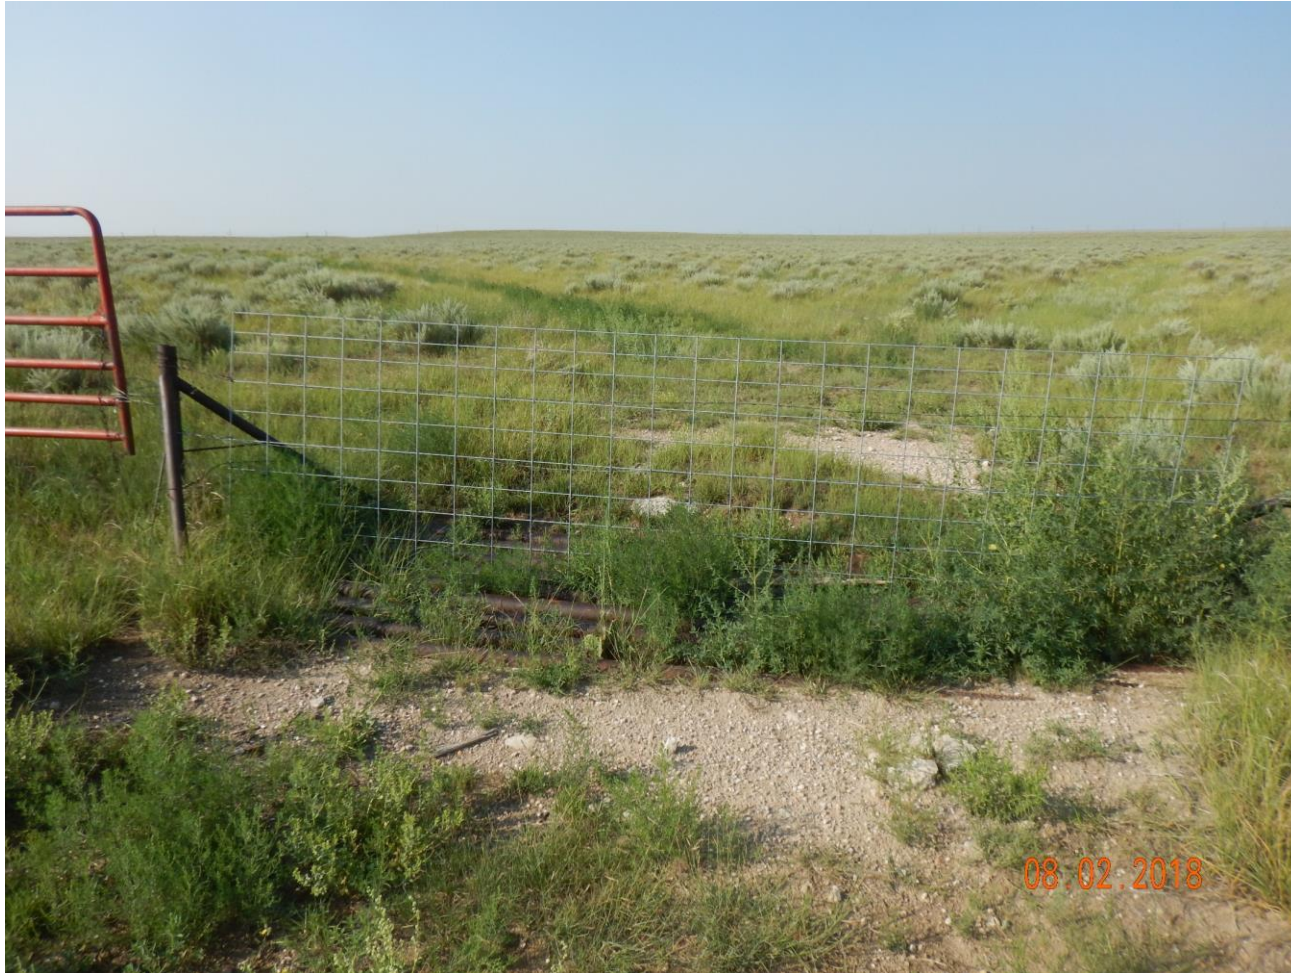
Photo 3: Photo taken at access road entrance. Photo shows surface owner appears to have constructed a panel across the cattle guard to prevent access. Cattle guard requires removal in accordance to COGCC 1000 series reclamation requirements.
