Inspection Photos

Operator: PCR OPERATING LLC - 10657

Location ID: 313768

Inspection Doc. Number: 682503692

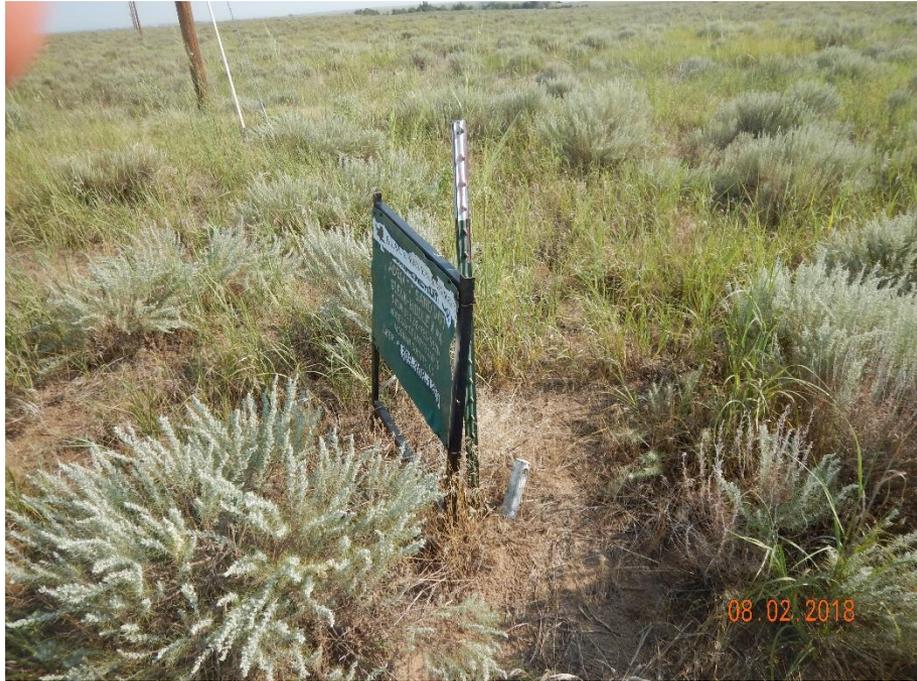
Photo 1: Photo taken from the southwest corner of the location, facing north. Photo shows 1 of the 4 anchors that remain on the location.

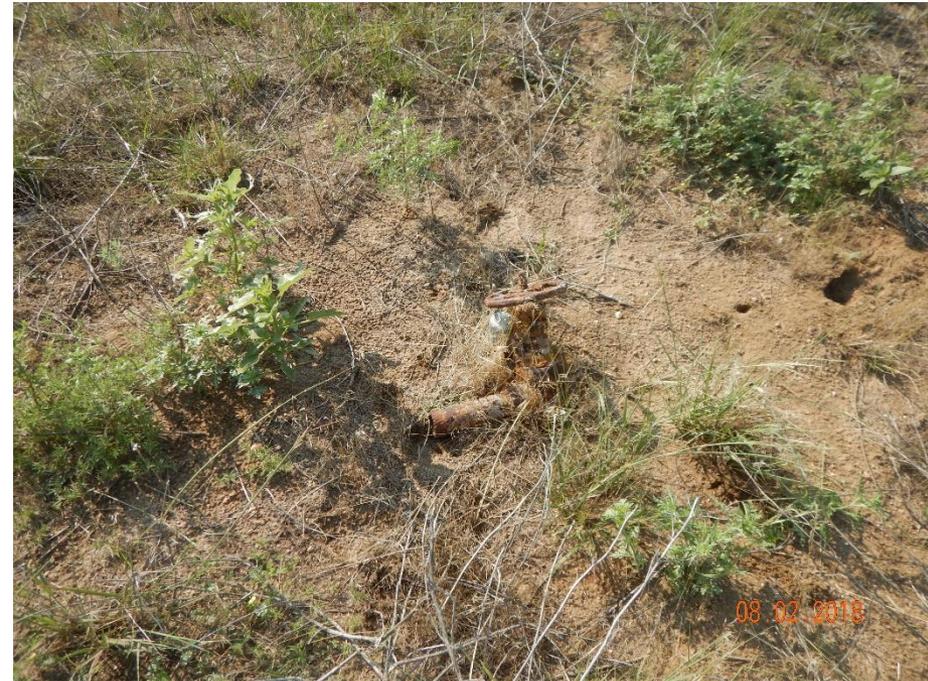
Photo 2: Photo taken from the location. Photo shows pipe riser has not been removed from the location per corrective actions.

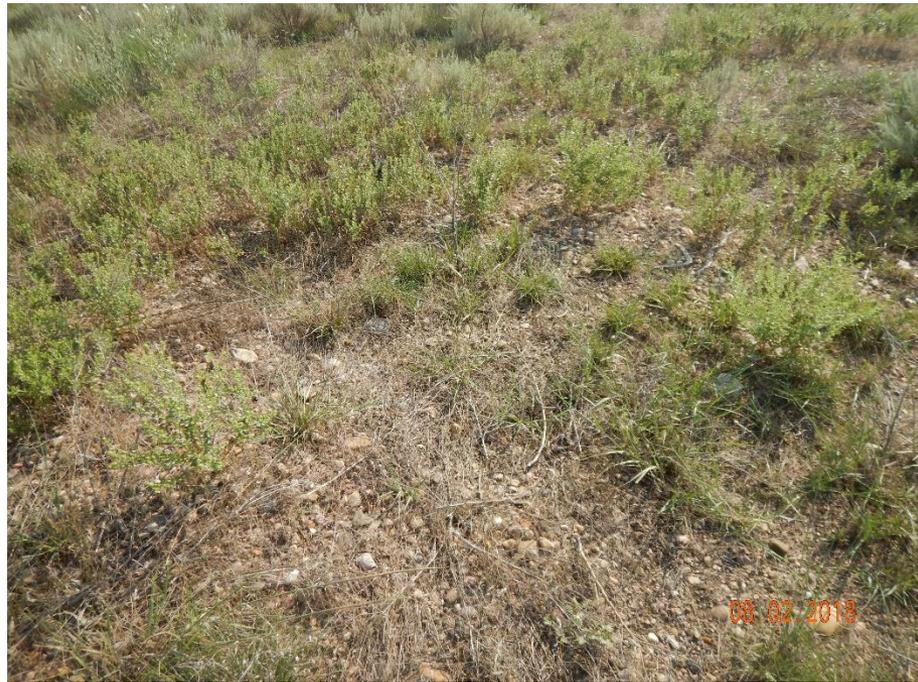
Photo 3: Photo taken from the location. Photo shows gravel and road base remains on location. Note: Though location appears to be green and vegetated, vegetation seen on location is predominantly undesirable weedy plant species, or annual forbs. Very little desirable perennial vegetative establishment observed.

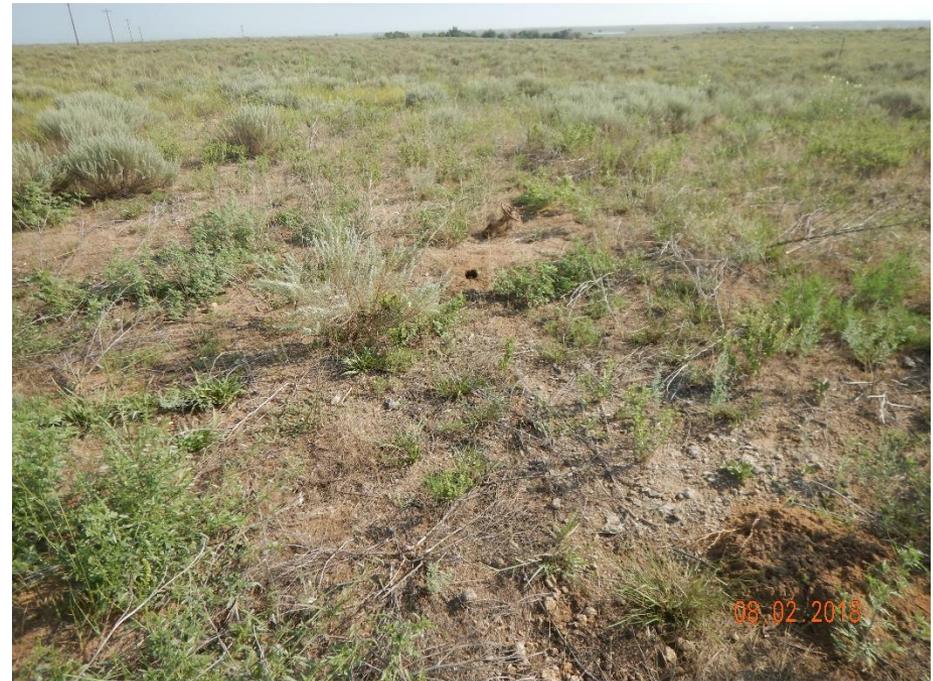
Photo 4: Photo taken from the location facing north. Photo shows that though location appears to be green and vegetated, vegetation seen on location is predominantly undesirable weedy plant species, or annual forbs. Very little desirable perennial vegetative establishment observed.

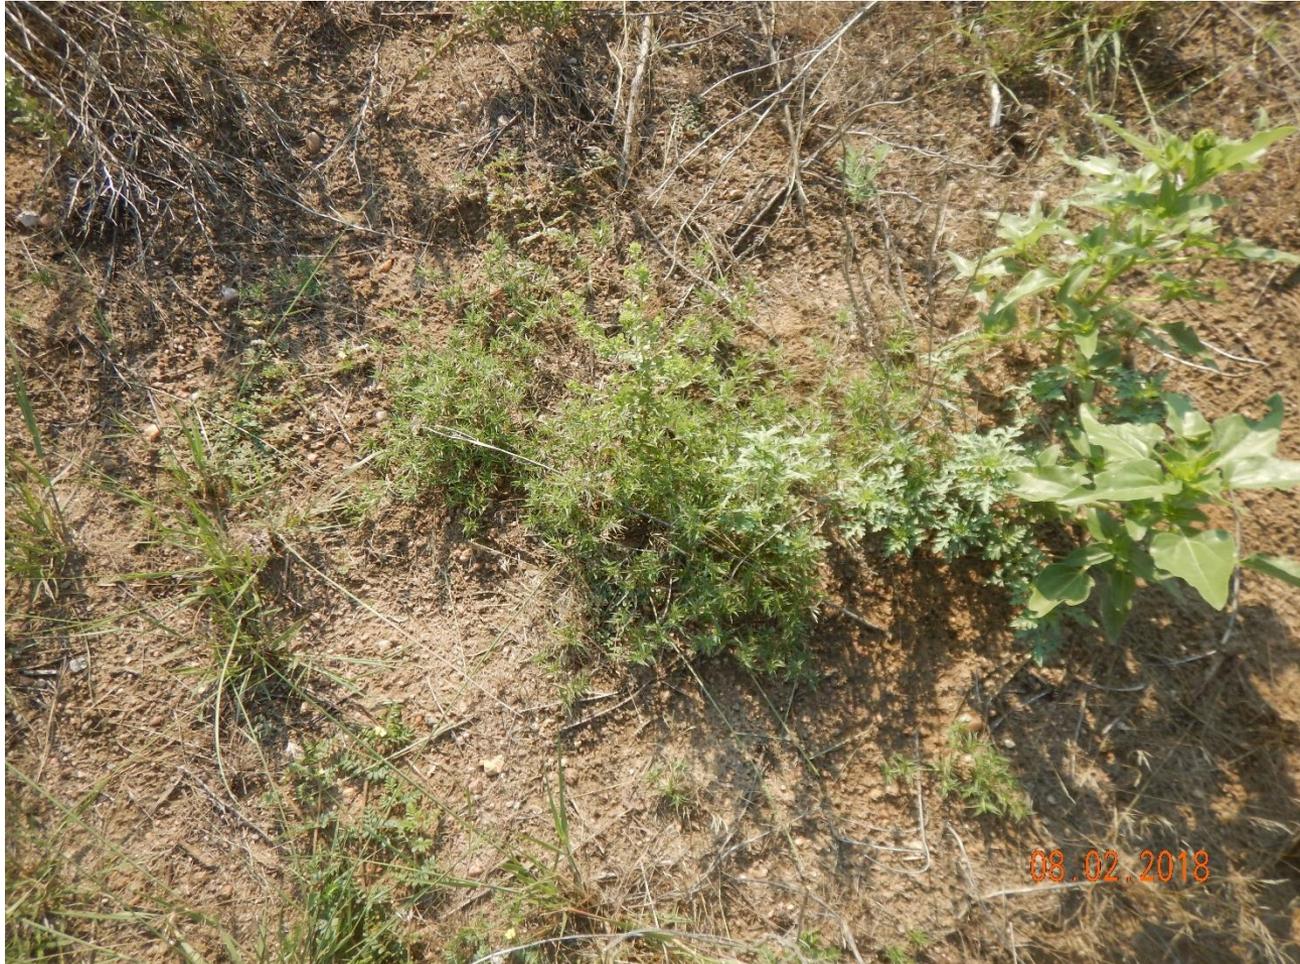
Photo 5: Photo of vegetation on location. Vegetation seen on location is predominantly undesirable weedy plant species, or annual forbs. Very little desirable perennial vegetative establishment observed
