Final Reclamation Inspection

Operator: TOP OPERATING COMPANY - 39560

API: 05-123-07899

Inspection Photos
Location Name: KNOX #1-23
API: 05-123-07899

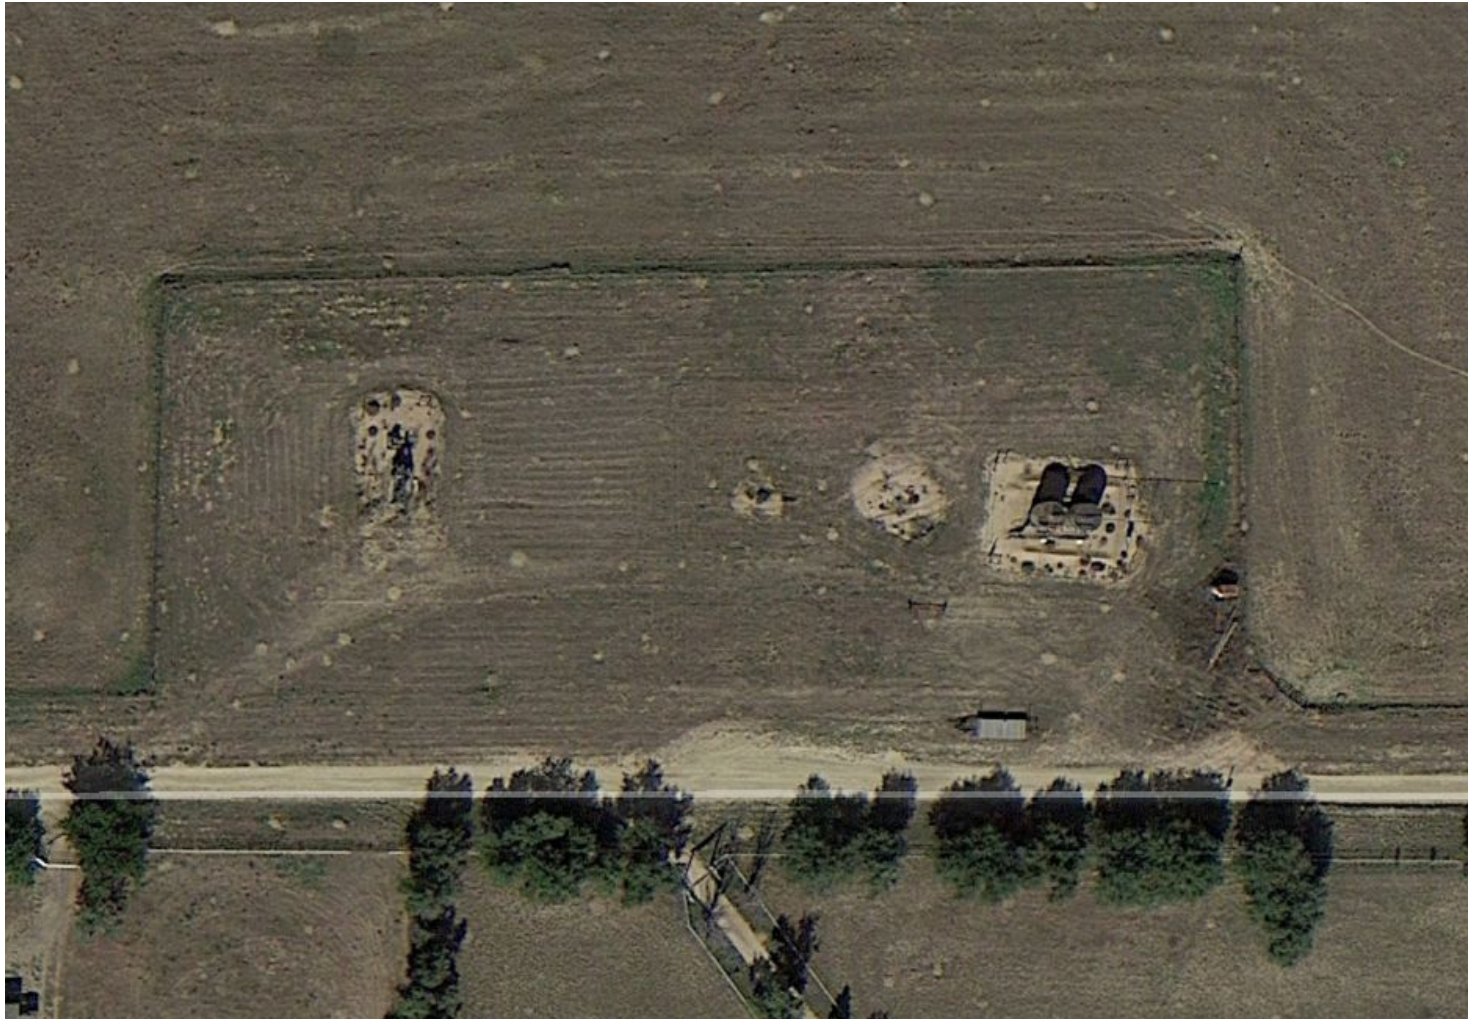
Google Earth aerial imagery taken October 6, 2014. Photo illustrates equipment had not been removed per Rule 1004.a. and remained 15 months after plugging and abandonment.

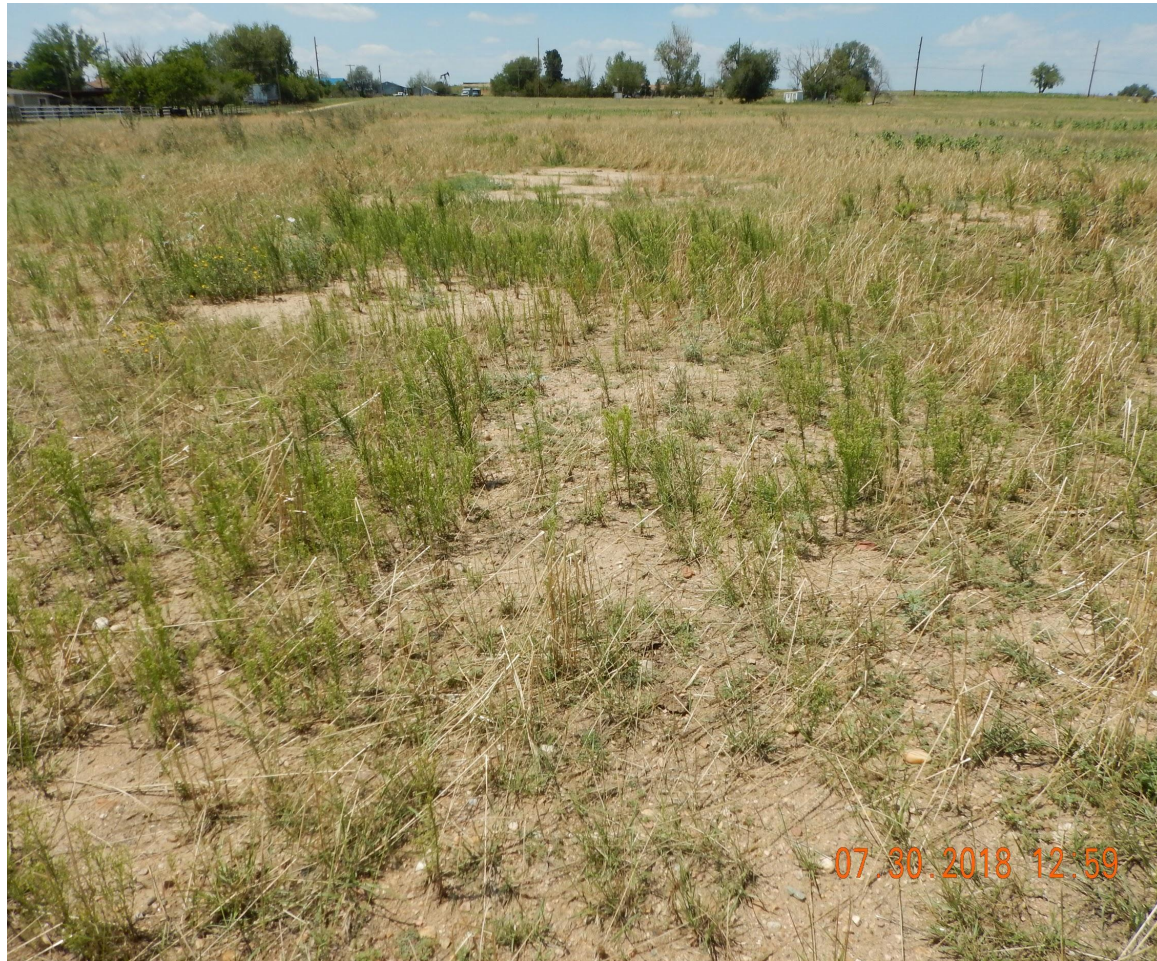
Photo 1. Photo taken from the eastern location, facing West. Vegetative growth does not meet Rule 1004 standards. Disturbance areas are evident with the lack of perennial vegetative growth and bare soil. Vegetative cover is not uniform or reflective of reference area vegetative growth.

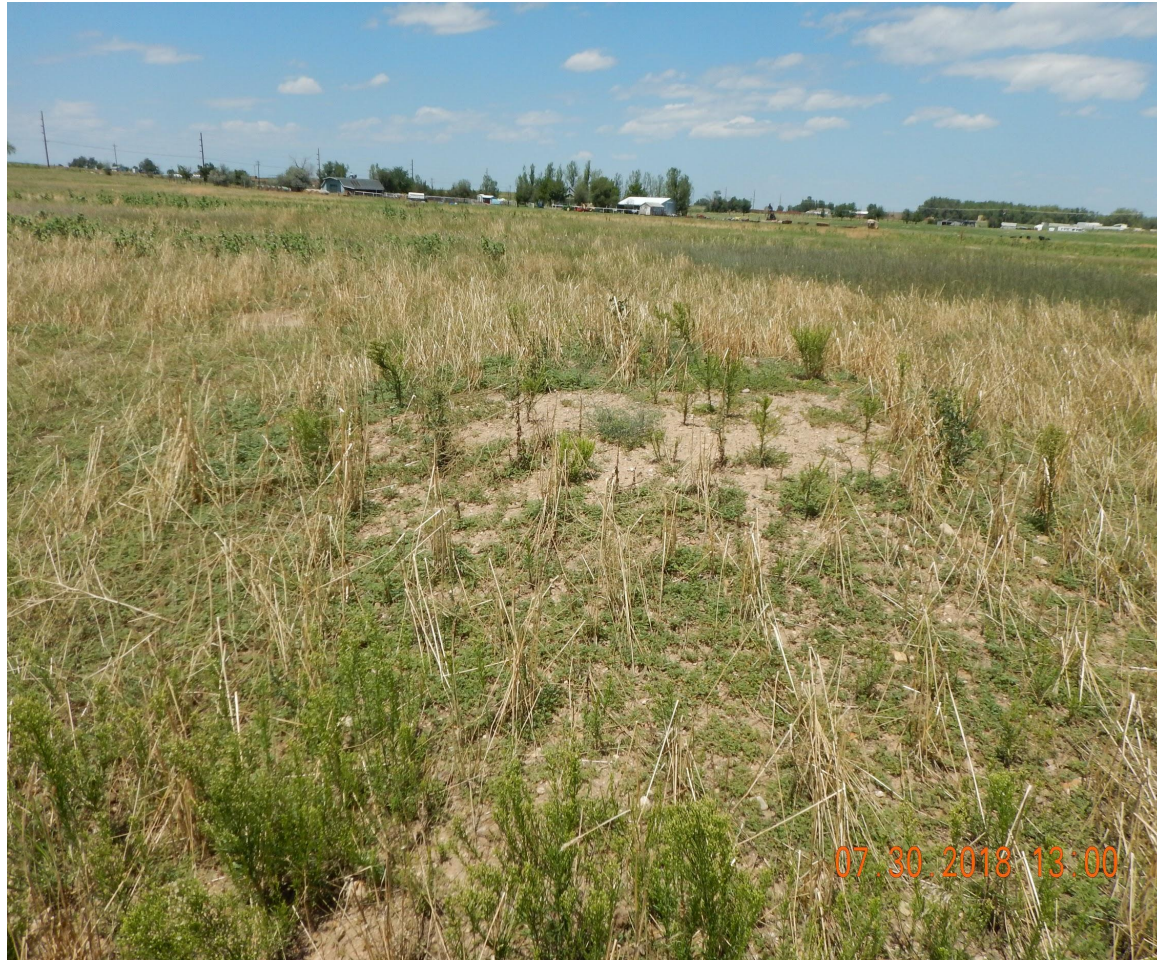
Photo 2. Photo taken from the western location, facing West. Operator has not contoured a portion of the location to match the surrounding landscape. Also, the photo illustrates vegetative standards do not meet Rule 1004 standards.

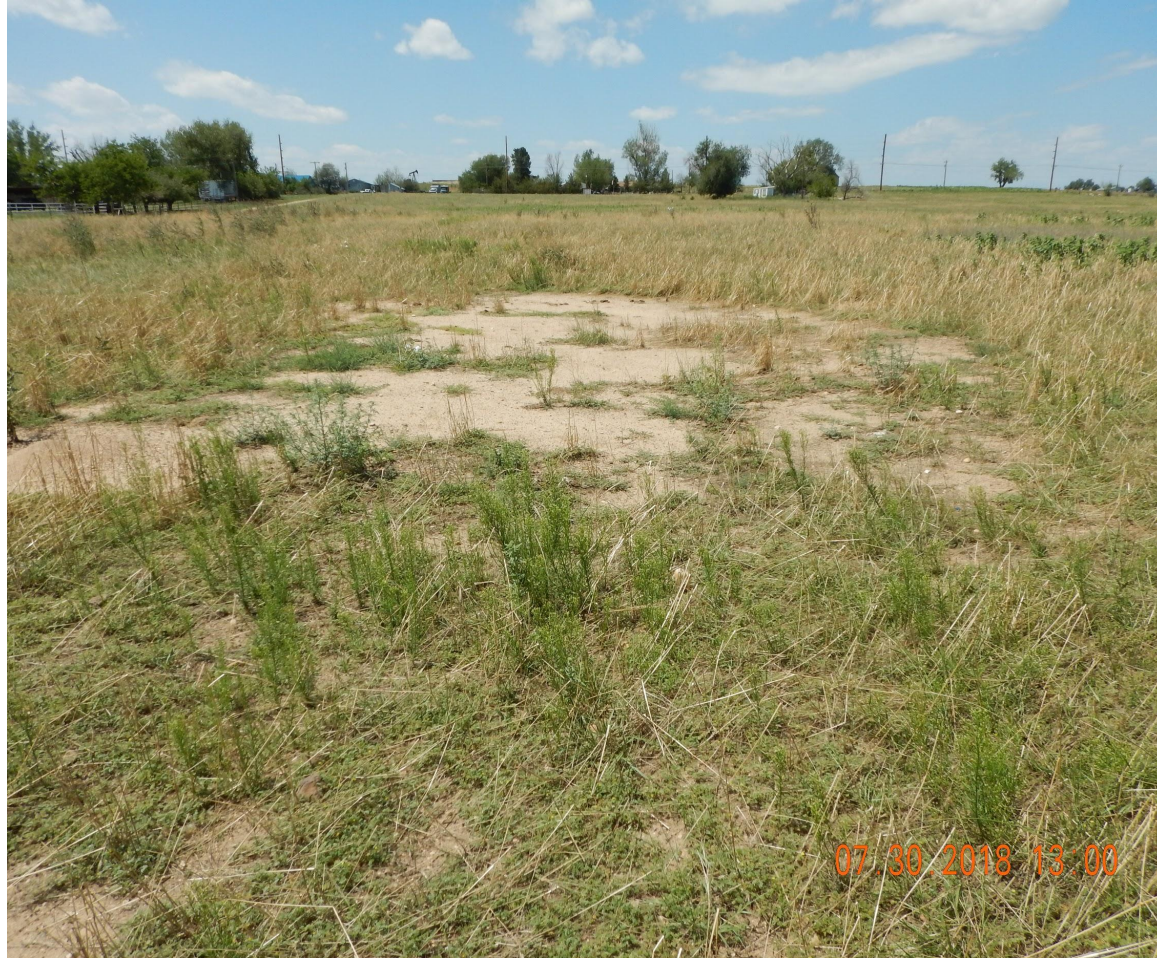
Photo 3. Photo taken from the western location, facing West. See comments under Photo 1.

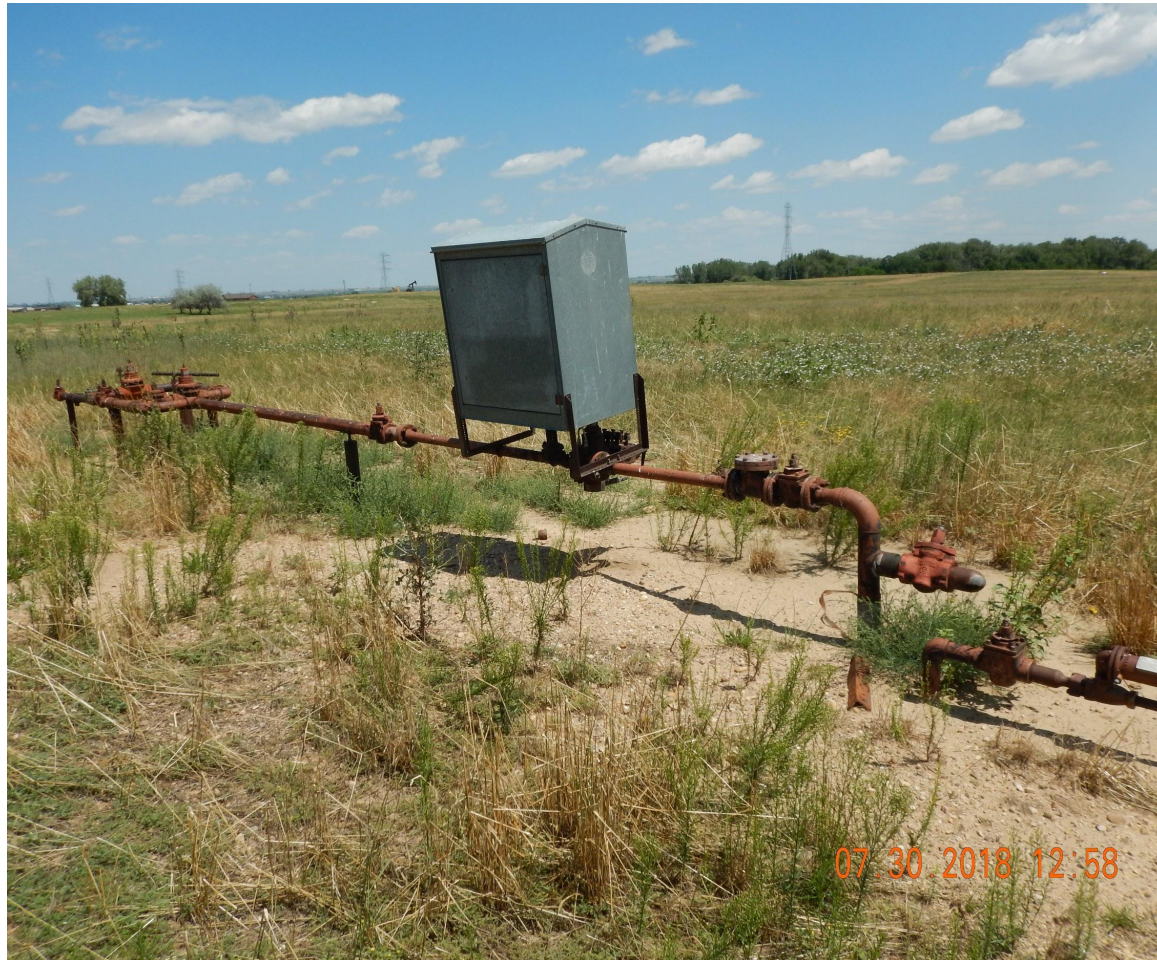
Photo 4. Photo taken from the eastern location, facing Northeast. Operator has failed to remove all equipment. It is the responsibility of the Operator to coordinate with the responsible parties to remove all equipment that was associated with oil and gas operations.

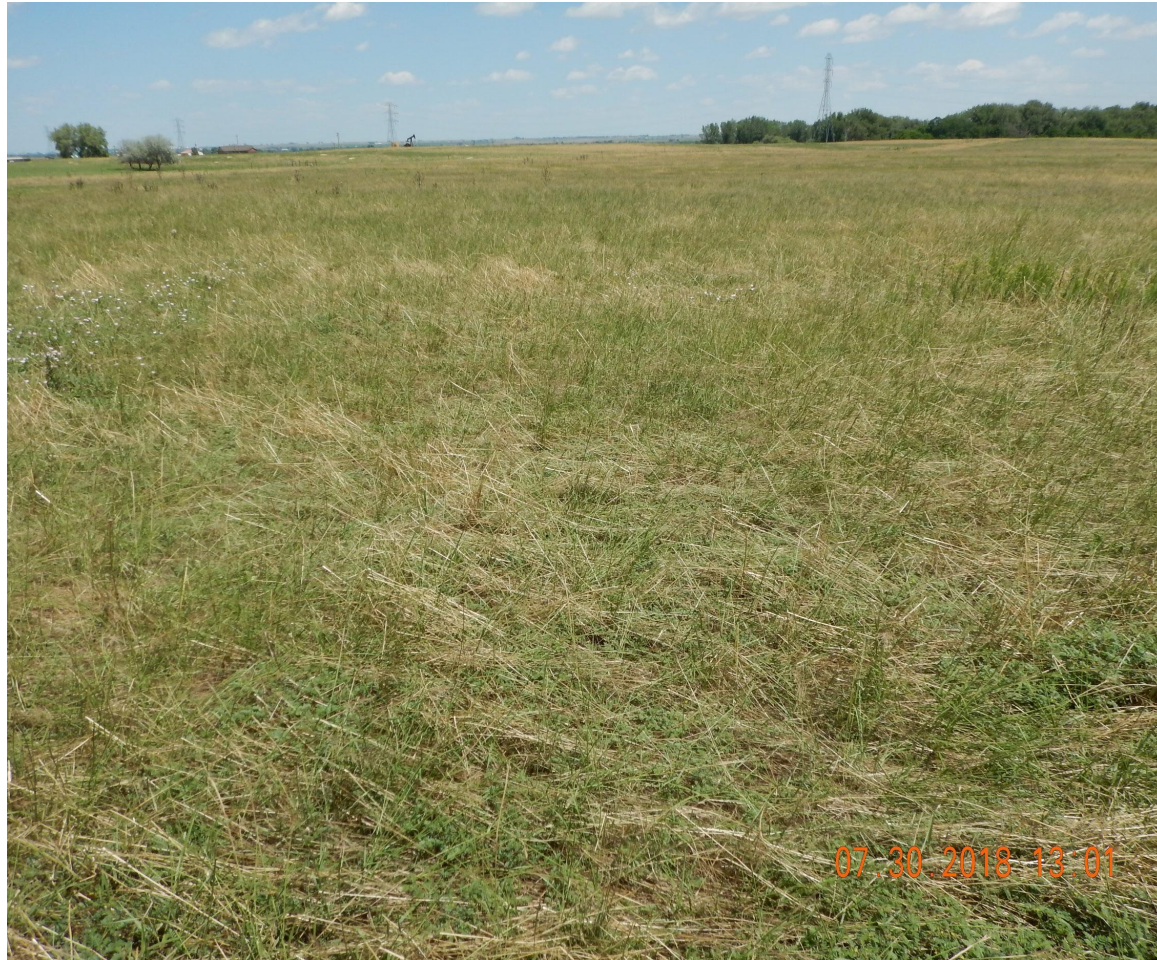
Photo 5. Reference photo taken east location, facing Northeast. Photo illustrates uniform vegetative cover which is not reflective of the Knox disturbance areas.
