# Final Reclamation Inspection

Operator: TOP OPERATING COMPANY - 39560

API: 05-123-08731

Inspection Photos  
Location Name: KNOX #22-23  
API: 05-123-08731

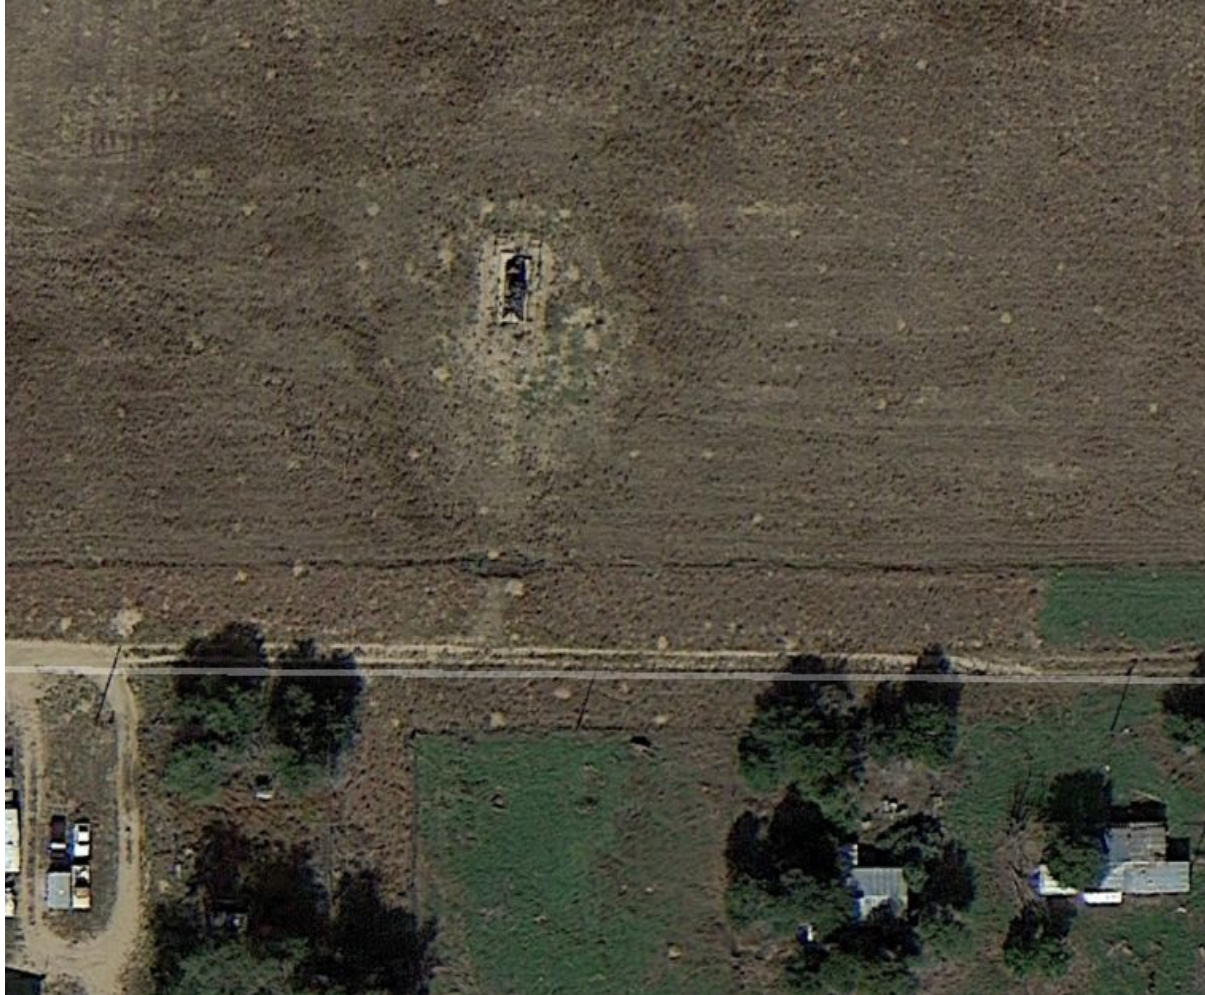
Google Earth aerial imagery taken October 6, 2014. Photo illustrates equipment had not been removed per Rule 1004.a. and remained 15 months after plugging and abandonment.

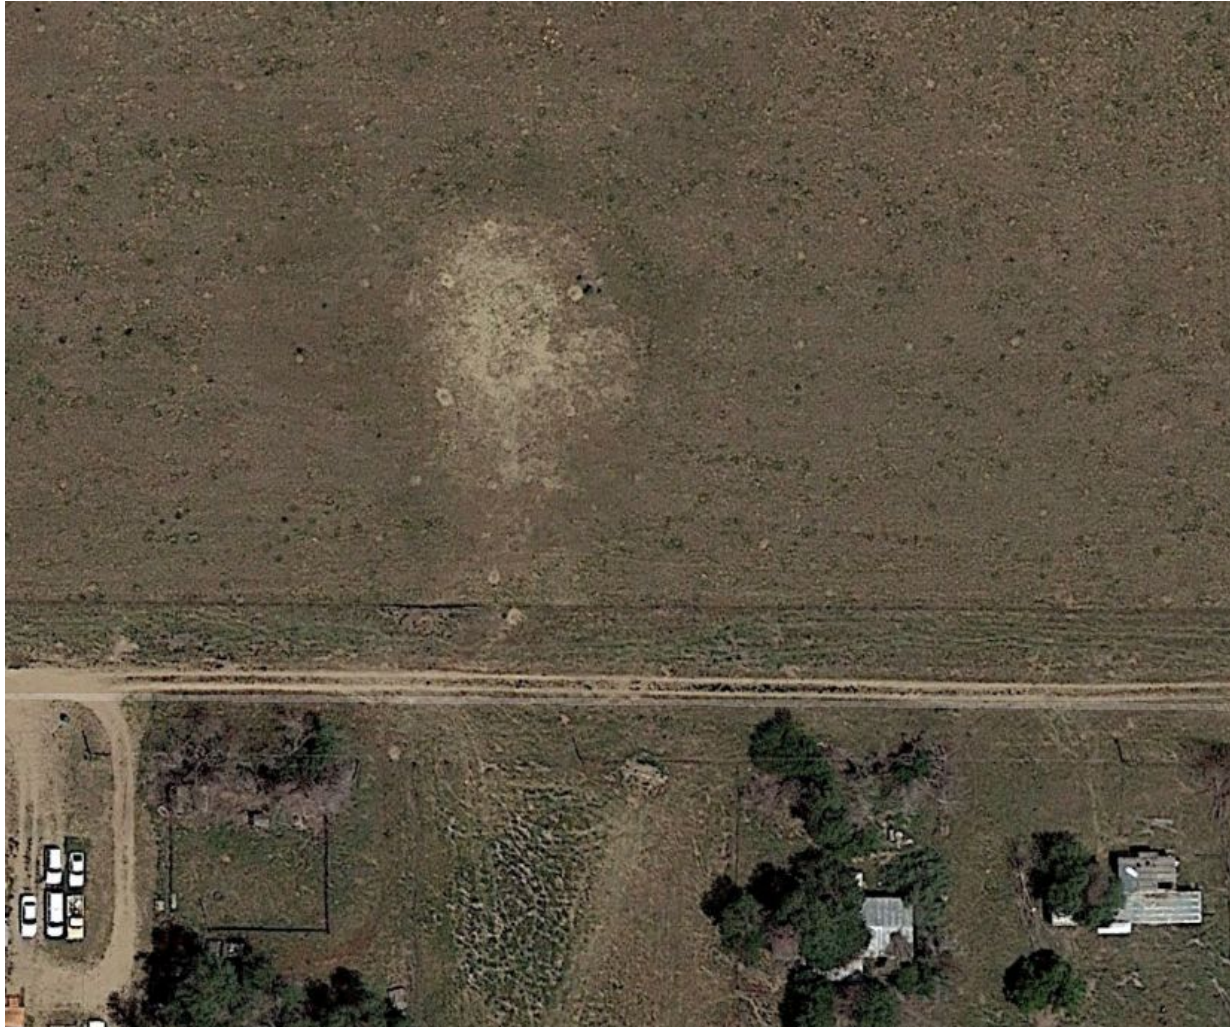
Google Earth aerial imagery taken June 9, 2017. Aerial imagery shows disturbance areas do not meet vegetative standards, even though the Operator submitted a Final Reclamation Complete Notice on January 28, 2016.

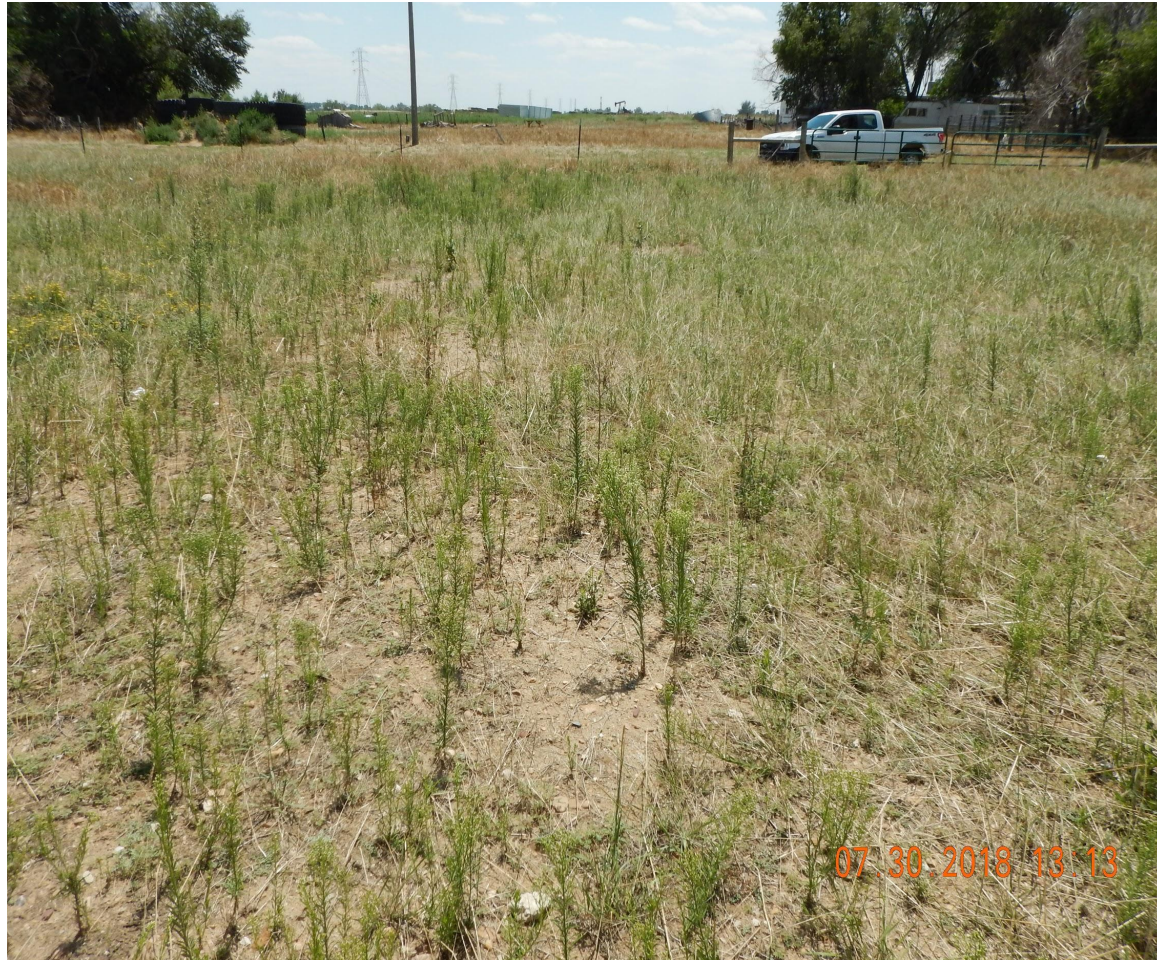
**Photo 1.** Photo taken from the approximate center of location, facing South. Vegetative growth does not meet Rule 1004 standards. Disturbance areas are evident with the lack of perennial vegetative growth and bare soil. Vegetative cover is not uniform or reflective of reference area vegetative growth.

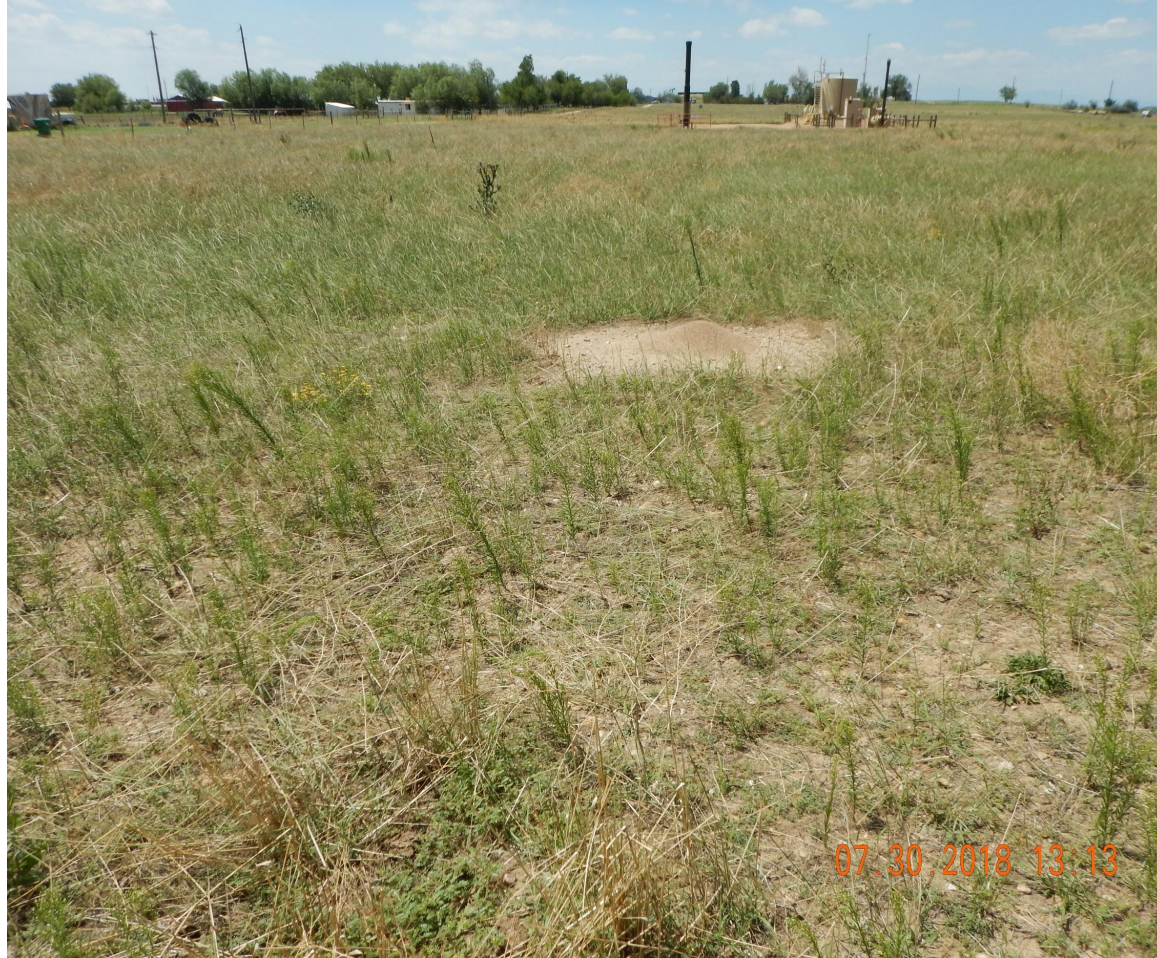
**Photo 2.** Photo taken from the approximate center of location, facing West. See comments under Photo 1.

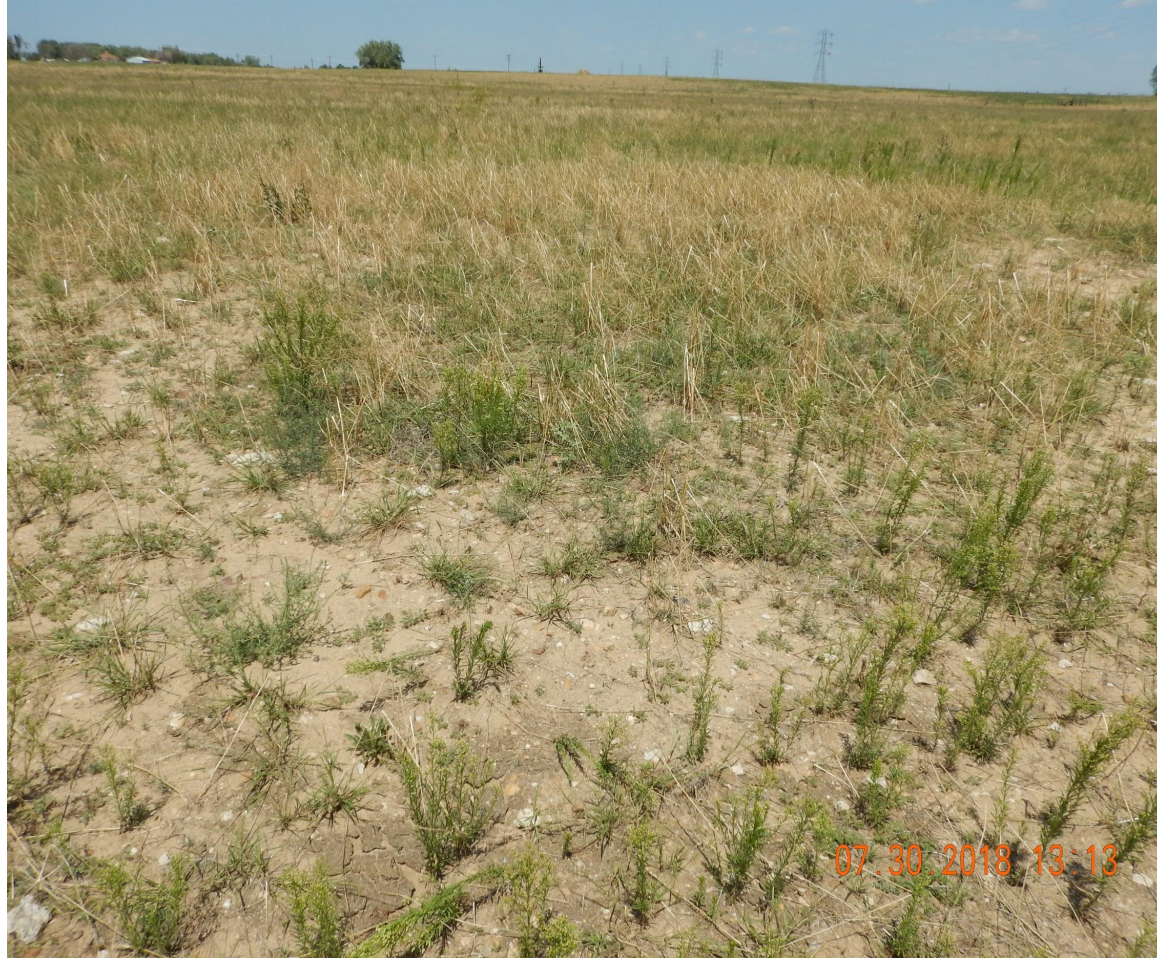
**Photo 3.** Photo taken from the approximate center of location, facing North. See comments under Photo 1.

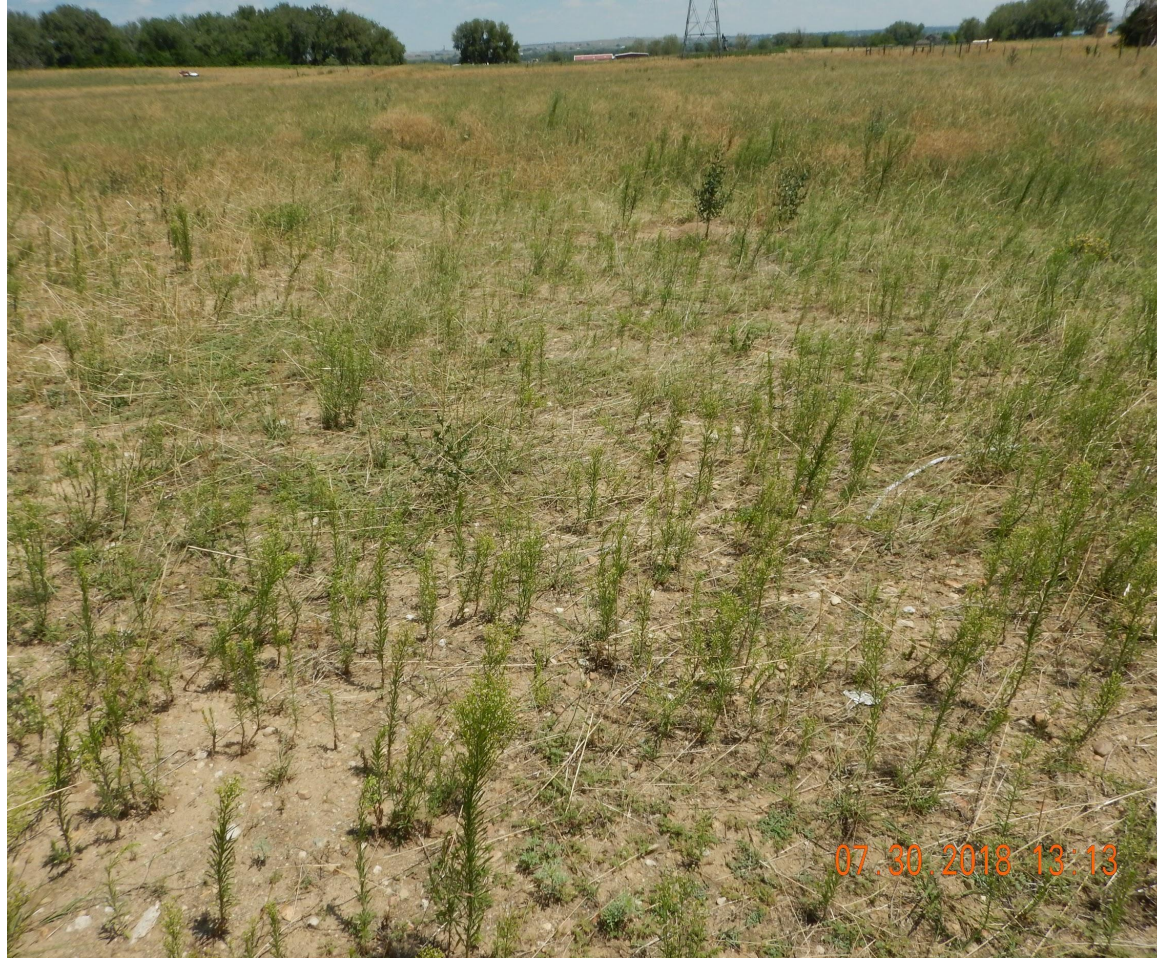
**Photo 4.** Photo taken from the approximate center of location, facing East. See comments under Photo 1.

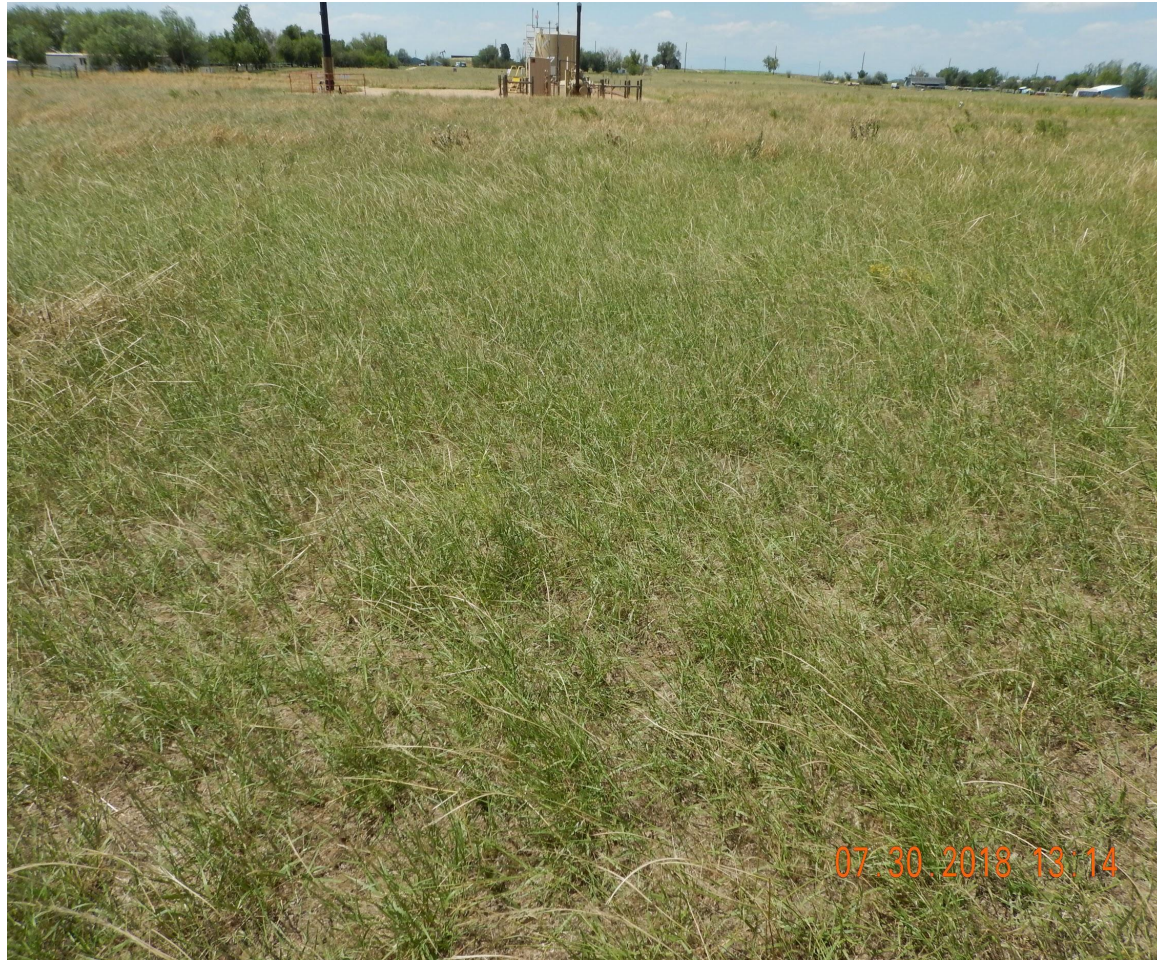
**Photo 5.** Reference photo taken west of the location, facing West. Photo illustrates uniform vegetative cover which is not reflective of the Knox disturbance areas.
