Final Reclamation Inspection

Operator: NOBLE ENERGY INC- #100322

API: 05-123-23921

Inspection Photos
Location Name: DESHAZO #24-44
API: 05-123-23921

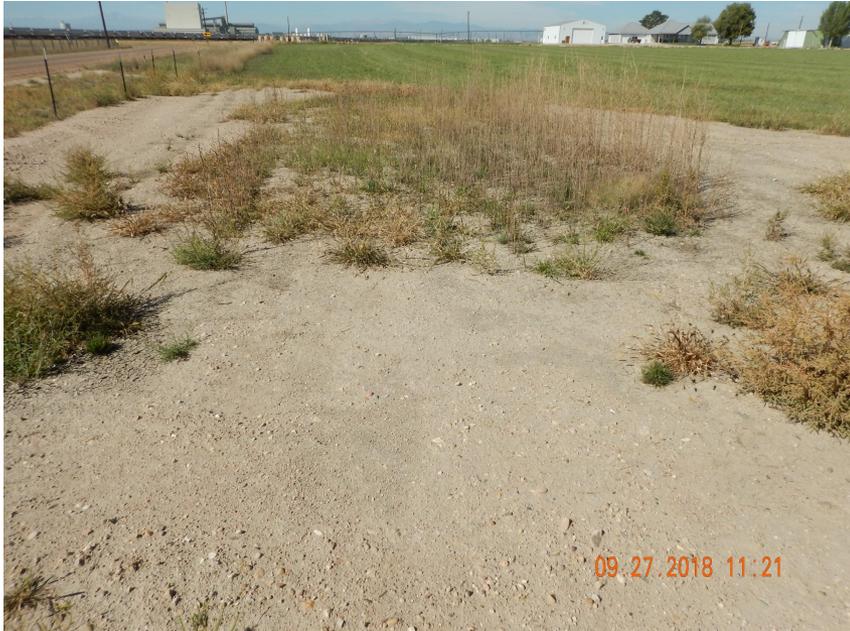
Photo 1. Photo taken from the battery location, facing West. Battery location is not in compliance with Rule 1004 standards. Mostly bare soil with little to no desirable vegetation was observed.

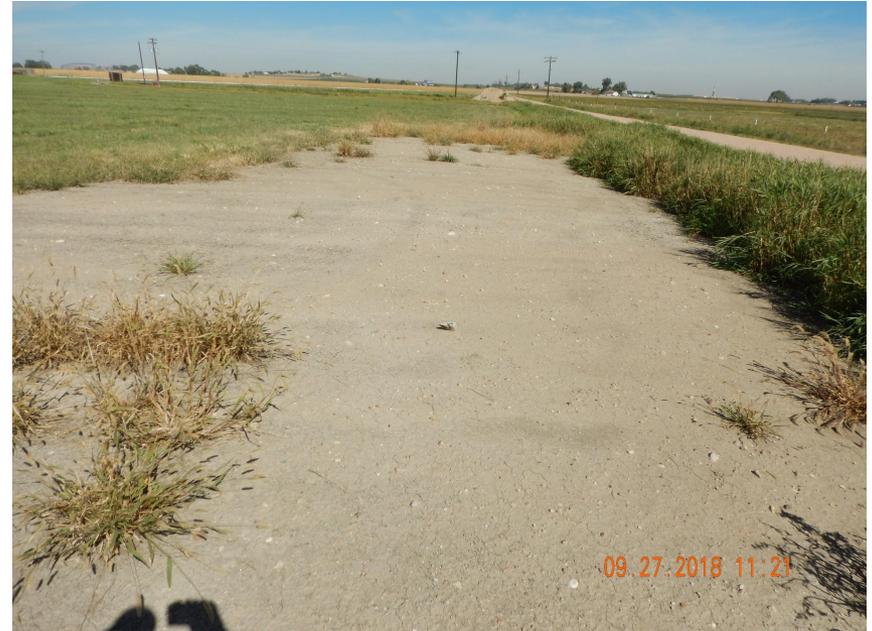
Photo 2. Photo taken from the battery location, facing North. See comments under Photo 1.

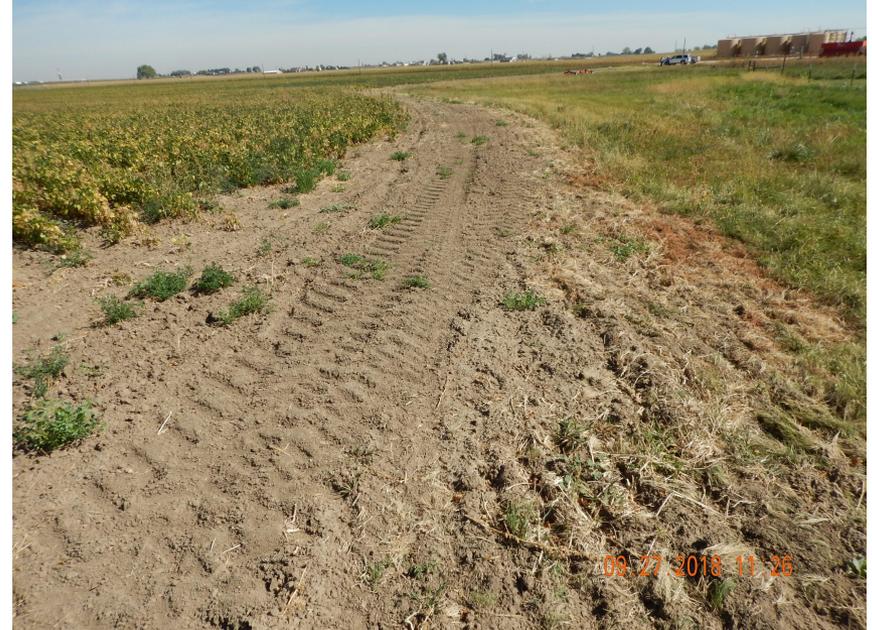
Photo 4. Photo taken from the well location access road, facing East. Appears a recent disturbance (tenant farmer) may have occurred. Appears the farmer may be using the former road to access the crop field.
