Inspection Photos

Operator: NOBLE ENERGY INC - 100322

Location ID: 431817

Inspection Doc. Number: 682503969

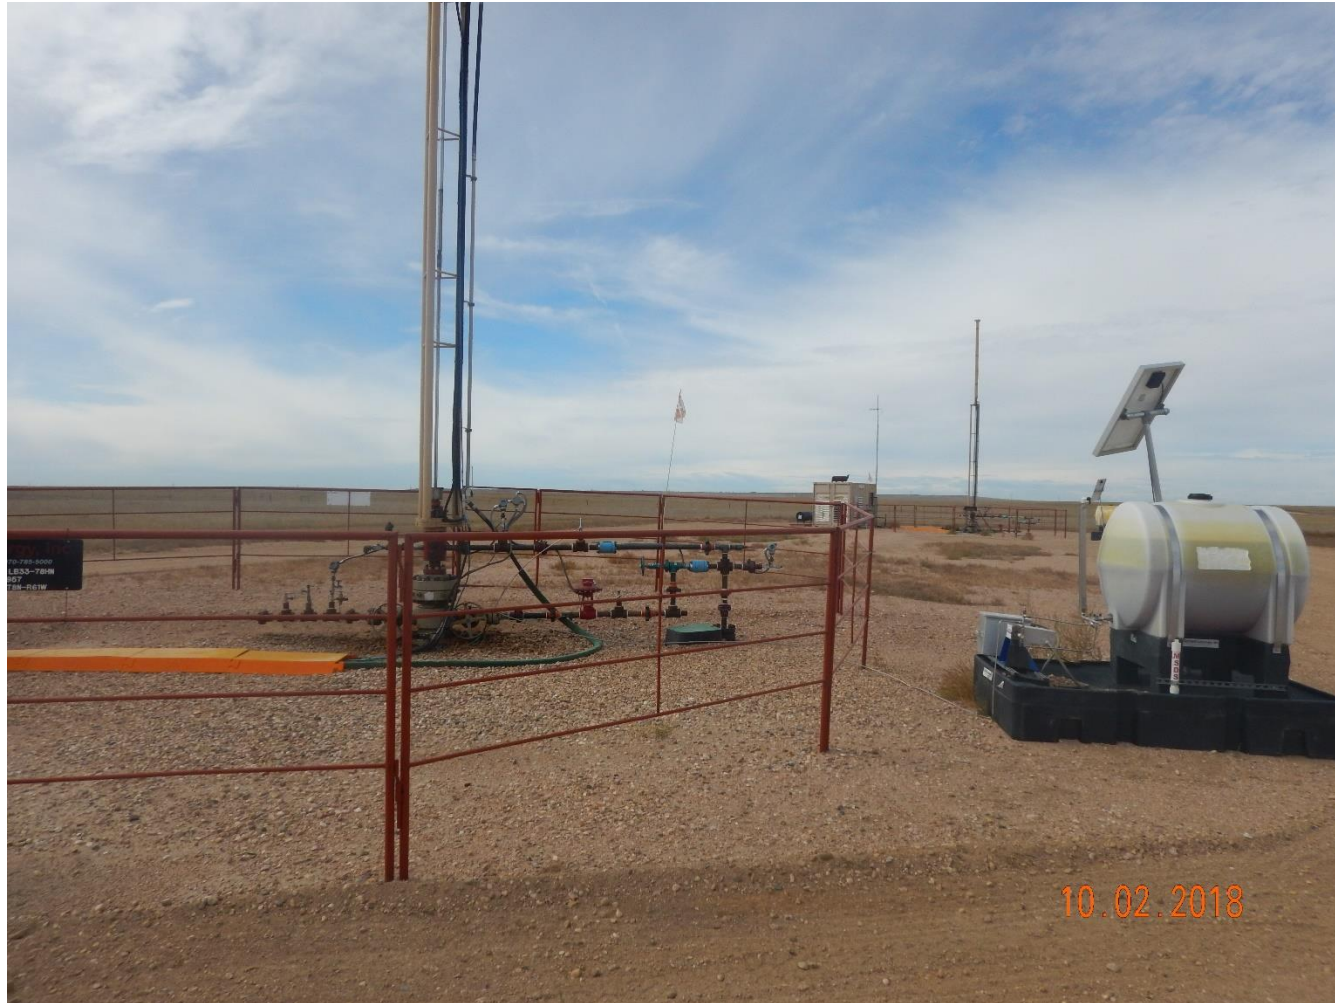
Photo 1: Photo taken from the east end of the two PR wells on location, facing west. Photo shows well API 123-36799 in foreground, and well 123-36800 in background. Photo also shows that the AL well 123-36831 does not appear to have been drilled.

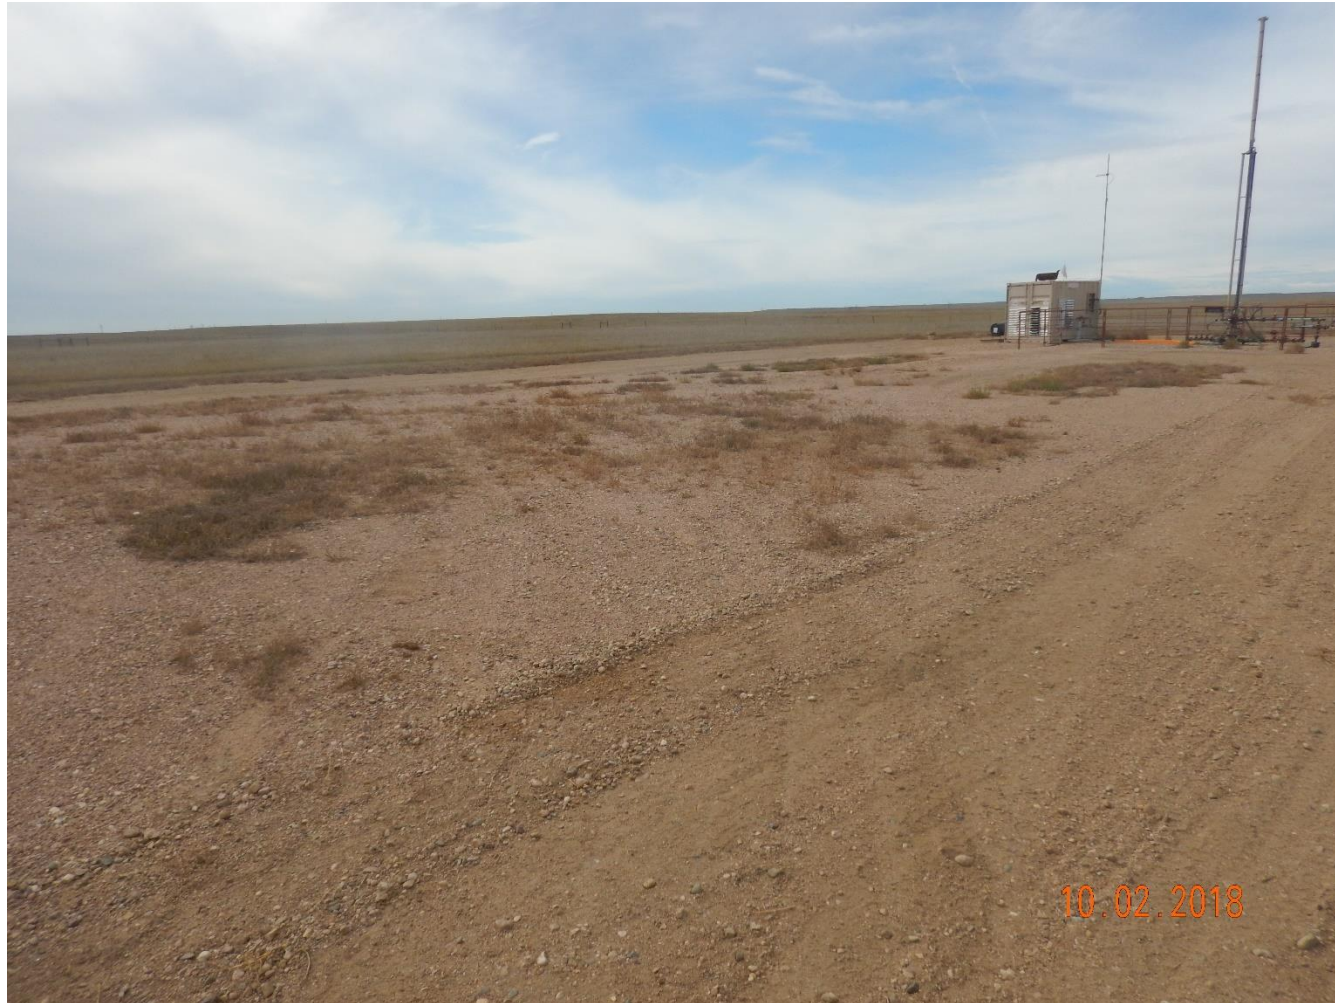
Photo 2: Photo taken from the PR wells, facing southwest. Photo shows that the AL well 123-36831 does not appear to have been drilled.

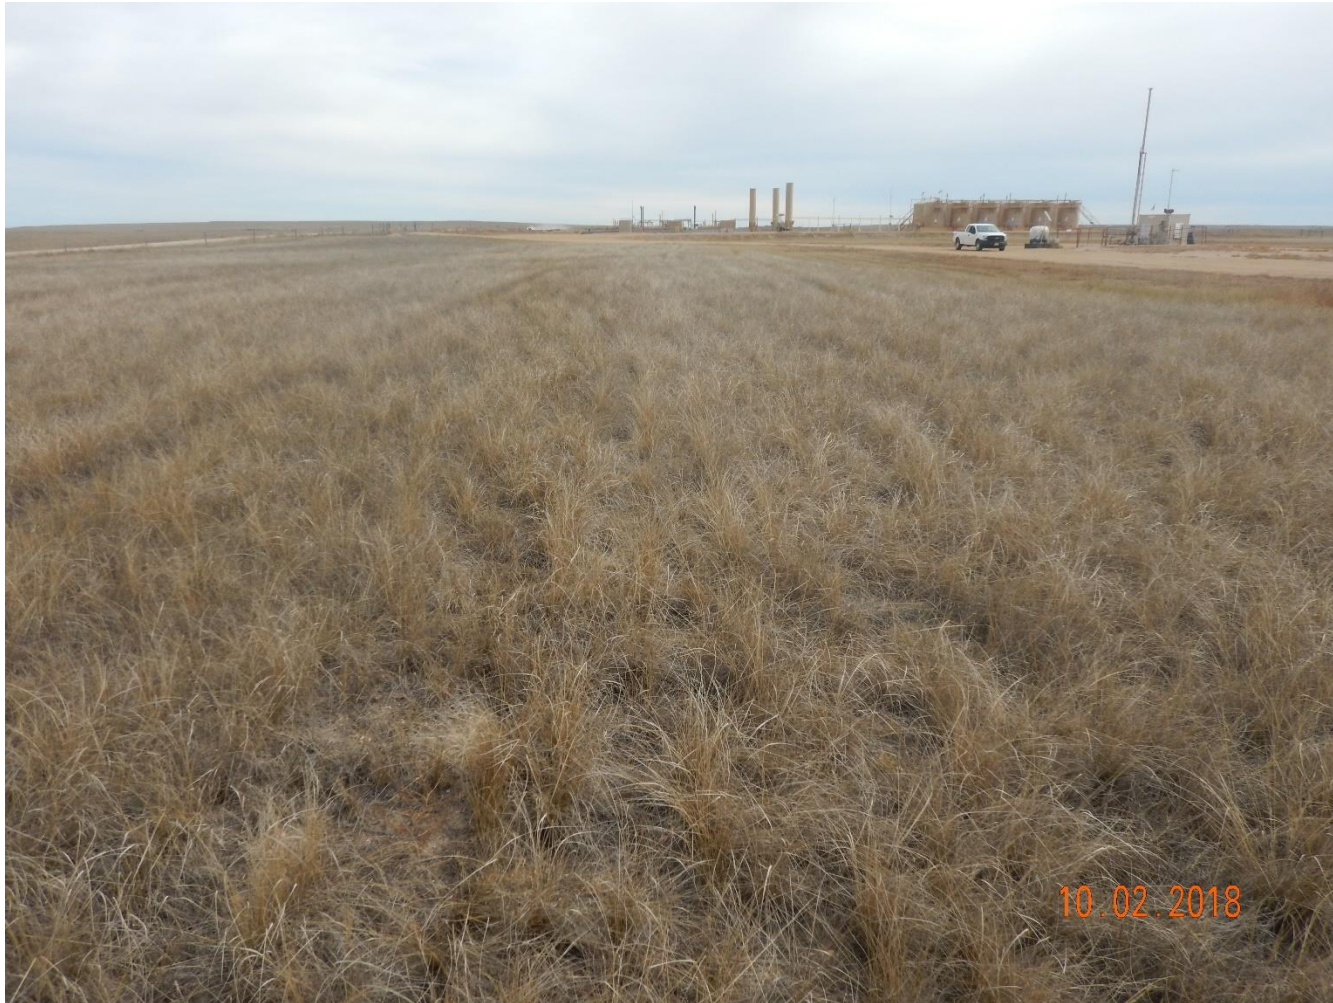
Photo 3: Photo taken from the northwest corner of the location, facing east. Photo shows vegetation over the interim area.

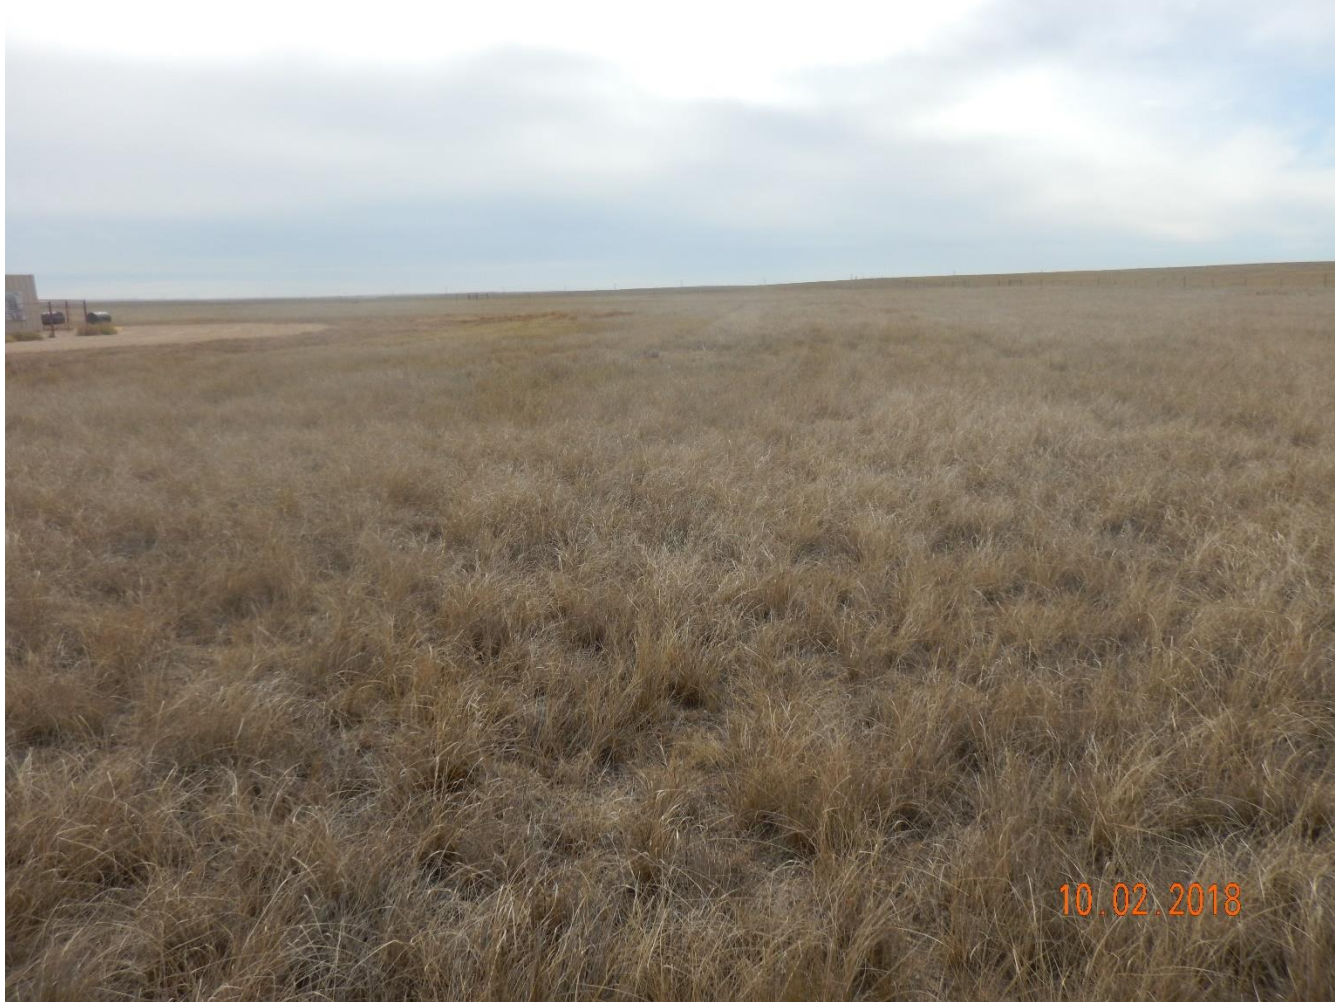
Photo 4: Photo taken from the northwest corner of the location, facing south. Photo shows vegetation over the interim area.

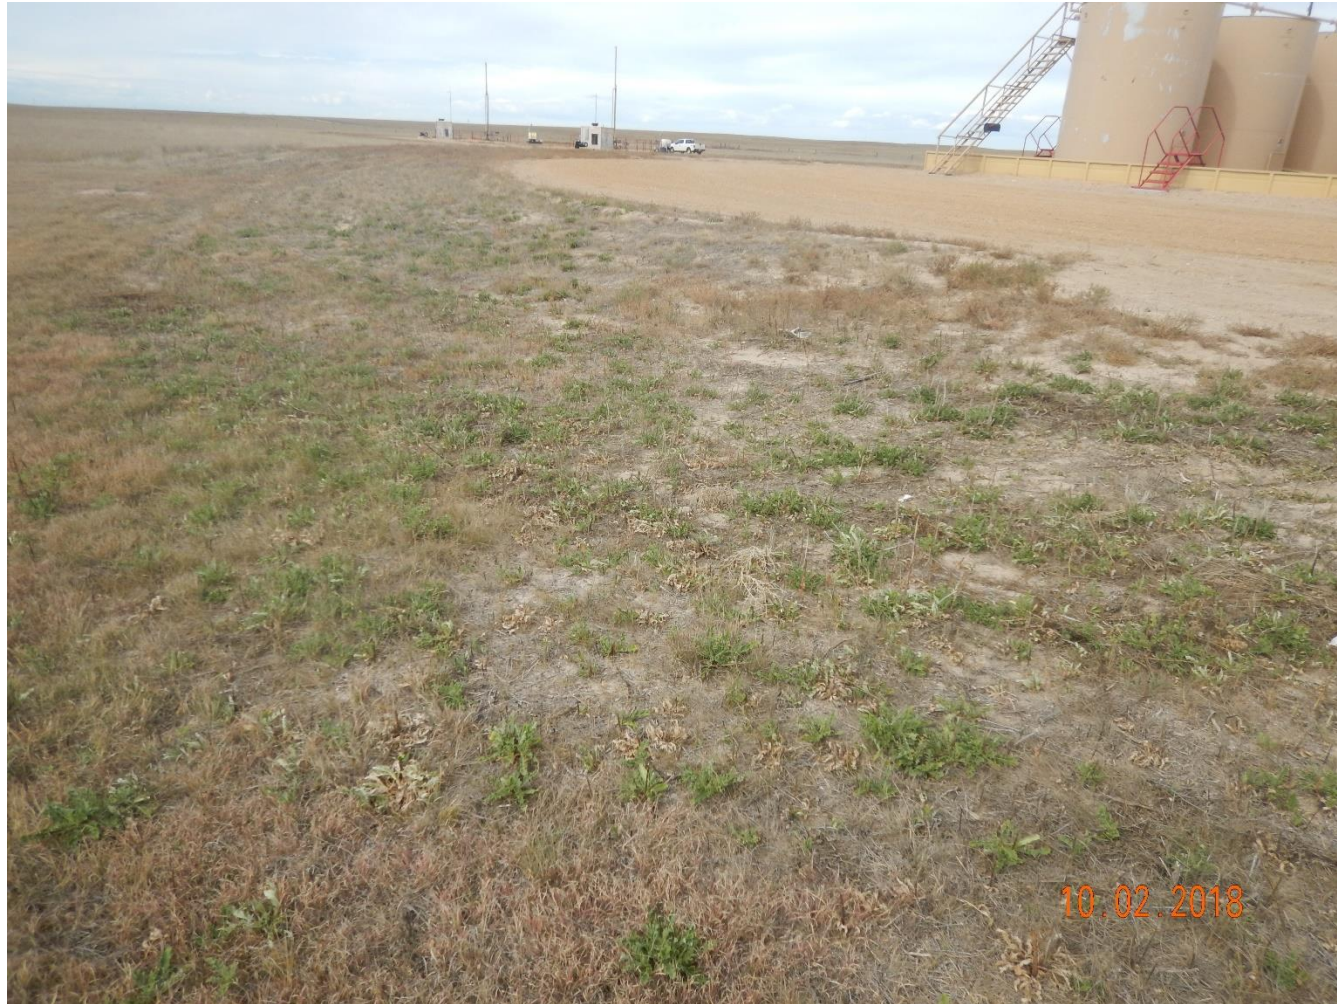
Photo 5: Photo taken from the south end of the tank battery facility, facing west. Photo shows areas where Canada Thistle rosettes were observed. This is a Colorado State listed noxious weed that needs to be managed.

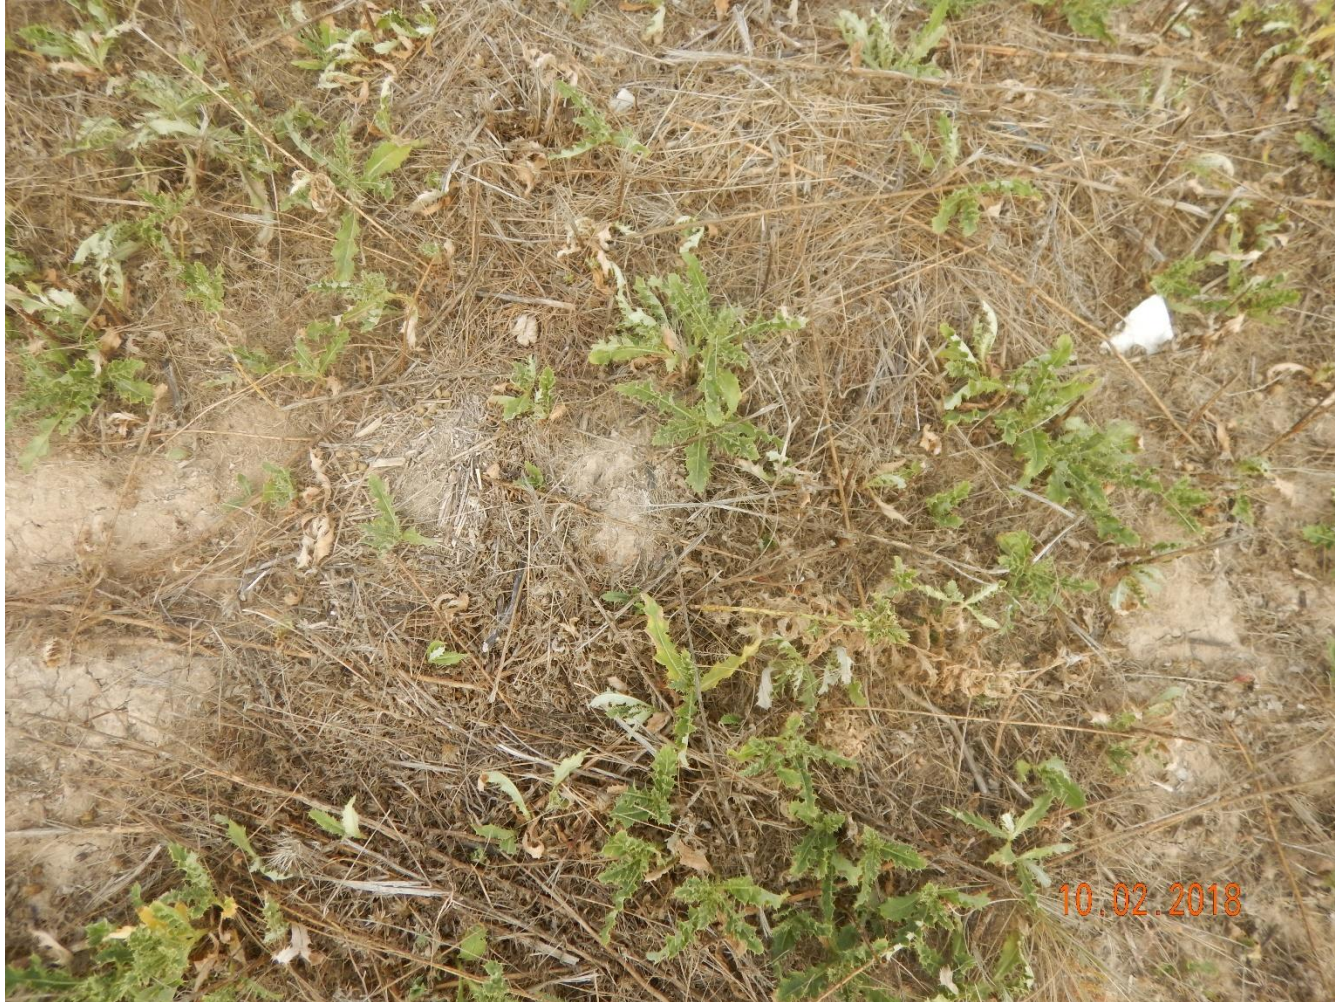
Photo 6: Continued from photo 5. Photo shows Canada Thistle rosettes. This is a Colorado State listed noxious weed that needs to be managed
