Inspection Photos

Operator: BP America

API: 05-067-06973

Date: 9/25/2018

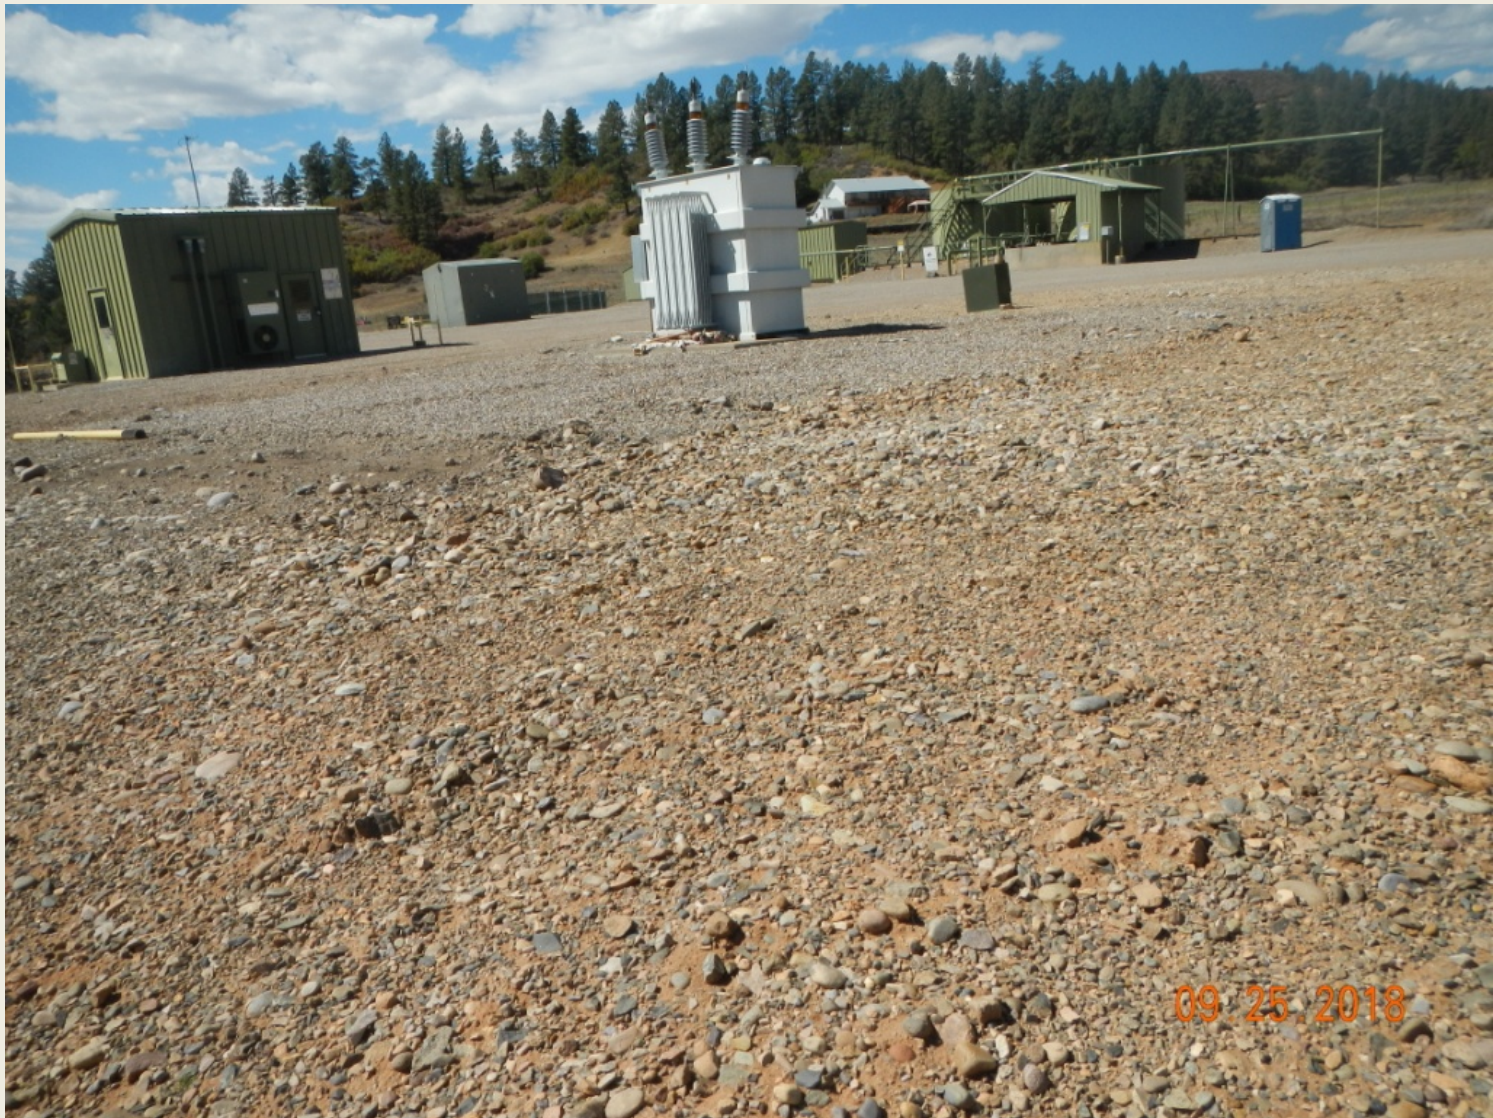
Photo 1. View of the project area from the northeastern corner facing center.

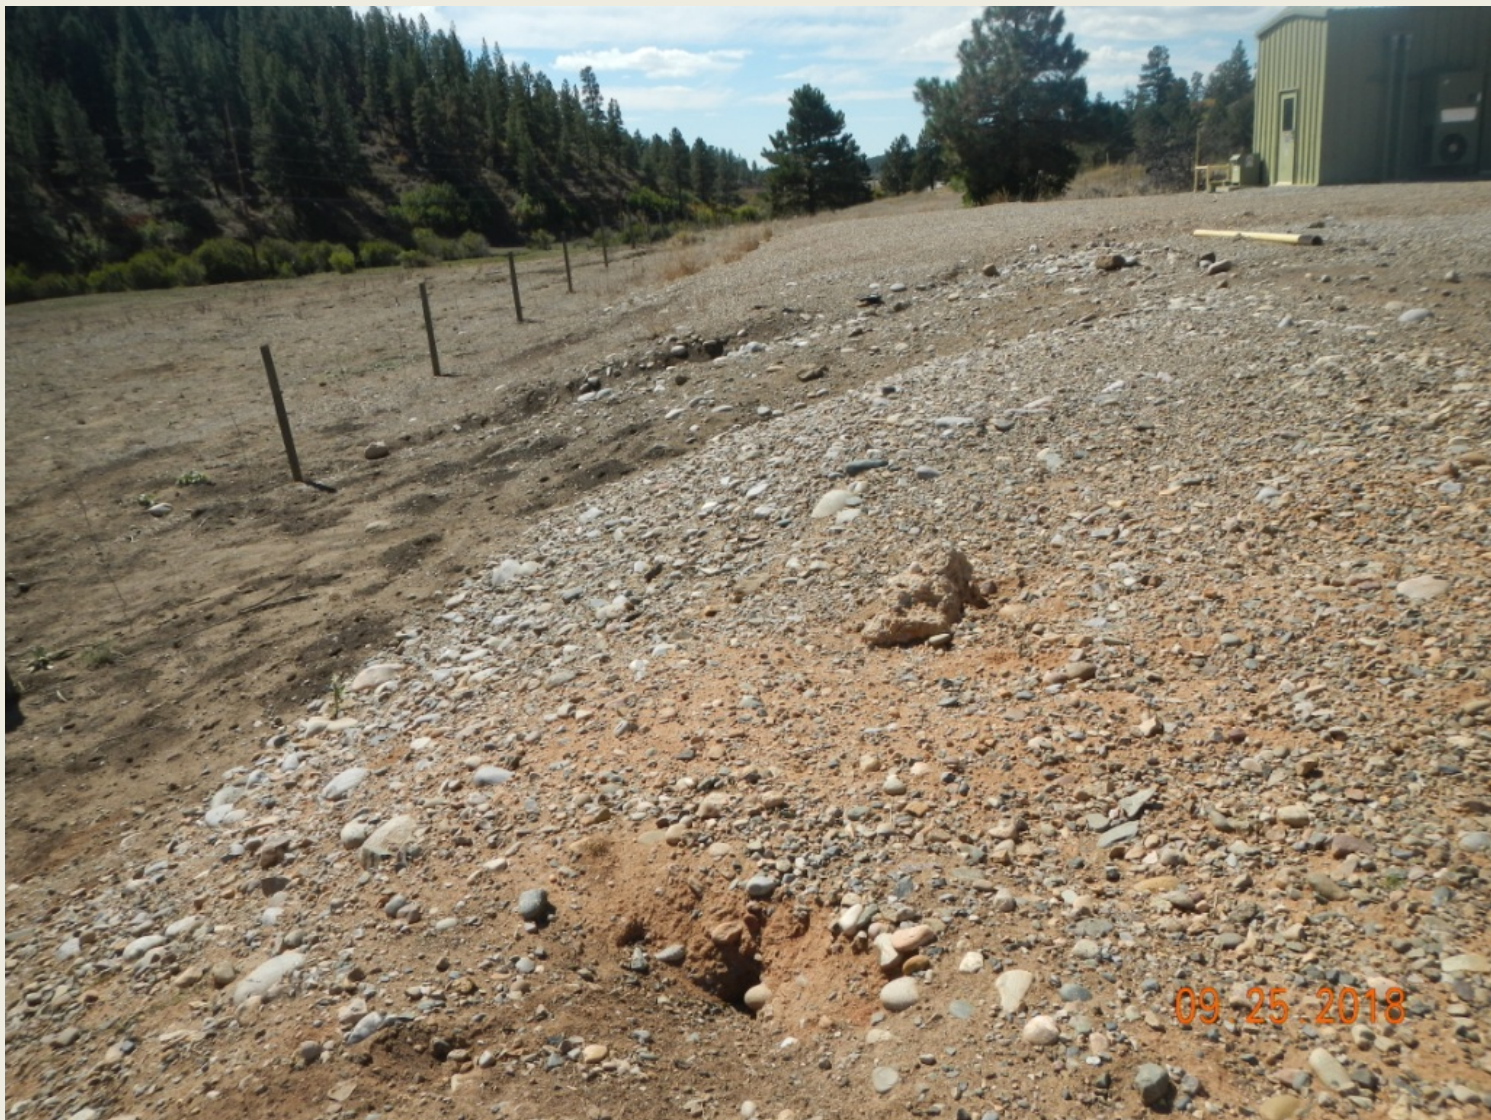
Photo 2. View of the eastern project area from the northeastern corner facing center.

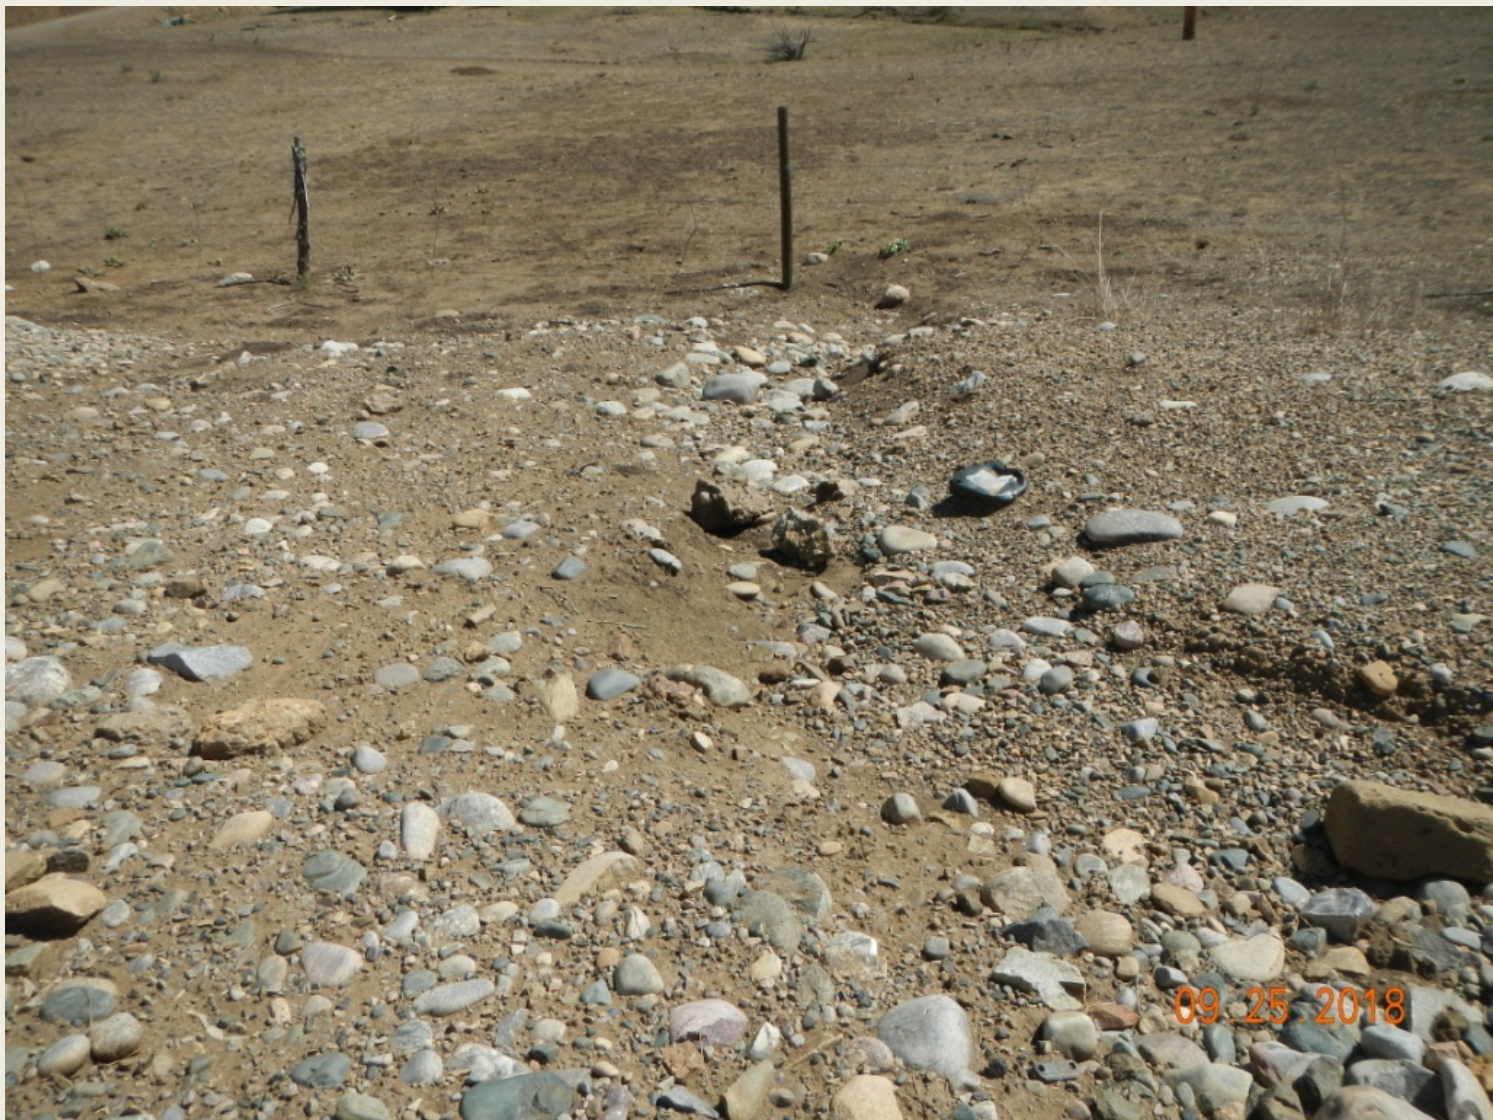
Photo 3. View of erosional channel approximately 1.5 feet wide and 8 inches deep in the eastern fill slope. Stabilization measures are needed here.

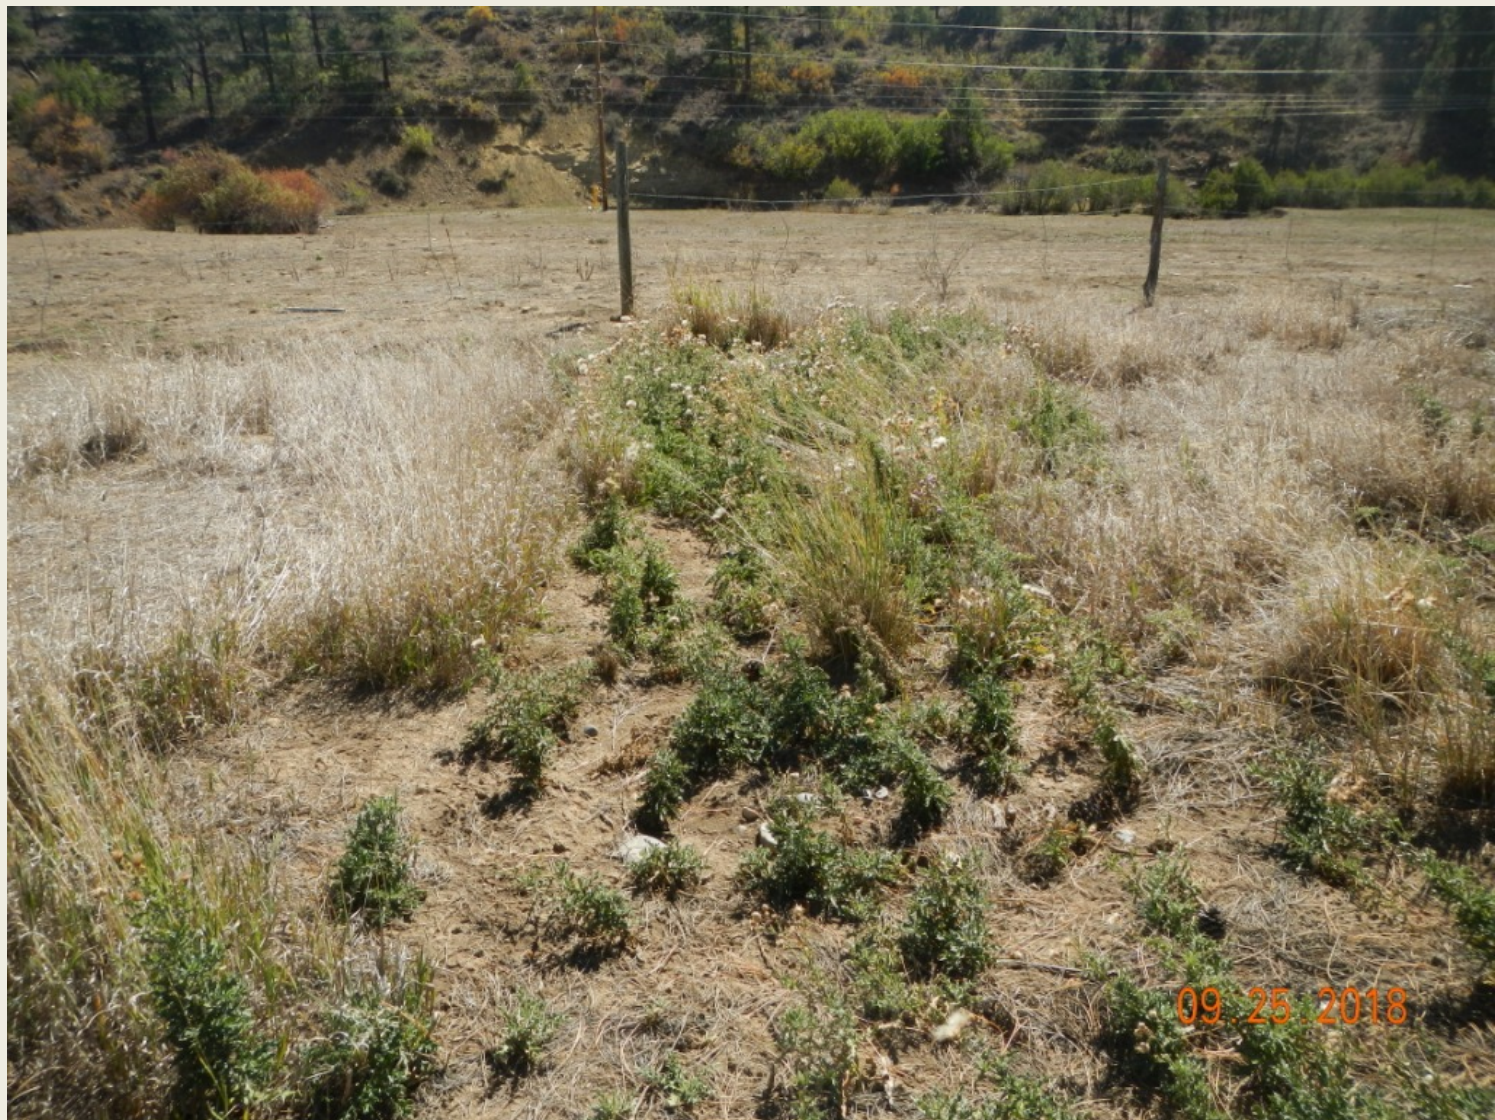
Photo 4. View of approximately 200 Canada thistles (*Cirsium arvense*) within the southeastern project area where concentrated stormwater flows off of the working area.
