Final Reclamation Inspection

Operator: EXTRACTION OIL & GAS INC - #10459

API: 05-123-19451

Inspection Photos
Location Name: WSC #11-9
API: 05-123-19451

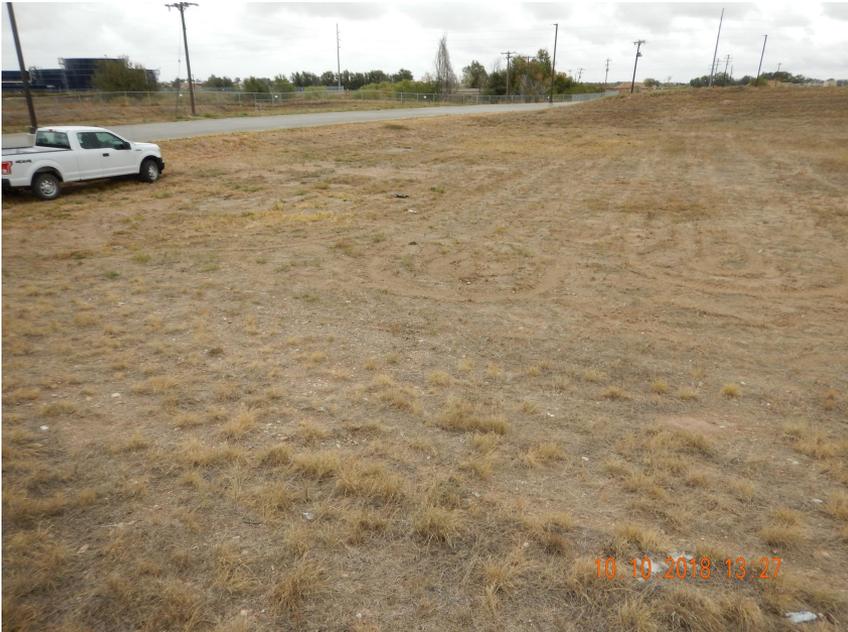
Photo 1. Photo taken from the western location, facing East. No visual evidence of equipment on location. Appears the Operator has performed final reclamation activities. Location will remain in-process. Portions of the location do not have uniform vegetative growth.

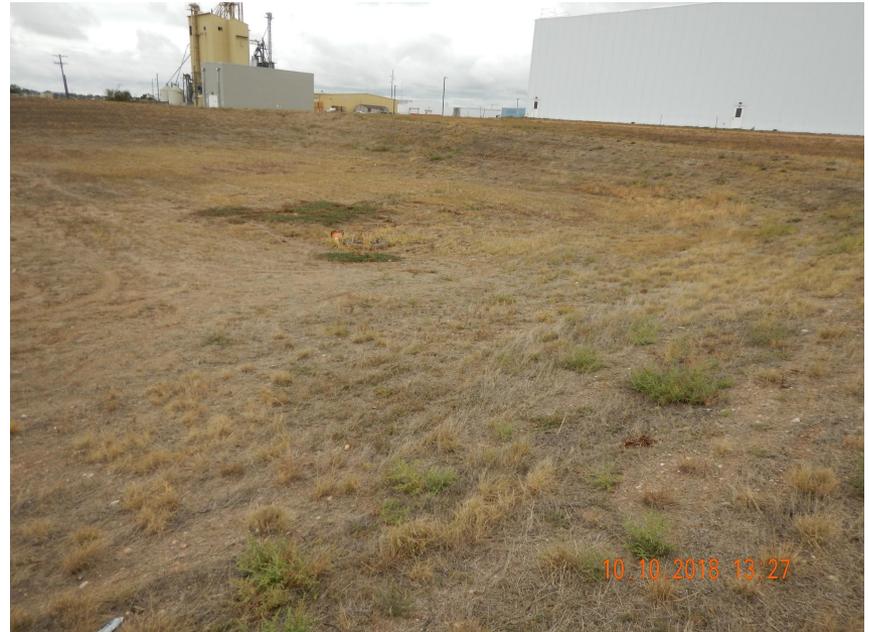
Photo 2. Photo taken from the western location, facing Southeast. See comments under Photo 1.

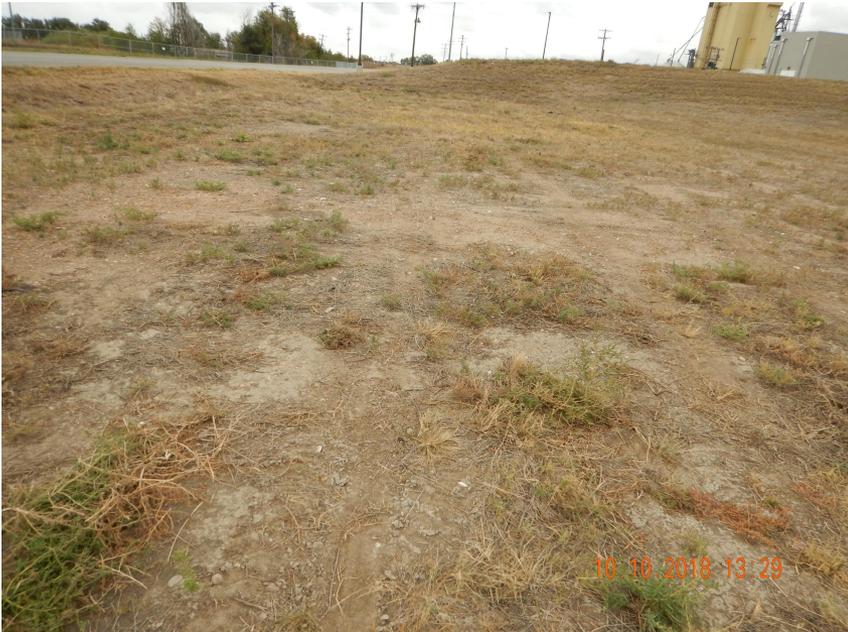
Photo 3. Photo taken from the northern location, facing East. Photo illustrates bare patches with little to no germination of desirable species.

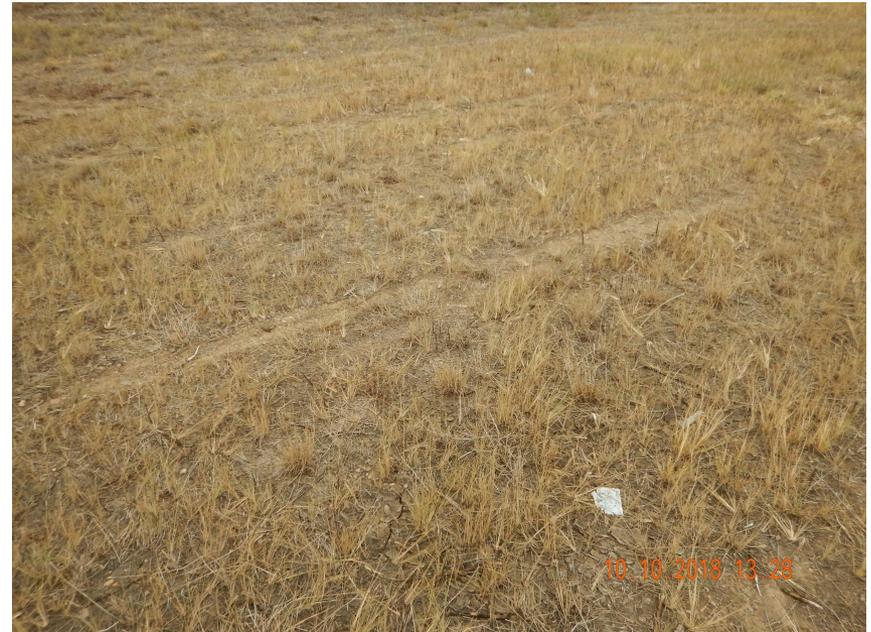
Photo 4. Photo taken from the southern location, facing South. Photo illustrates uniform vegetative growth which is not consistent throughout the location.
