Inspection Photos

Location Name: Sitzman 1U Location ID 319532, Remediation Project #11252

Inspection Date: 10/17/2018

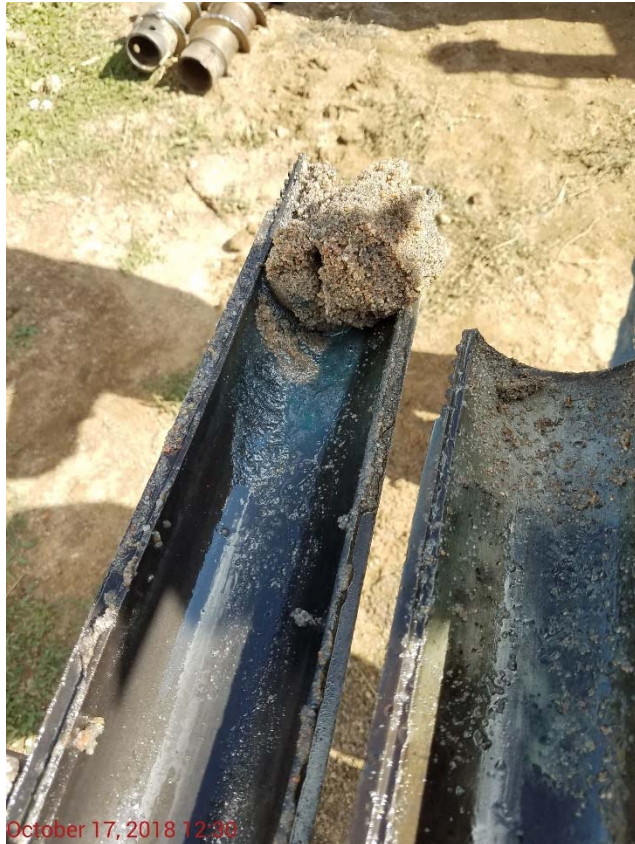
Photo 1 – Photo of continuous sampler at BH03, 9-14' below surface. Note low recovery of material in sampler, saturated sand, and hydrocarbons in sampler barrel.

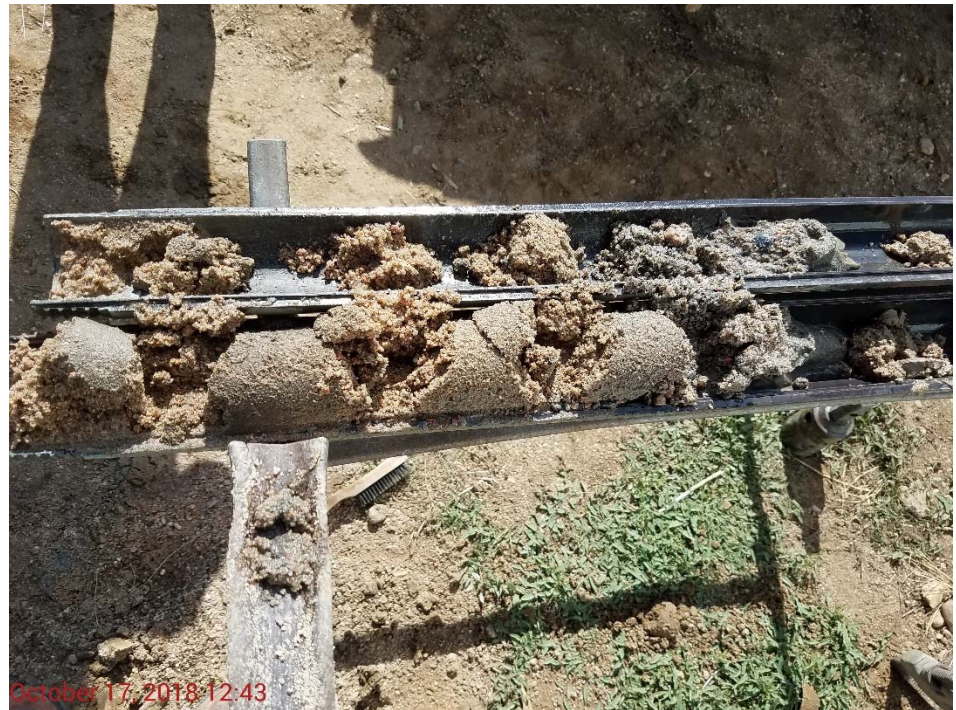
Photo 2 – Photo of continuous sampler at BH03, 19-24' below ground surface. Top of sampler is to right of photo. Approximately 50% recovery of material in this sample. Shallower material exhibits impact. Deeper material to left appears non-impacted.
