Inspection Photos

Operator: GRAND MESA OPERATING CO - 35080

Location ID: 456580

Inspection Doc. Number: 682504055

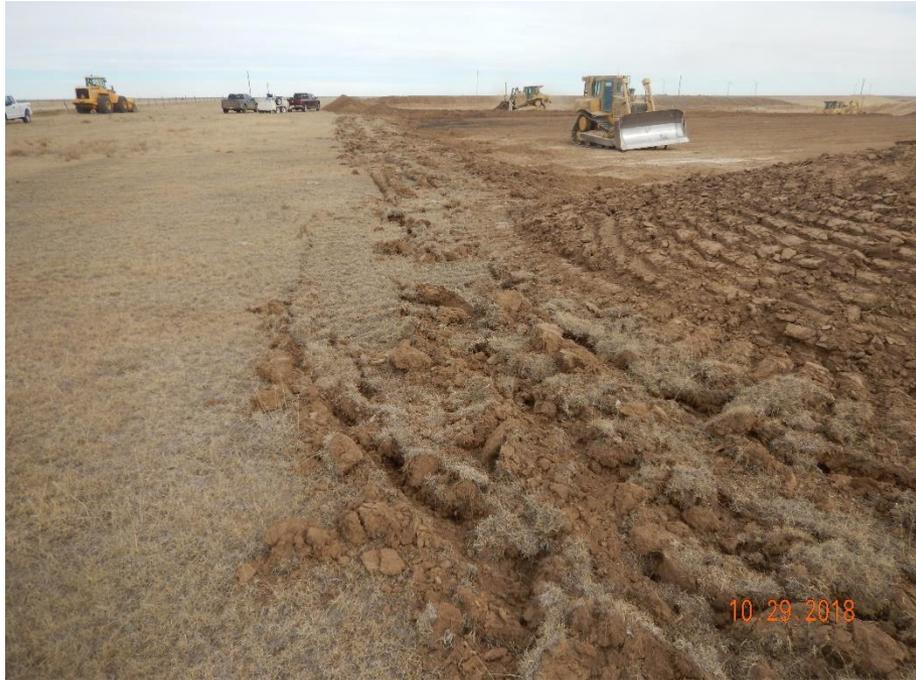
Photo 1: Photo taken from the southwest corner of the location, facing north. Photo shows surface roughening has been used as a perimeter stormwater and erosion control BMP. Photo also shows topsoil pile on the south end of the location.

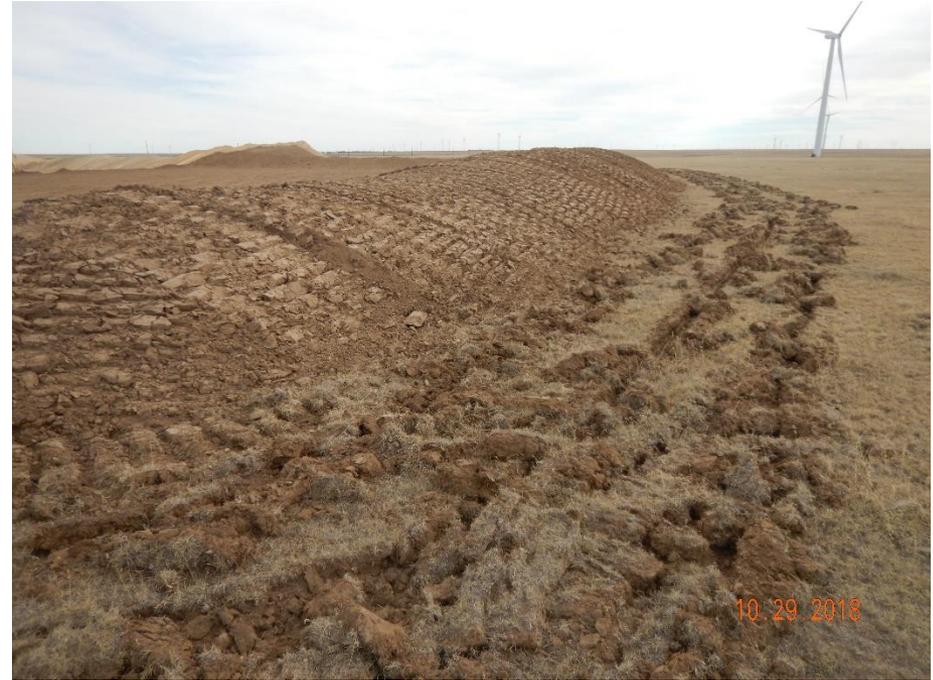
Photo 2: Photo taken from the southwest corner of the location, facing east. Photo shows surface roughening has been used as a perimeter stormwater and erosion control BMP. Photo also shows topsoil pile on the south end of the location.

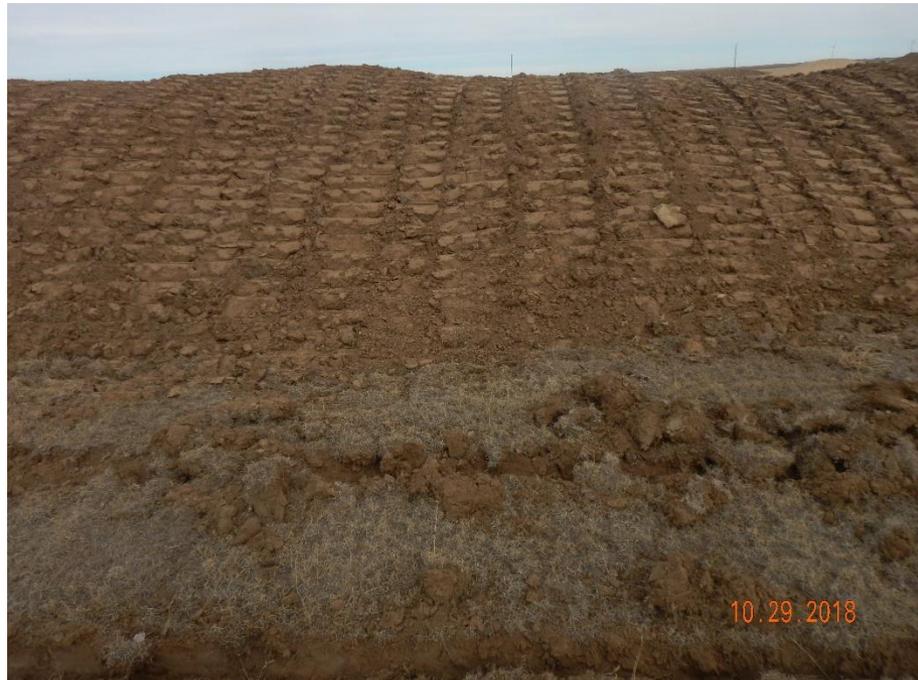
Photo 3: Photo taken from the south end of the location, facing north. Photo shows topsoil pile has been tracked.

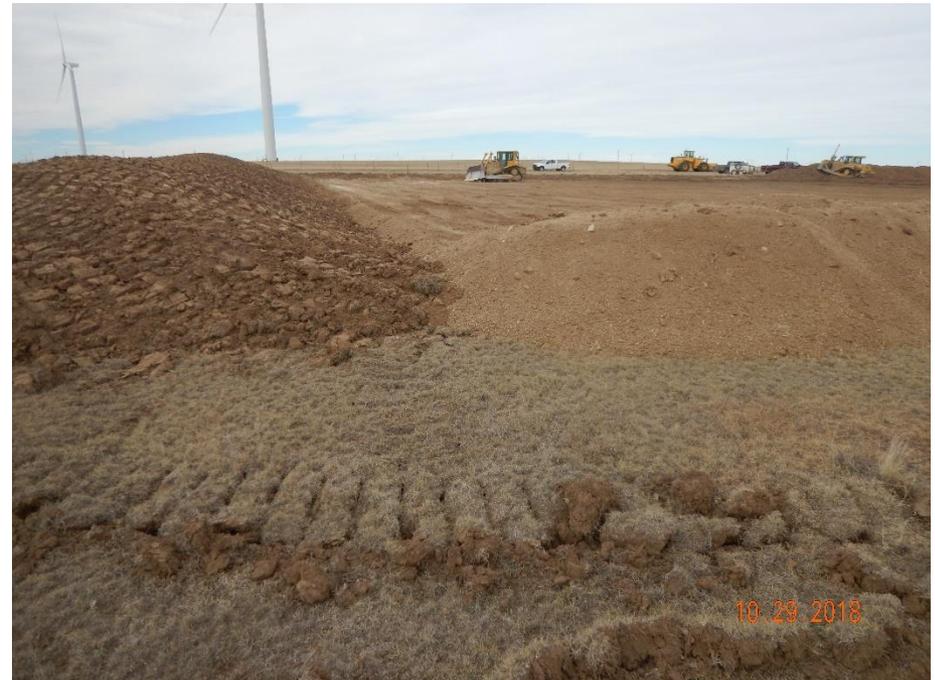
Photo 4: Photo taken from the southeast end of the location, facing west. Photo shows operator has segregated the topsoil pile (left) and a "B" horizon (right).

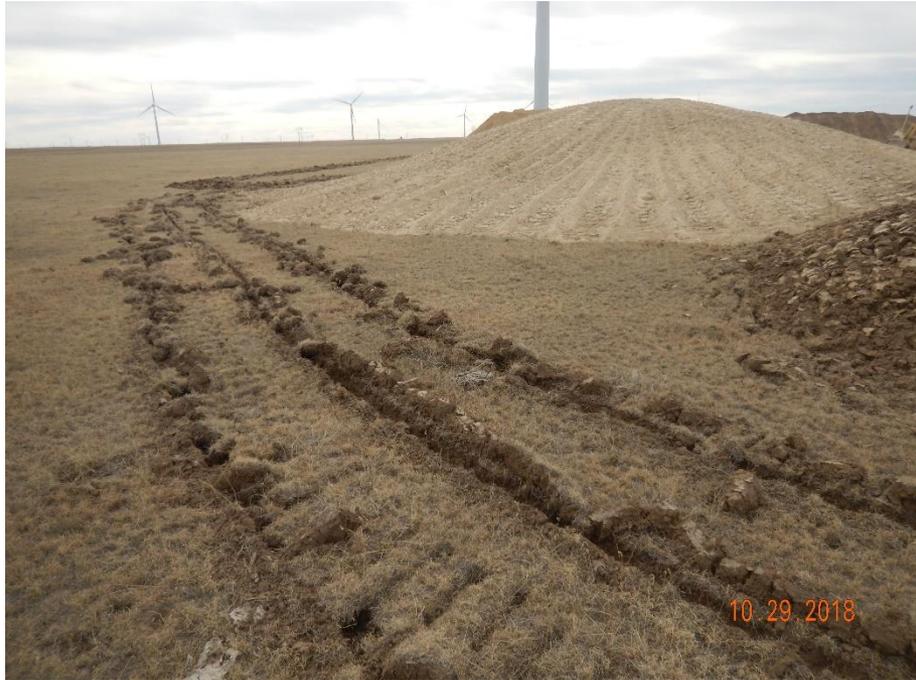
Photo 5: Photo taken from the northeast corner of the location, facing south. Photo shows surface roughening has been used as a perimeter stormwater and erosion control BMP. Photo also shows subsoil stockpile on the east end of the location.

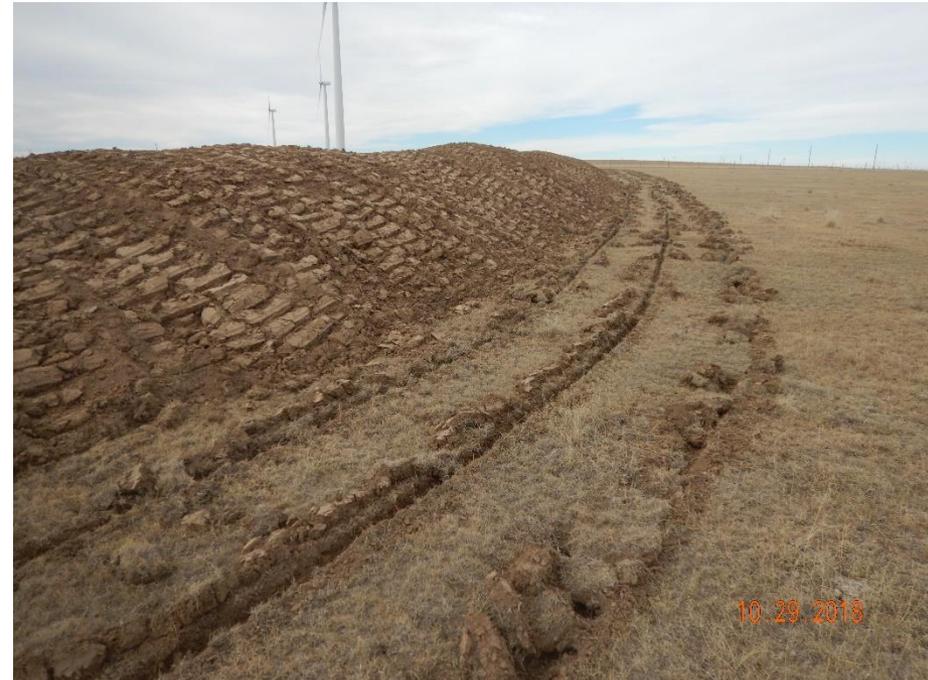
Photo 6: Photo taken from the northeast corner of the location, facing west. Photo shows surface roughening has been used as a perimeter stormwater and erosion control BMP. Photo also shows topsoil pile on the south end of the location.
