Inspection Photos

Operator: NIGHTHAWK PRODUCTION LLC -
10399

Location ID: 443310

Inspection Doc. Number: 682504059
Lincoln County, CO

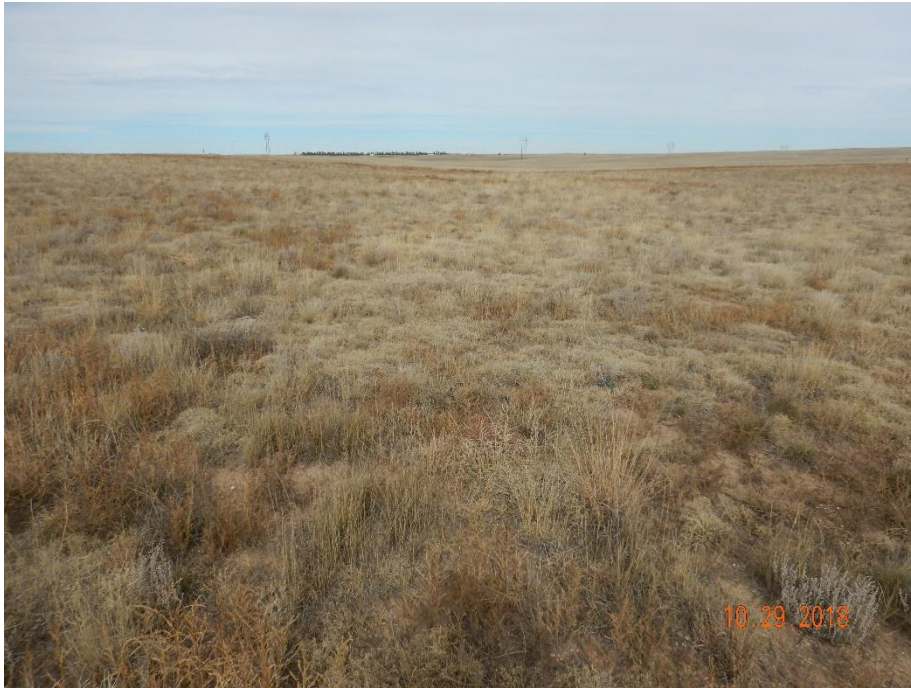
Photo 1: Photo taken from the south end of the location, facing northwest. Photo shows vegetation over the location appears to be progressing to reclamation requirements.

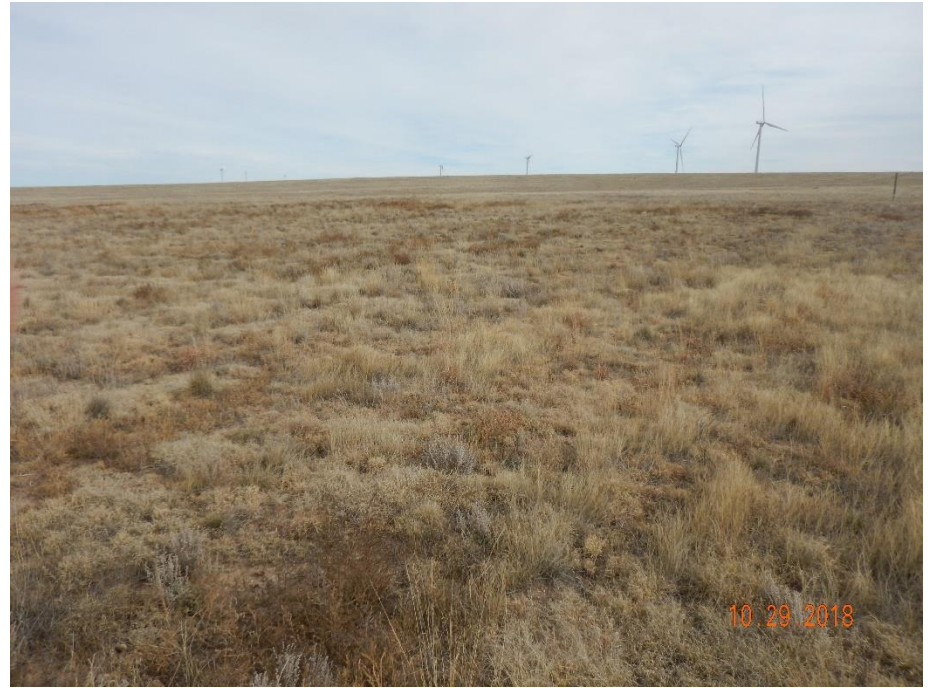
Photo 2: Photo taken from the south end of the location, facing northeast. Photo shows vegetation over the location appears to be progressing to reclamation requirements.

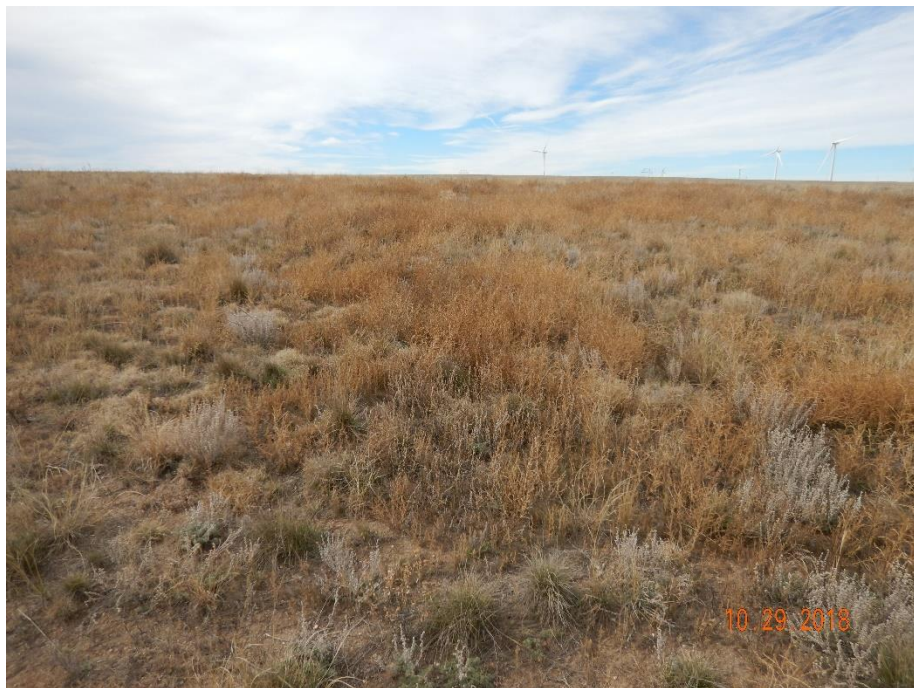
Photo 3: Photo taken from the north end of the location, facing west. Photo shows areas of the location that remain predominantly undesirable weedy plant species such as Russian thistle. Desirable perennial vegetation does appear to be establishing. Location appear to require additional time to meet uniform vegetative standards.

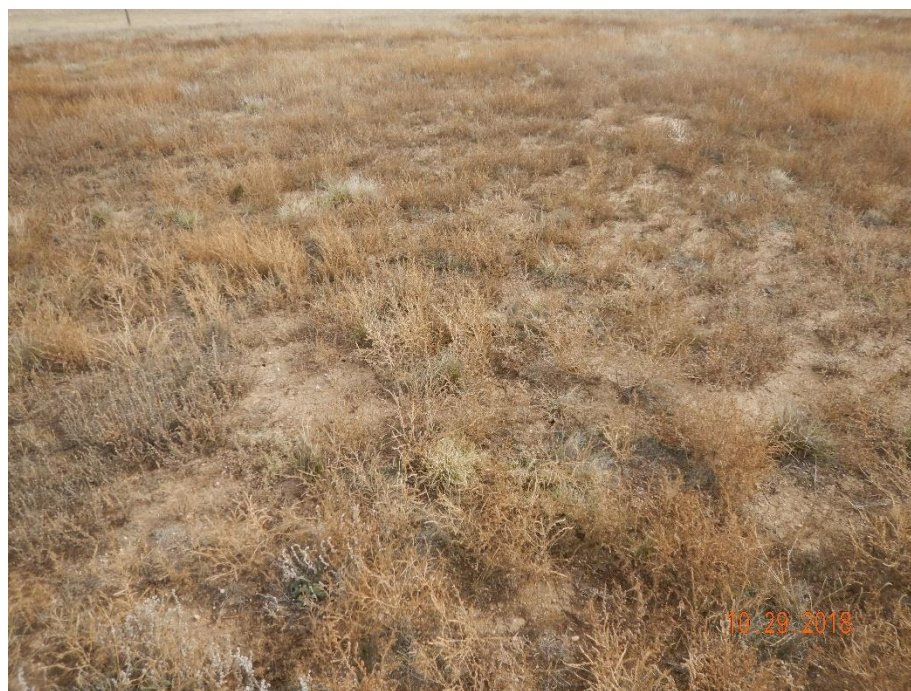
Photo 4: Photo taken from the north end of the location, facing east. Photo shows areas of the location that remain predominantly undesirable weedy plant species such as Russian thistle. Desirable perennial vegetation does appear to be establishing. Location appear to require additional time to meet uniform vegetative standards.

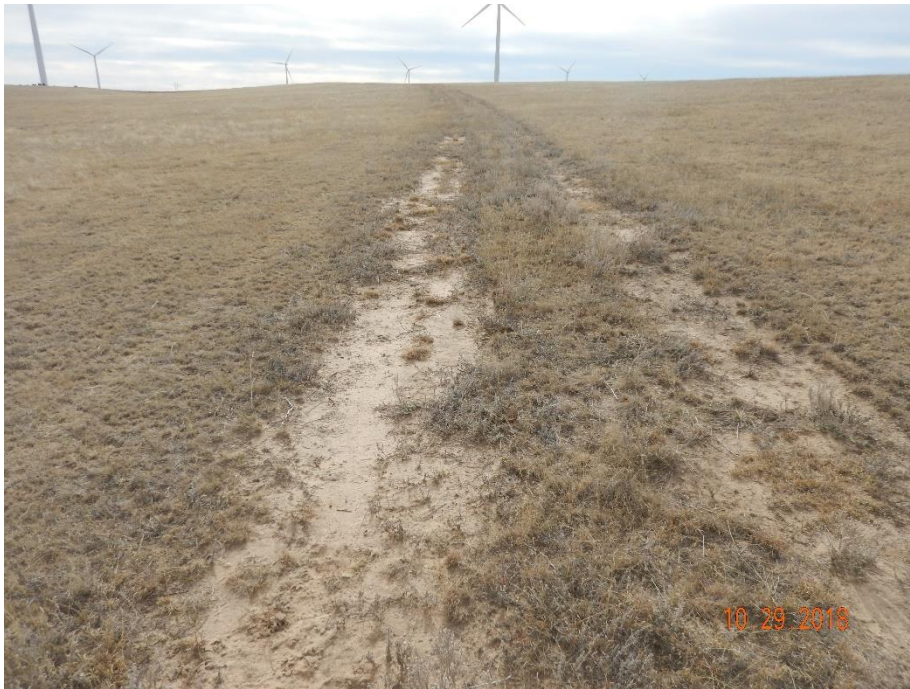
Photo 5: Photo taken from the access road, south of the location, facing south. Photo shows access road remains evident and will likely require additional reclamation activities.

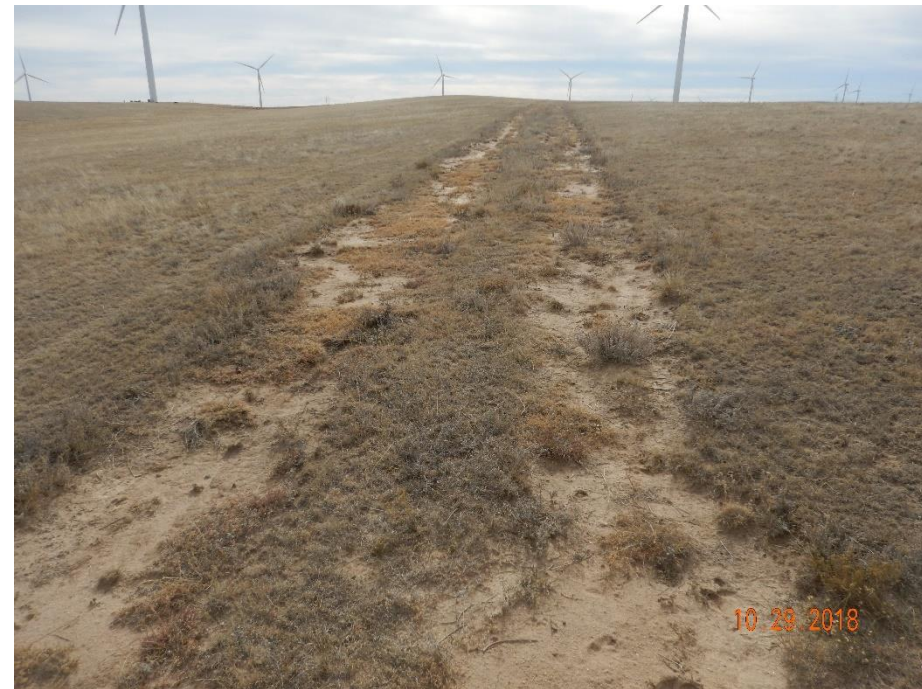
Photo 6: Photo taken from the access road, south of the location, facing south. Photo shows access road remains evident and will likely require additional reclamation activities.
