Interim Reclamation and Stormwater Inspection

Operator: PDC ENERGY INC - #69175

Location ID: 420241

Inspection Photos
Location Name: Knieval SW-12
Location ID: 420241

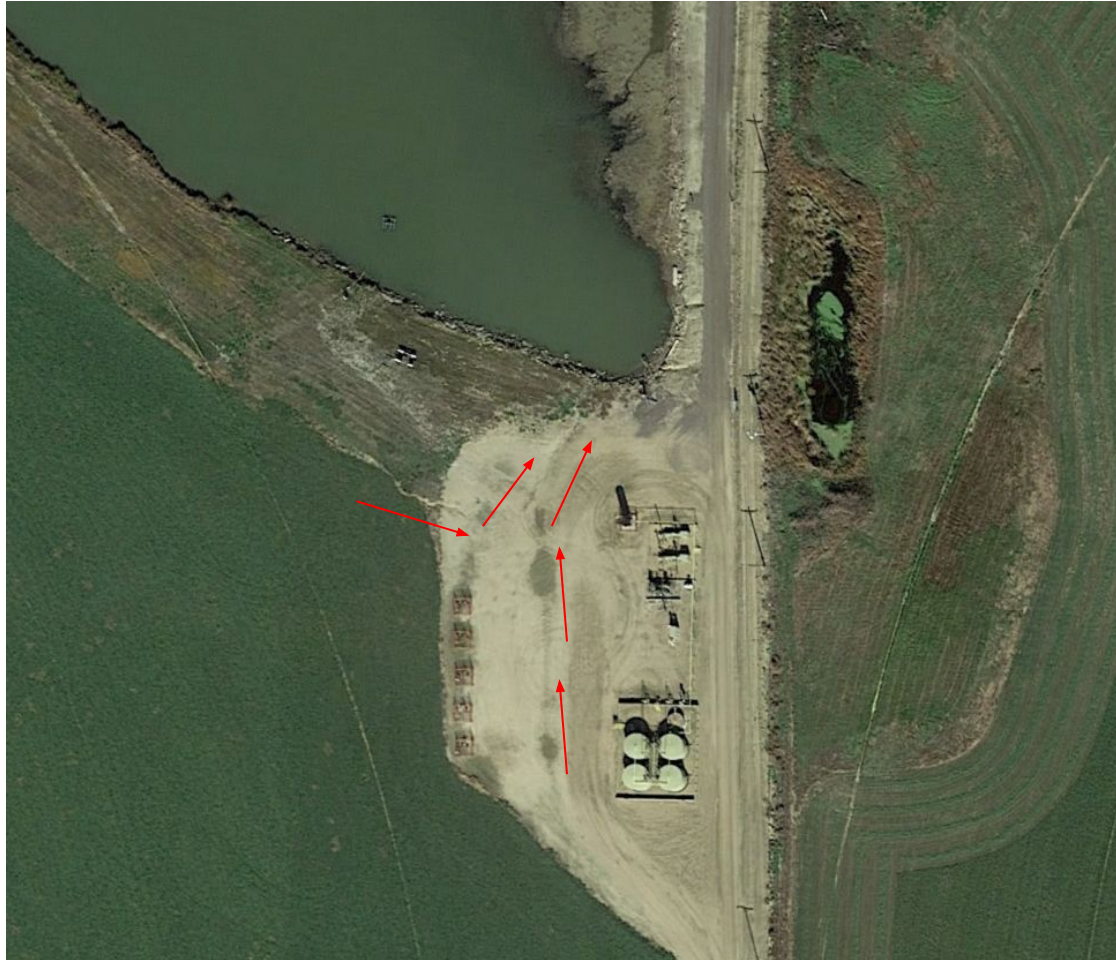
Google Earth aerial imagery illustrates the Location and two potential run-on paths (red arrows) that extend to the north and discharge off location. Per Rule 1002.f., Operator shall control both run-on and run-off from a location.

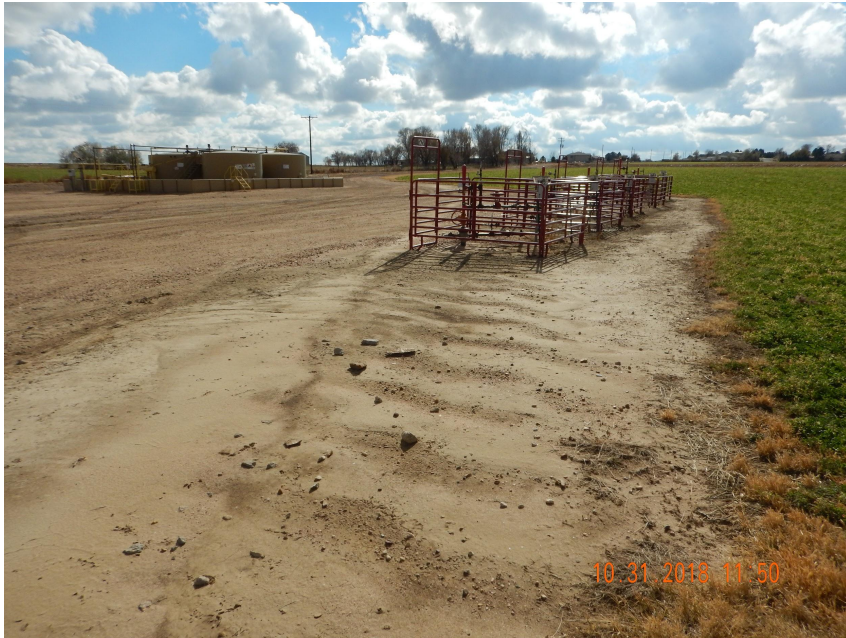
Photo 1. Photo taken from the northwestern perimeter of the location, facing South. Operator has performed interim reclamation activities to reduce disturbance areas only needed for production operations and interim areas appear to meet Rule 1003.

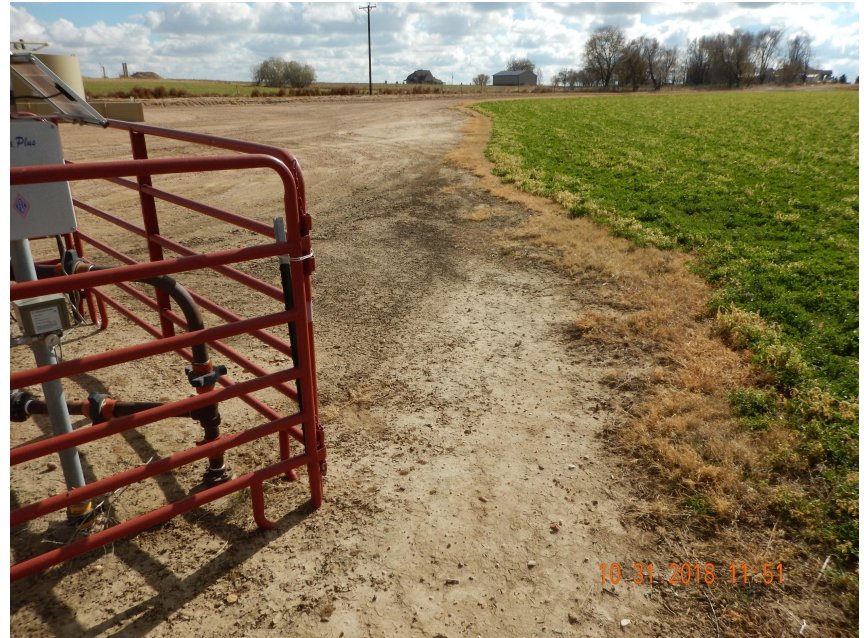
Photo 2. Photo taken from the western perimeter of the location, facing South. See comments under Photo 1.

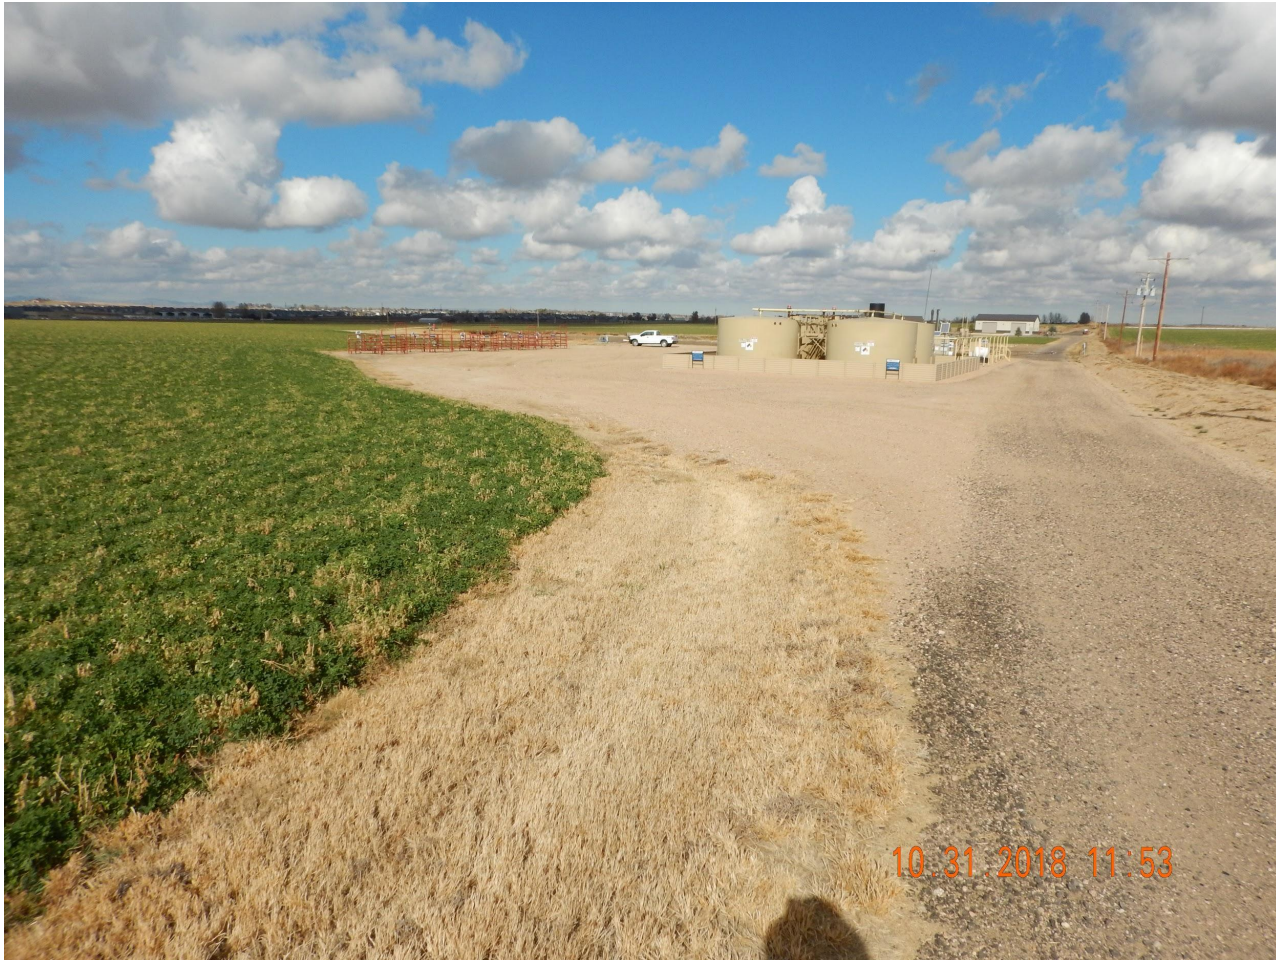
Photo 3. Photo taken from the southern location, facing North. See comments under Photo 1.

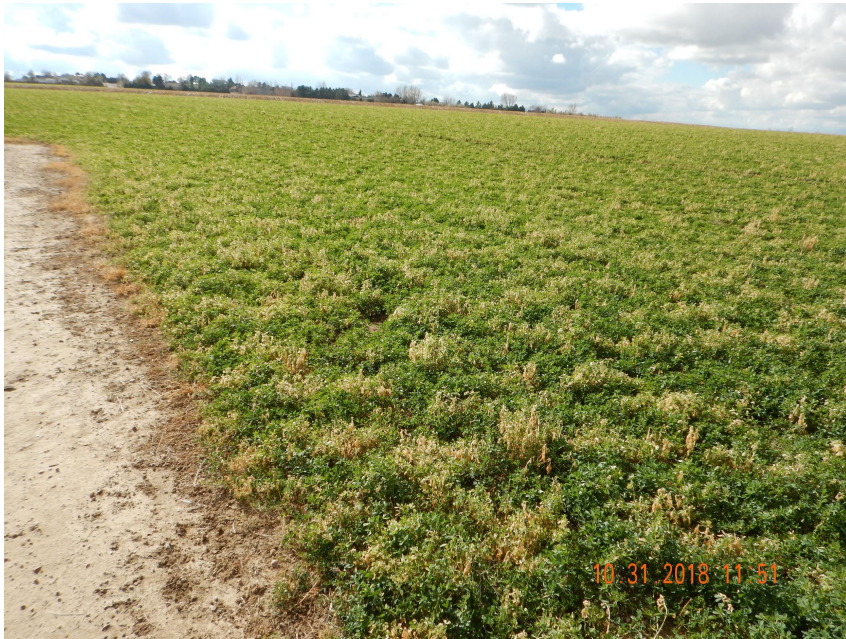
Photo 4. Photo taken from the western interim area, facing Southwest. See comments under Photo 1.

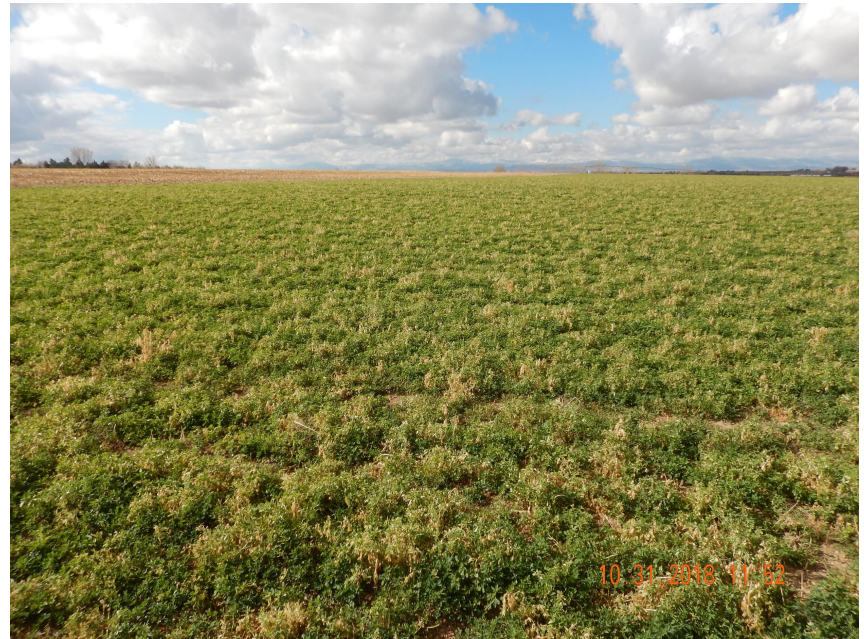
Photo 5. Reference photo taken south of the location, facing West. Photo illustrates reference area vegetative levels are similar in interim areas.

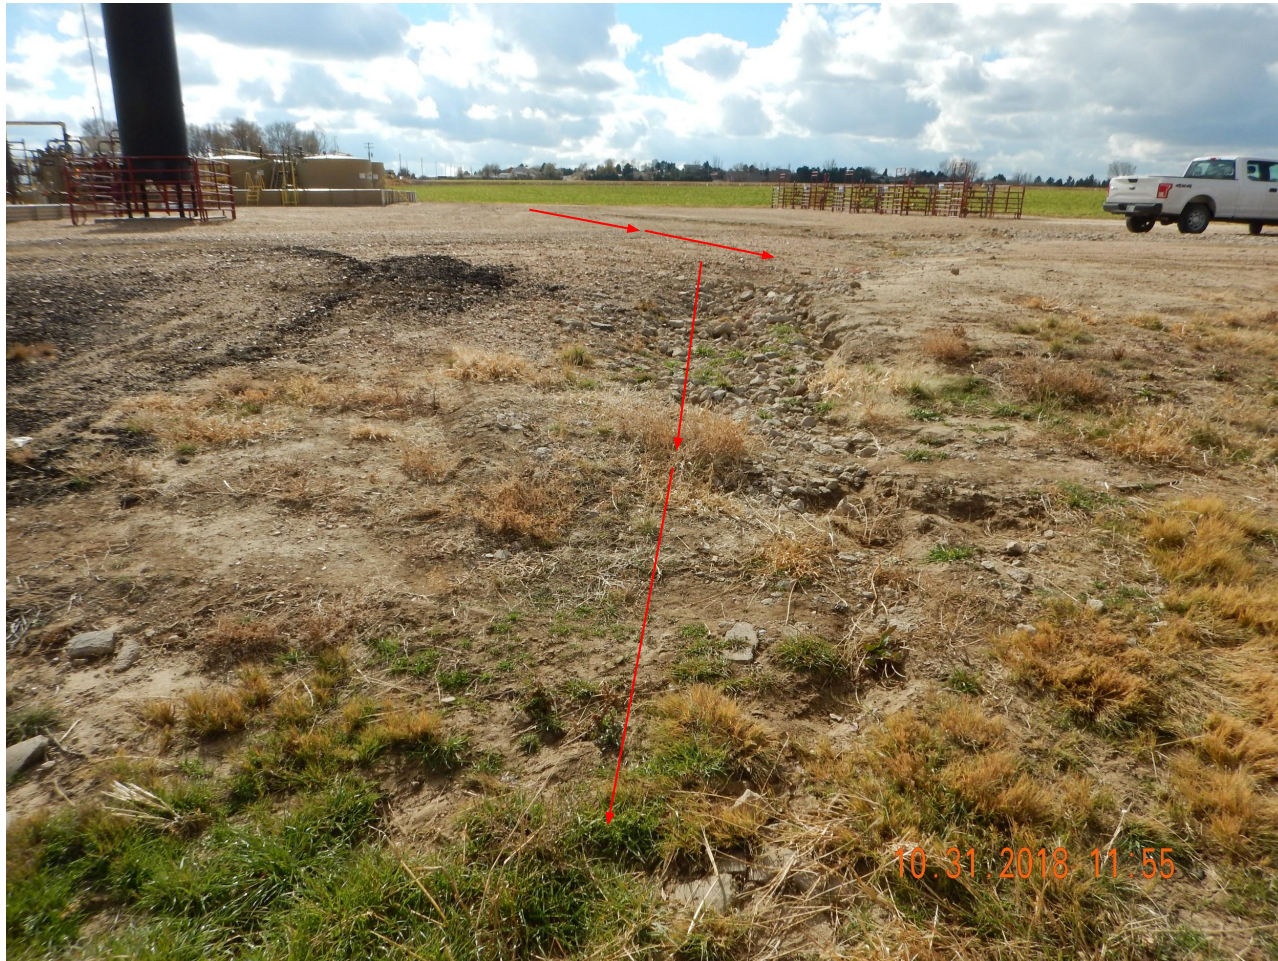
Photo 6. Photo taken from the northern location, facing South. Photo illustrates stormwater runoff from location with the evidence of an erosion channel.

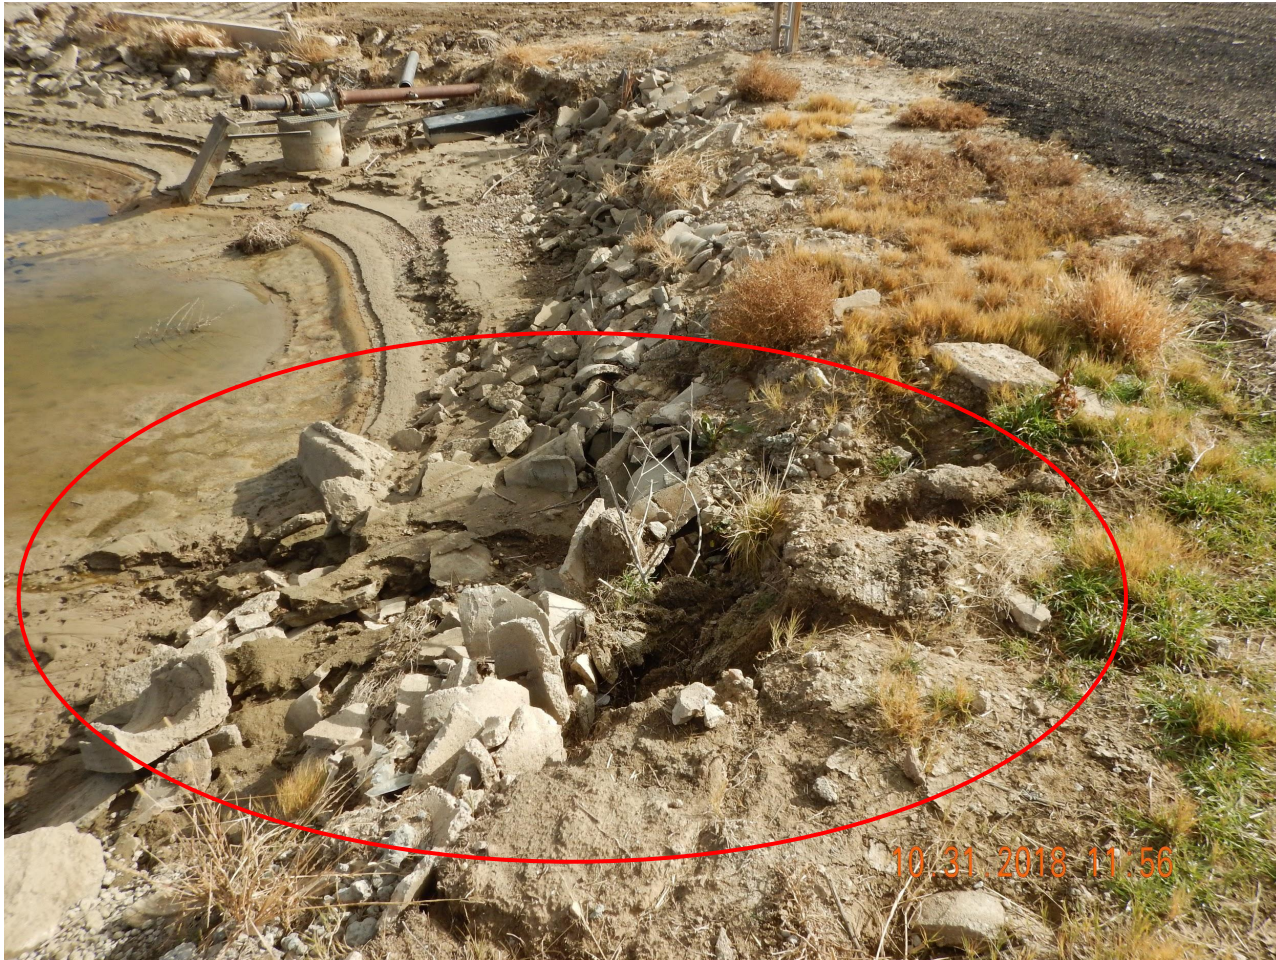
Photo 7. Photo taken from the point of discharge off location. Photo illustrates erosion going off location into an adjacent water body.

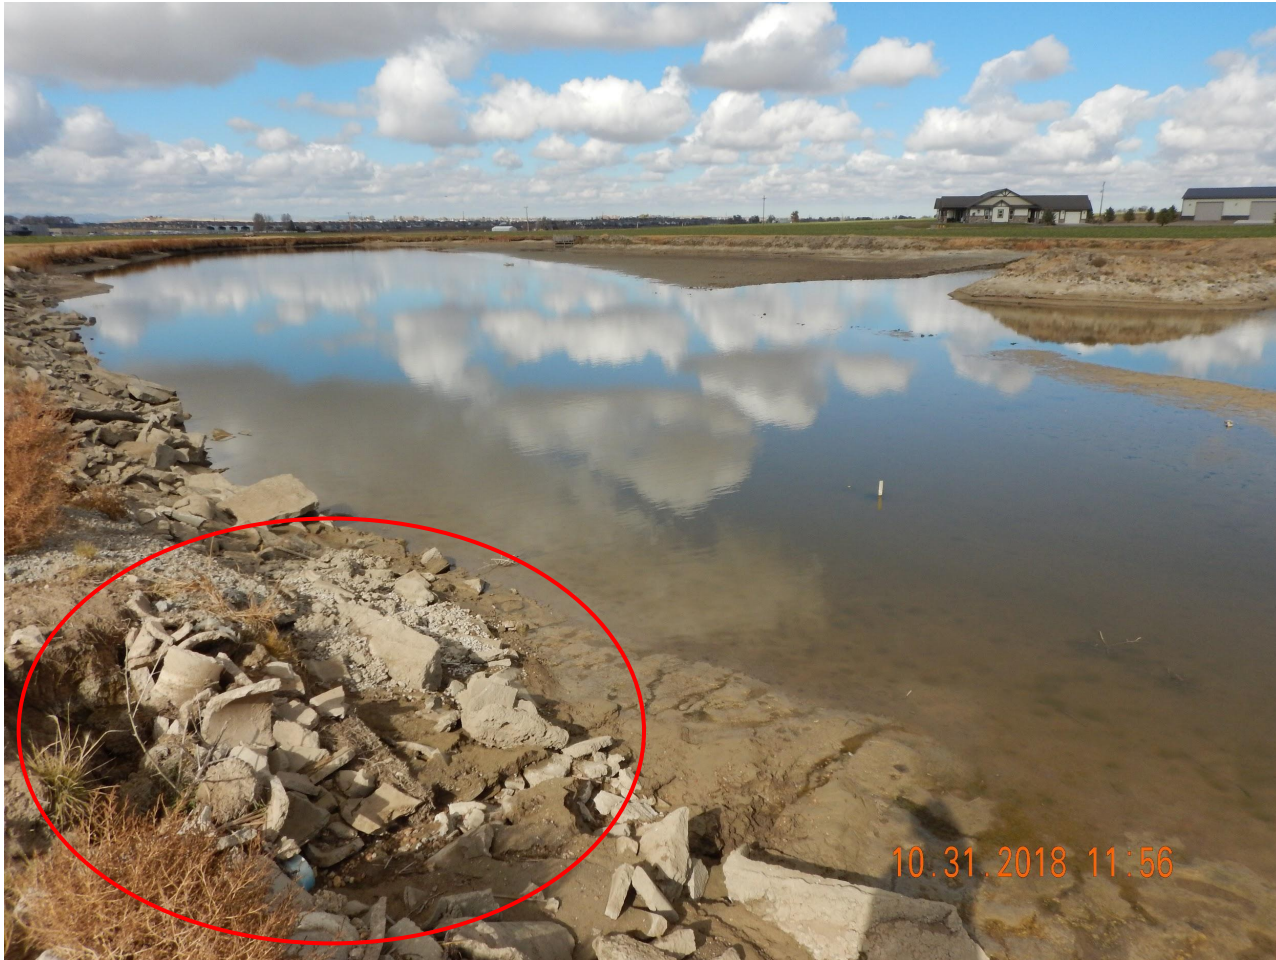
Photo 8. Photo taken from the point of discharge off location. See comments under Photo 7.
