Final Reclamation Inspection

Operator: KERR MCGEE OIL & GAS ONSHORE LP #47120

API: 05-123-15038

Inspection Photos
Location Name: UPRC #17-16J
API: 05-123-15038

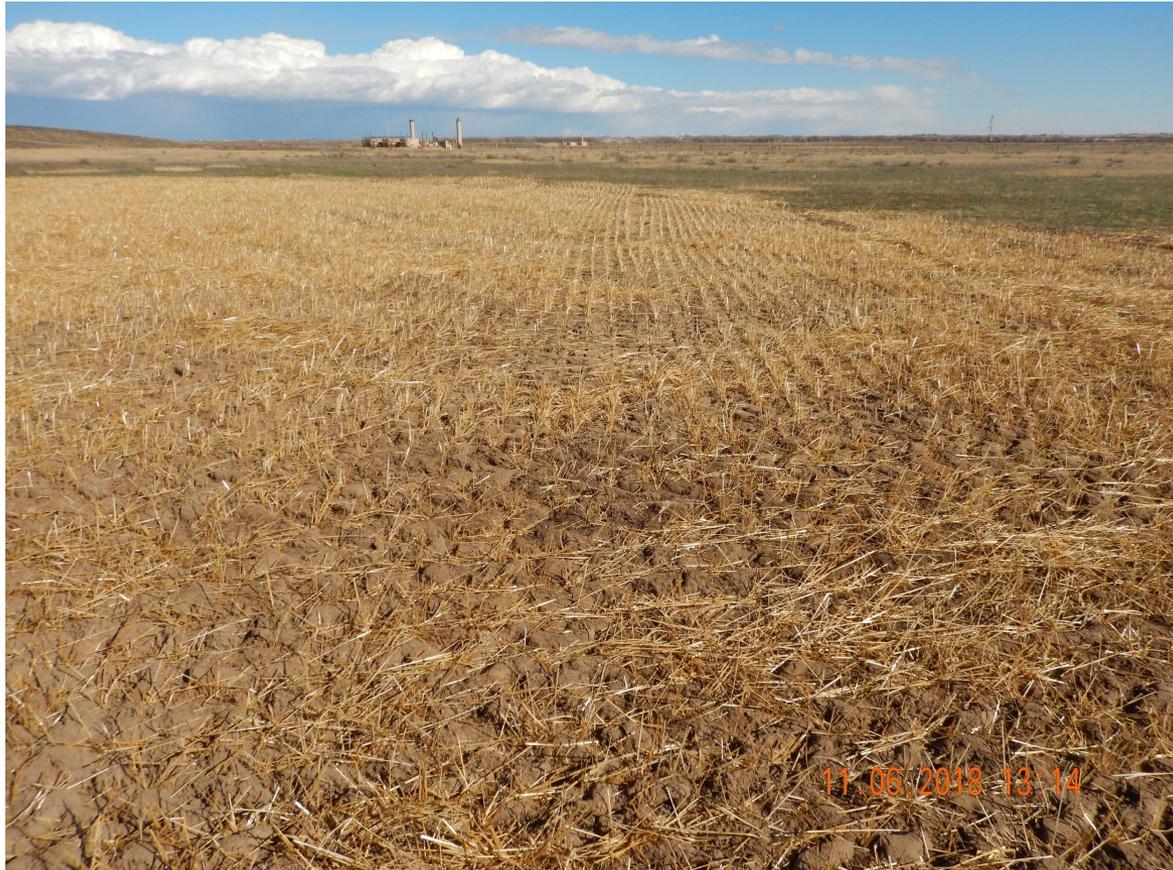
Photo 1. Photo taken from the southern location, facing East. Well has been plugged and abandoned. Photo illustrates final reclamation activities (i.e., straw crimped mulch and seeded). Operator shall continue to control weeds and erosion until the Location meets Rule 1004 standards.

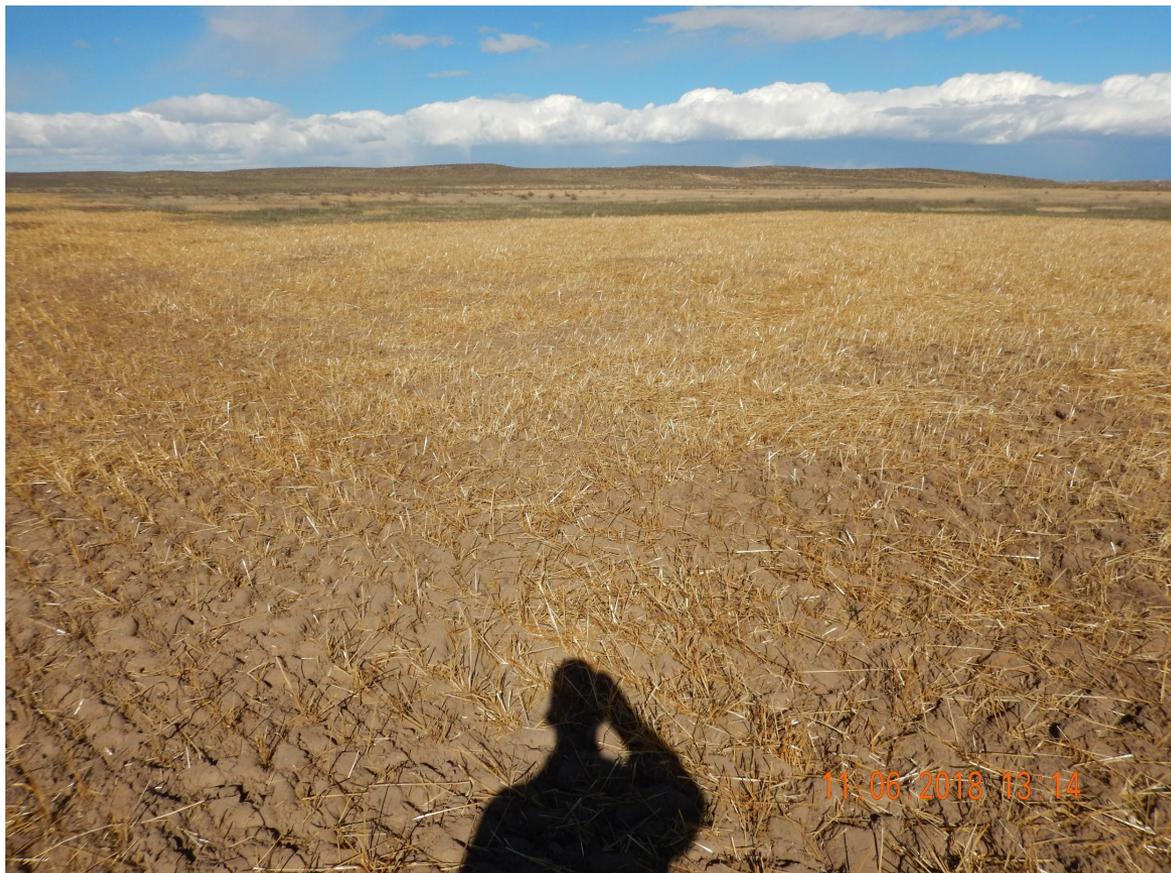
Photo 2. Photo taken from the southern location, facing North. See comments under Photo 1.

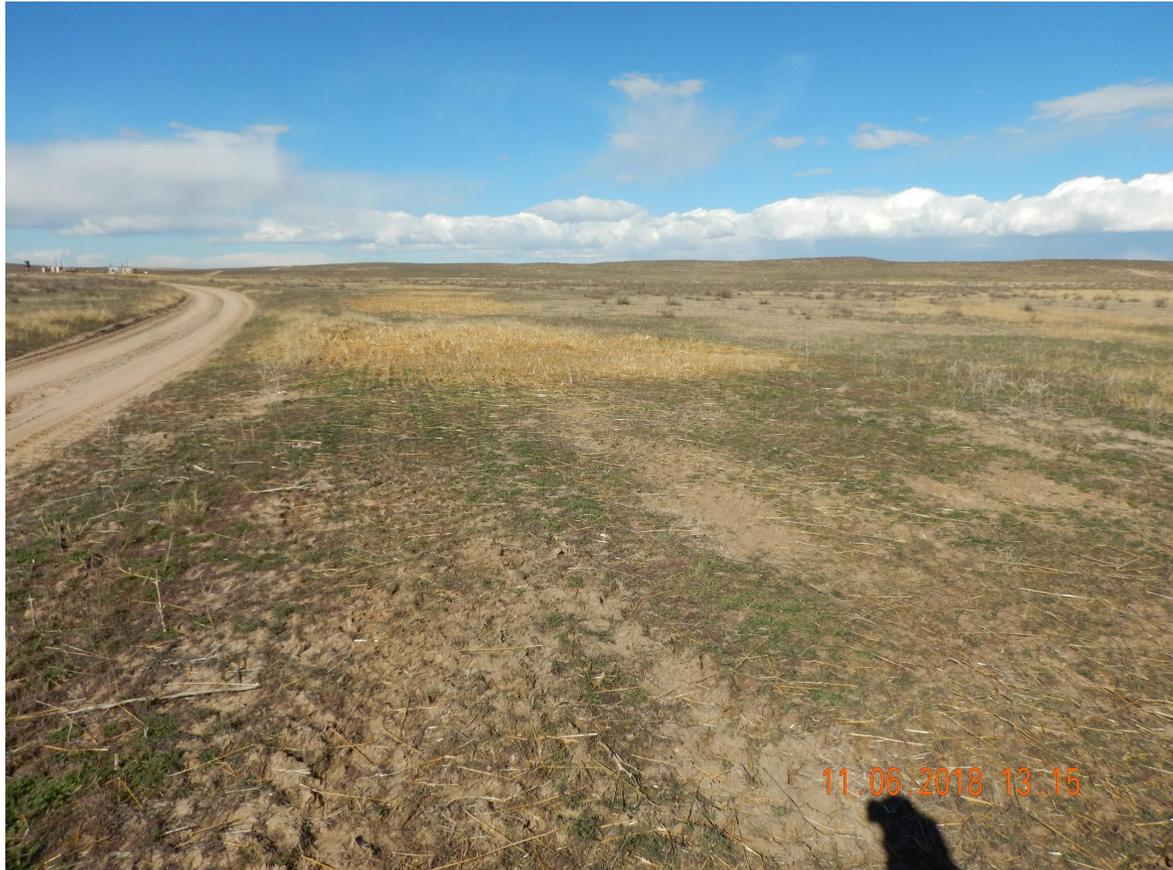
Photo 3. Photo taken north location, facing North. Appears the Operator has performed final reclamation activities along flowline removal areas.
