Inspection Photos

Operator: WESTERN OPERATING COMPANY -
95620

Location ID: 312233

Inspection Doc. Number: 682504103

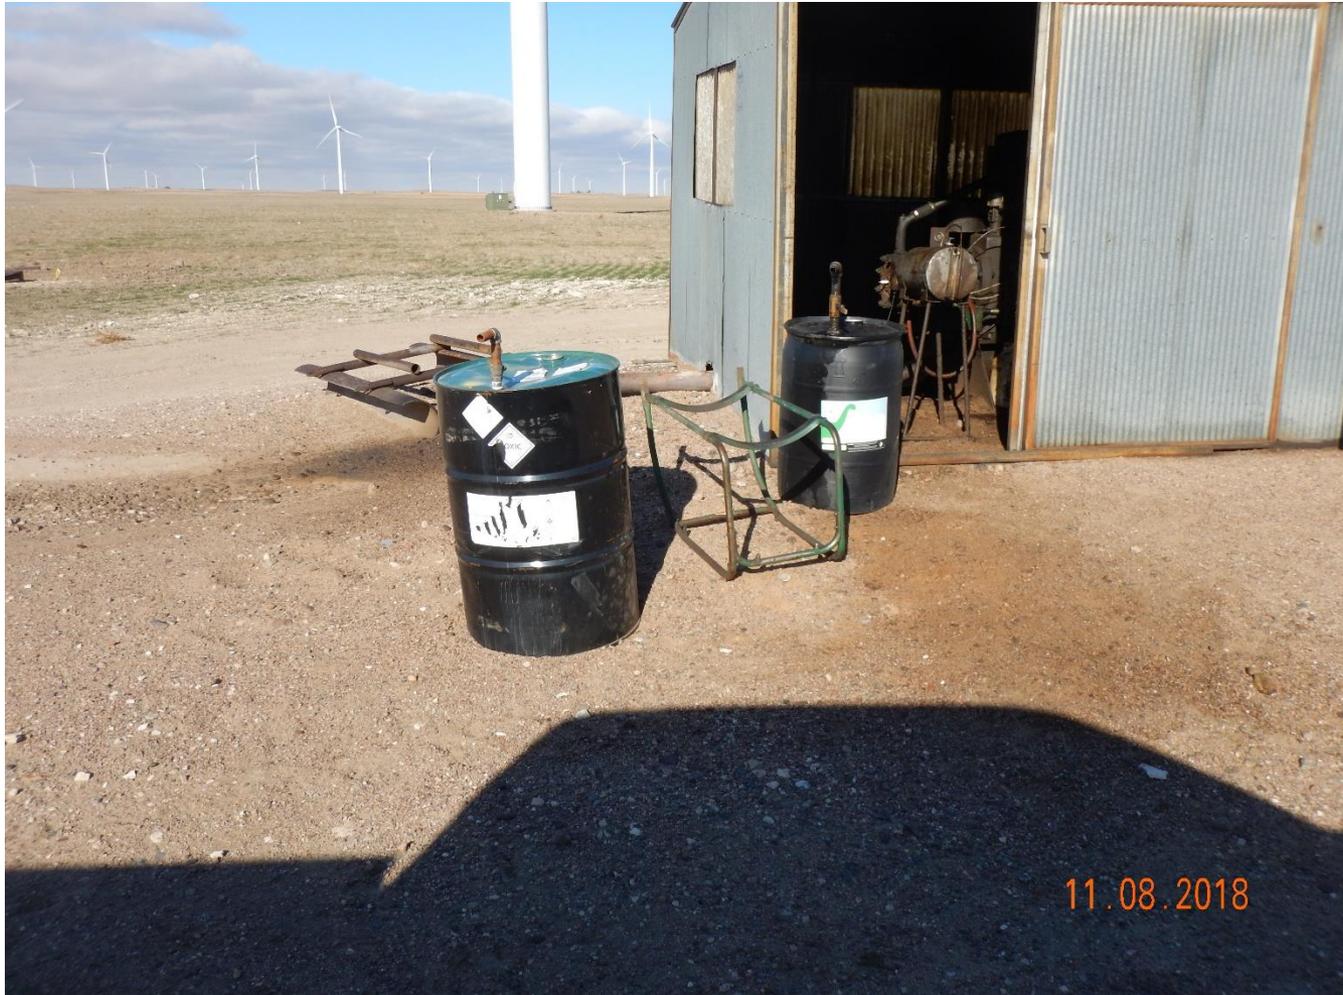
Photo 1: Photo taken from well location, facing north. Previous inspection required barrels to be placed into secondary containment. Photo shows barrels have not been placed into secondary containment.

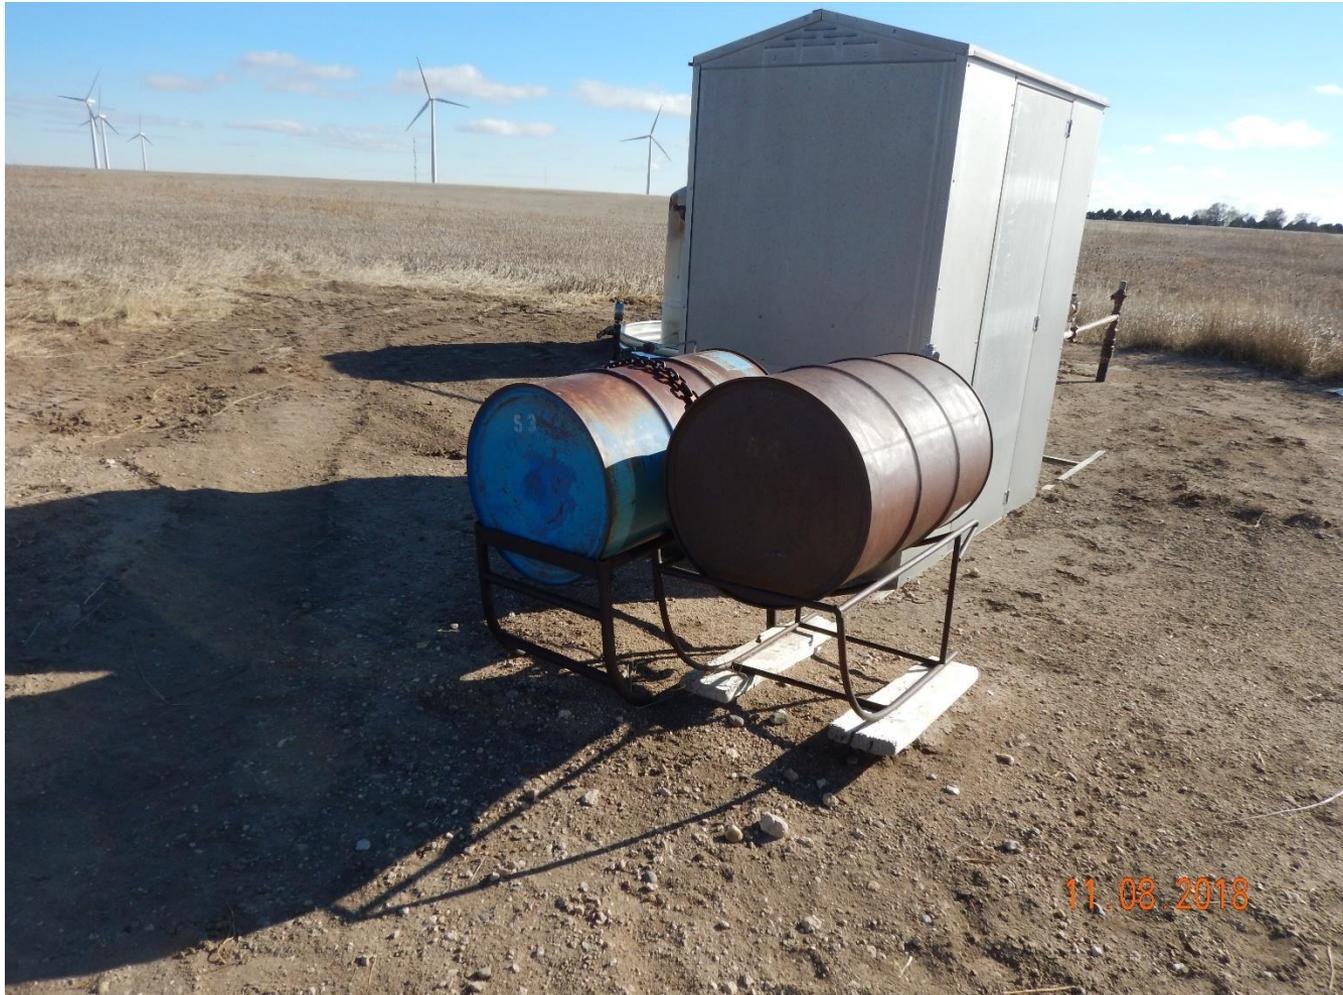
Photo 2: Photo taken from meter shed, facing south. Previous inspection required barrels to be placed into secondary containment. Photo shows barrels have not been placed into secondary containment.

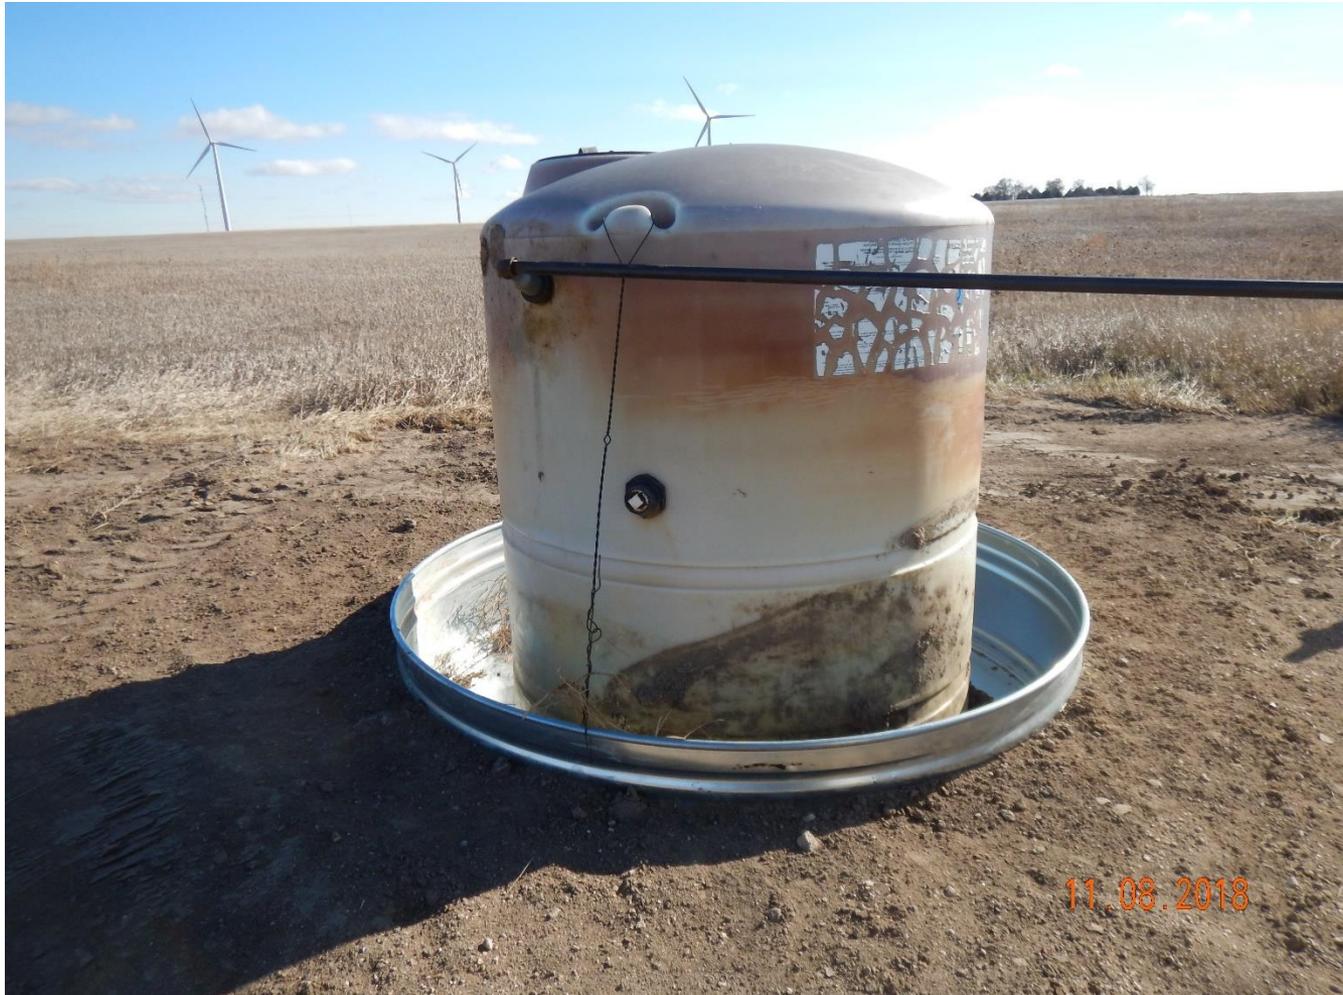
Photo 3: Photo taken from meter shed, facing south. Previous inspection required plastic tank to be placed back. Operator appears to have installed secondary containment and returned the tank. Previous inspection also required operator to replace signage/placards on tank. Photo shows signage/placards have not been replaced.

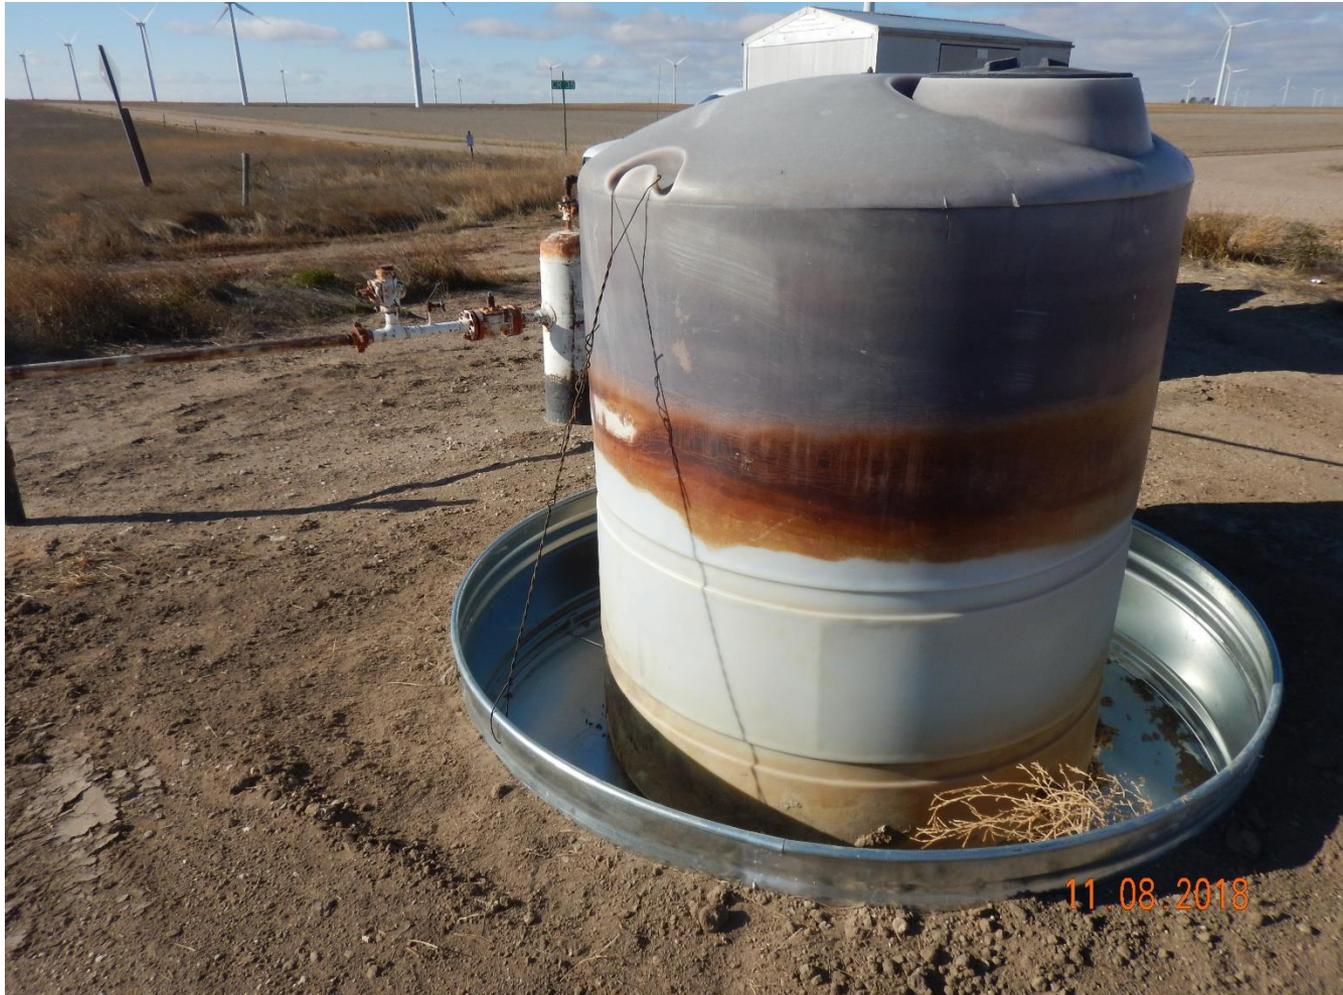
Photo 4: Continued from photo 3. Photo shows signage/placards have not been replaced.
