# Inspection Photos

Operator: WESTERN OPERATING COMPANY -  
95620

Location ID: 312292

Inspection Doc. Number: 682504105

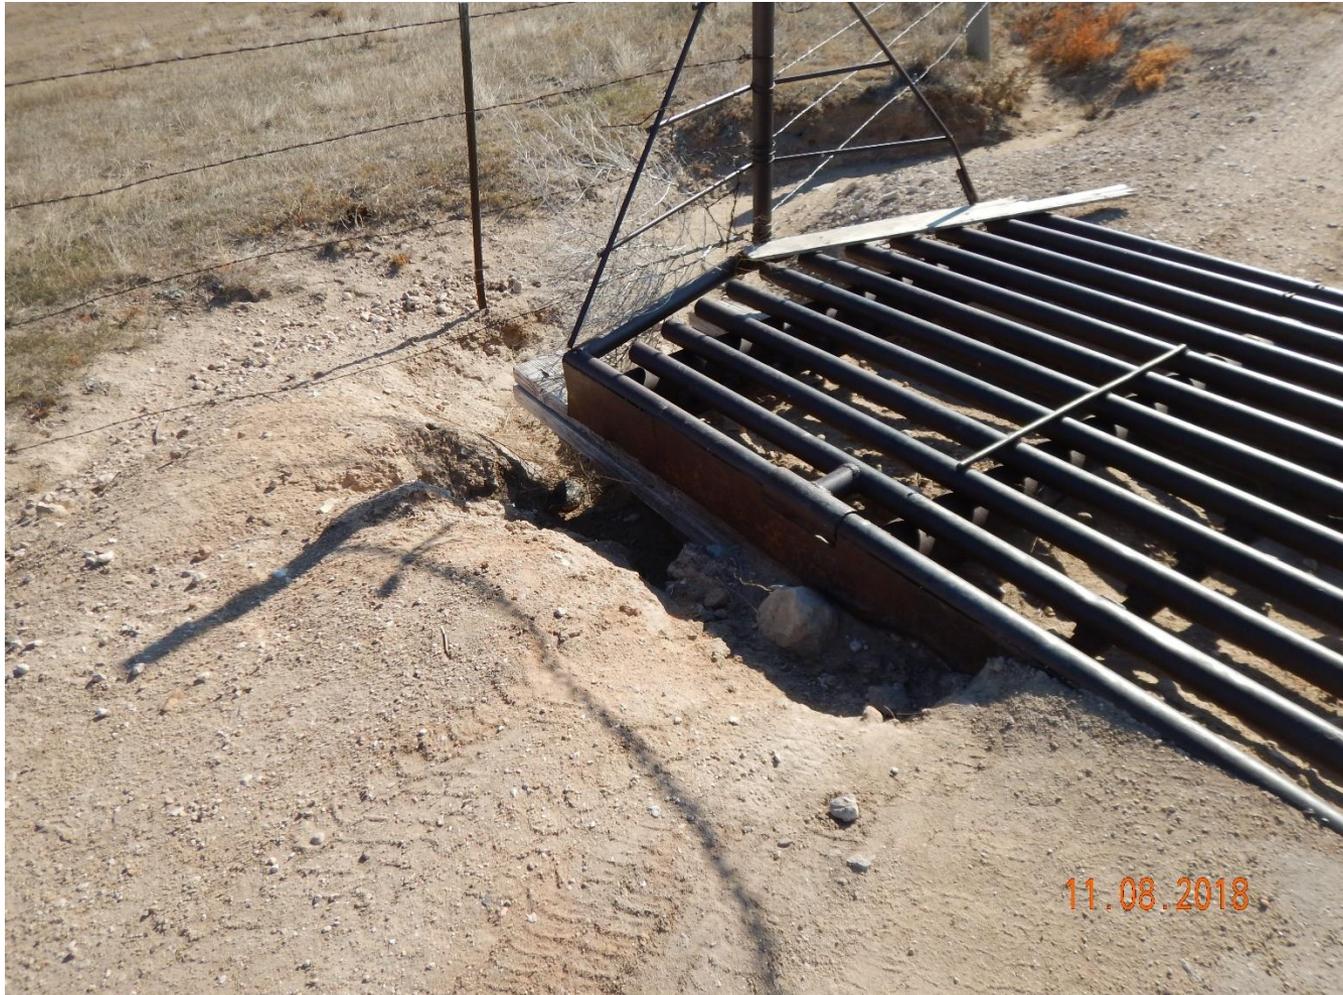
**Photo 1:** Photo taken from the access road. Photo shows erosion degradation occurring at the cattle guard has not been repaired.

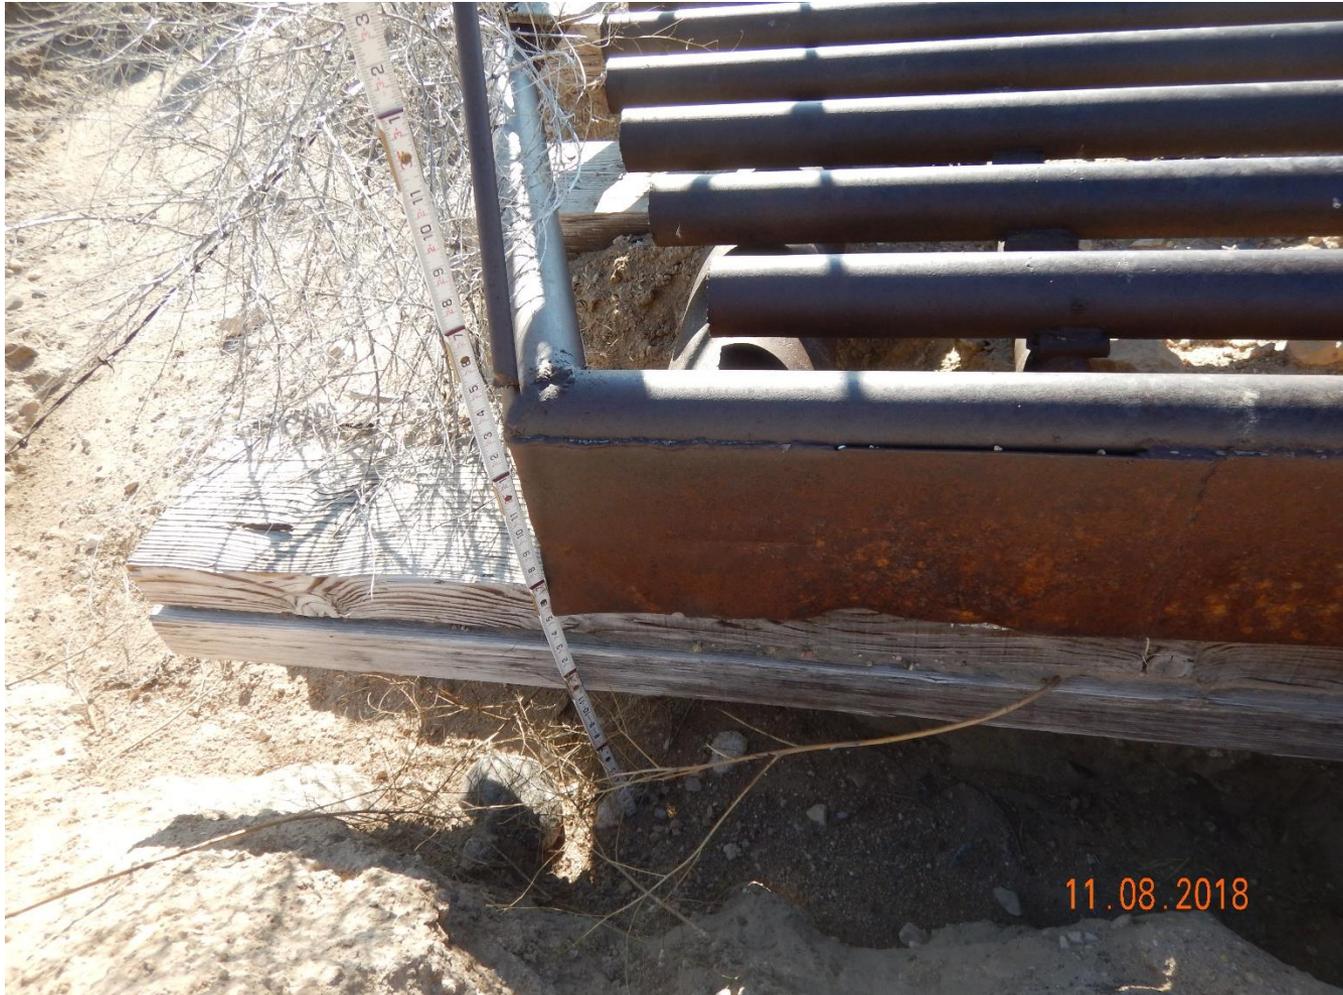
**Photo 2:** Photo taken from the access road. Photo shows erosion degradation occurring at the cattle guard has not been repaired. Photo also shows ~ 2 feet of soil has been washed out beneath the cattle guard.

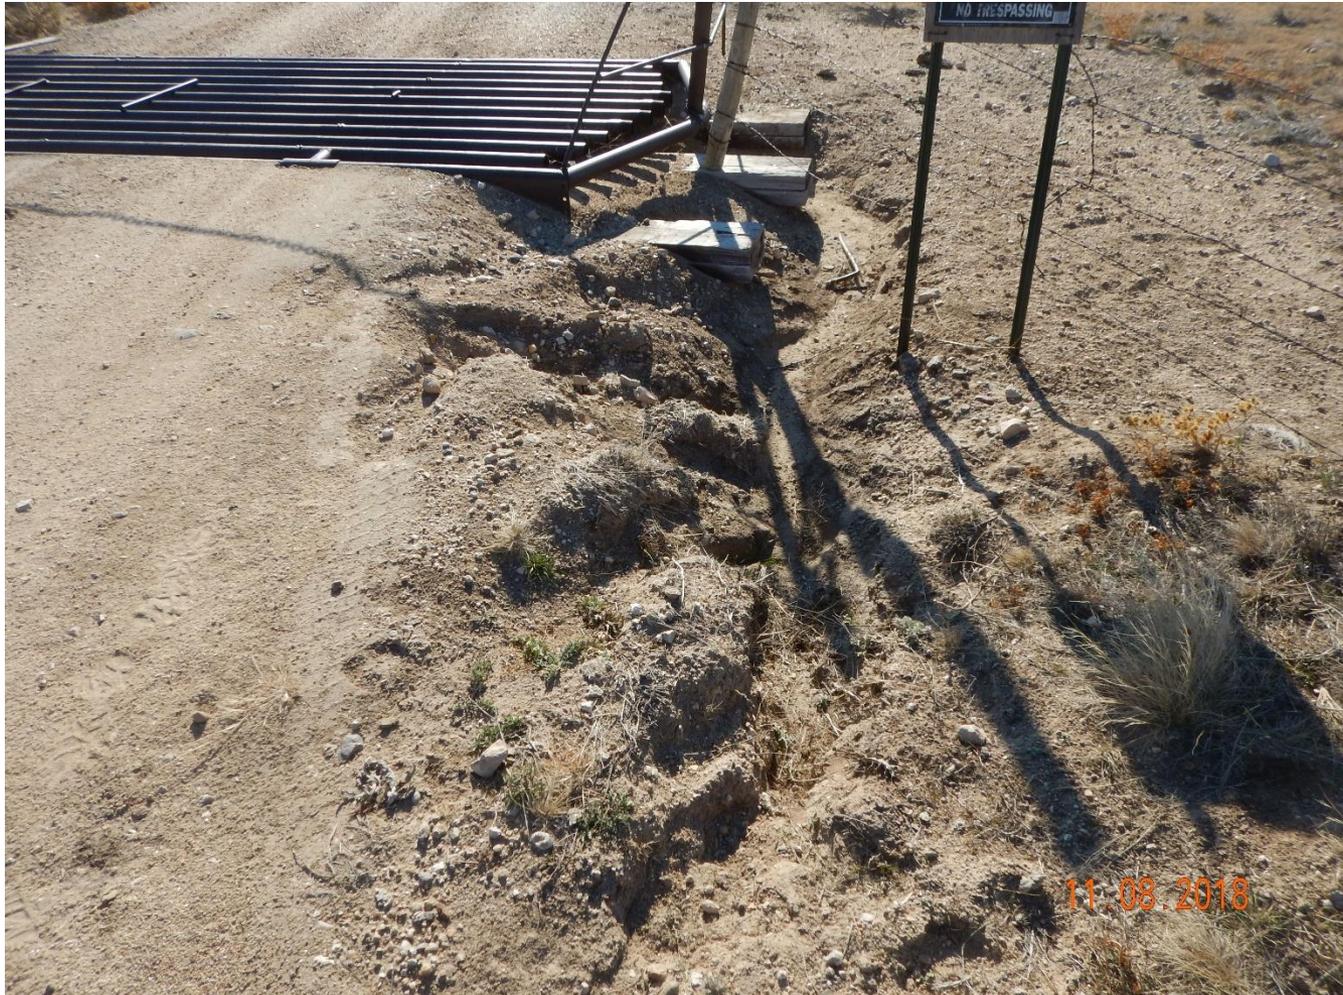
**Photo 3:** Photo taken from the access road. Photo shows erosion degradation occurring at the cattle guard has not been repaired.

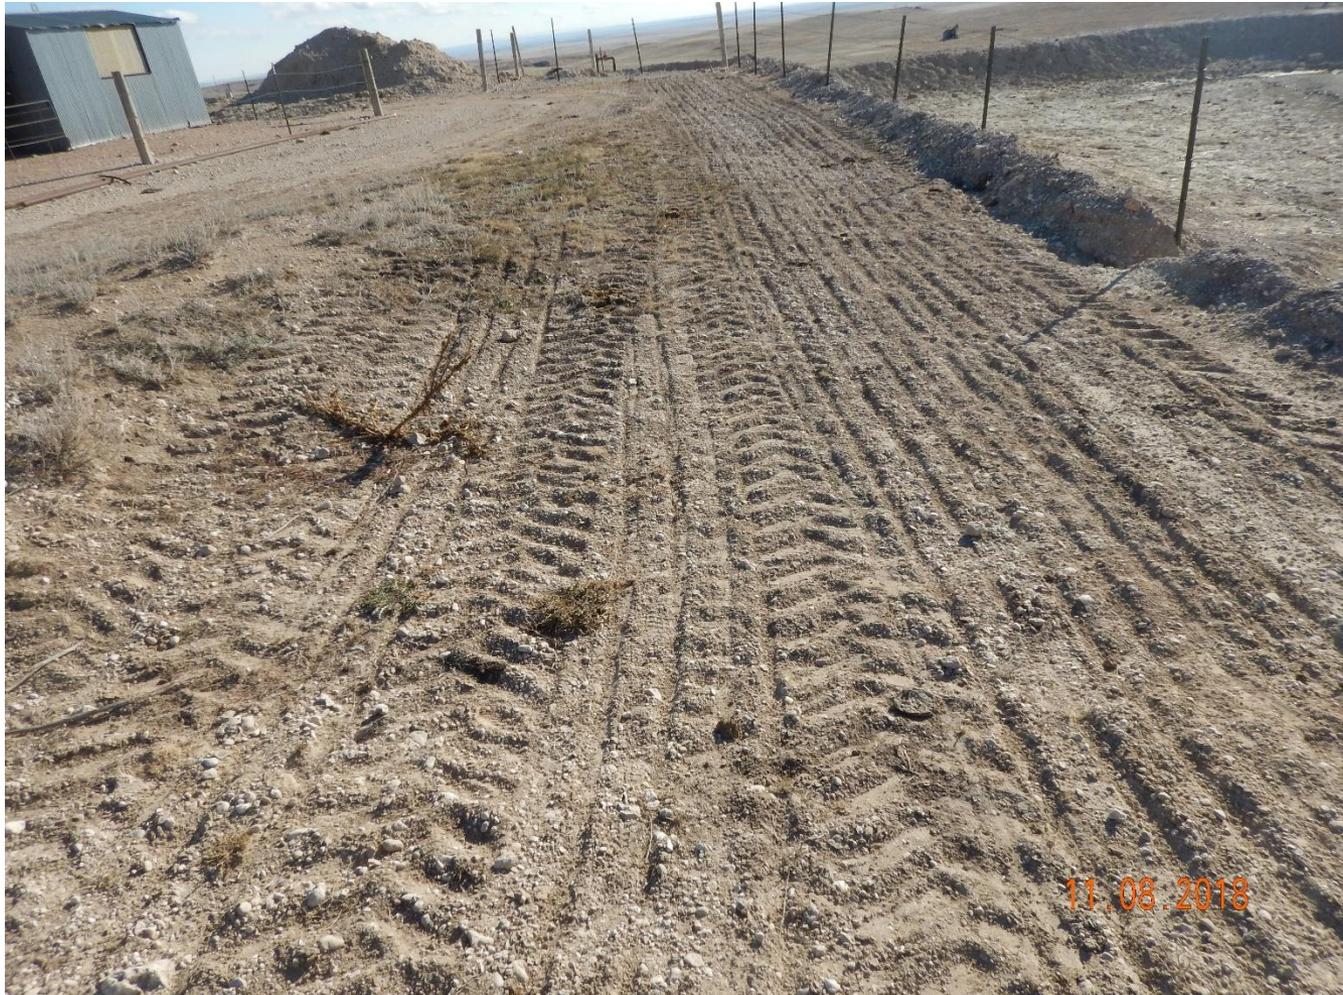
**Photo 4:** Photo taken from the west end of the well pad. Photo shows areas of the location where additional reclamation activities appear to have been conducted.

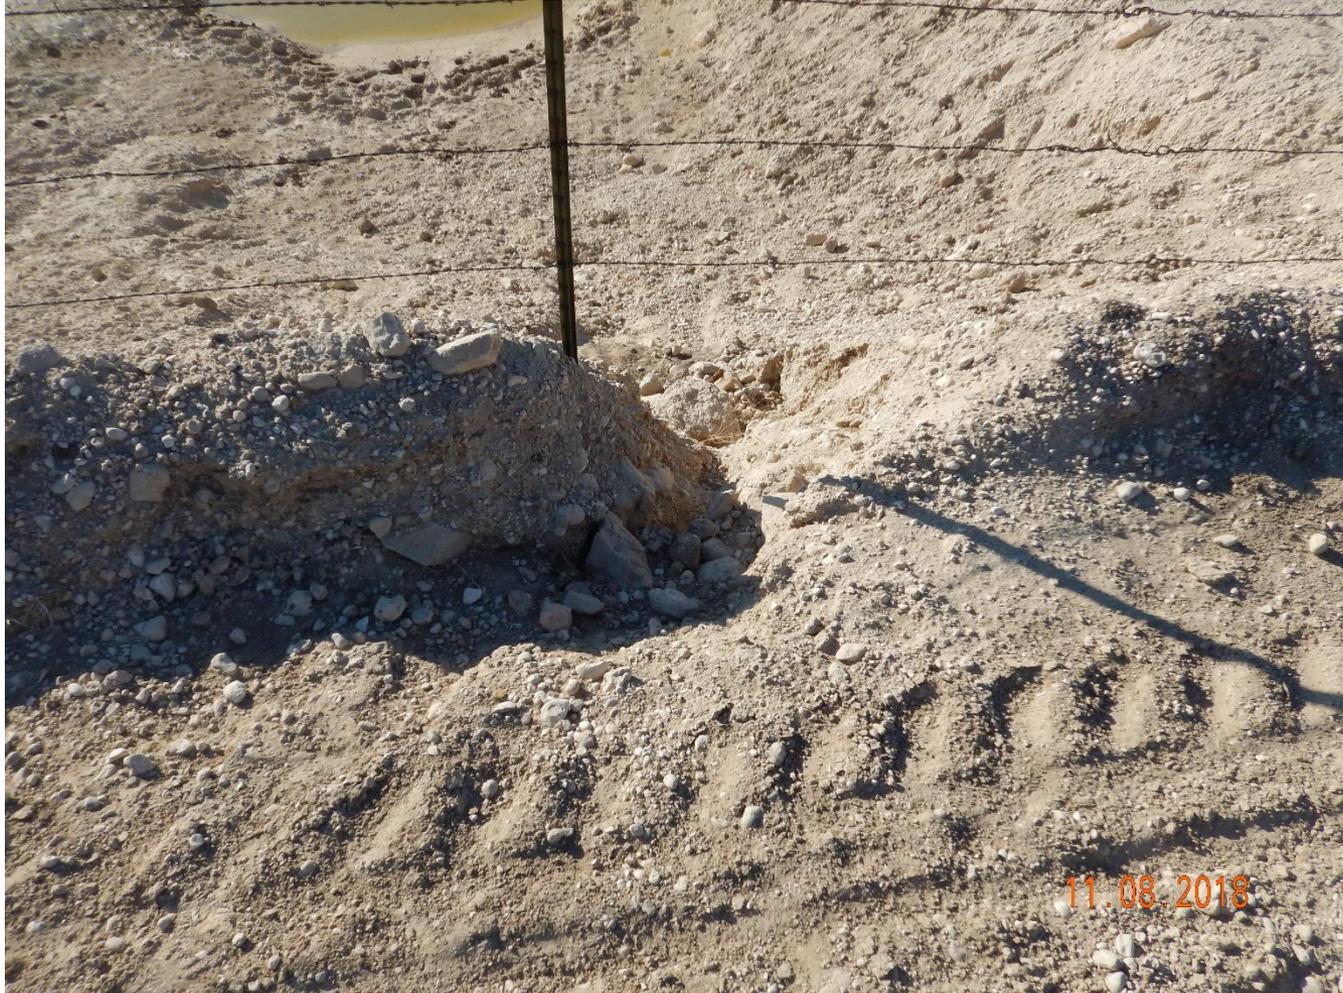
**Photo 5:** Photo taken from the west end of the pad (east end of pit). Photo shows gully erosion from the pit has not been addressed.

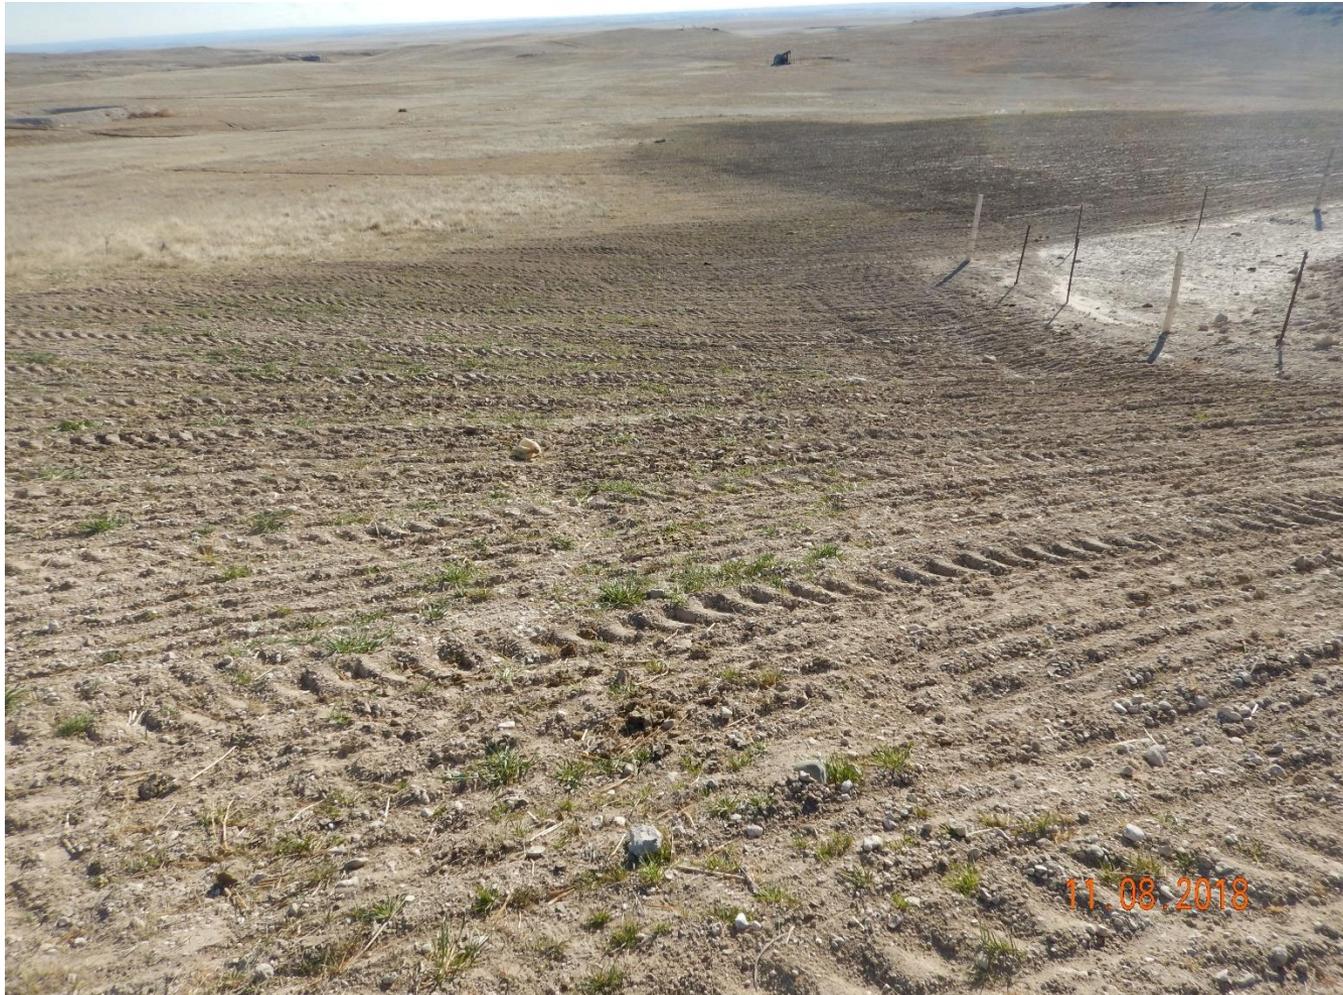
**Photo 6:** Photo taken from the south end of the pad, facing south. Photo shows additional reclamation activities appear to have been conducted on the spill areas to the south of the pit.

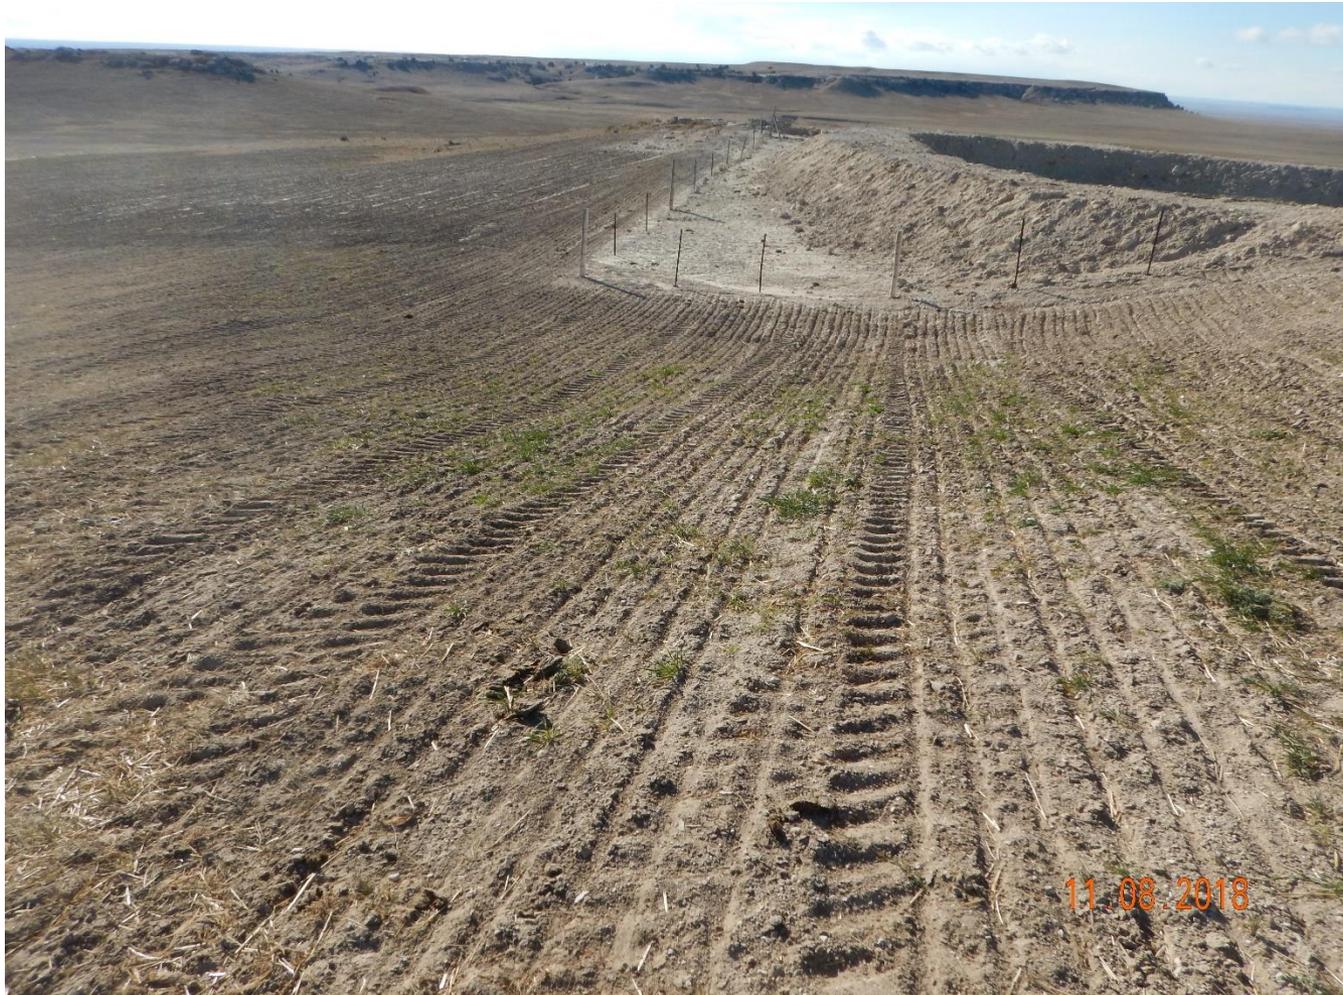
**Photo 7:** Photo taken from the south end of the pad, facing west. See comments under photo 6.

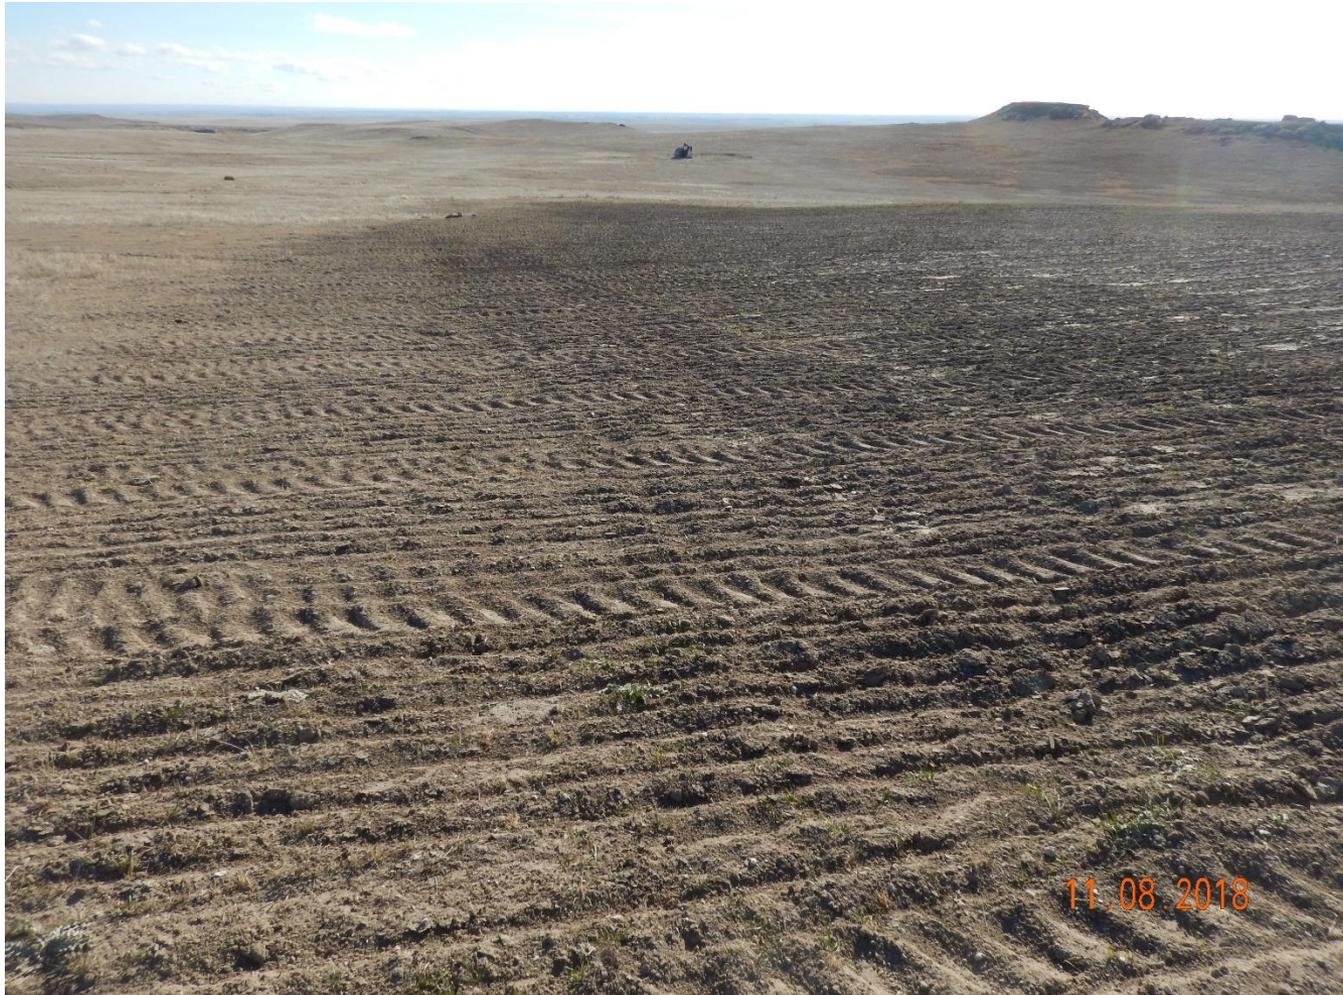
**Photo 8:** Photo taken from the south end of the pit, facing south. See comments under photo 6.

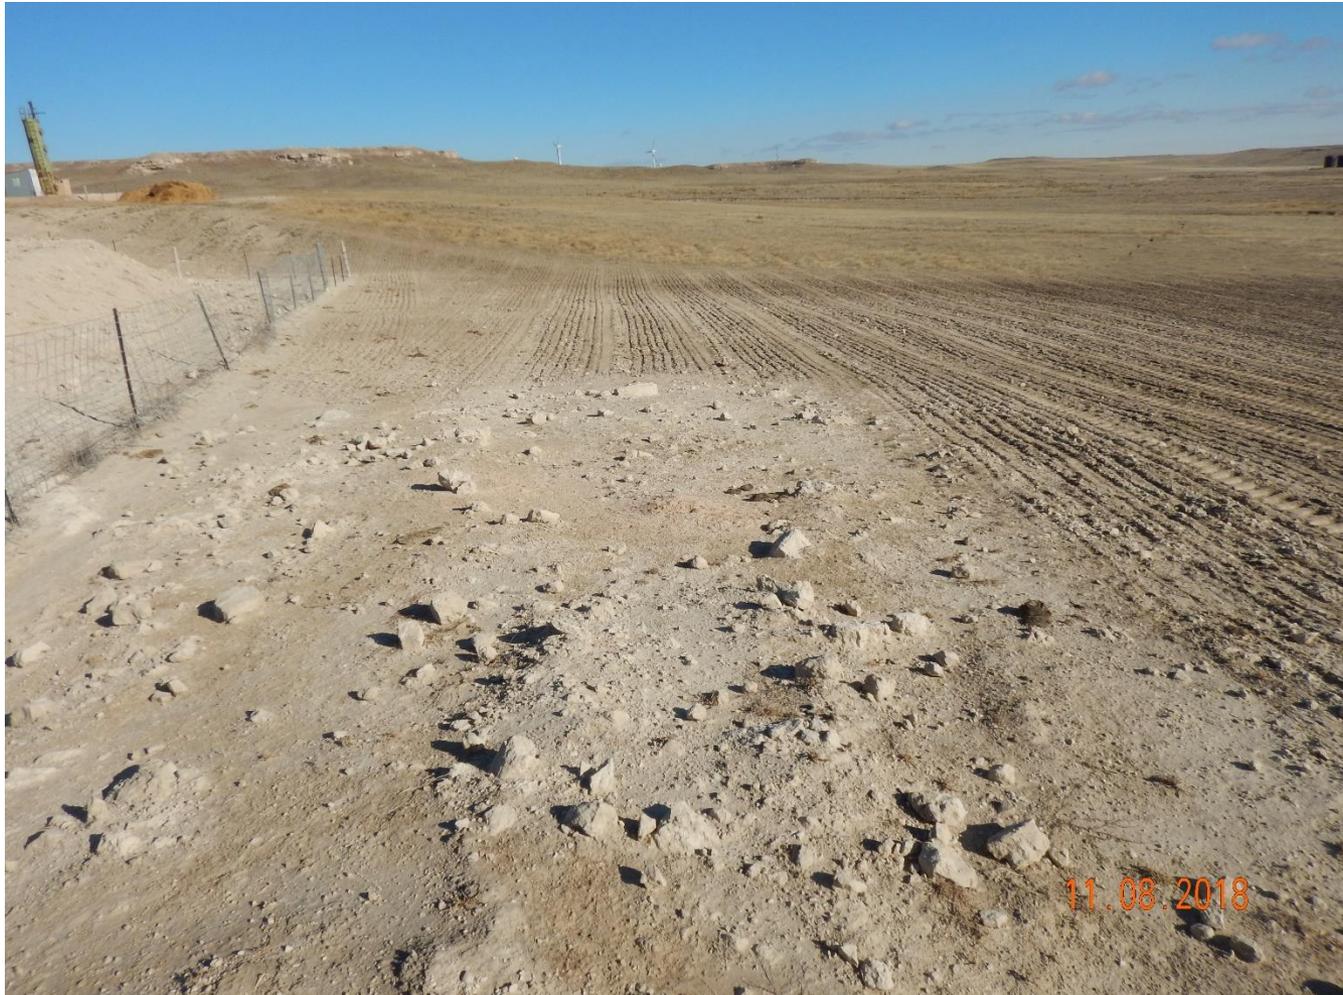
**Photo 9:** Photo taken from the southwest end of the pit, facing east. See comments under photo 6.

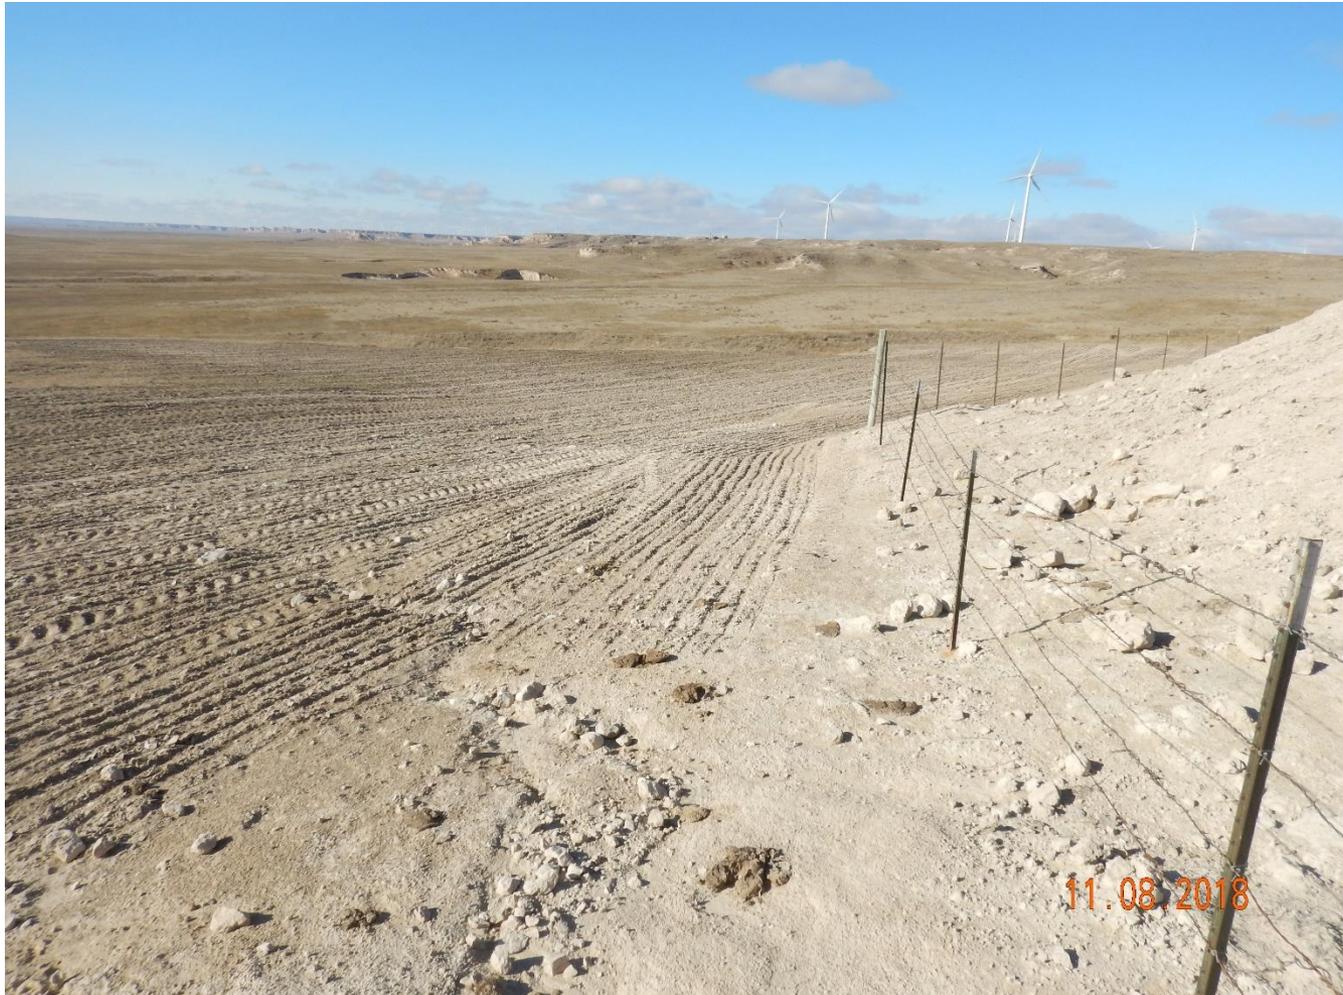
**Photo 10:** Photo taken from the southwest end of the pit, facing northwest. See comments under photo 6.

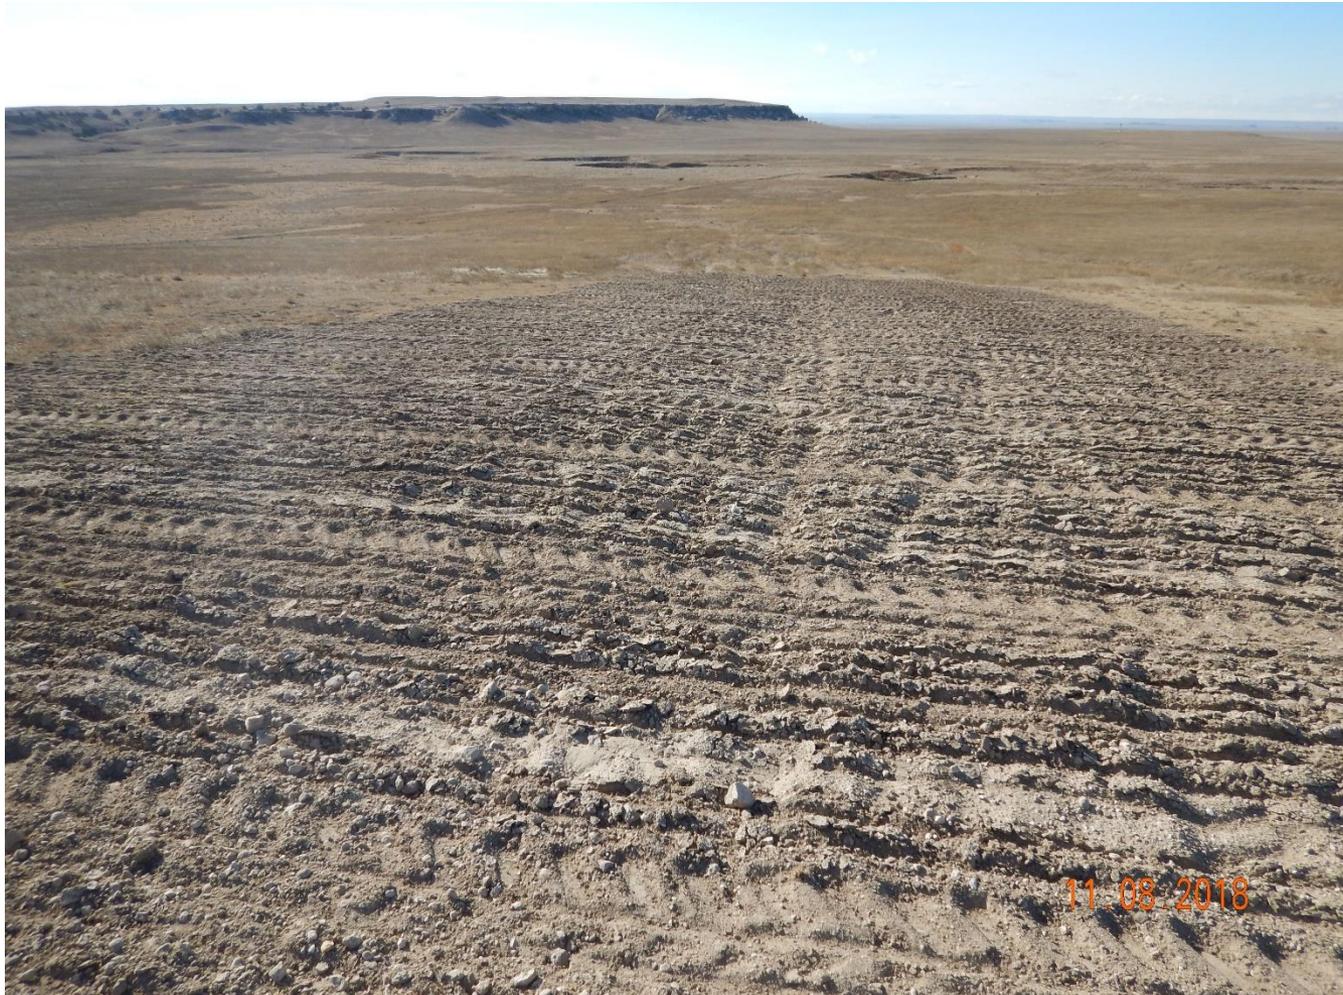
**Photo 11:** Photo taken from the west end of the pit, facing west. See comments under photo 6.

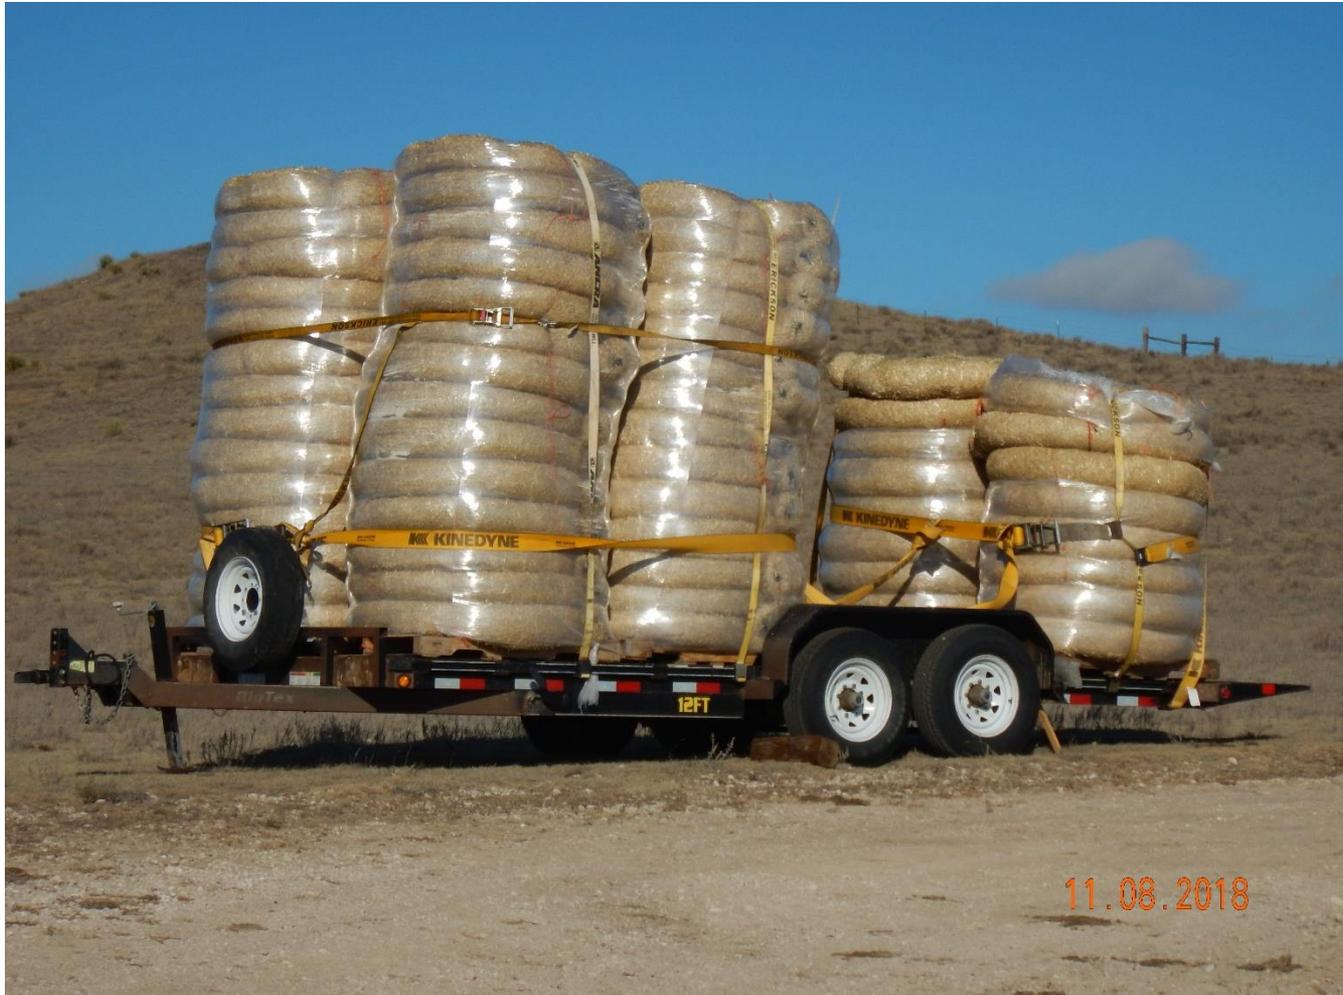
**Photo 12:** Photo taken from the north end of the location. Photo shows trailer containing straw erosion logs.
