Inspection Photos

11/19/2018

Operator: MALLARD EXPLORATION LLC - 10670

Location ID: 454592

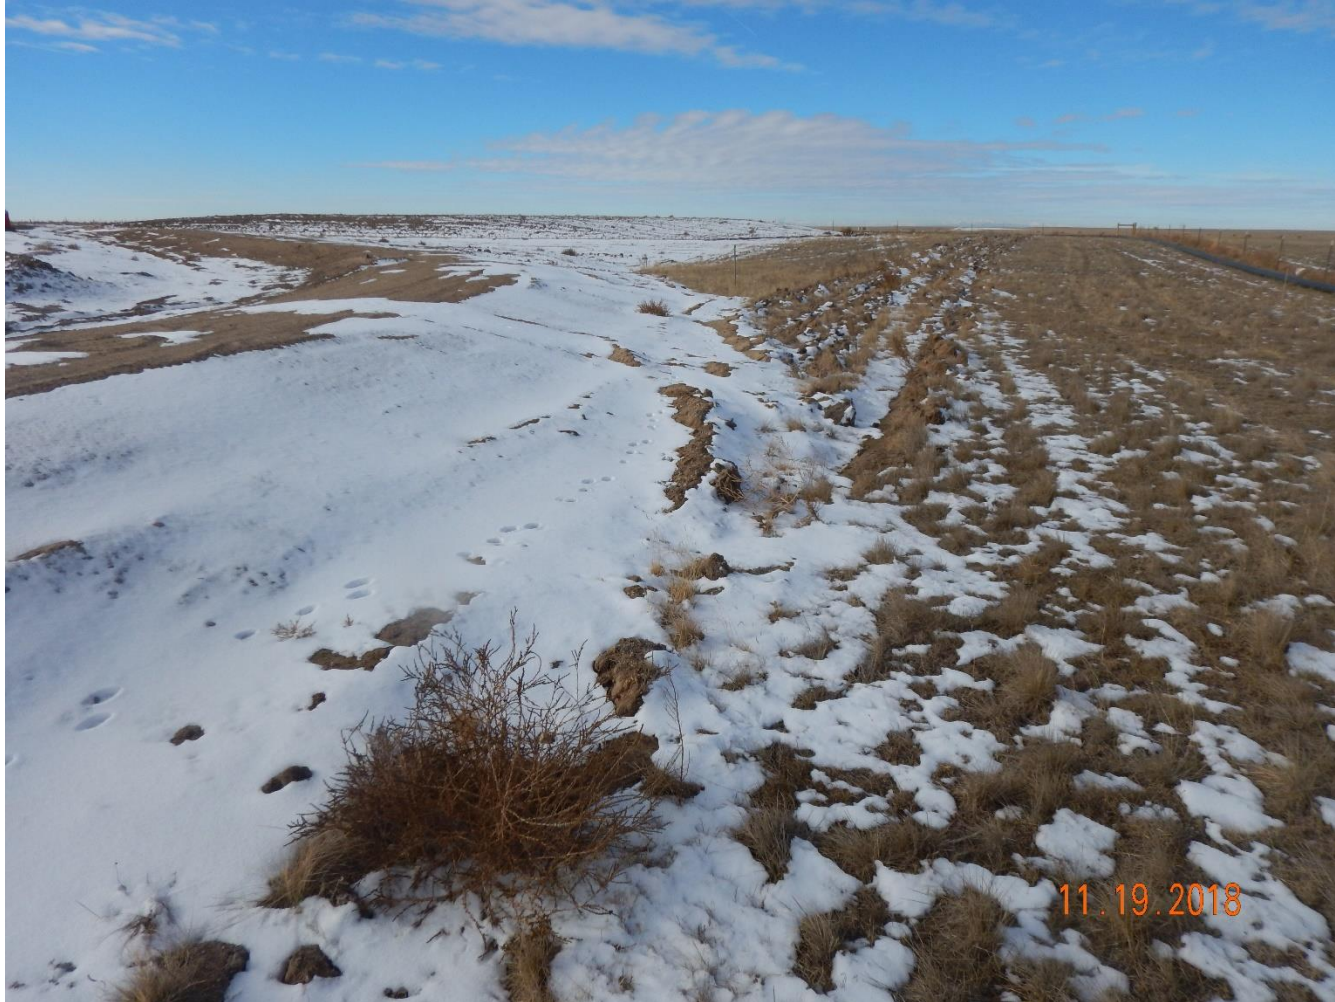
Photo 1: Photo taken from the north end of the location, facing west. Photos 1-3 provide an overview of the location from west, south, to east

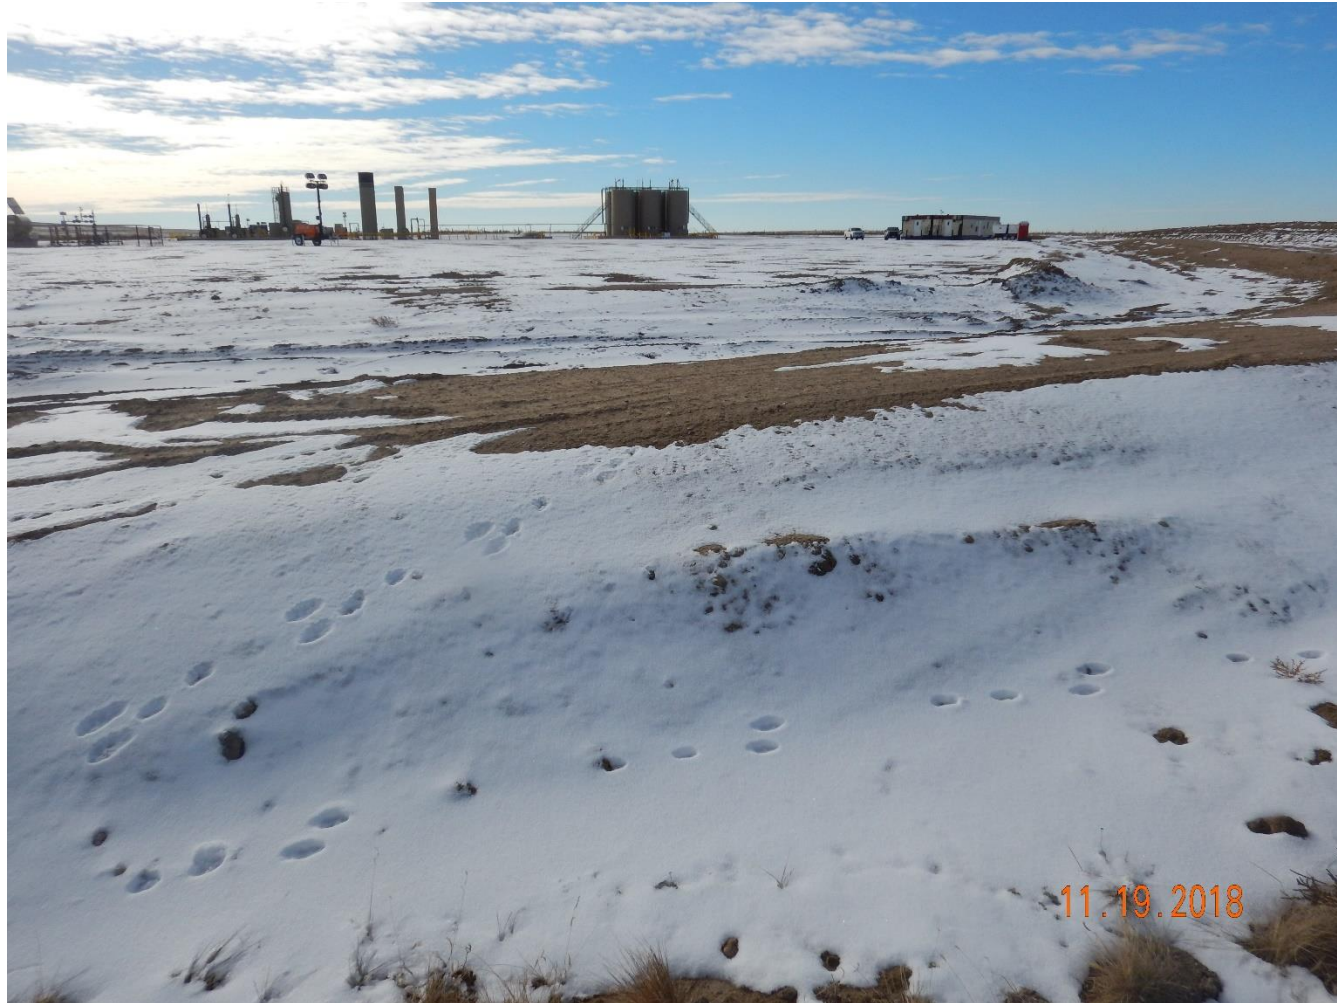
Photo 2: See comments under photo 1.

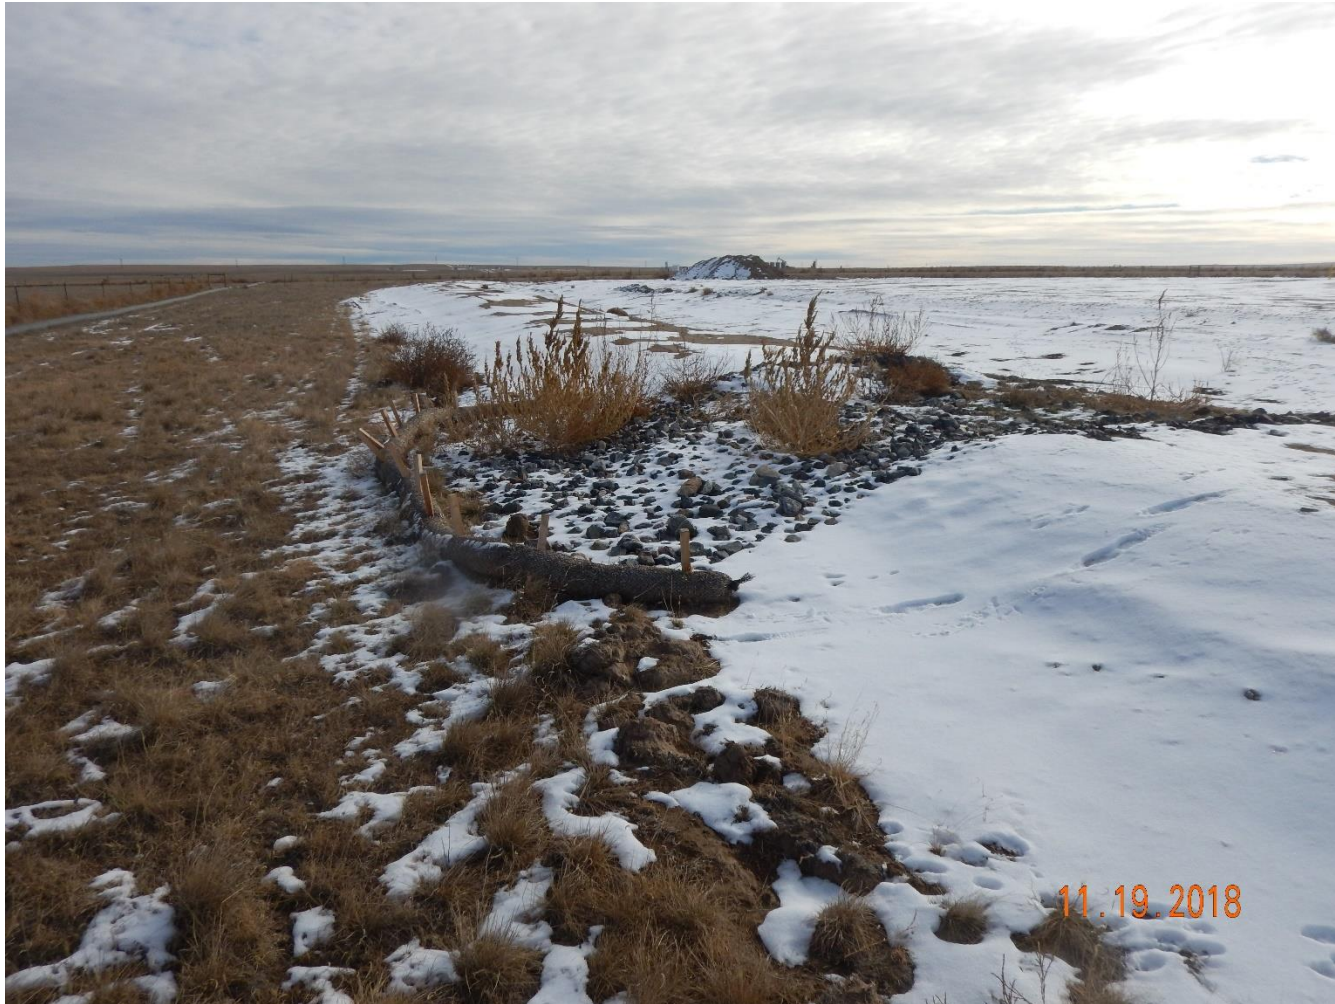
Photo 3: See comments under photo 1.

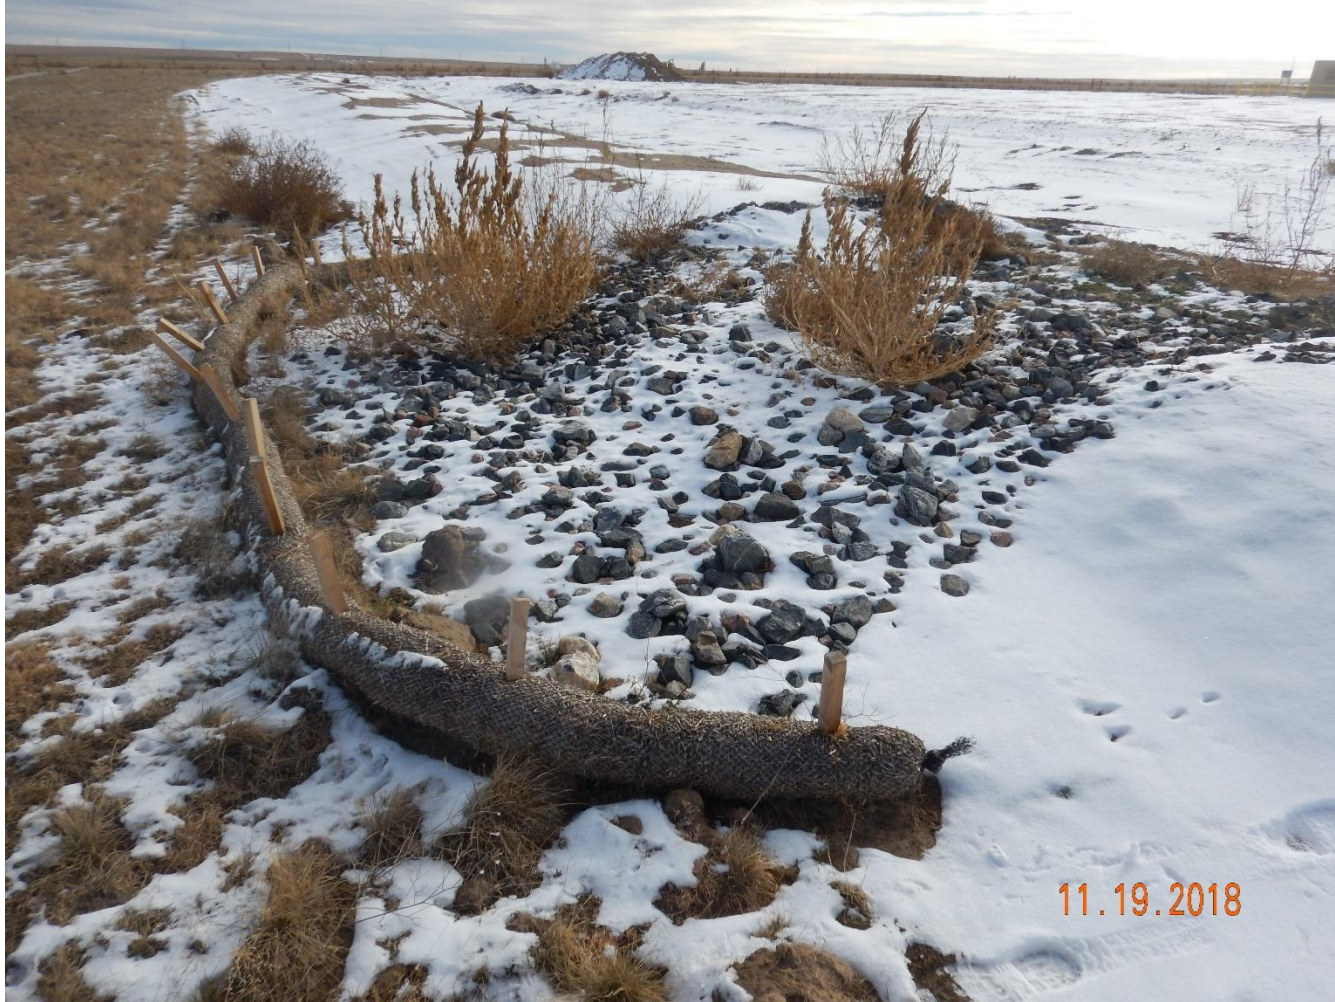
Photo 4: Photo taken from the sediment trap on the north end of the location. Photo shows outlet appears to be in proper functioning condition.

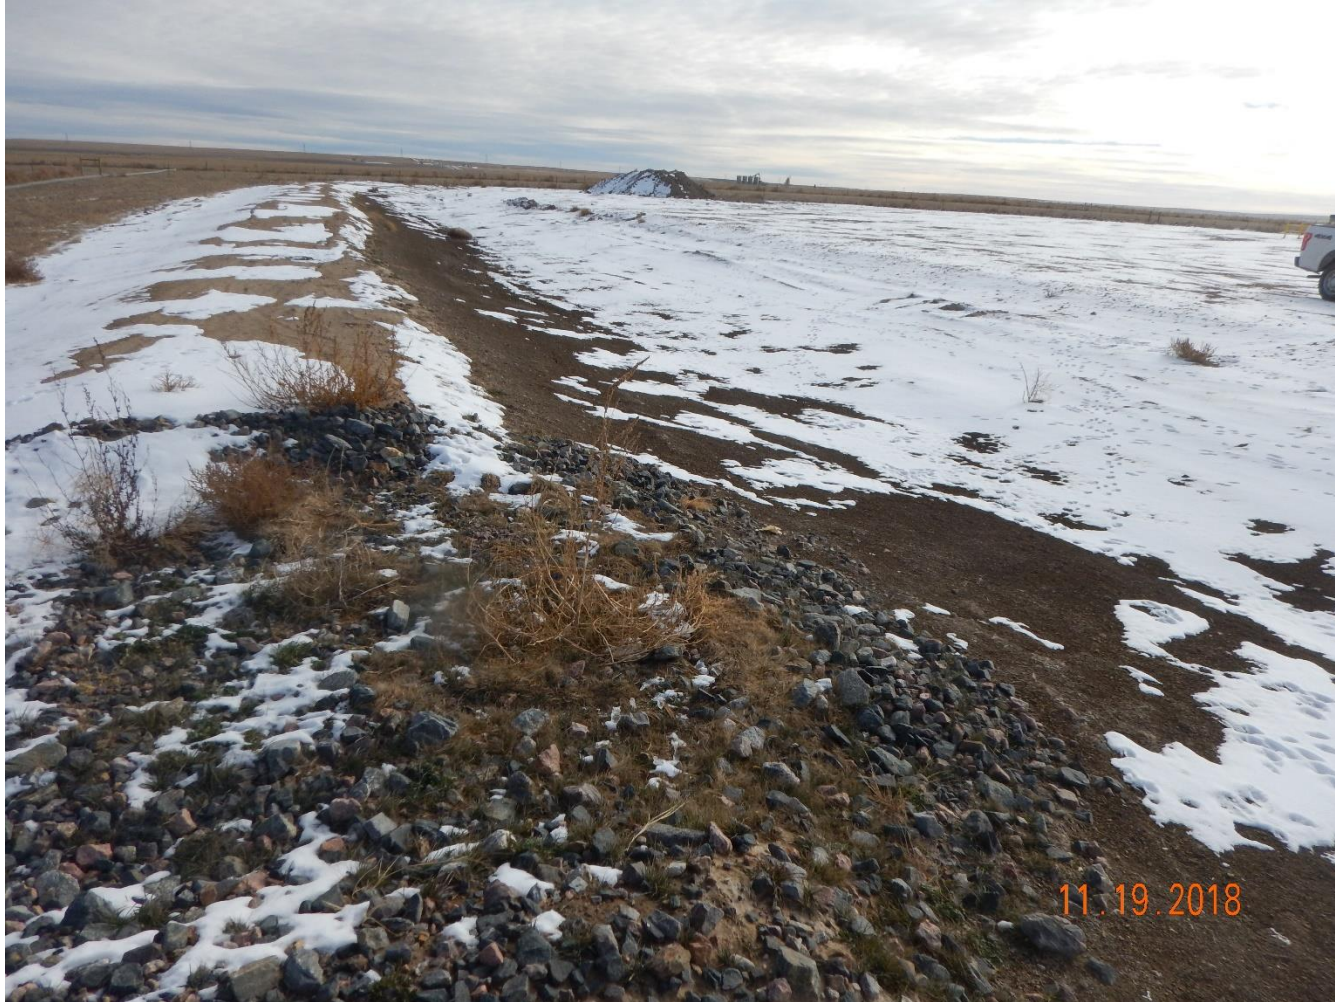
Photo 5: Photo taken from the north end of the location, facing east. Photo shows sediment trap and stormwater ditch.

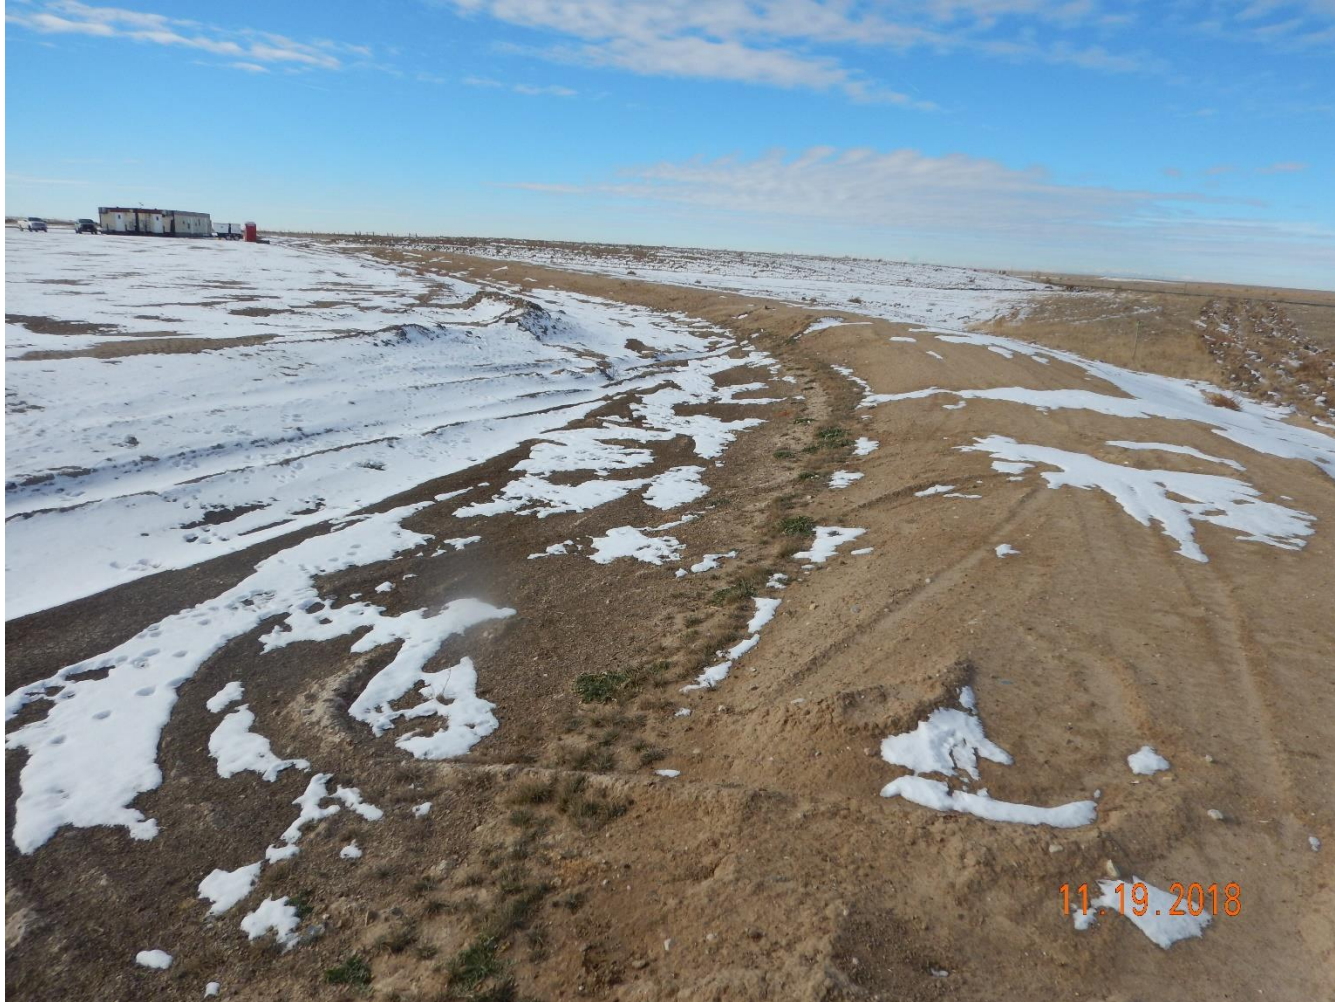
Photo 6: Photo taken from the north end of the location, facing west. Photo shows sediment trap and stormwater ditch.

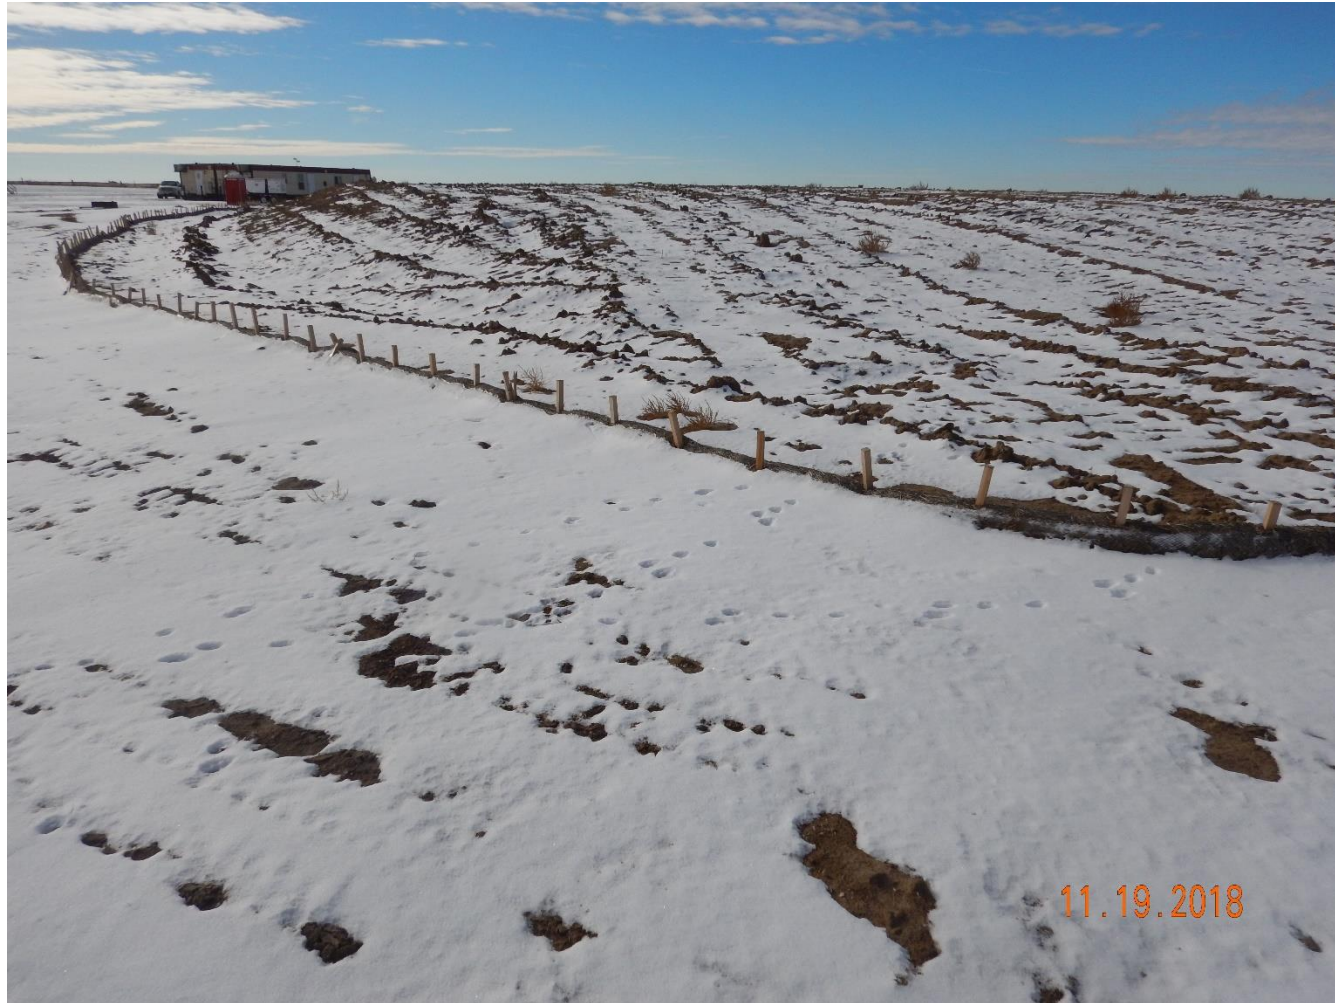
Photo 7: Photo taken from the northwest corner of the pad, facing south. Photo shows topsoil stockpile and straw wattle stormwater BMP along the base.

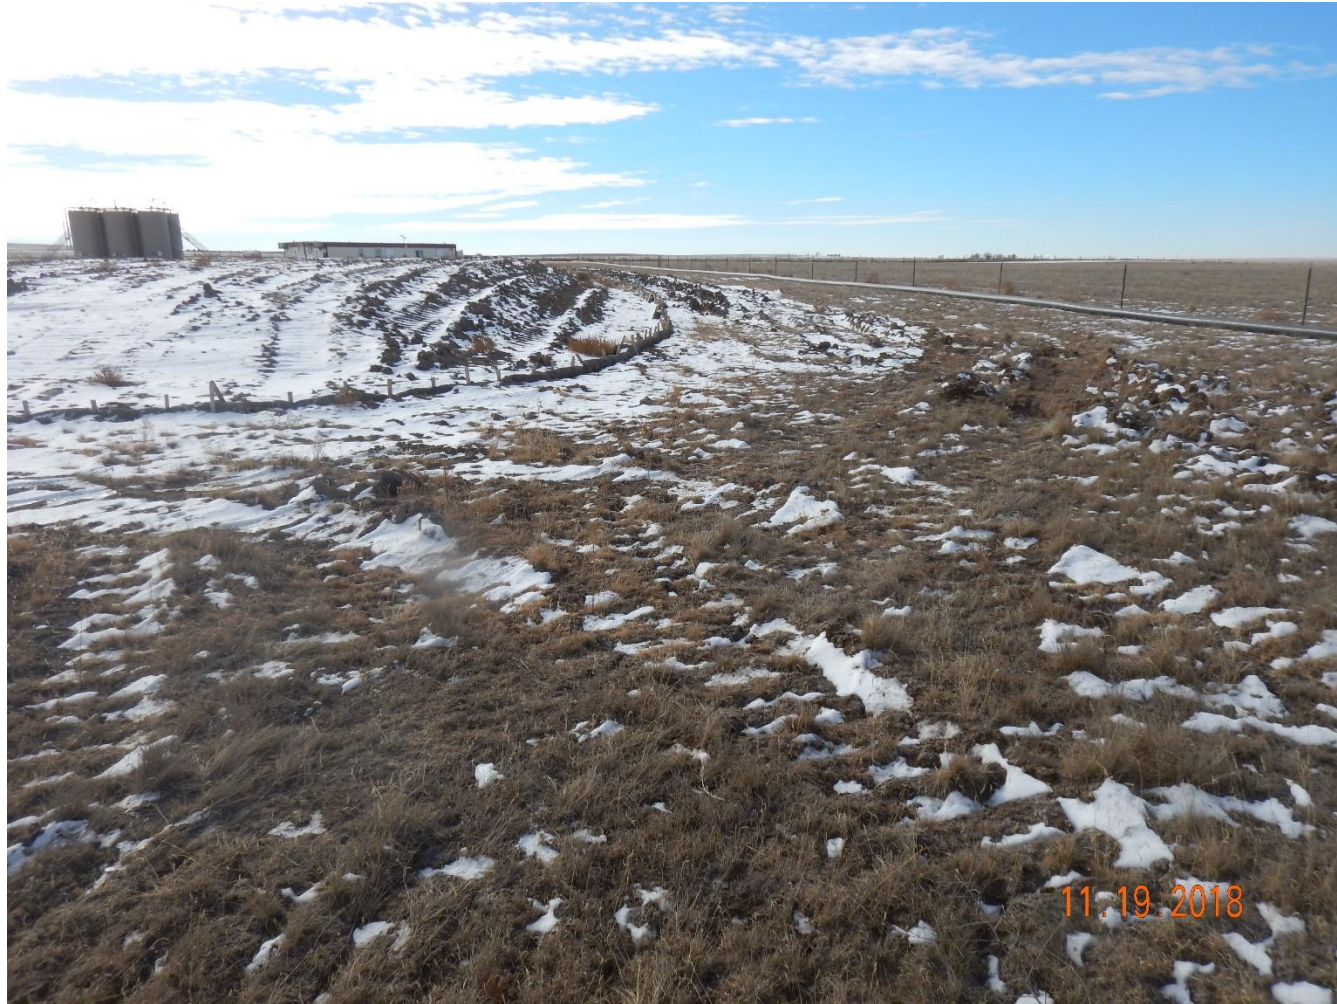
Photo 8: Photo taken from the northwest corner of the pad, facing southwest. Photo shows topsoil stockpile and straw wattle stormwater BMP along the base

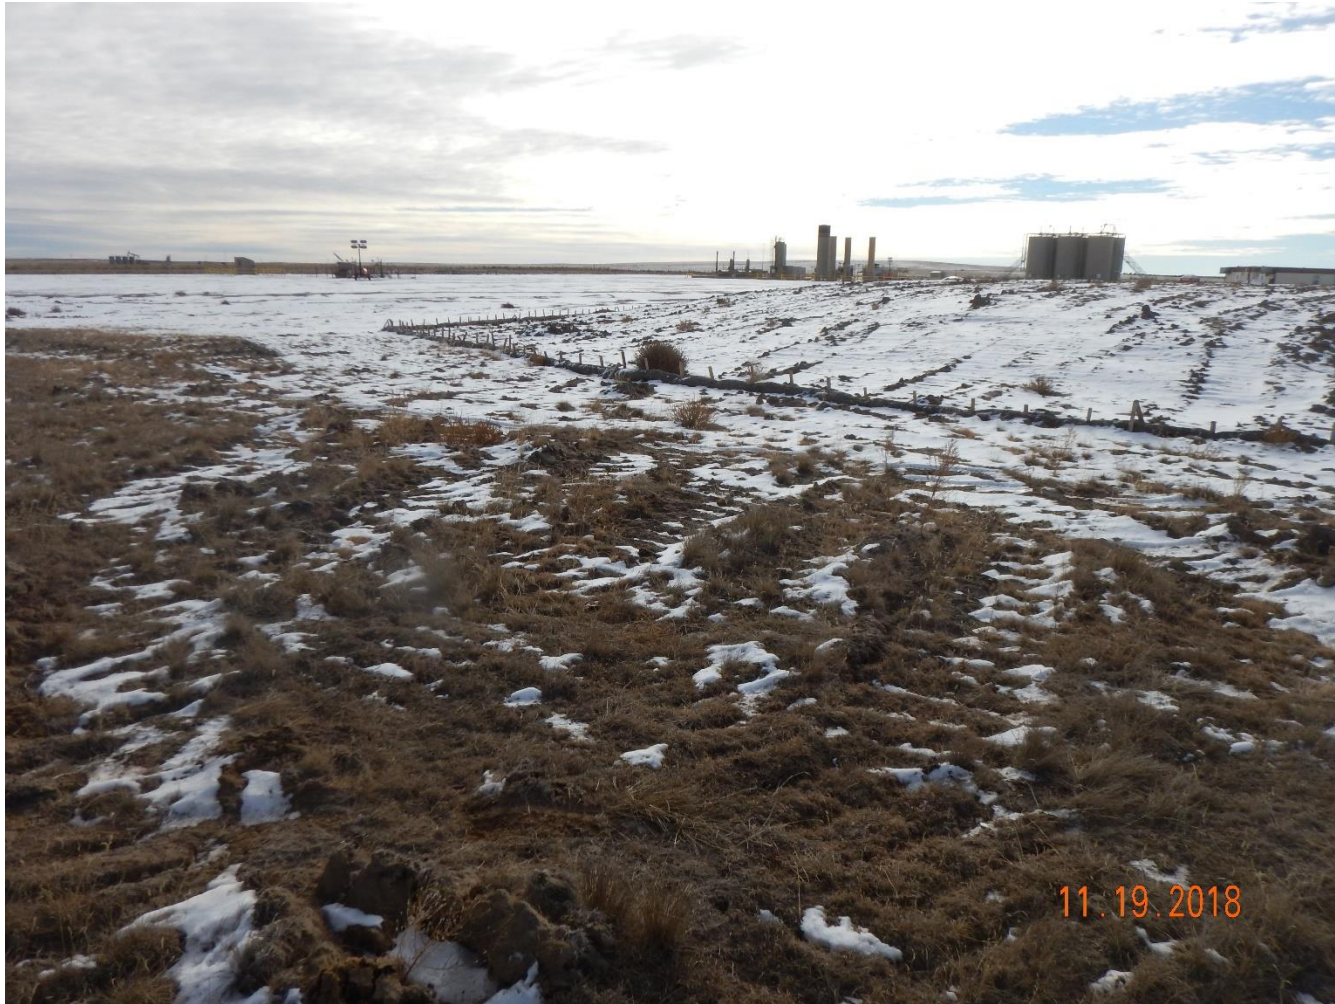
Photo 9: Photo taken from the northwest corner of the pad, facing southeast. Photo shows topsoil stockpile and straw wattle stormwater BMP along the base

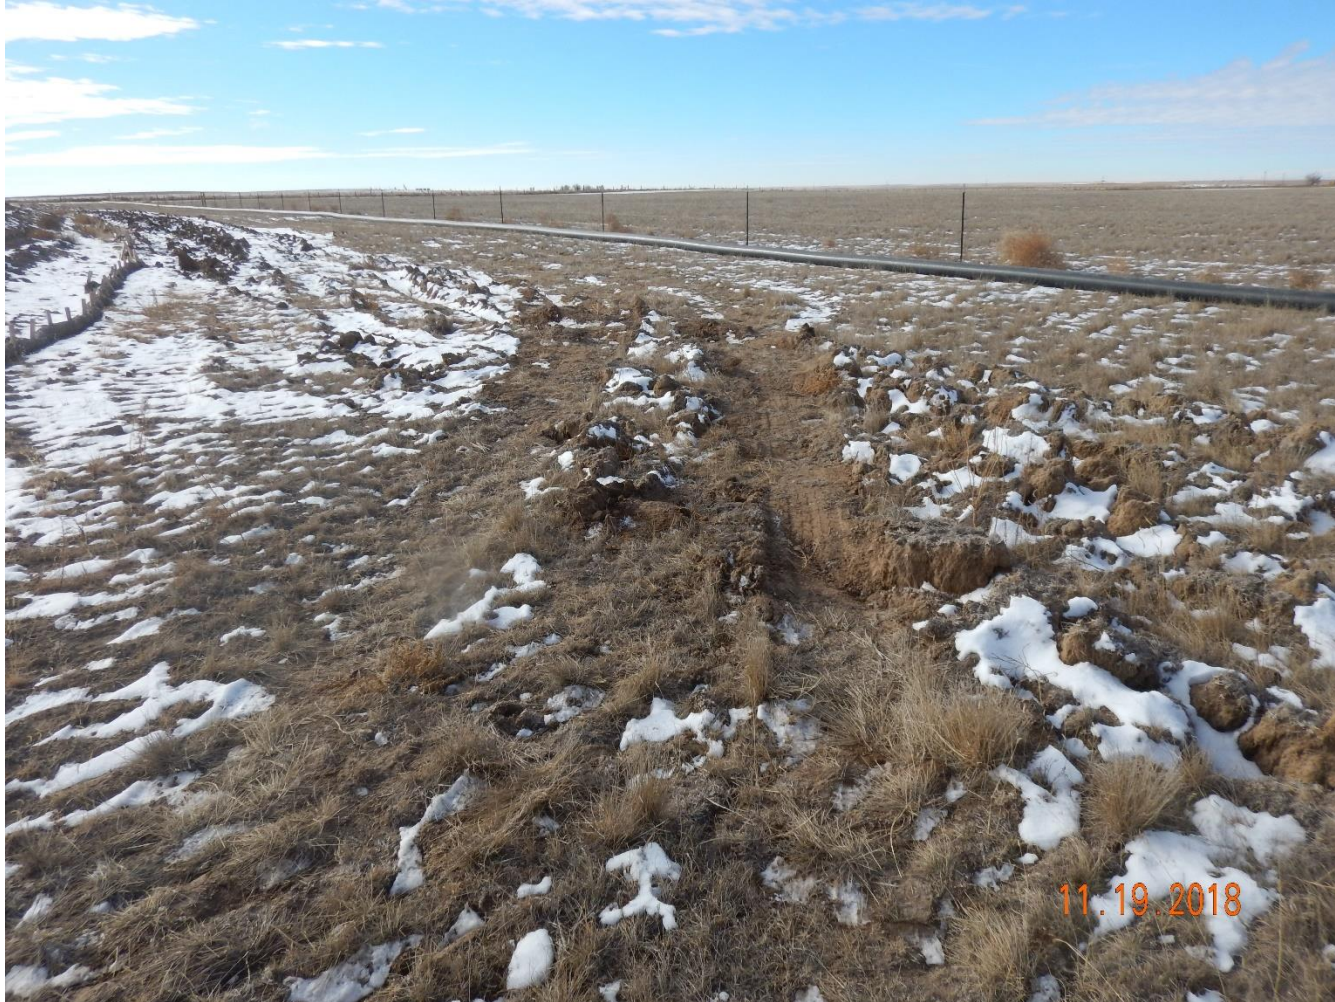
Photo 10: Photo taken from the northwest corner of the pad, facing southwest. Photo shows vehicle traffic appears to have traveled over the surface roughening.

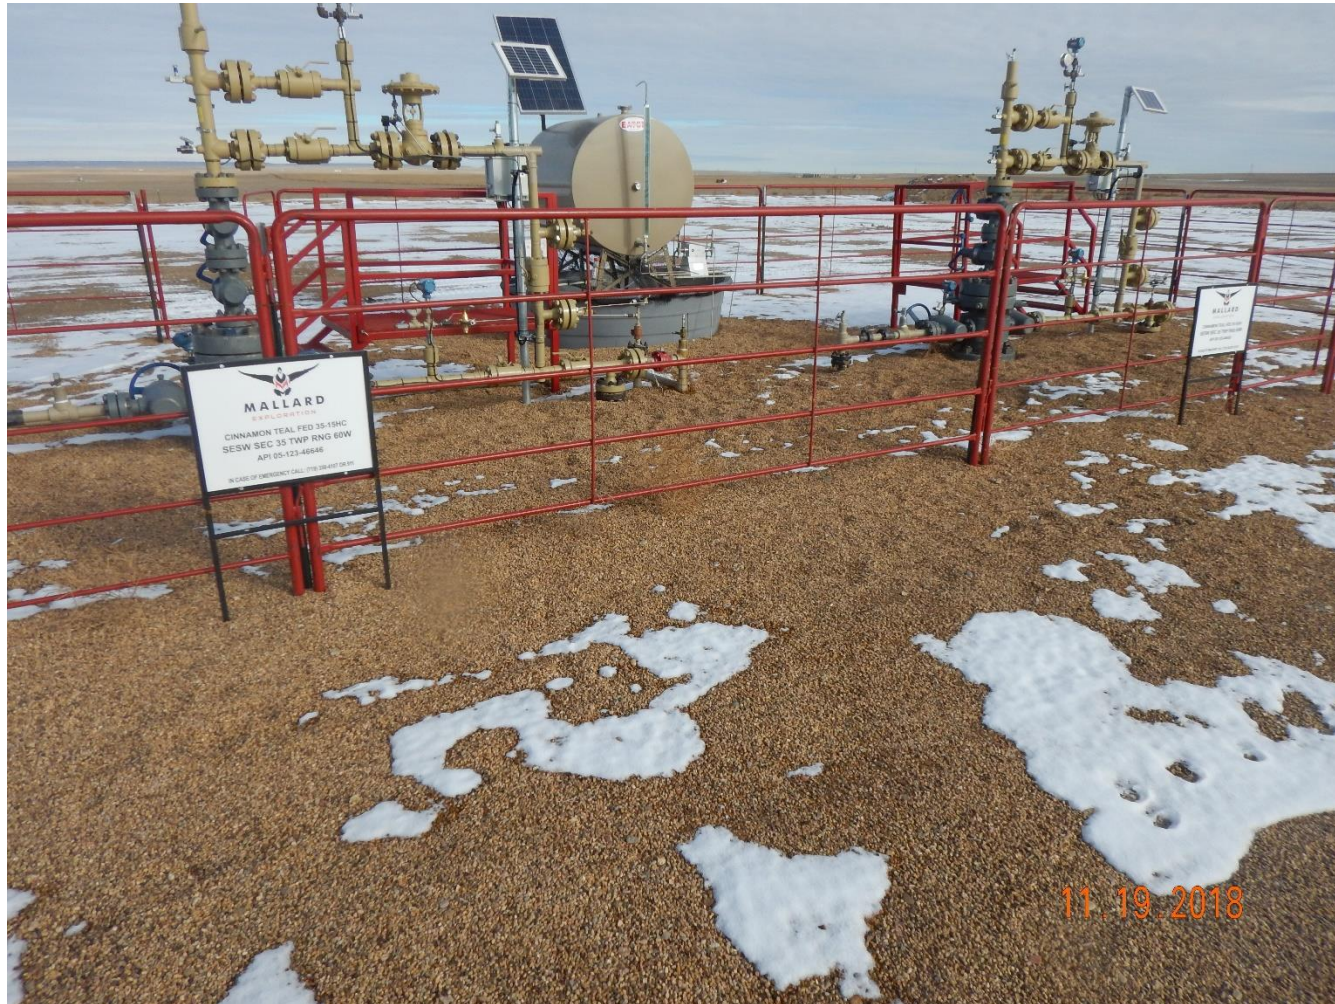
Photo 11: Photo of the two producing wells on the pad.

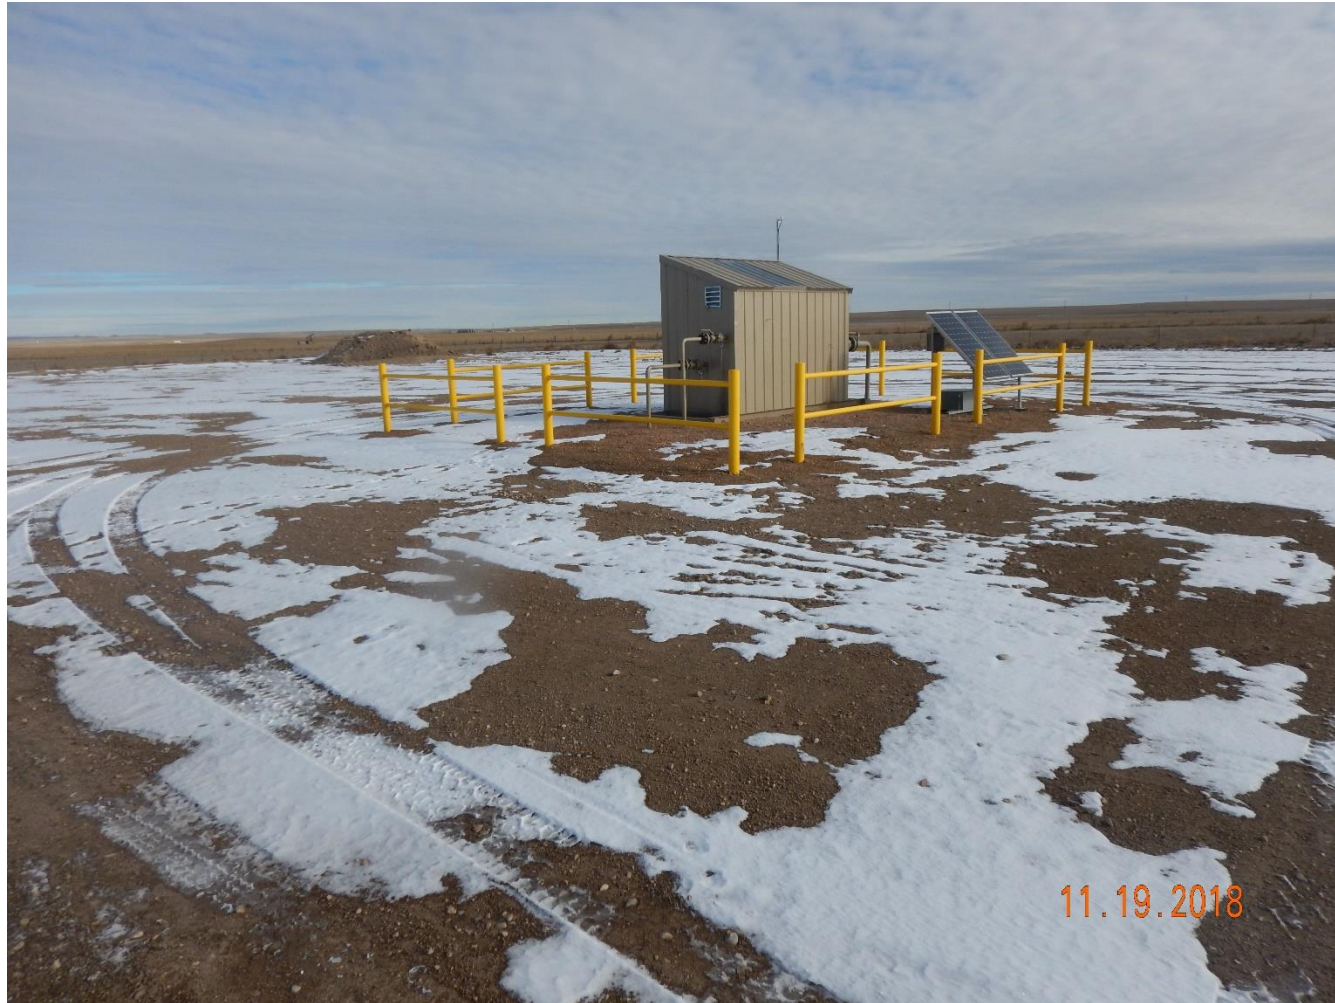
Photo 12: Photo taken from the location, facing west. Photos 12-19 shows equipment/facilities on location.

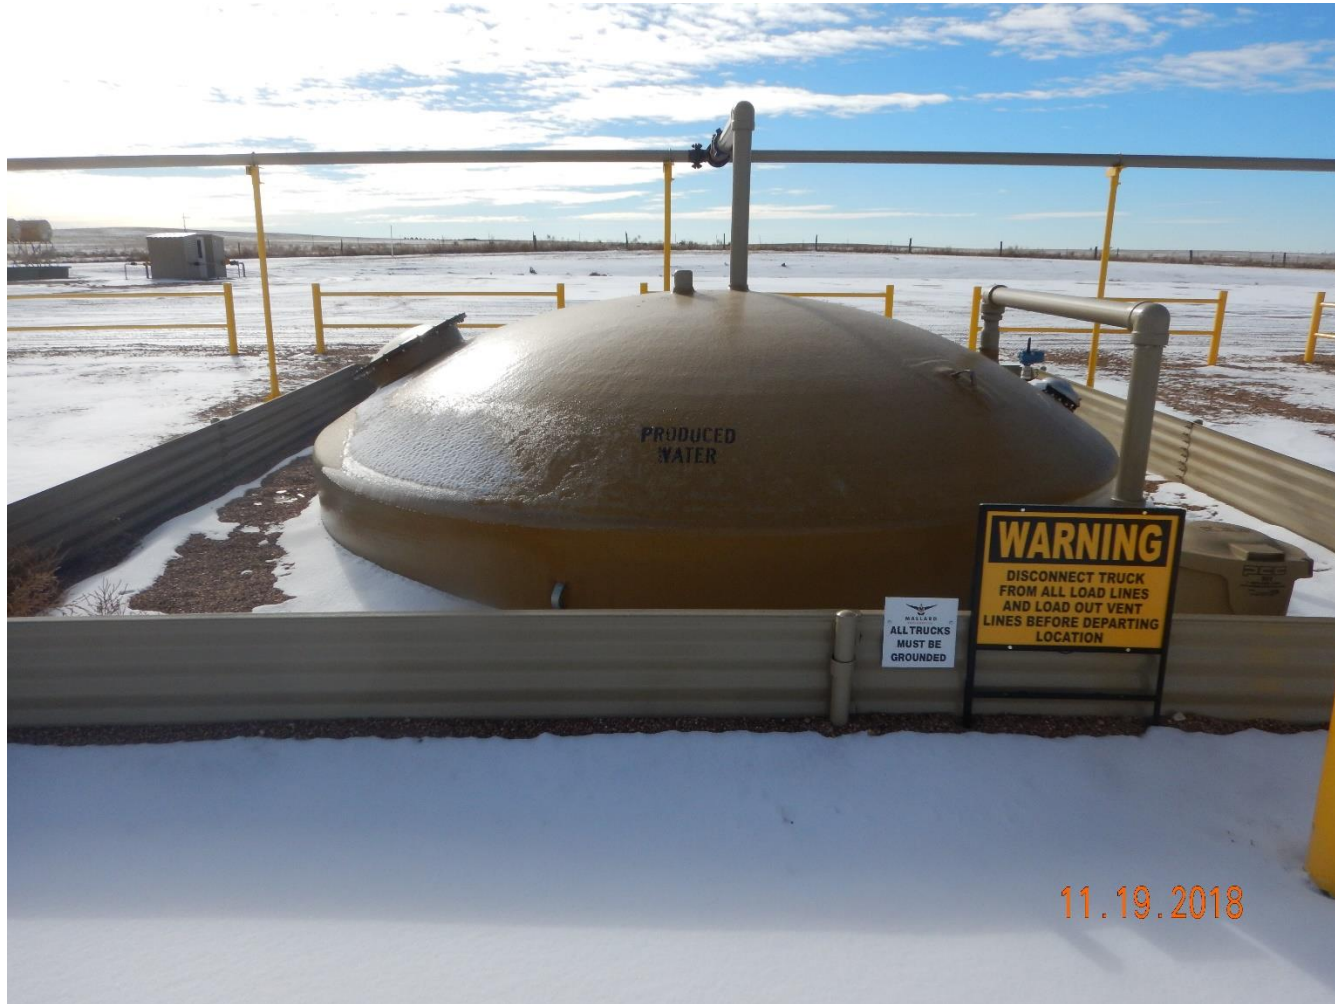
Photo 15: Produced water tank. 210 bbl

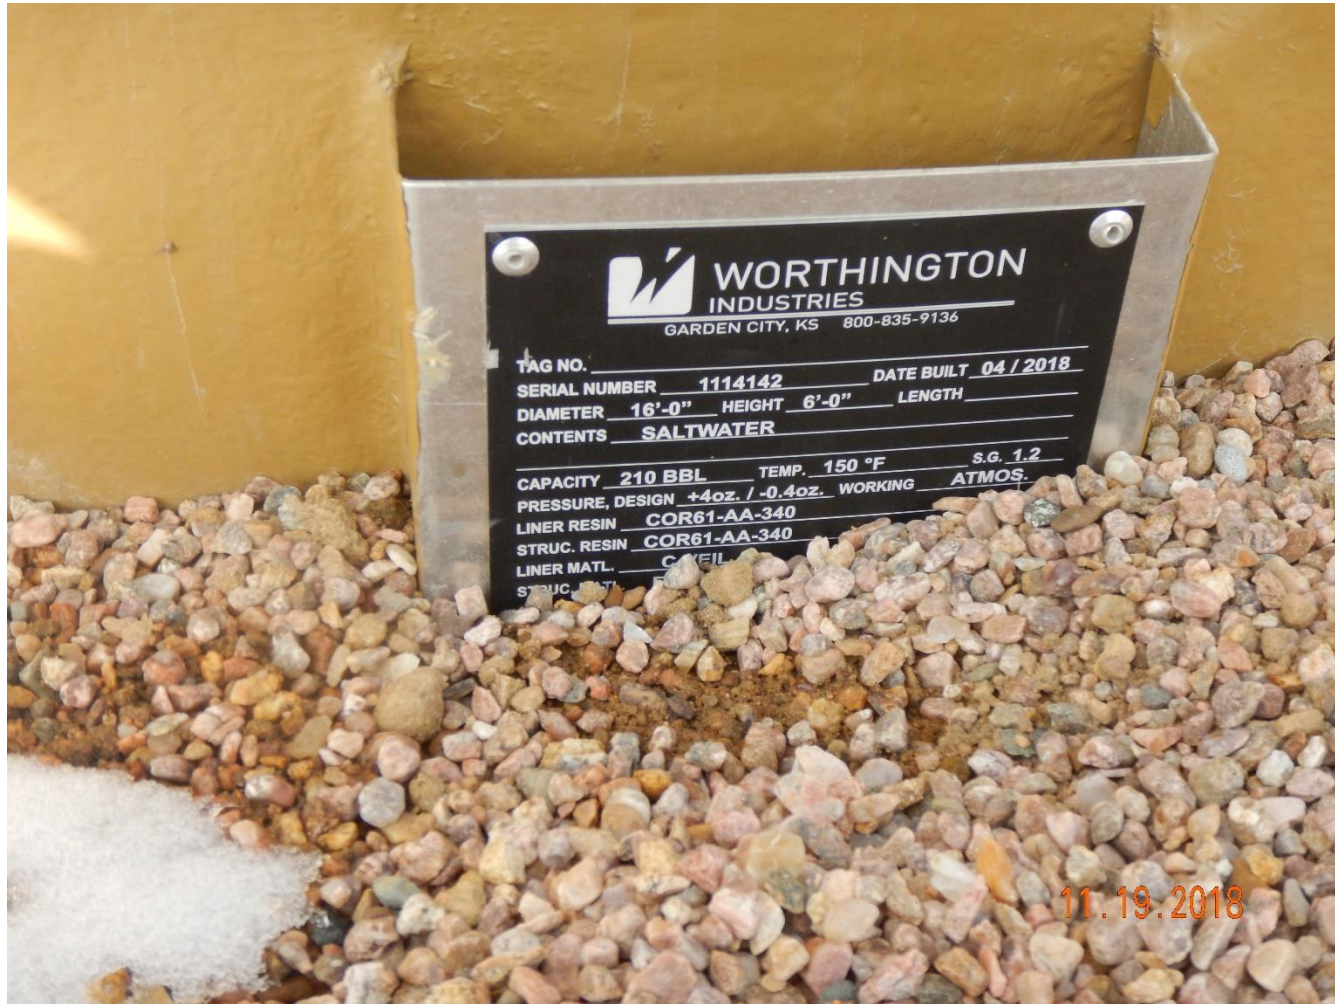
Photo 16: Produced water tank.

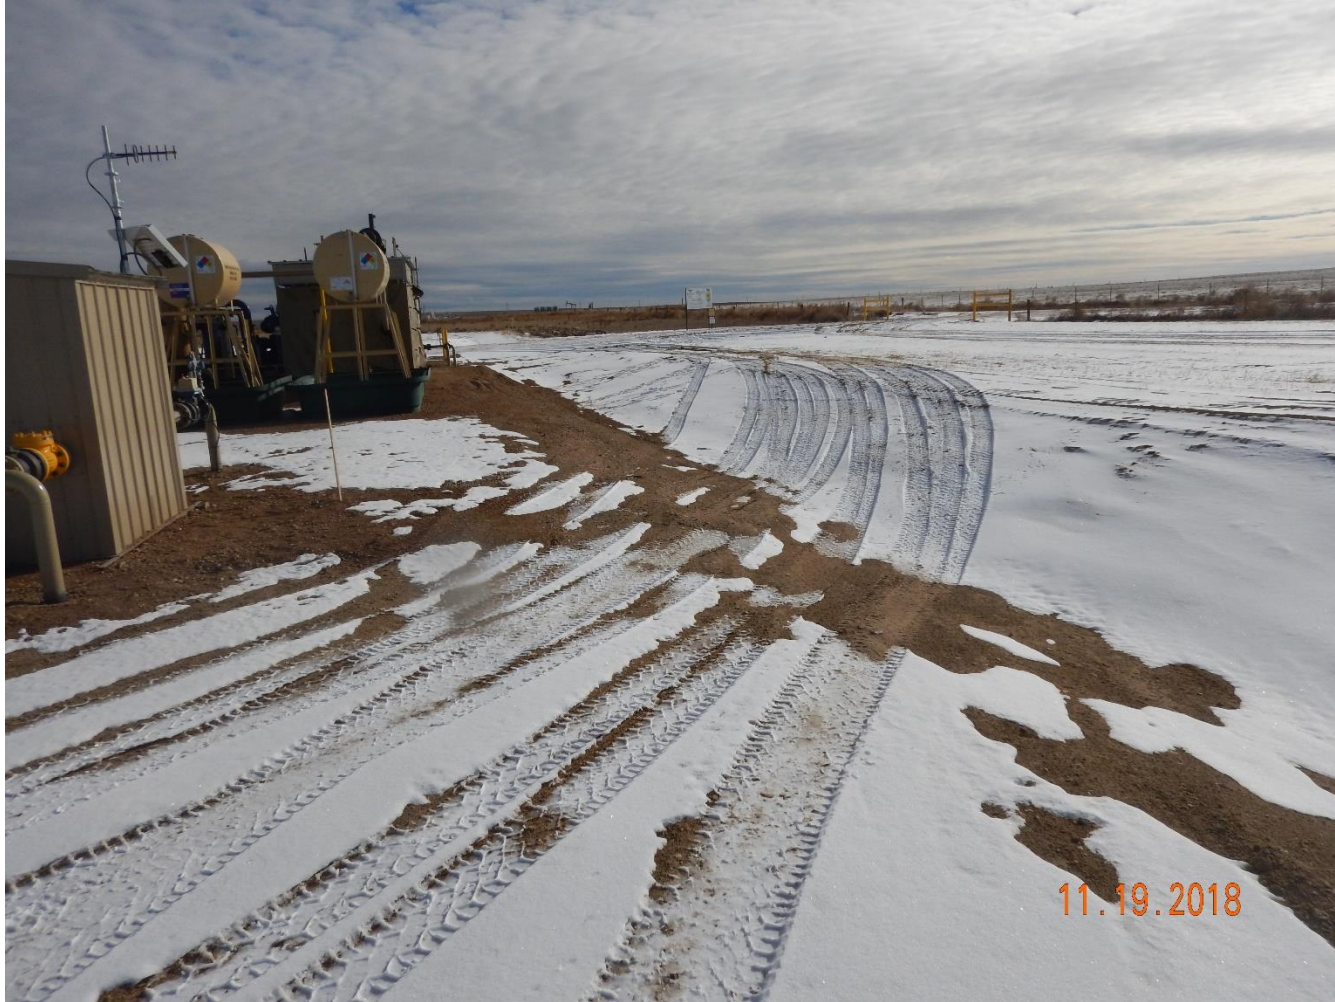
Photo 20: Photo taken from the south end of the location, facing southeast. Photo shows vehicle traffic has been traveling off the pad and over stormwater ditch in order to exit the location. This is not compliant with 1002.e

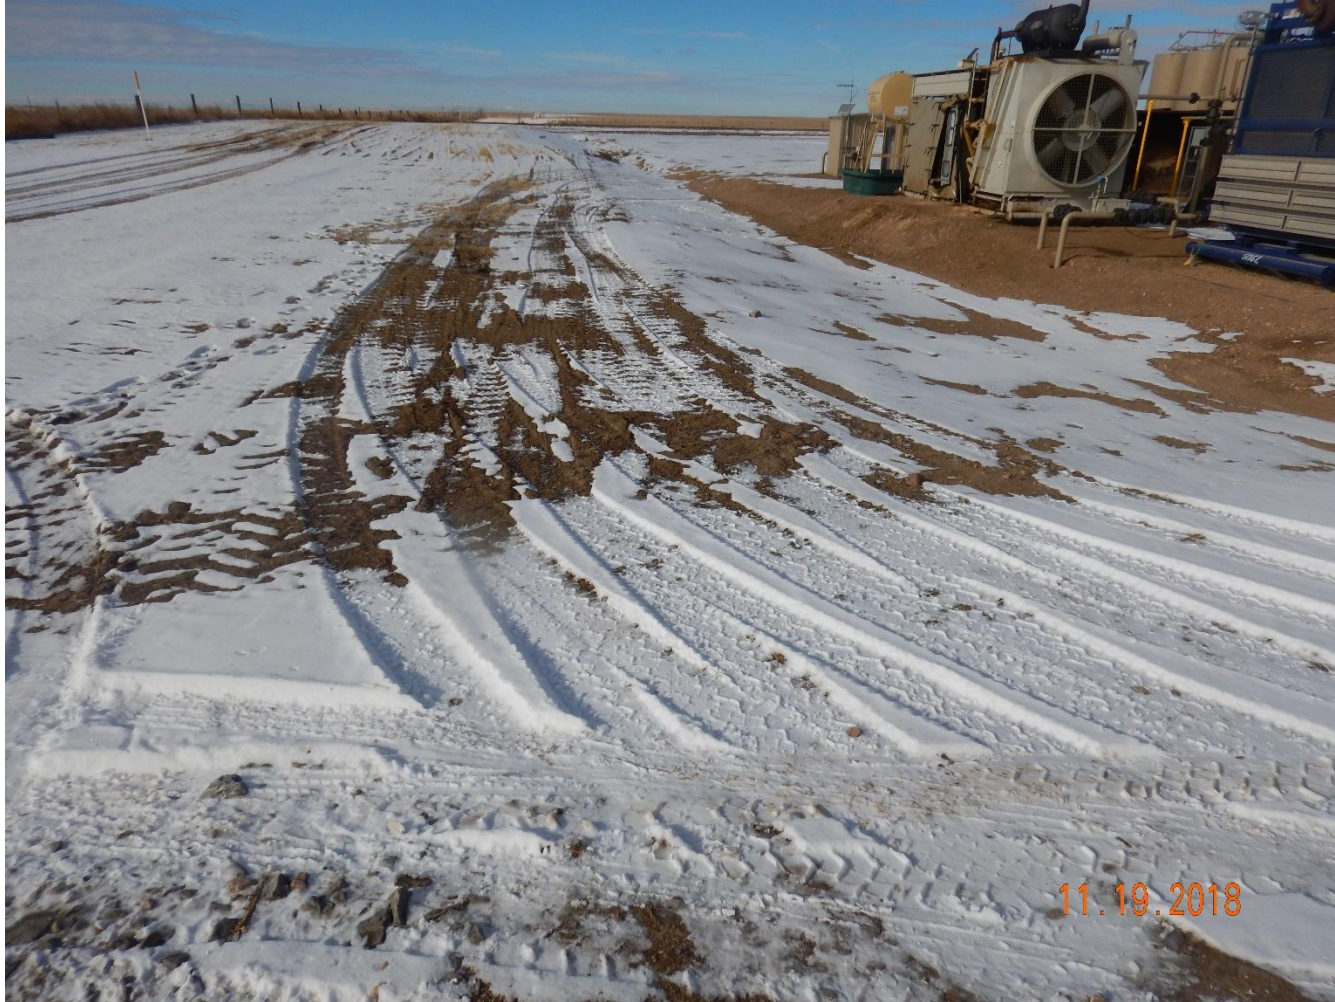
Photo 21: Photo taken from the access road on the south end of the location, facing west. Photo shows vehicle traffic has been traveling off the pad and over stormwater ditch in order to exit the location. This is not compliant with 1002.e
