Inspection Photos

Operator: WESTERN OPERATING COMPANY -
95620

Location ID: 312233

Inspection Doc. Number: 682504211
Logan County, CO

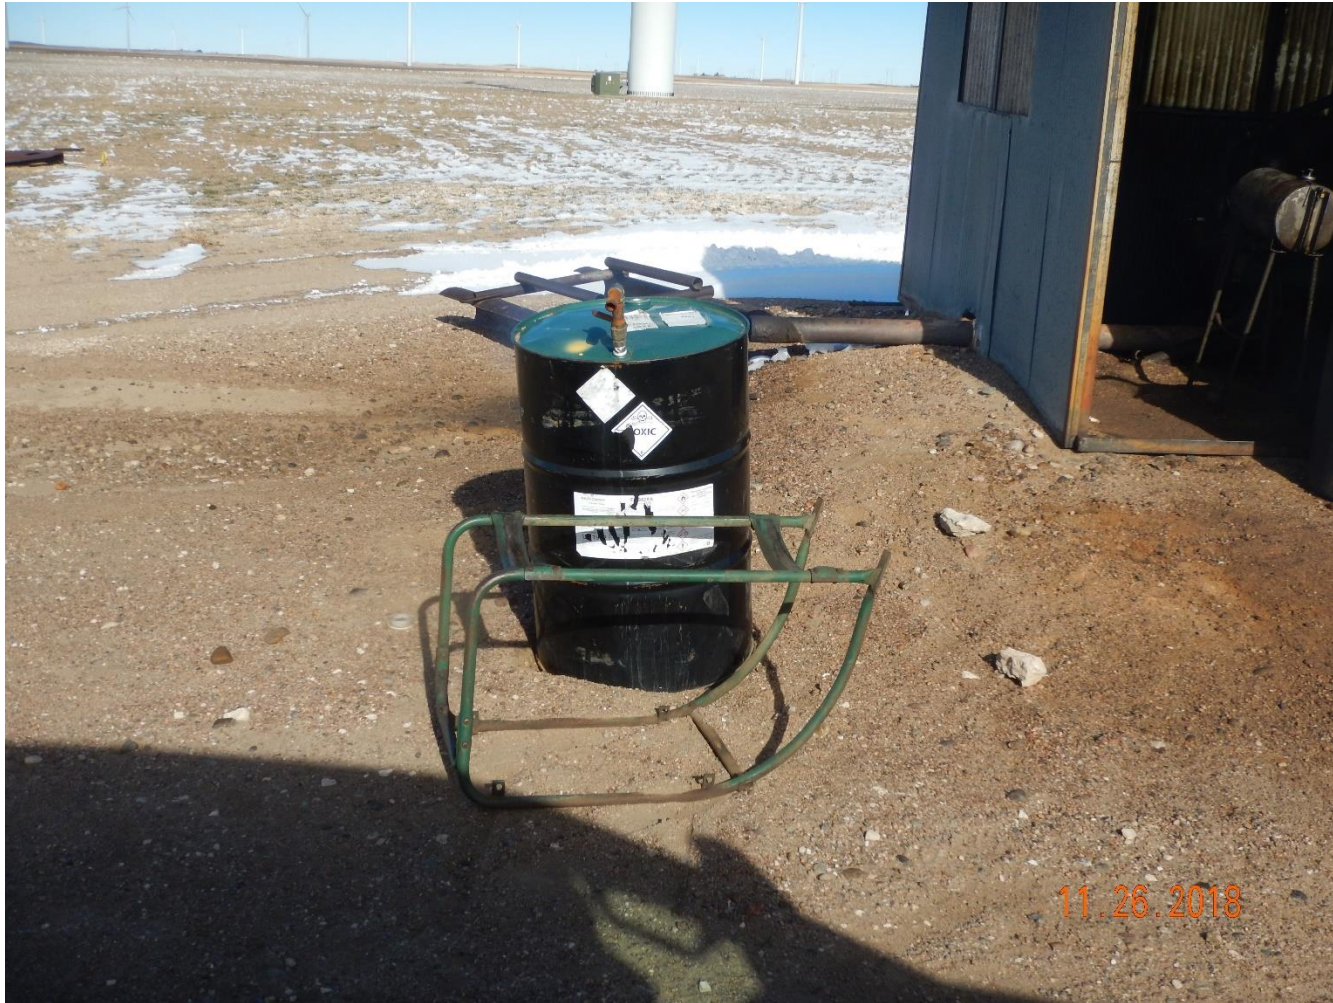
Photo 1: Photo taken from the well facing north. Photo shows one of the two barrels on location that have not been removed or placed into secondary containment.

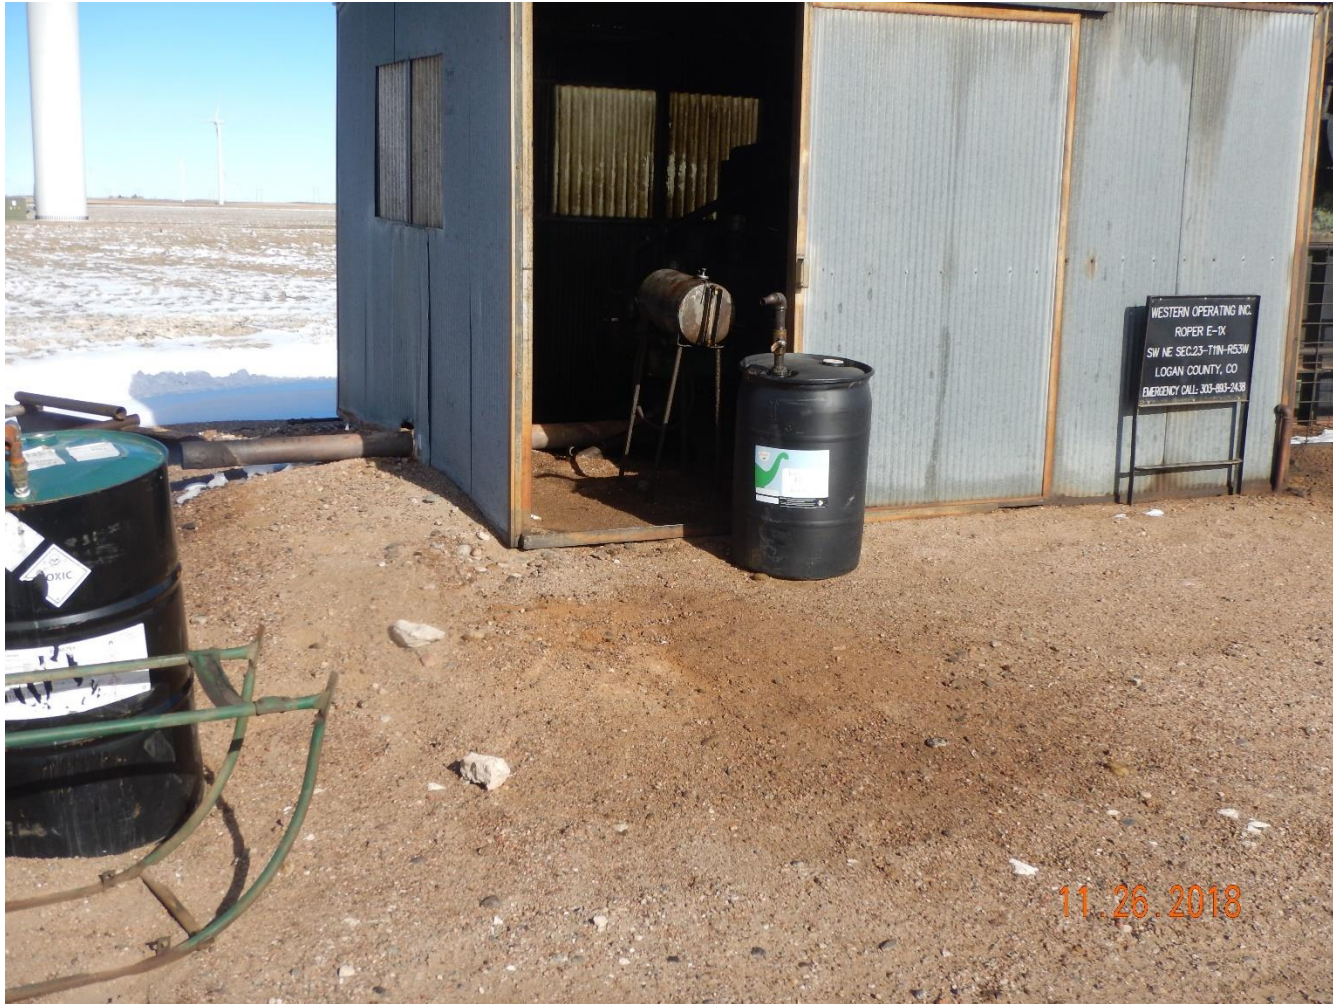
Photo 2: Photo taken from the well facing north. Photo barrels on location that have not been removed or placed into secondary containment.

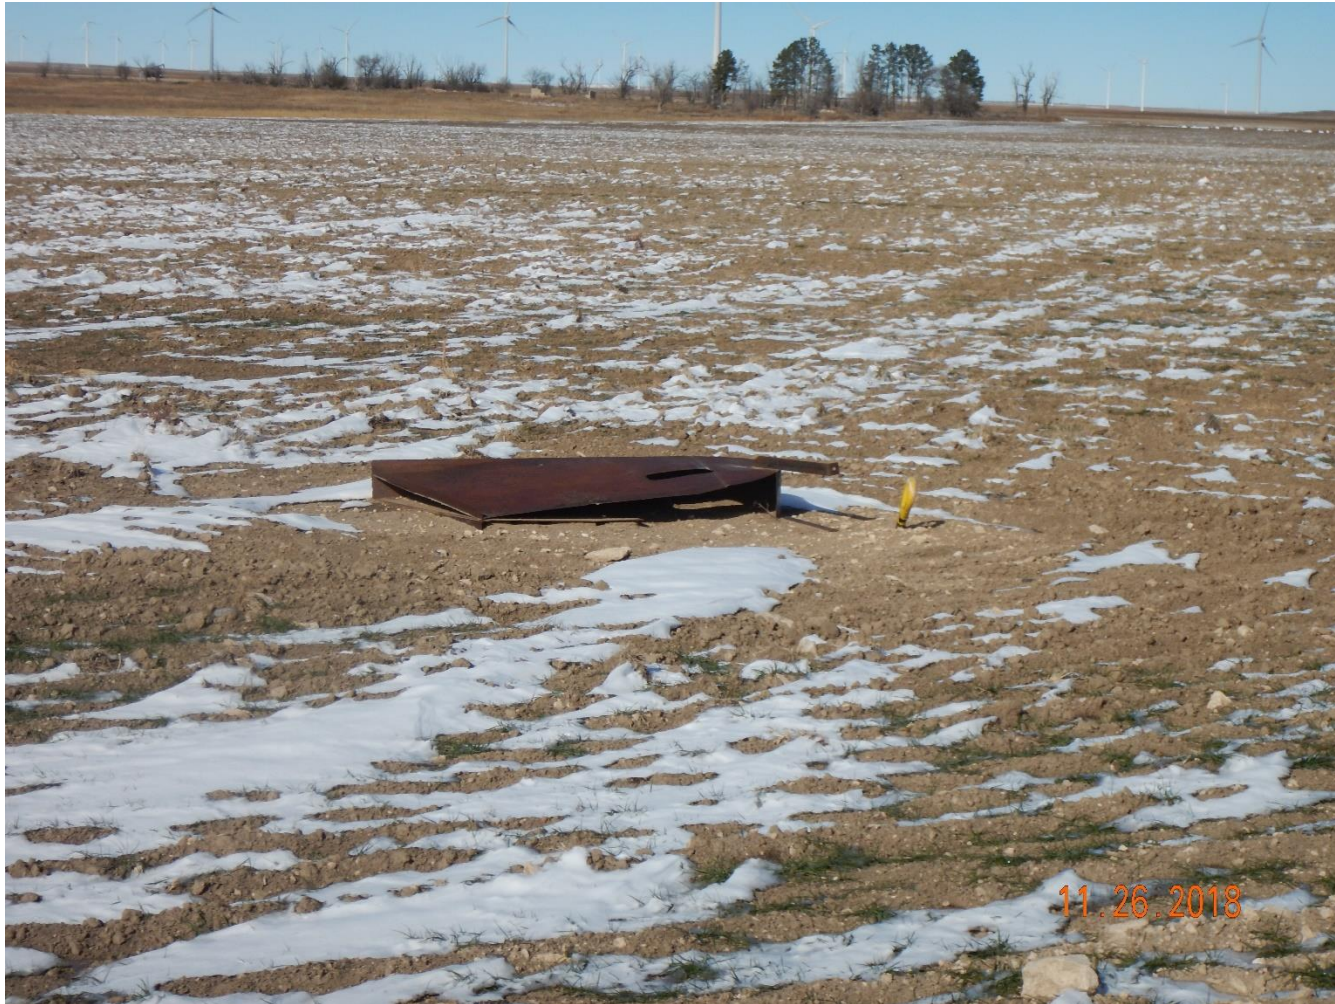
Photo 3: Photo taken from the well location facing northwest. Photo shows northwest anchor is not marked in accordance with 1003.a

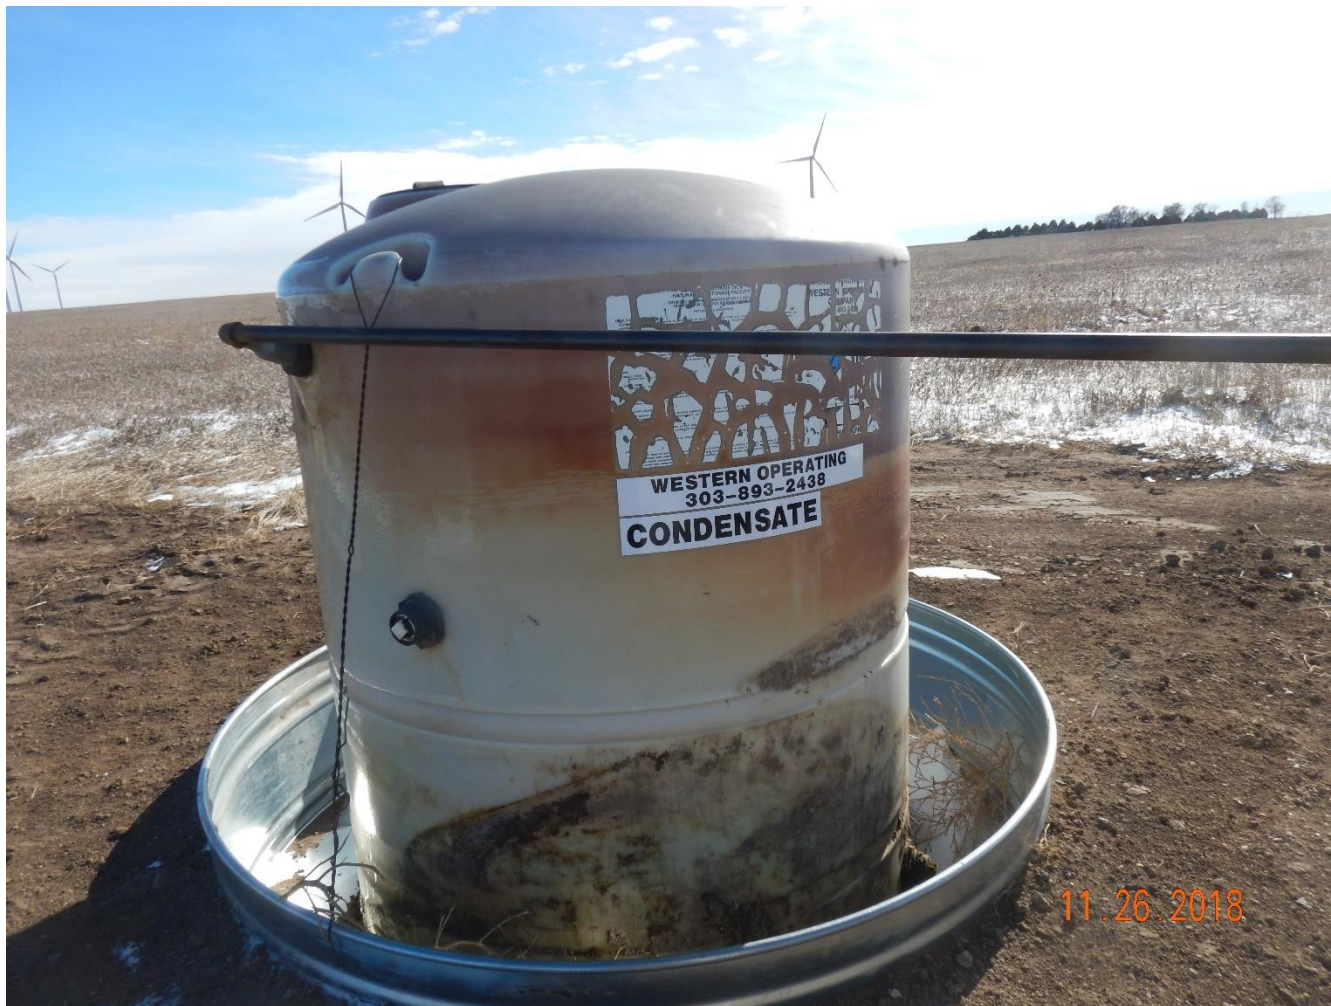
Photo 5: Photo taken from meter shed. Photo shows additional signage has been placed on tank.
