Inspection Photos

Operator: RINCON OPERATING CO - 74660

Location ID: 395295

Inspection Doc. Number: 682504258

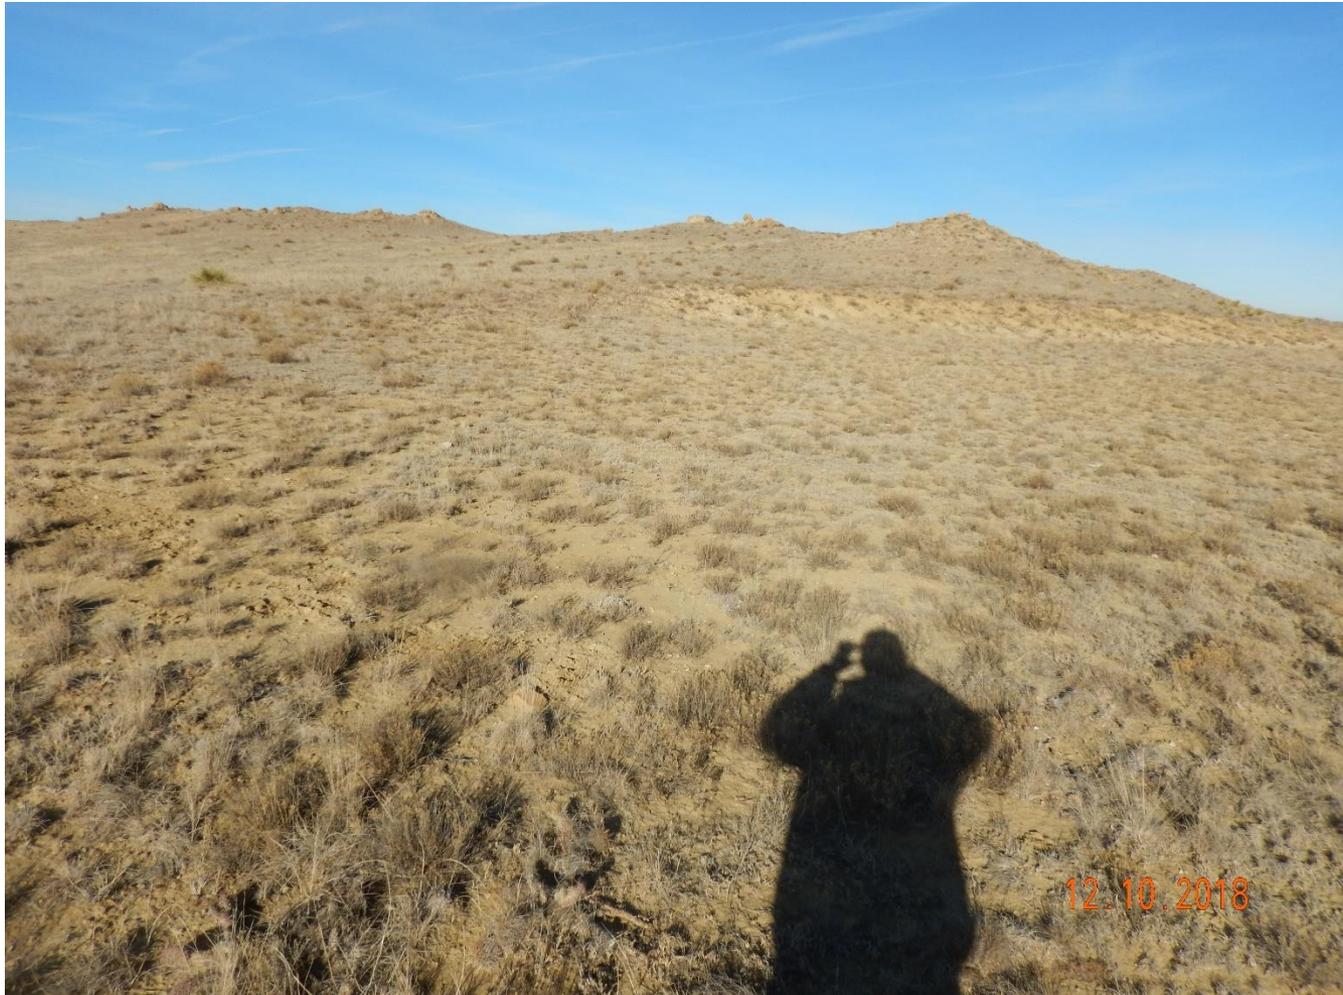
Photo 1: Photo taken from the south end of the location, facing northwest. Photo shows overview of the location. Photo also shows vegetation on the location has not achieved a uniform establishment, and that vegetation has failed to establish on the cut slopes.

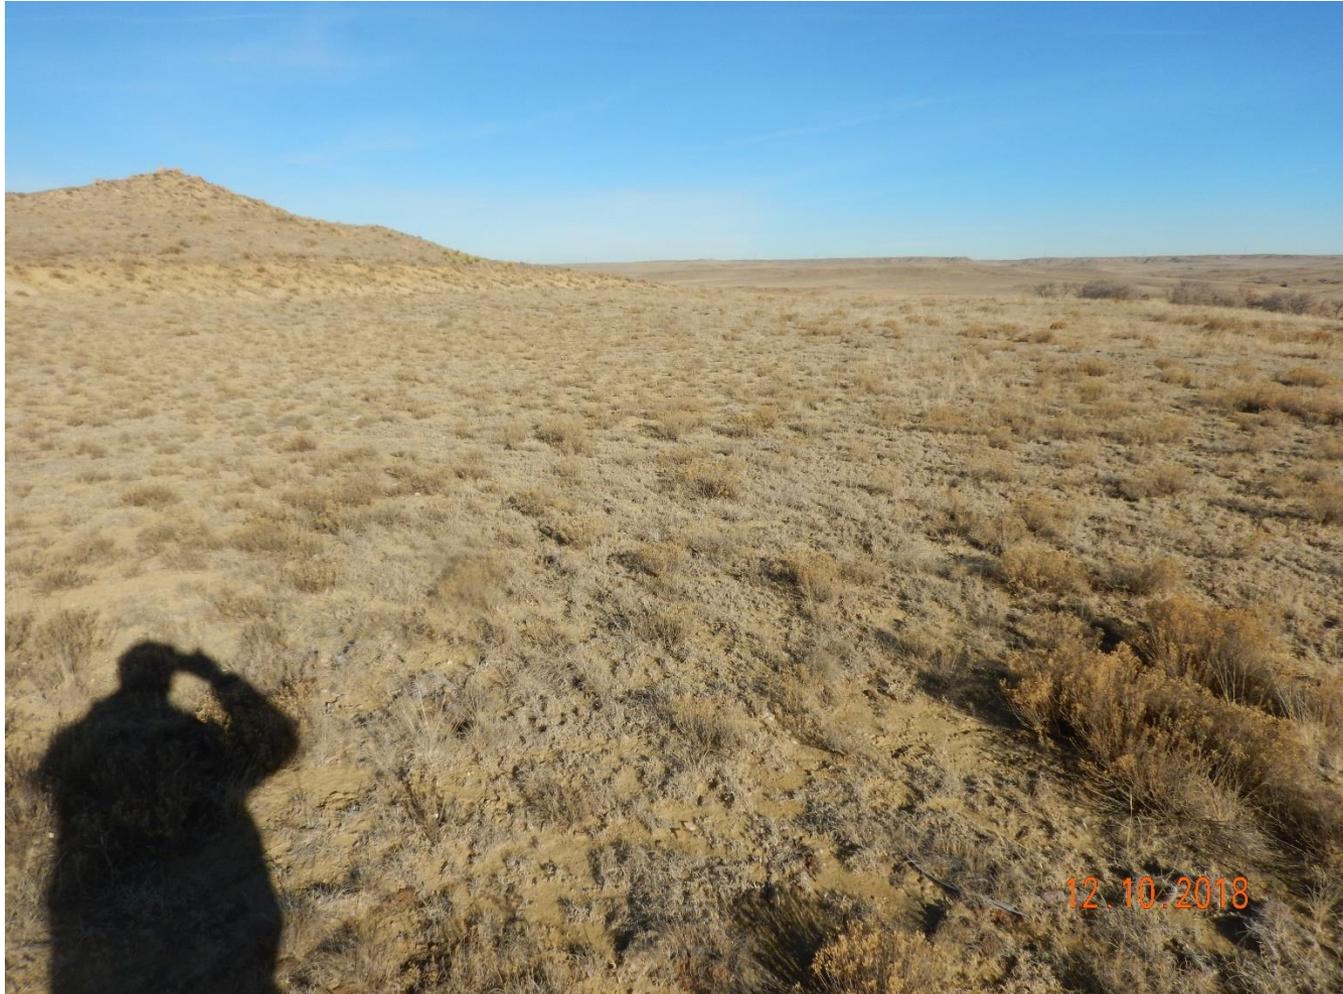
Photo 2: Photo taken from the south end of the location, facing northwest. See comments under photo 1.

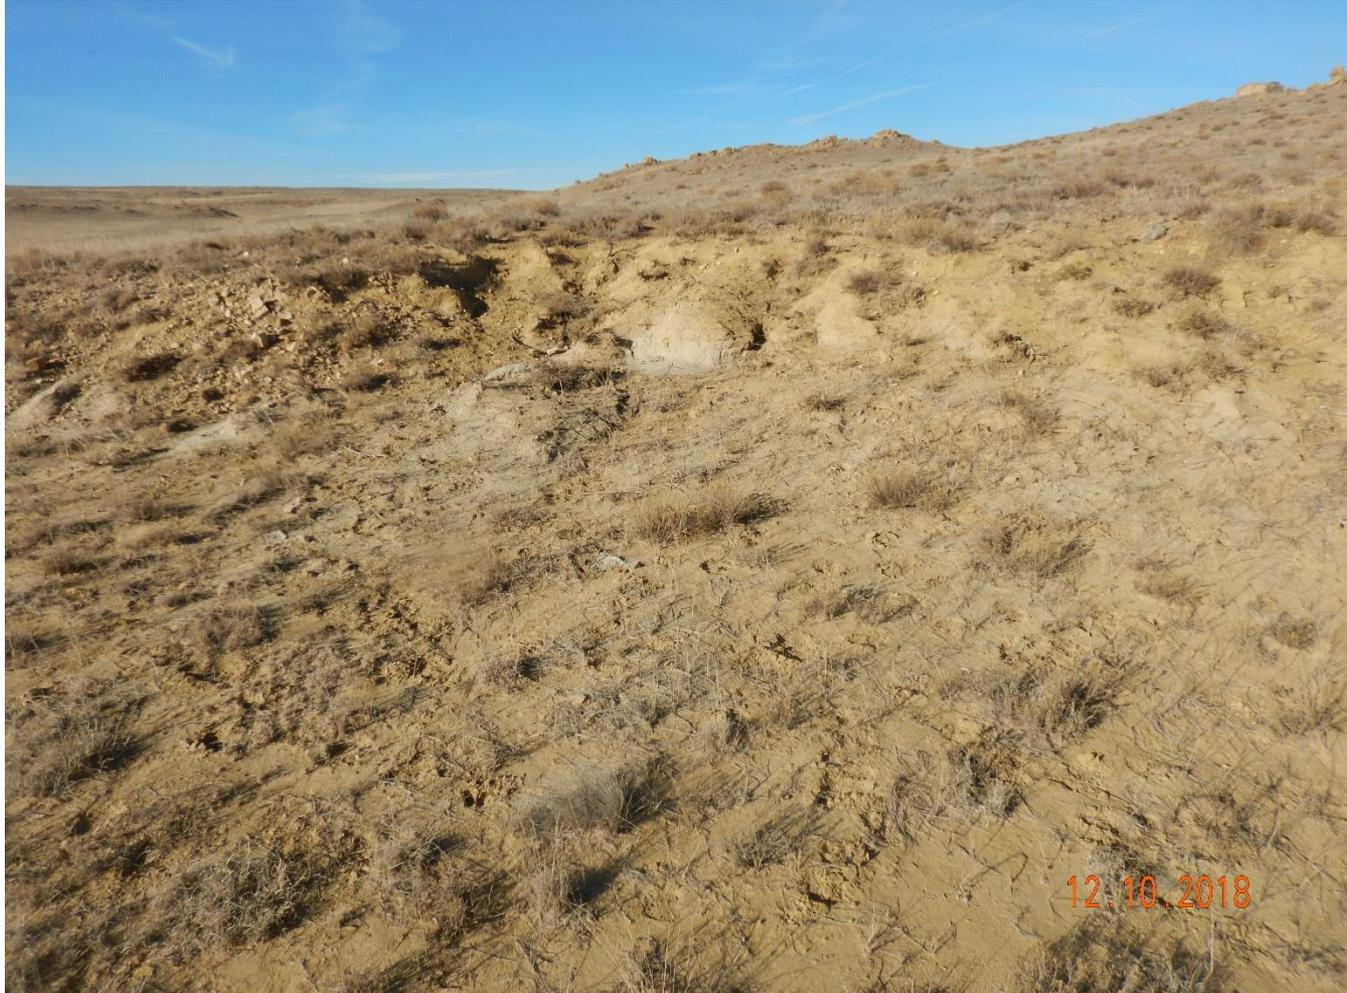
Photo 3: Photo taken from the southwest end of the pad, facing west. Photo shows vegetation has failed to achieve a uniform establishment, and stormwater runoff has caused erosion degradation on the pad.

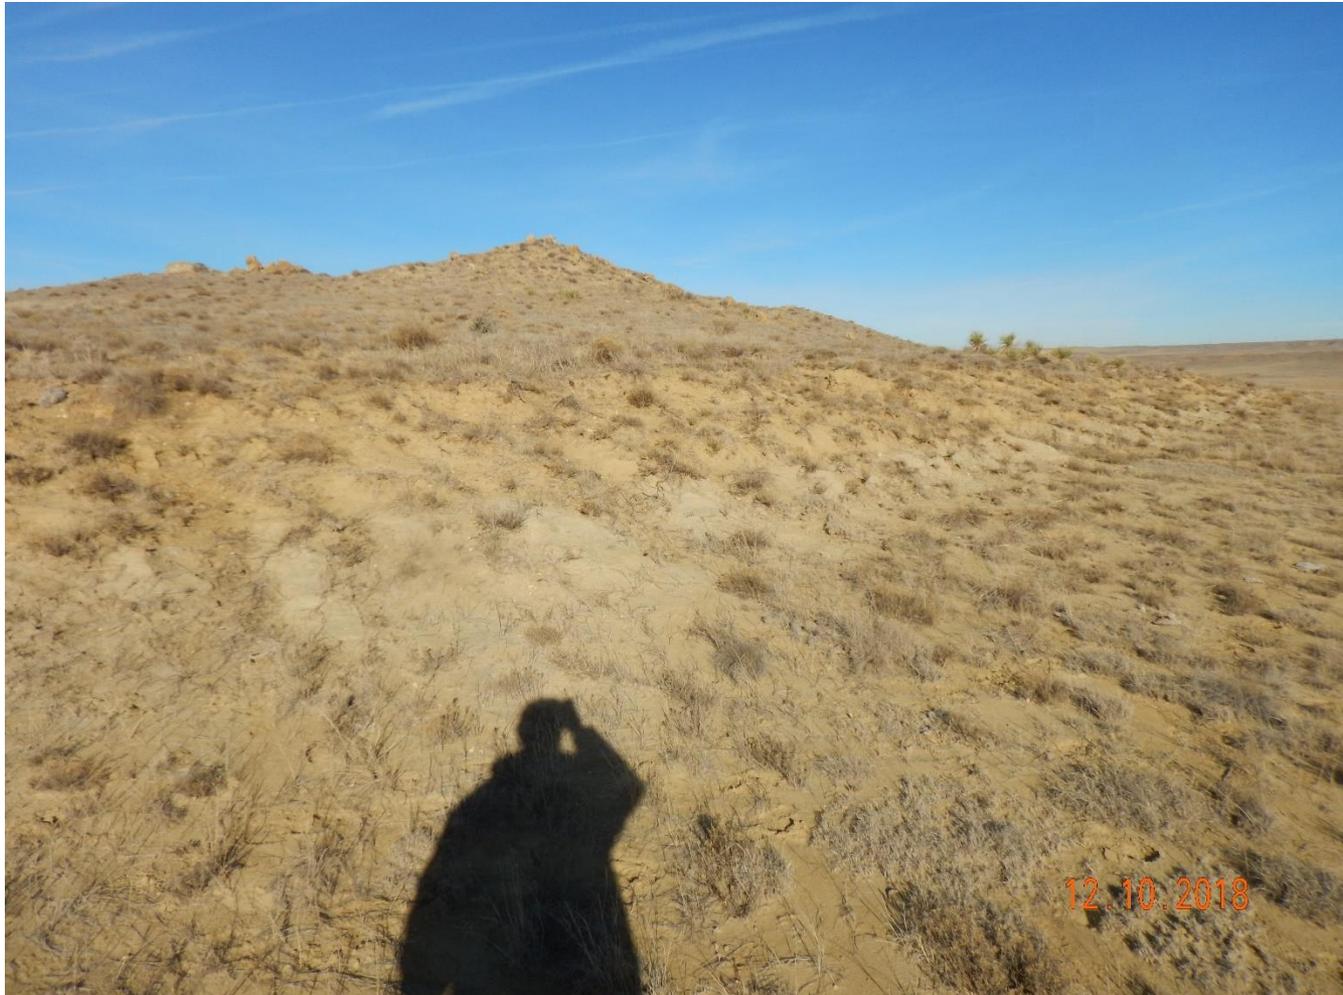
Photo 4: Photo taken from the southwest end of the pad, facing north. Photo shows vegetation has failed to achieve a uniform establishment, and stormwater runoff has caused erosion degradation on the pad.

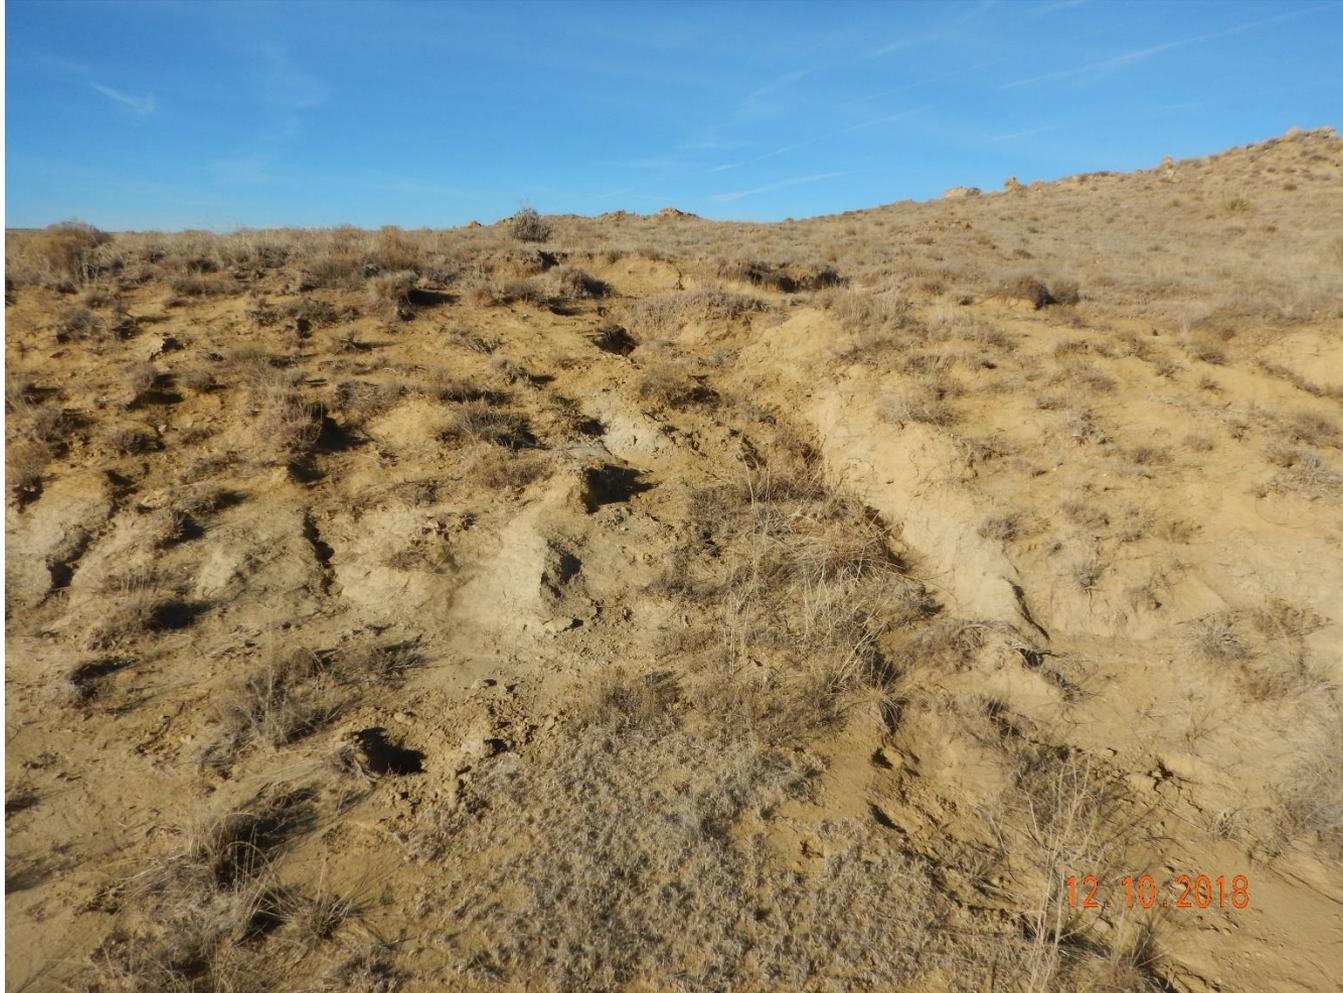
Photo 5: Photo taken from the west end of the pad, facing west. Photo shows vegetation has failed to achieve a uniform establishment, and stormwater runoff has caused erosion degradation on the pad.

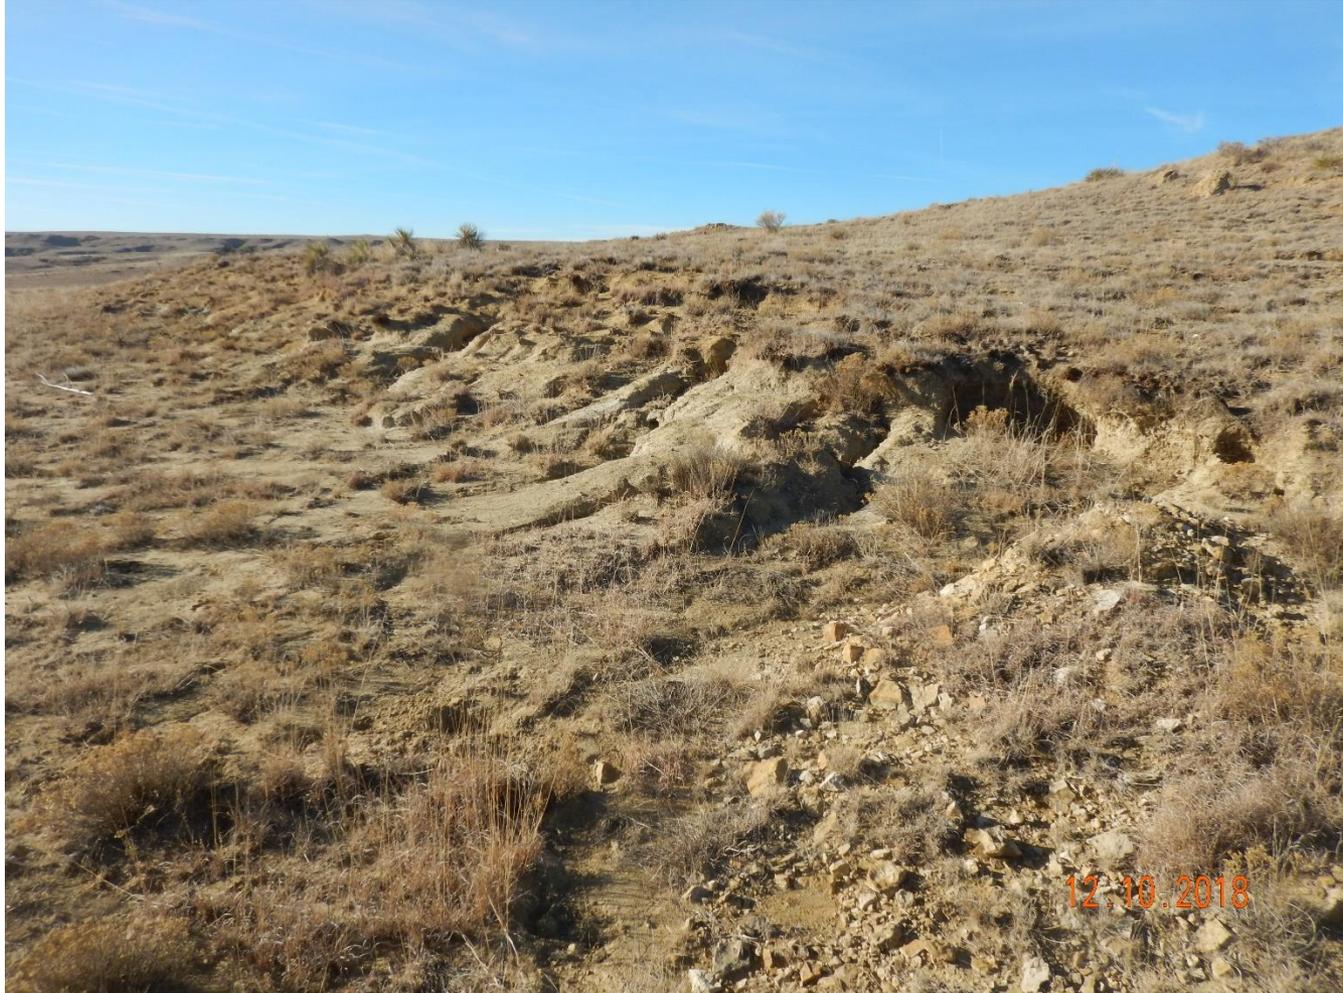
Photo 6: Photo taken from the northwest end of the pad, facing southwest. Photo shows vegetation has failed to achieve a uniform establishment, and stormwater runoff has caused erosion degradation on the pad.

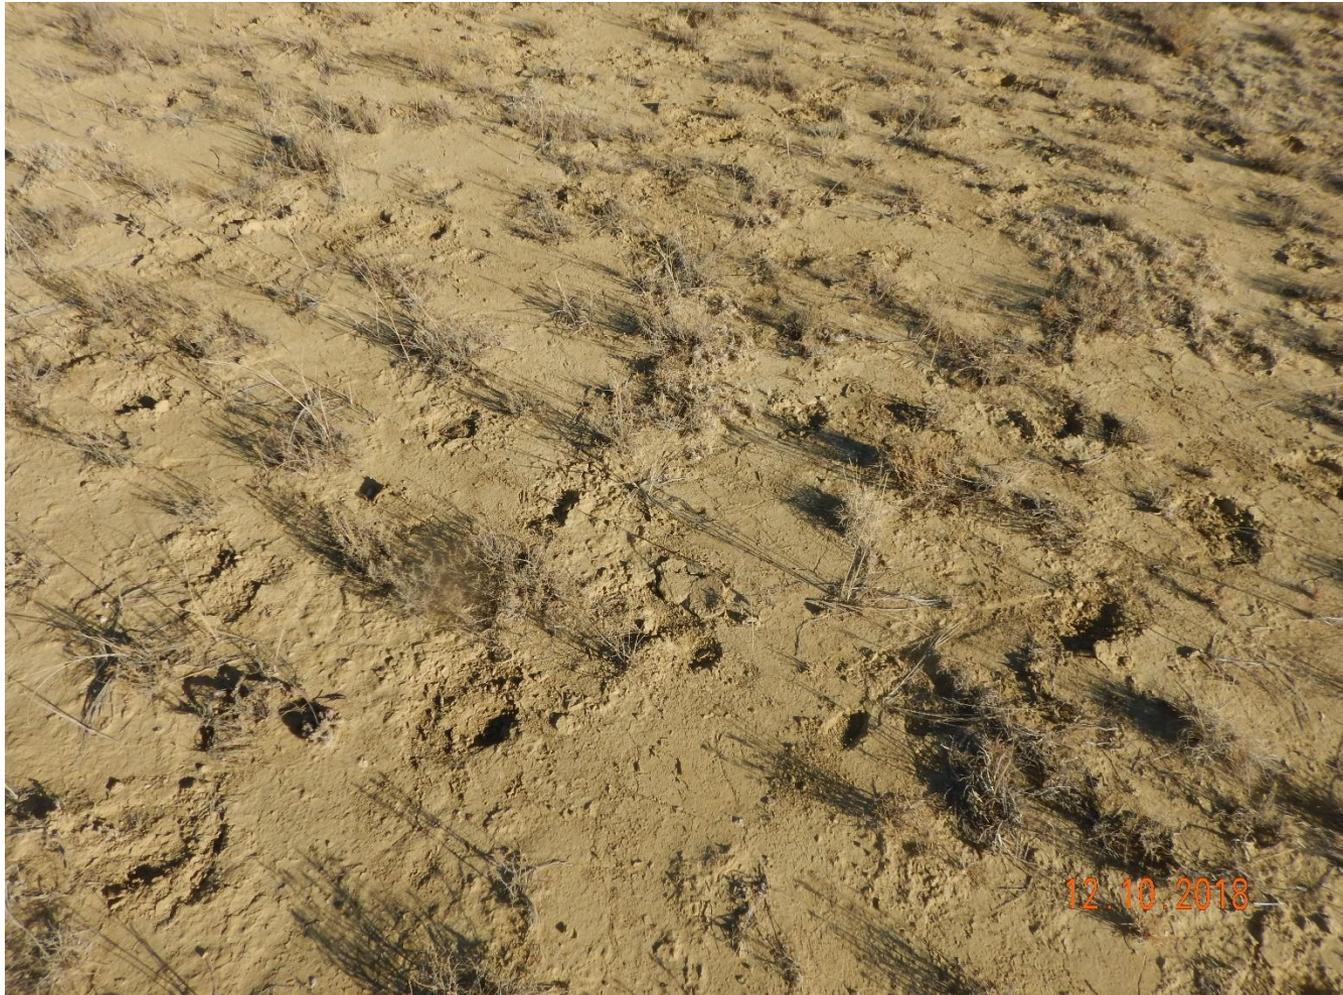
Photo 7: Photo taken from the south end of the pad. Photo shows vegetation has not achieved a uniform establishment in accordance with 1004.a

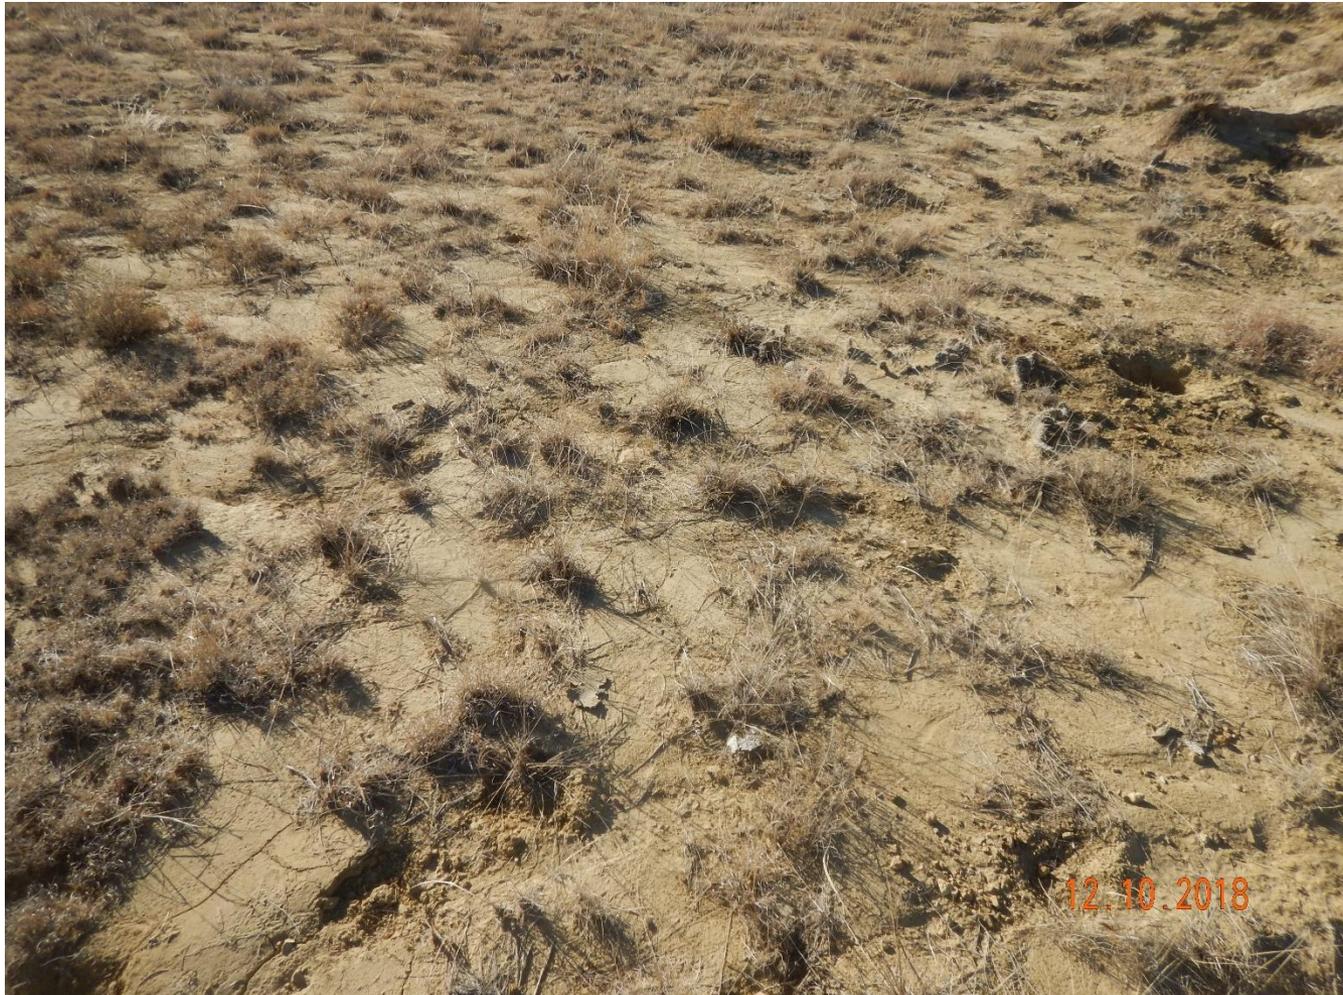
Photo 8: Photo taken from the north end of the pad. Photo shows vegetation has not achieved a uniform establishment in accordance with 1004.a

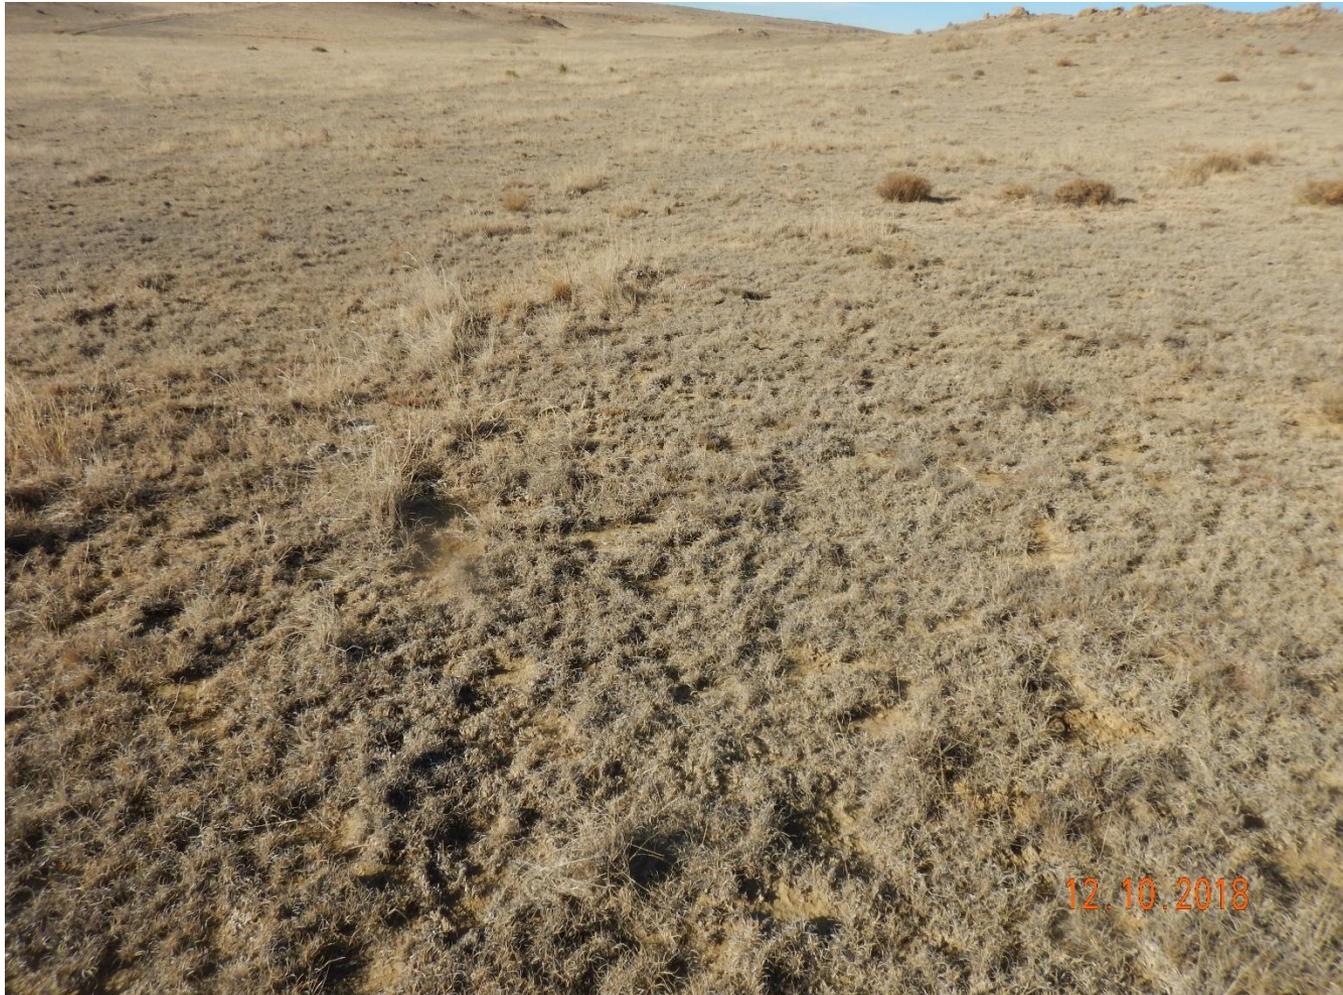
Photo 9: Photo taken from the adjacent reference area. Photo shows reference vegetation for compare/contrast to vegetation on pad.
