# Inspection Photos

Operator: DAVIS OIL COMPANY - 22900

Location ID: 381816

Inspection Doc. Number: 682504277

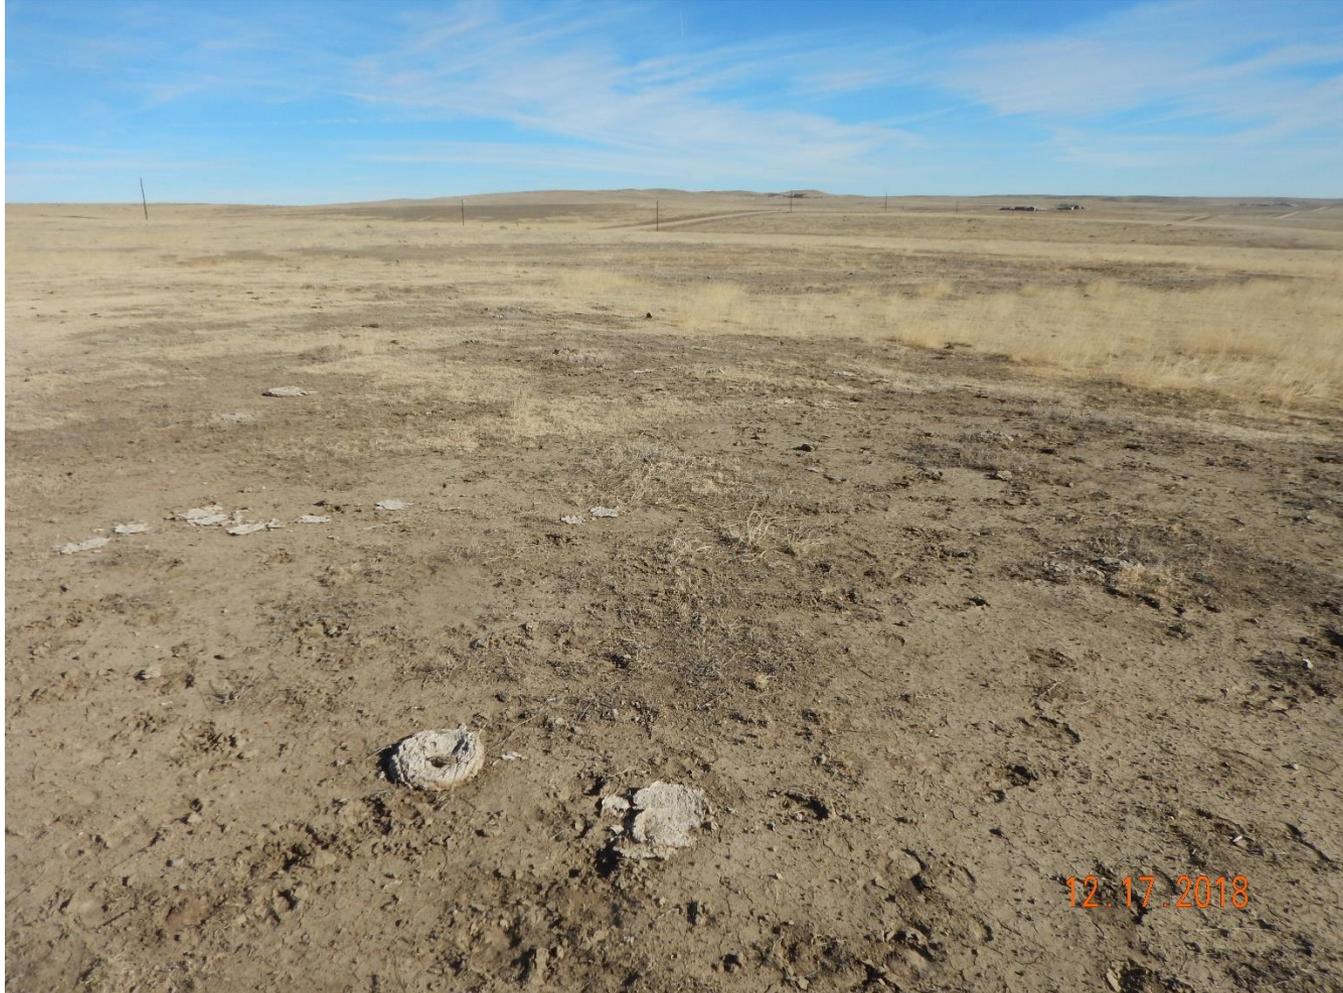
**Photo 1:** Photo taken from the south end of the well location, facing northeast. Photo shows well location (foreground) and the former pit (background) remains predominantly bare and exposed soil. Sundry doc. #1494774 indicates additional reclamation work was conducted in 2005, including reseeding.

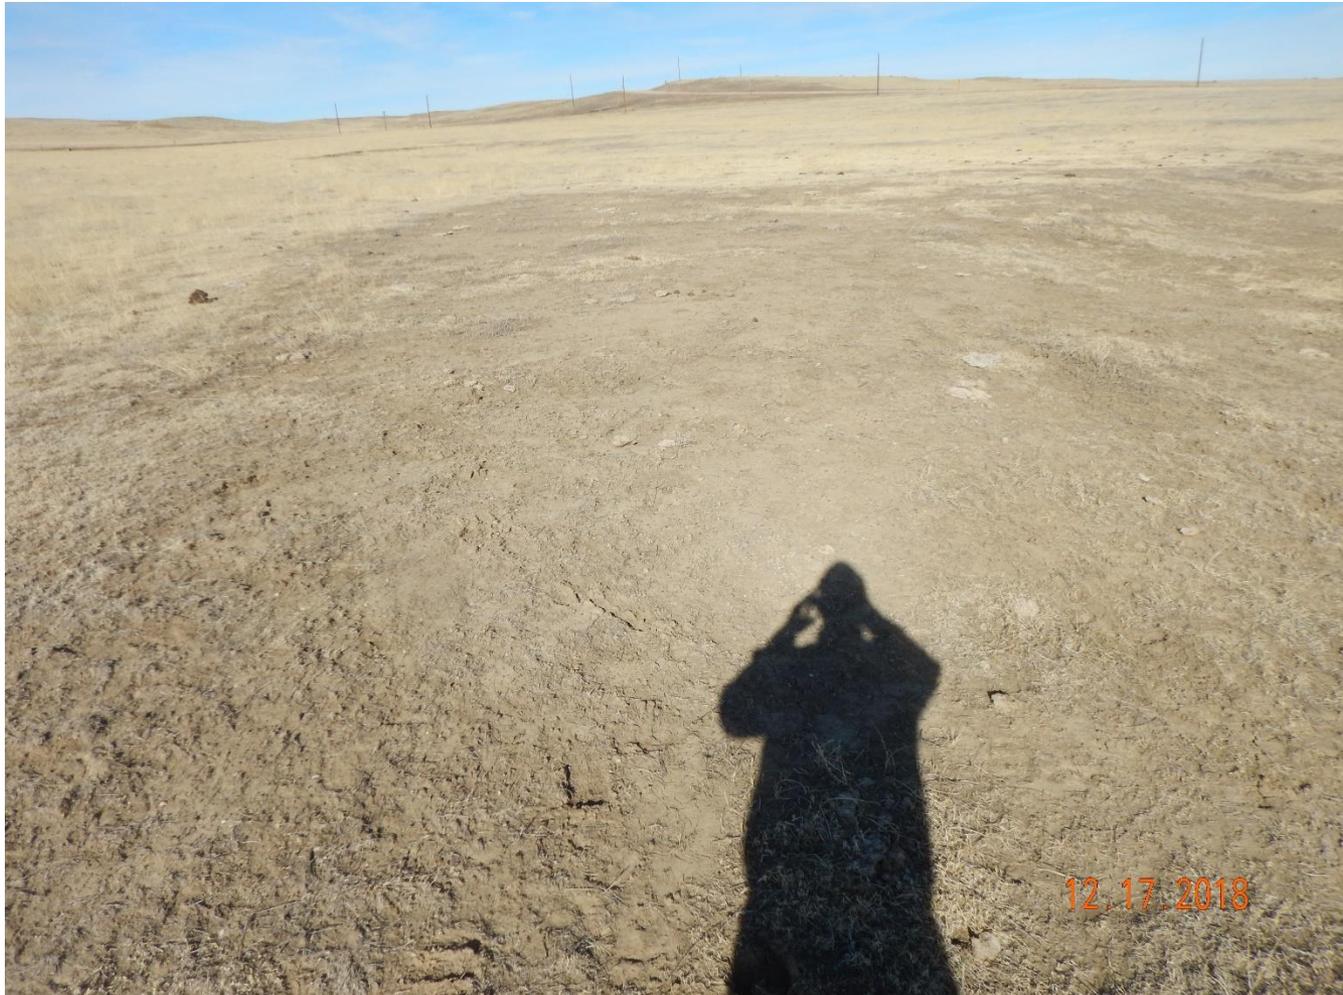
**Photo 2:** Photo taken from the south end of the well location, facing northwest. Photo shows well location remains predominantly bare and exposed soil.

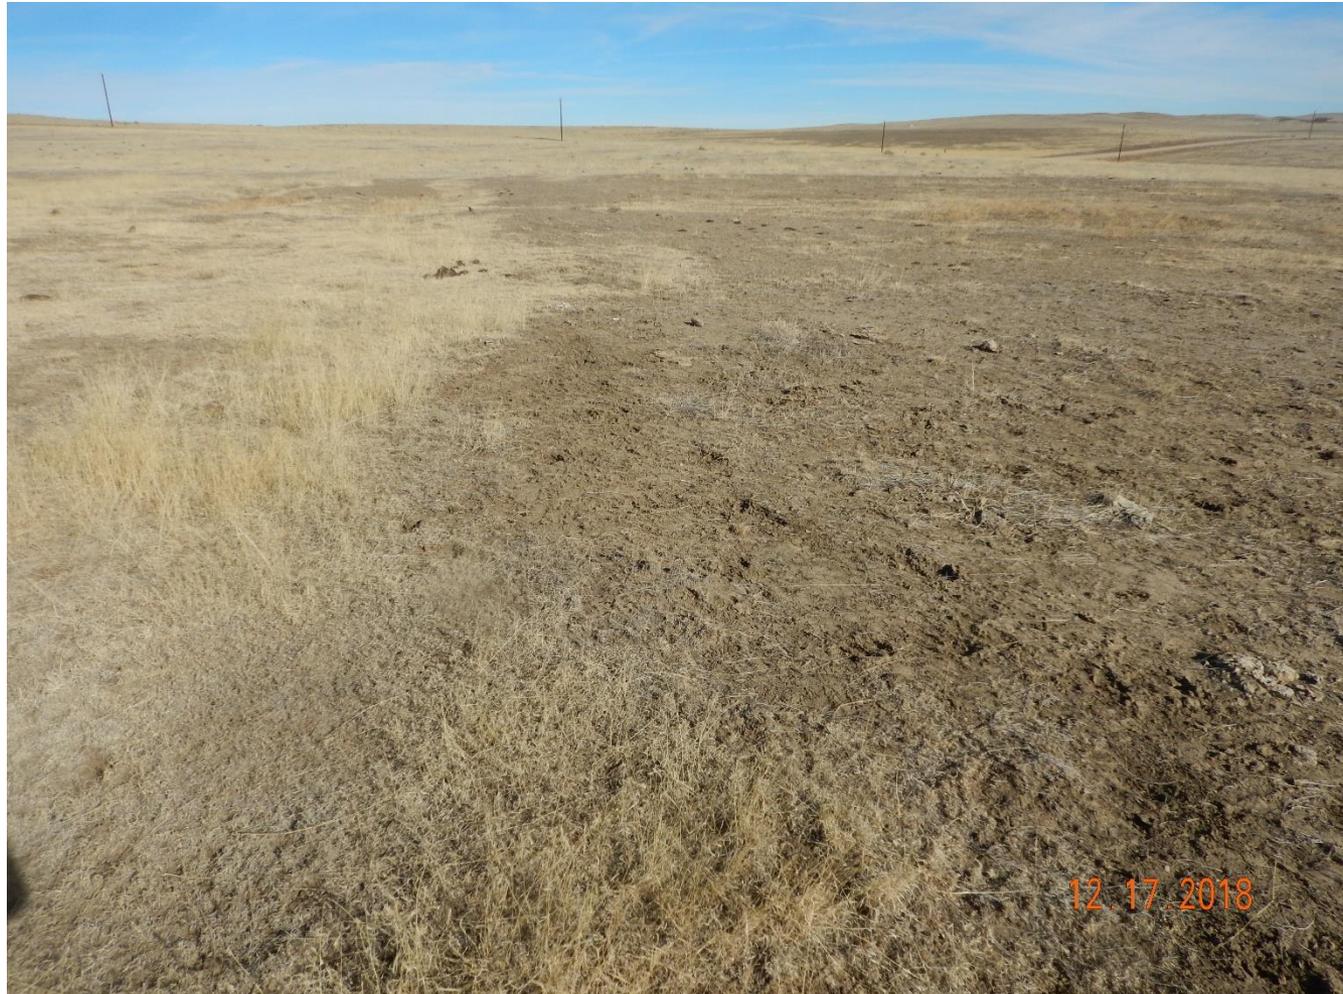
**Photo 3:** Photo taken from the southwest corner of the former pit, facing north. Photo shows that the pit remains predominantly bare and exposed soil.

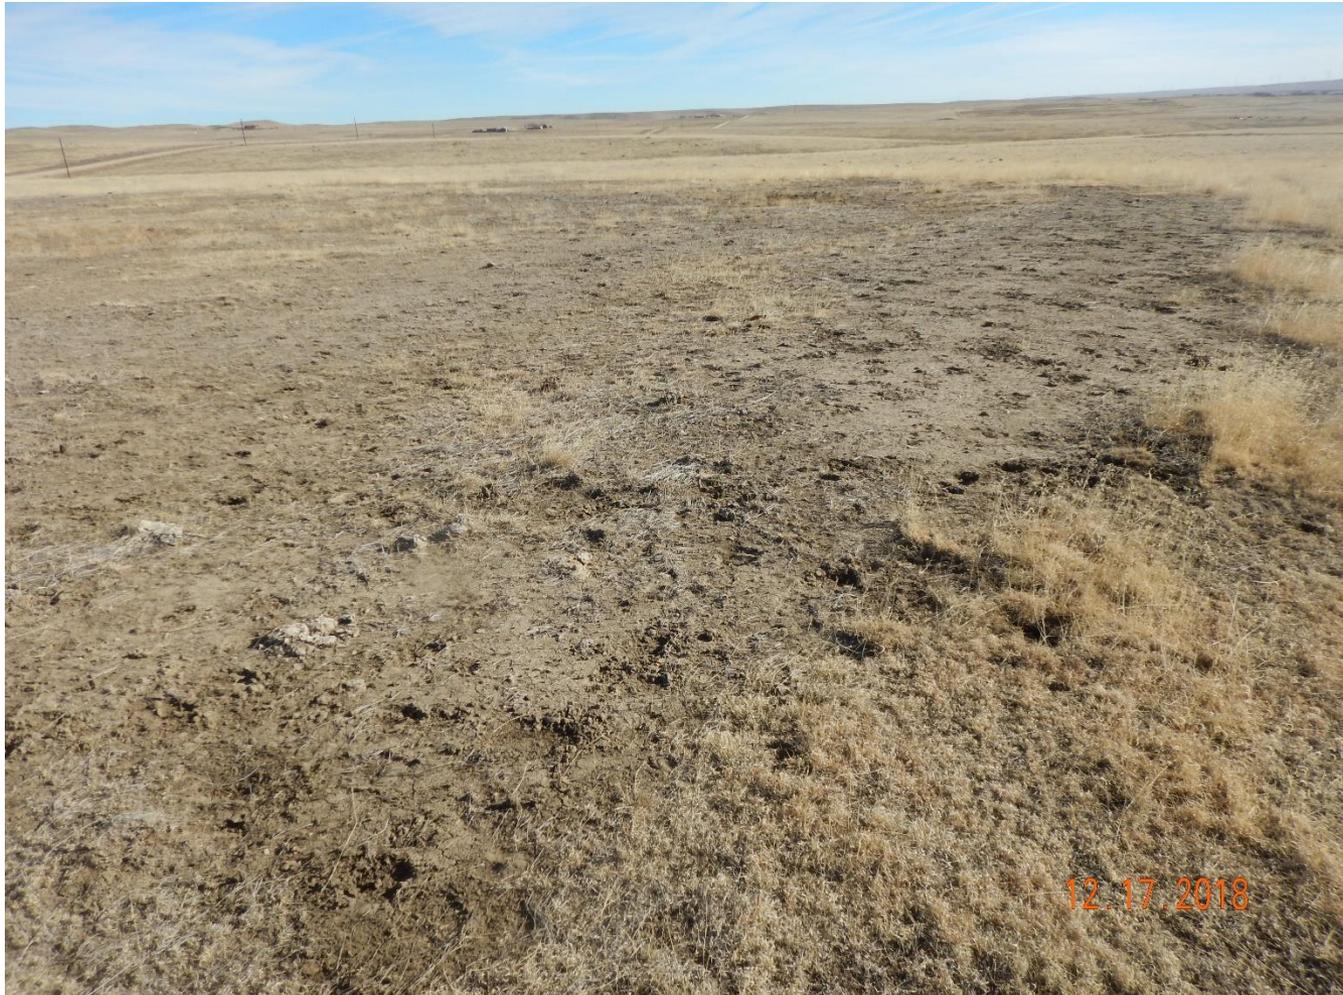
**Photo 4:** Photo taken from the southwest corner of the former pit, facing east. Photo shows that the pit remains predominantly bare and exposed soil.

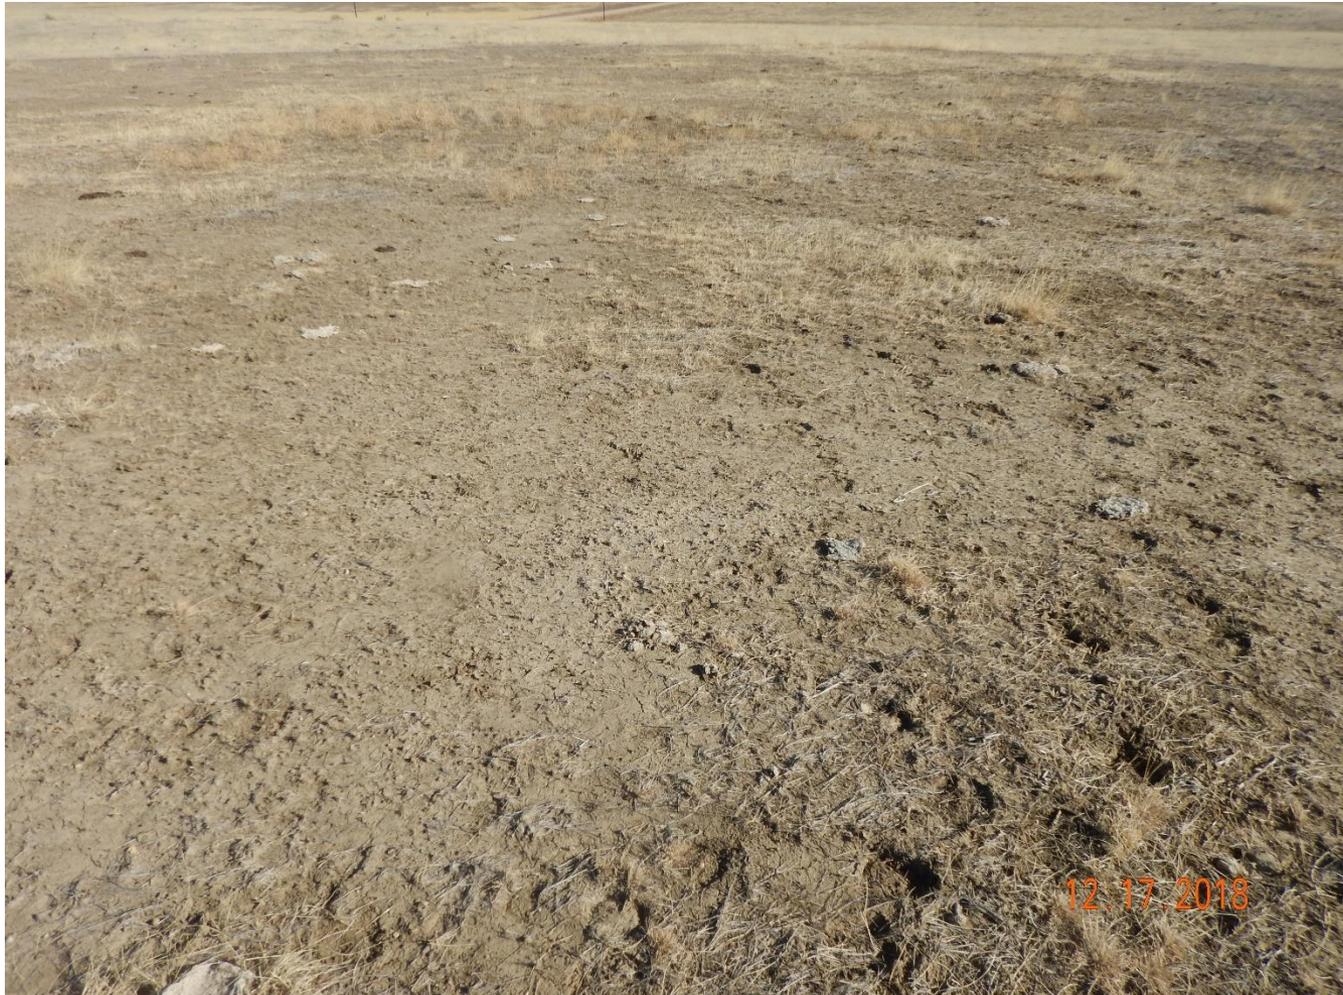
**Photo 5:** Photo taken from the former pit. Photo shows pit remains predominantly bare and exposed soil.

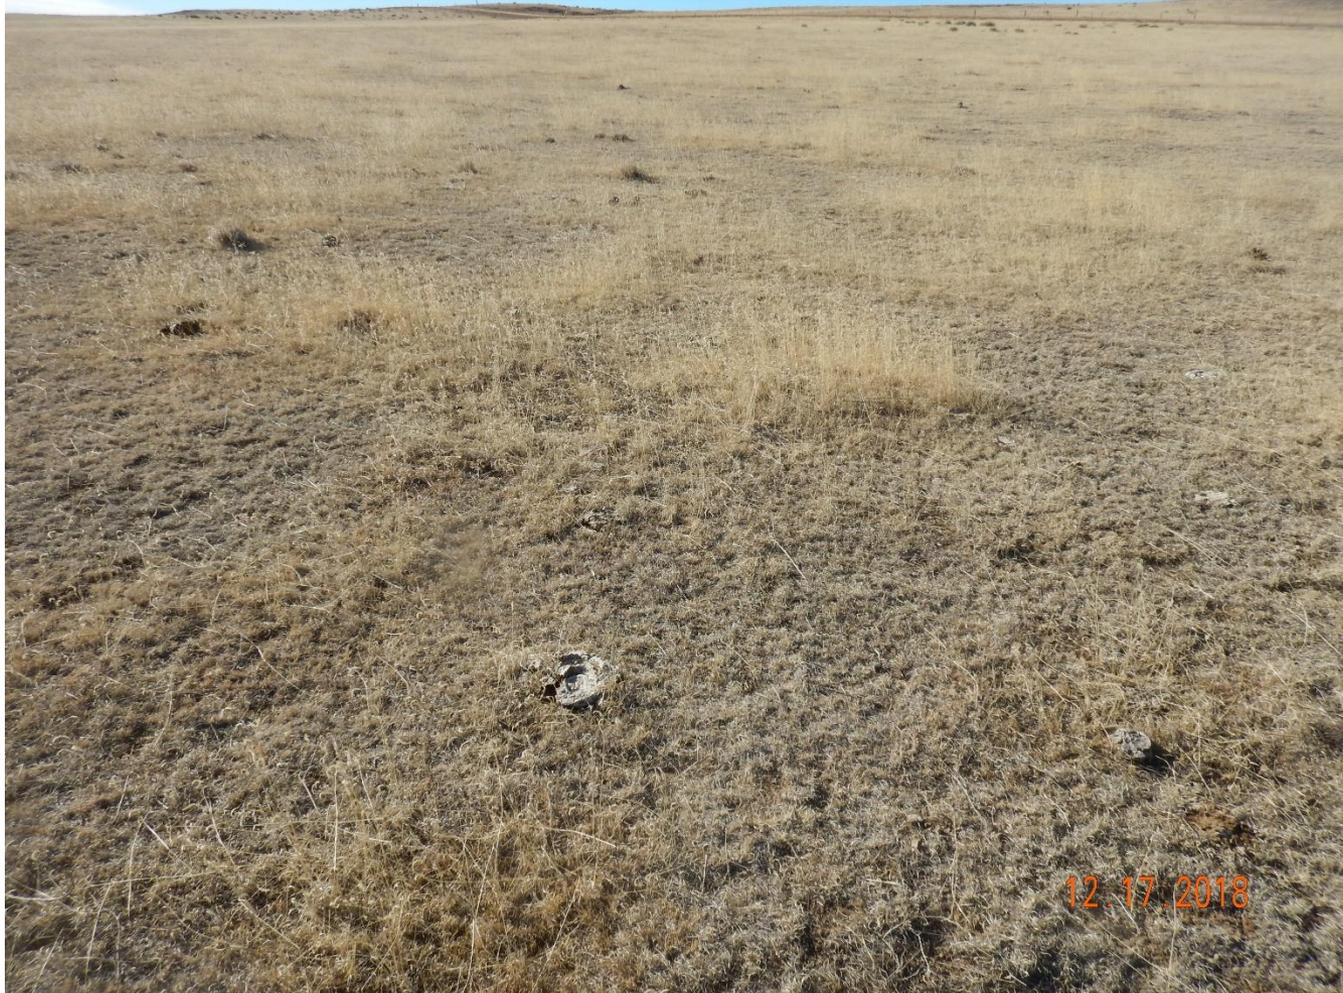
**Photo 6:** Photo taken from the adjacent reference area. Photo shows vegetation in the reference area appears to be predominantly a Blue grama and Buffalo grass community. Very little exposed soils were observed in the reference; well location and pit is not reflective of the reference area.
