# Inspection Photos

Operator: WESCO OPERATING INC - 95520

Location ID: 317082

Inspection Doc. Number: 682504295

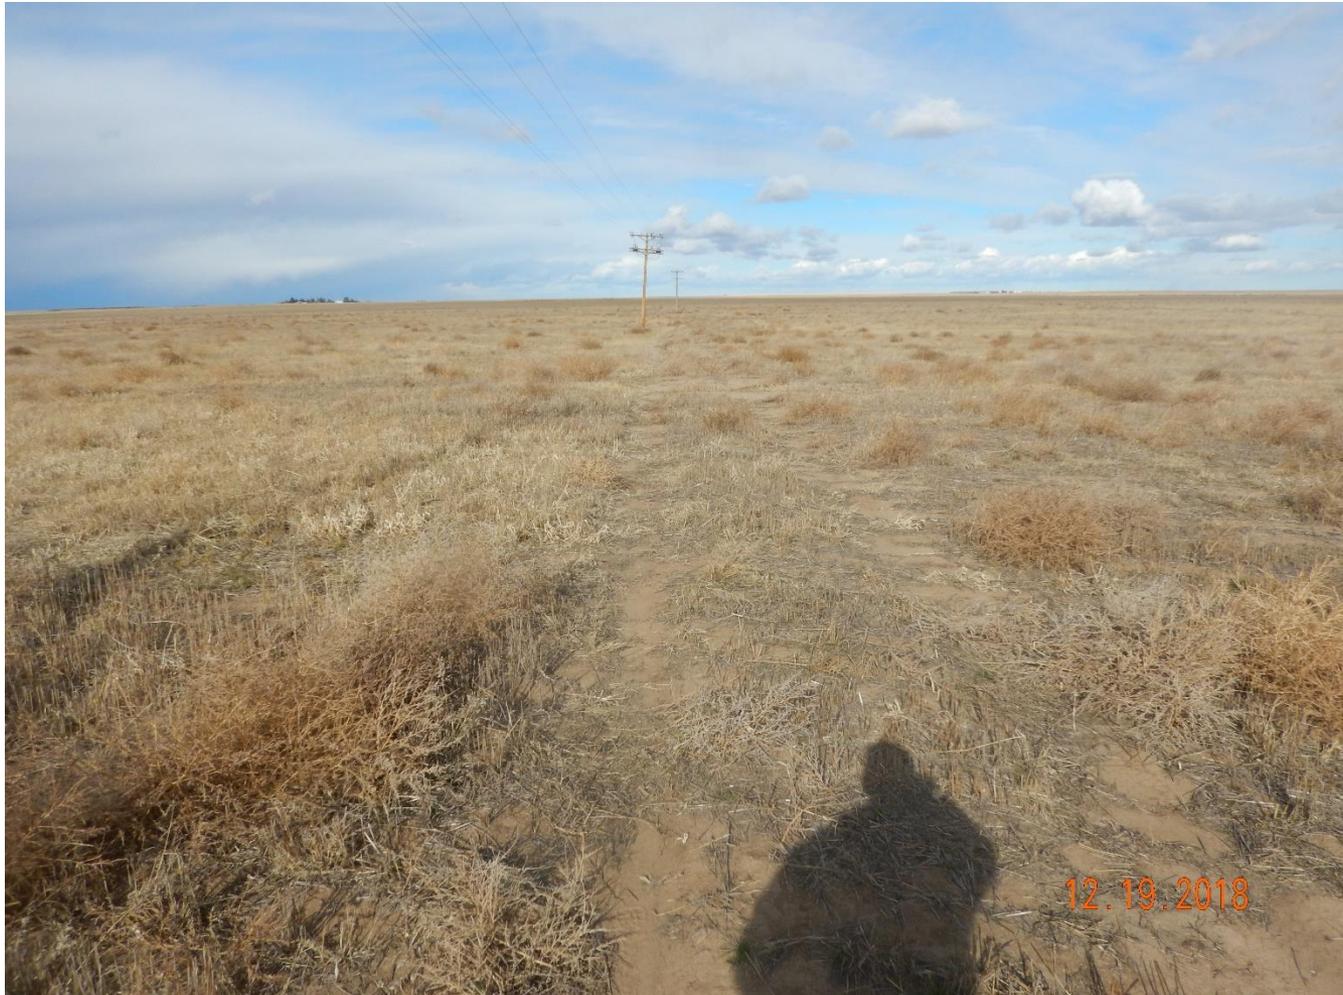
**Photo 1:** Photo taken from the access road, south of the location facing north. Photo shows that the access road within the crop field remains evident. Insufficient reclamation activities have been conducted in accordance with 1000 series rules. Photo also shows utility power lines (4 poles) leading north from the Rudnik 33-27 ending at the Rudnik 32-27. This is This is surface equipment associated with the abandoned oil and gas location and requires removal.

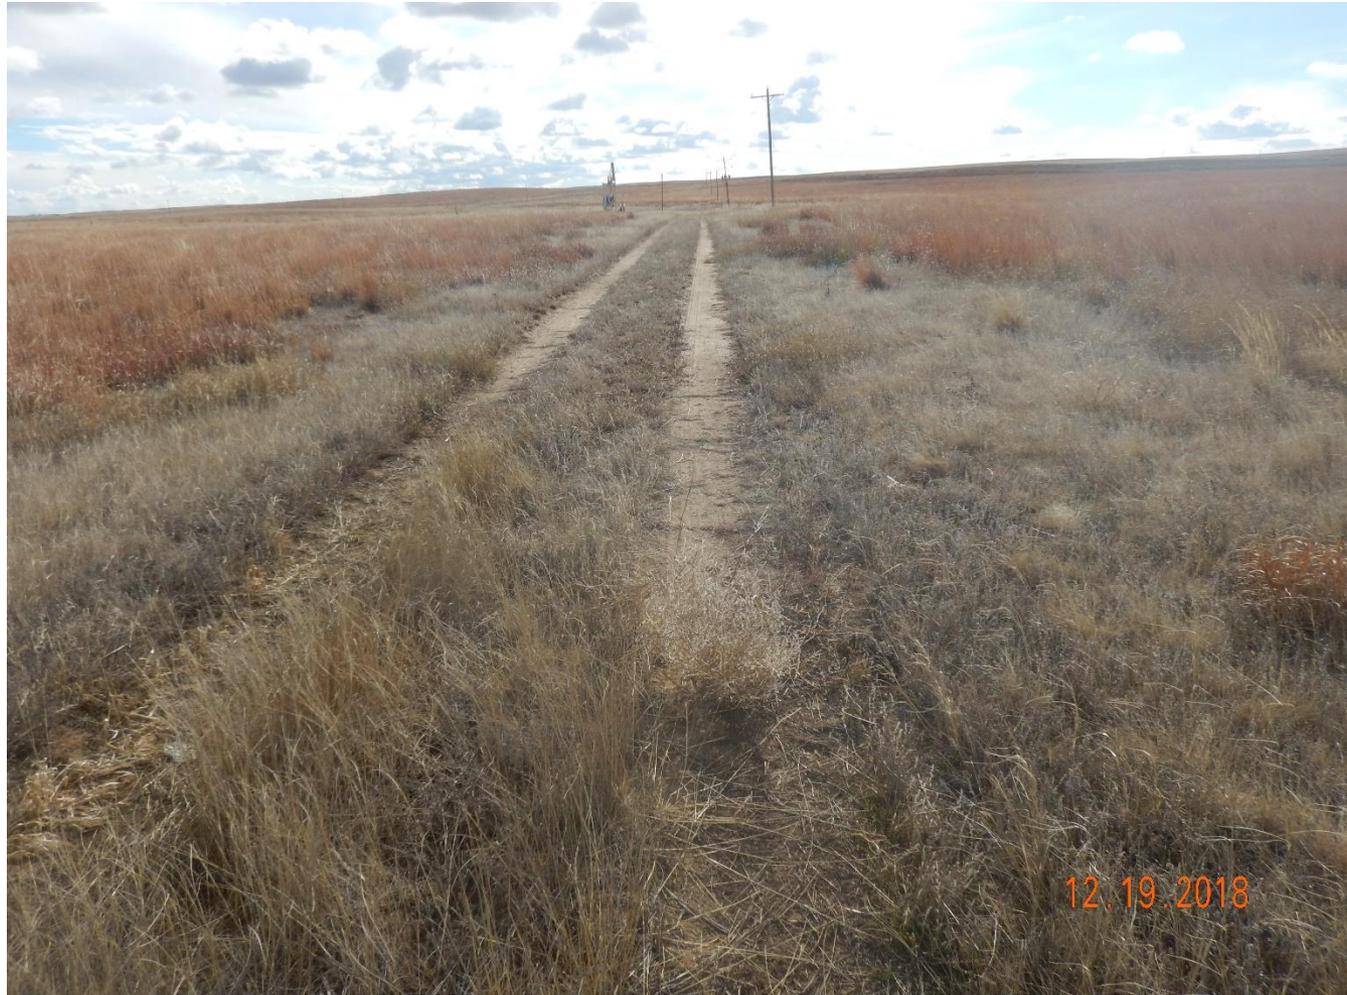
**Photo 2:** Photo taken from the access road, south of the location facing north. See comments under photo 1

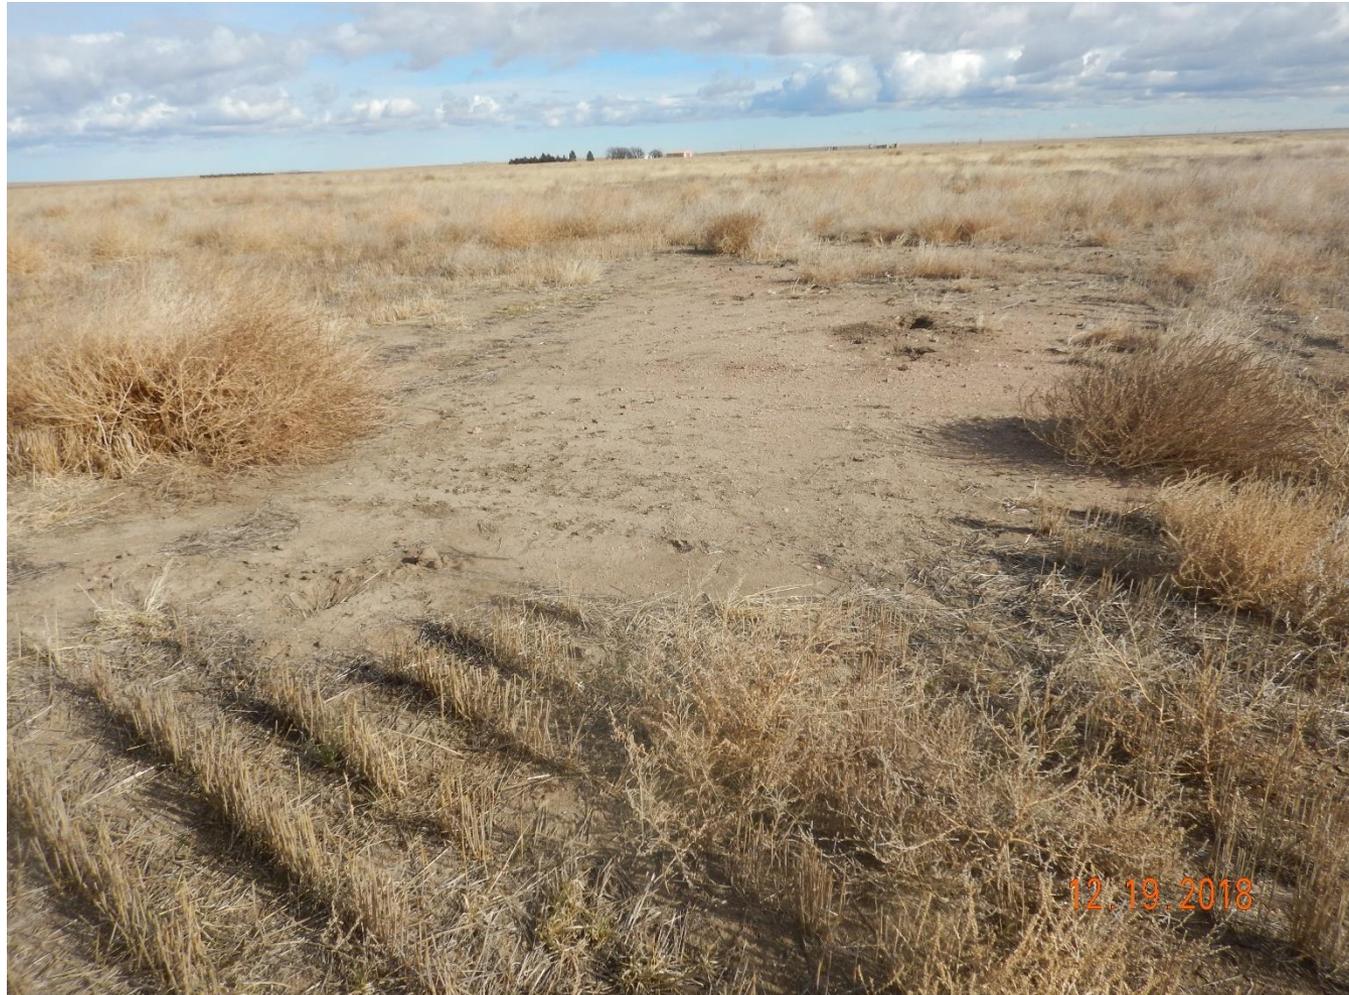
**Photo 3:** Photo taken from well location. Photo shows that crop vegetation has failed to establish over the well.

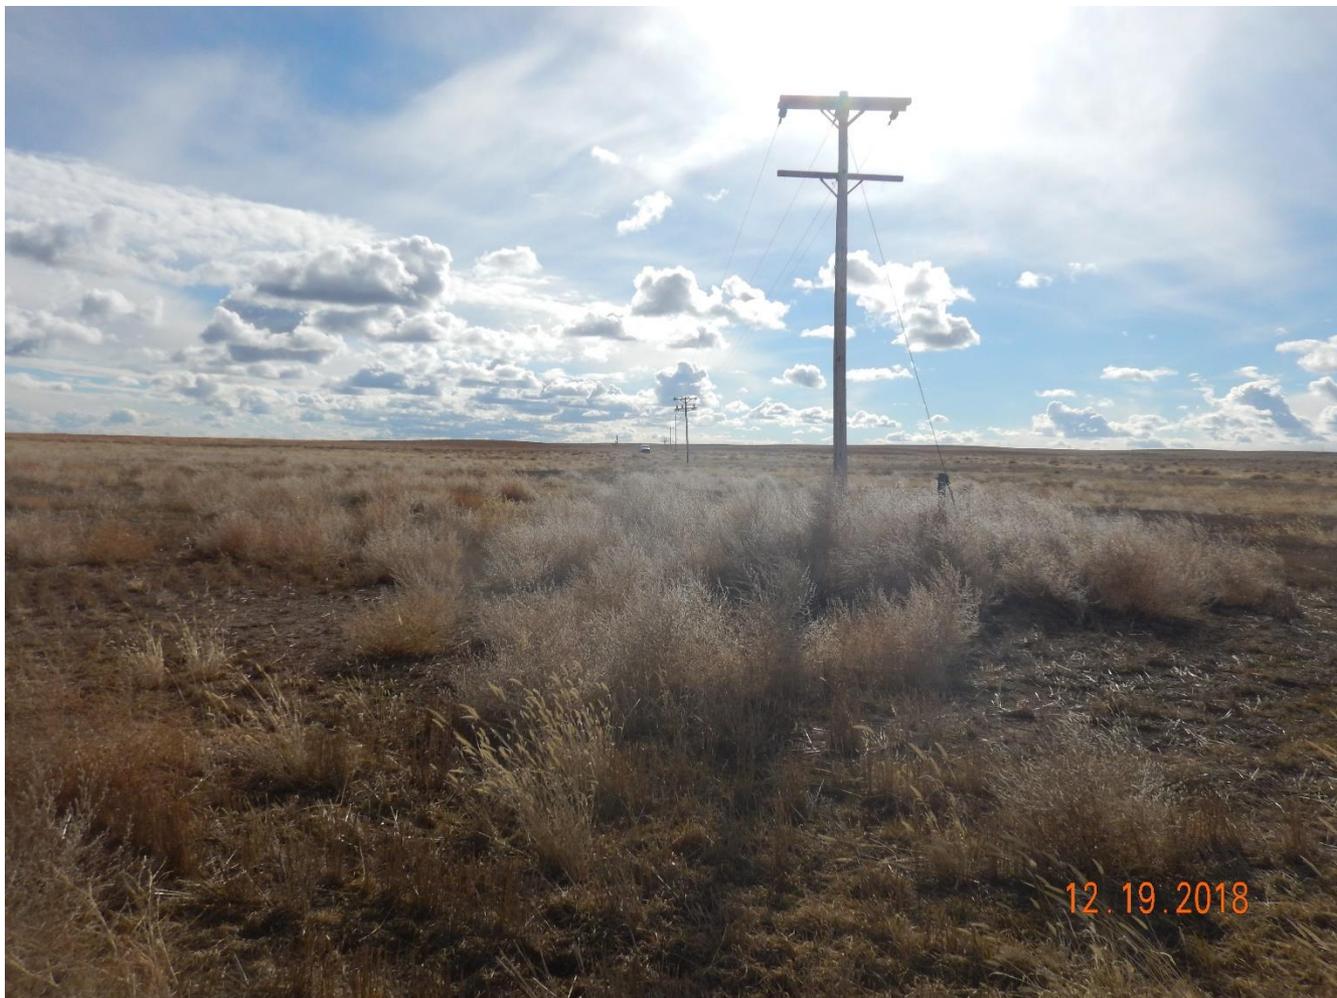
**Photo 4:** Photo taken from the well location, facing south. Photo shows utility power lines (4 poles) leading north from the Rudnik 33-27 ending at the Rudnik 32-27. This is surface equipment associated with the abandoned oil and gas location and requires removal.

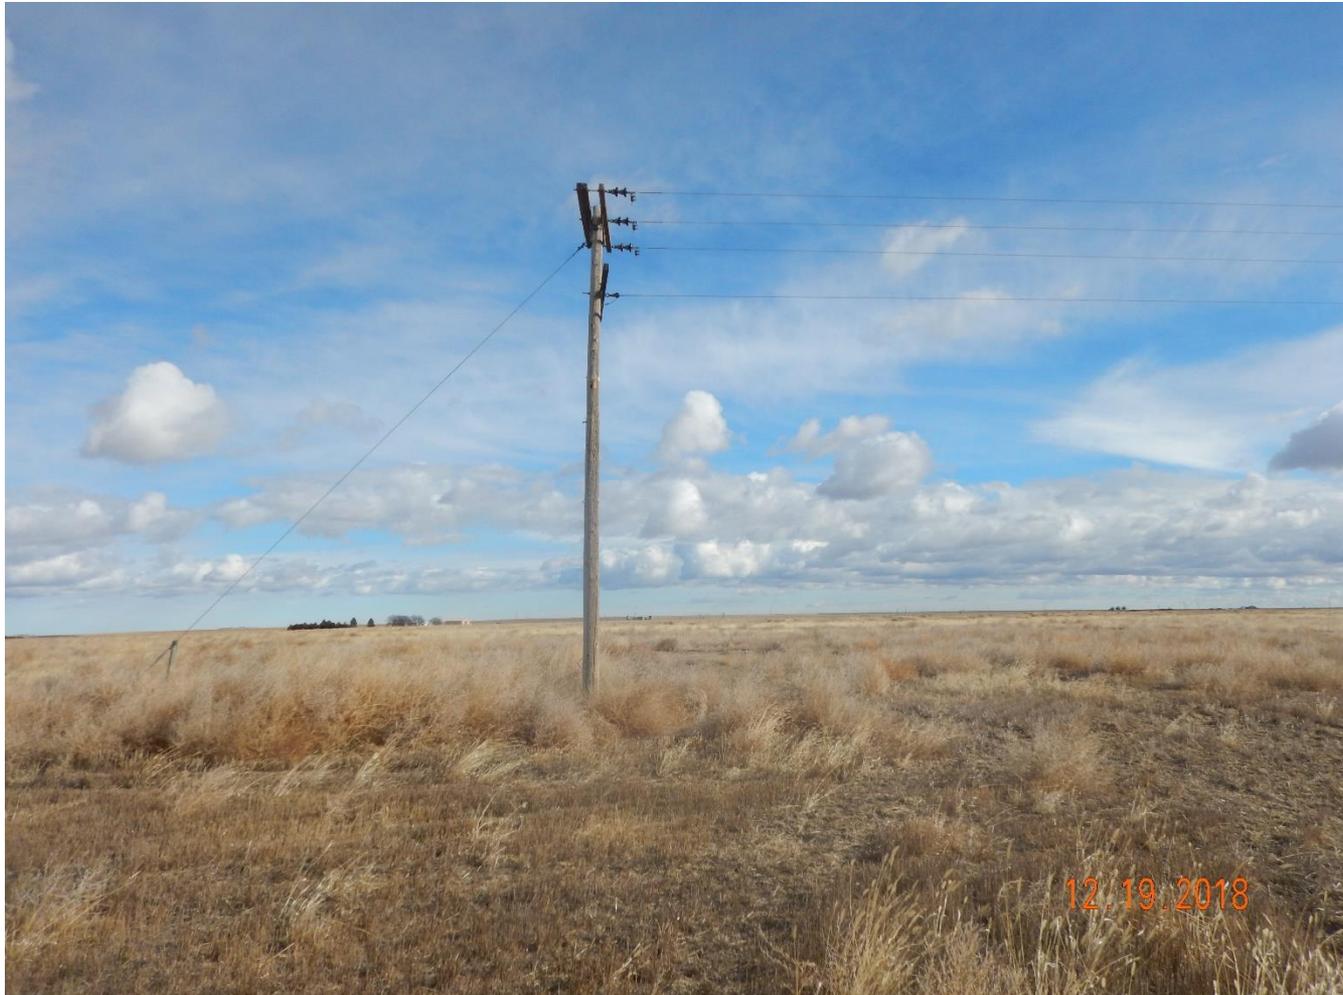
**Photo 5:** Photo taken from the west of the well location, facing east. Photo shows utility power lines remaining. Poles appear to be interfering with the surface owner's agricultural activities.
