Inspection Photos

Operator: FOUNDATION ENERGY
MANAGEMENT LLC - 10112

Location ID: 331849

Inspection Doc. Number: 682504337
Weld County, CO

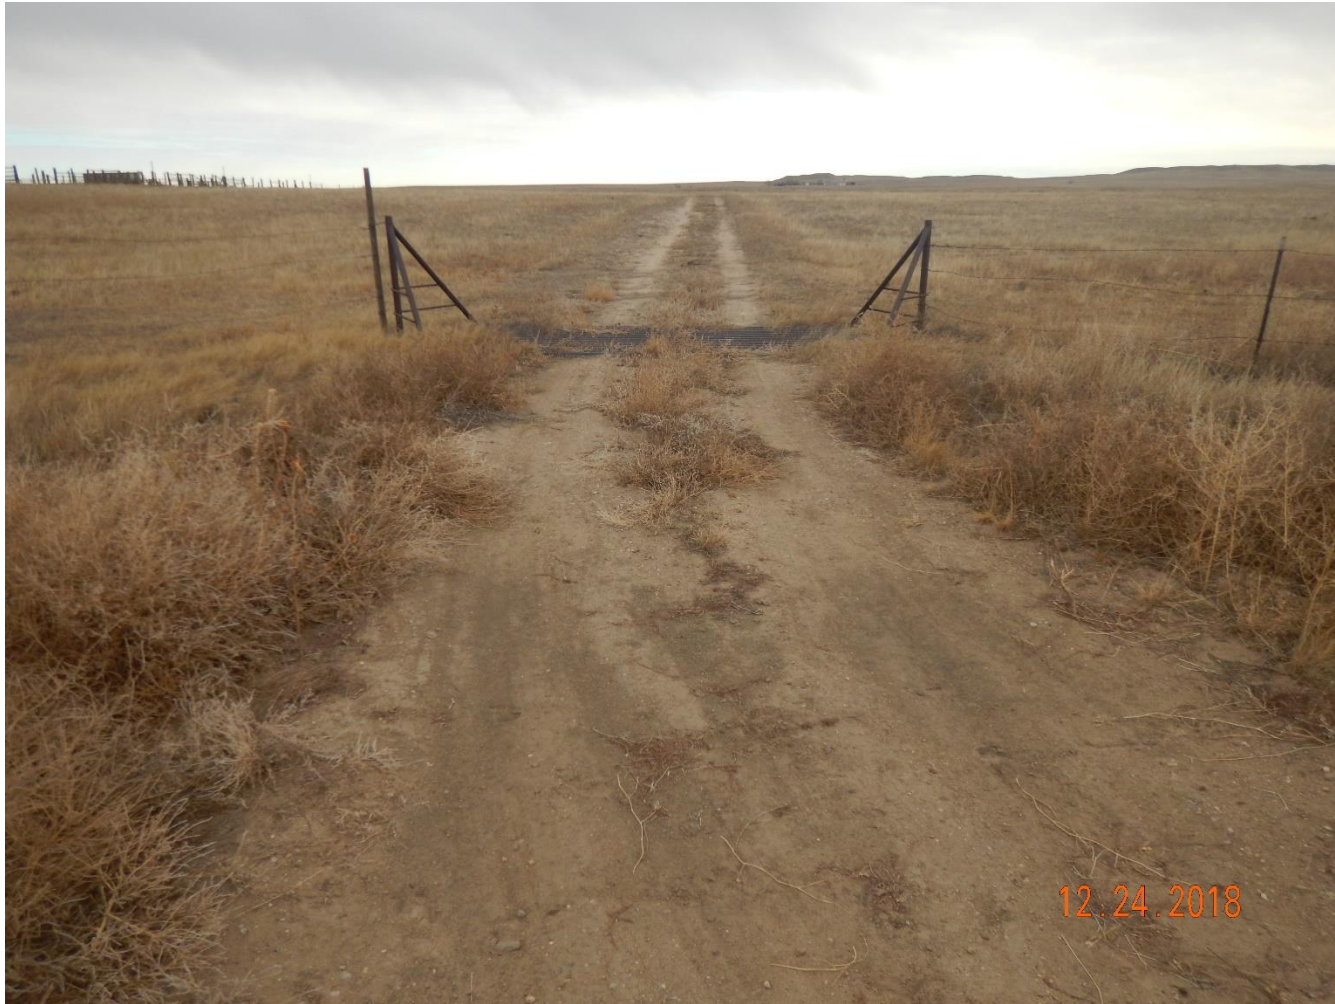
Photo 1: Photo taken from the access road entrance, facing east. Photo shows that access road and cattle guard have not been reclaimed.

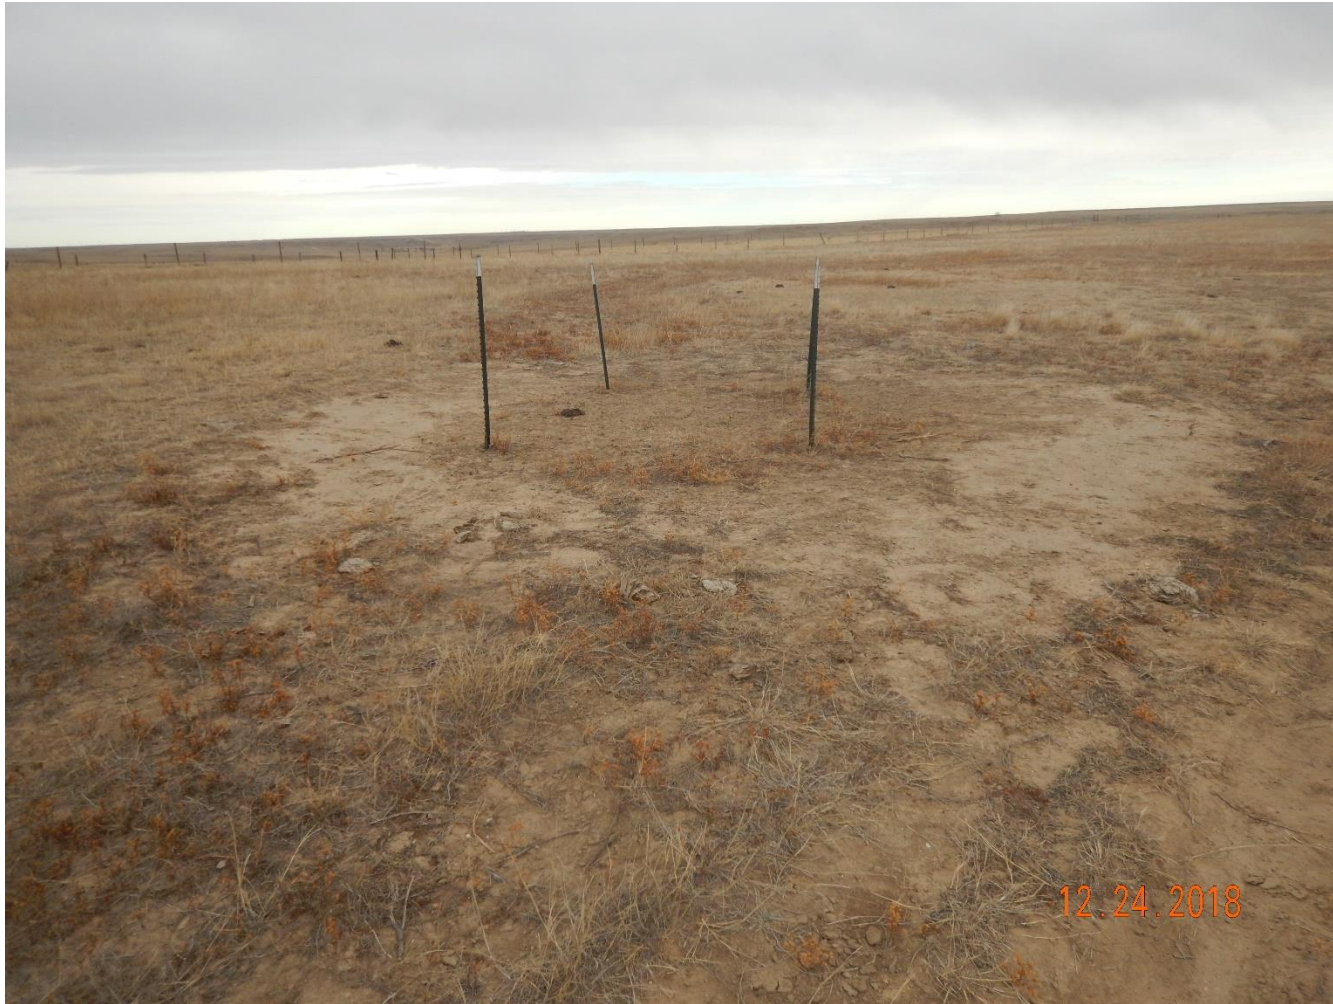
Photo 2: Photo taken from the southwest end of location, facing northeast. Photo shows location and access road remain predominantly bare and exposed soil. Unable to find evidence that reclamation activities have been conducted.

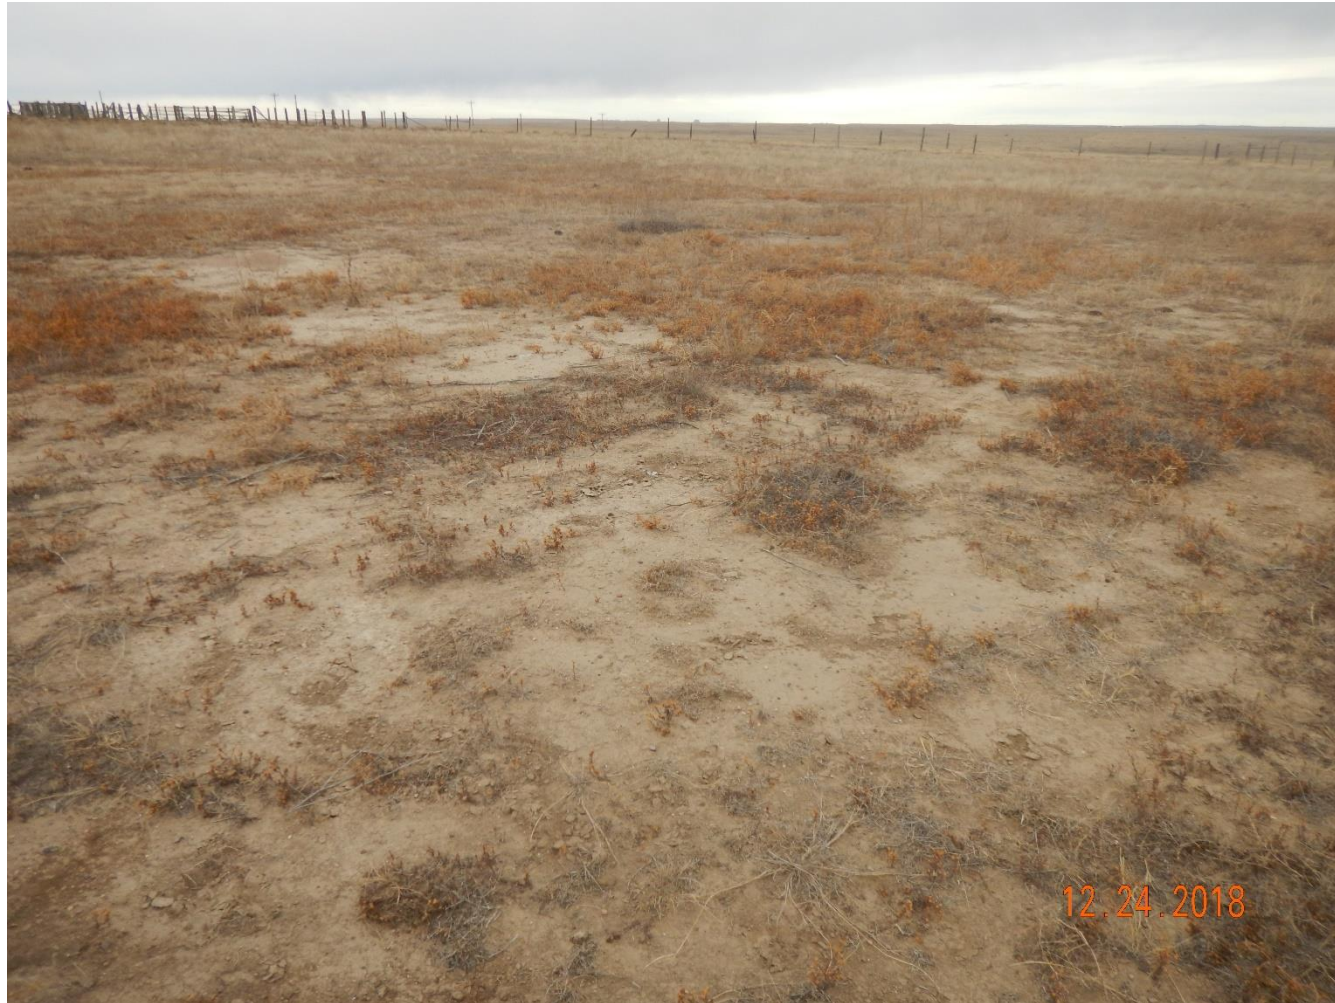
Photo 3: Photo taken from the southeast end of location, facing northwest. Photo shows location and access road remain predominantly bare and exposed soil. Unable to find evidence that reclamation activities have been conducted.

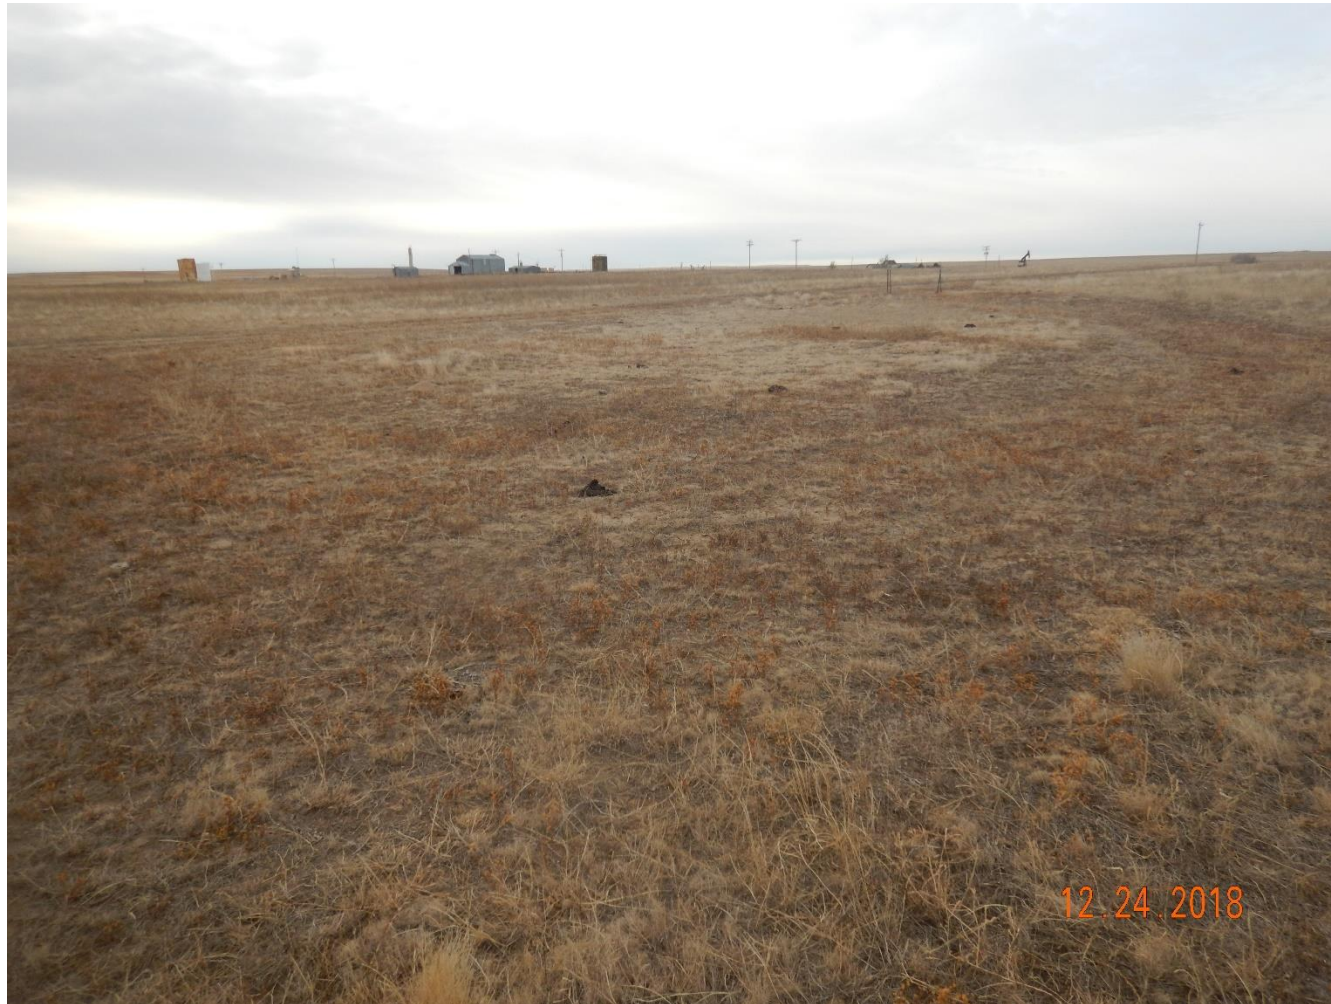
Photo 4: Photo taken from the northeast end of the location, facing southwest. Photo shows the turn-around portion of the access road. Photo shows no additional reclamation appears to have been conducted. Vegetation observed in photo is predominantly undesirable weedy plant species.

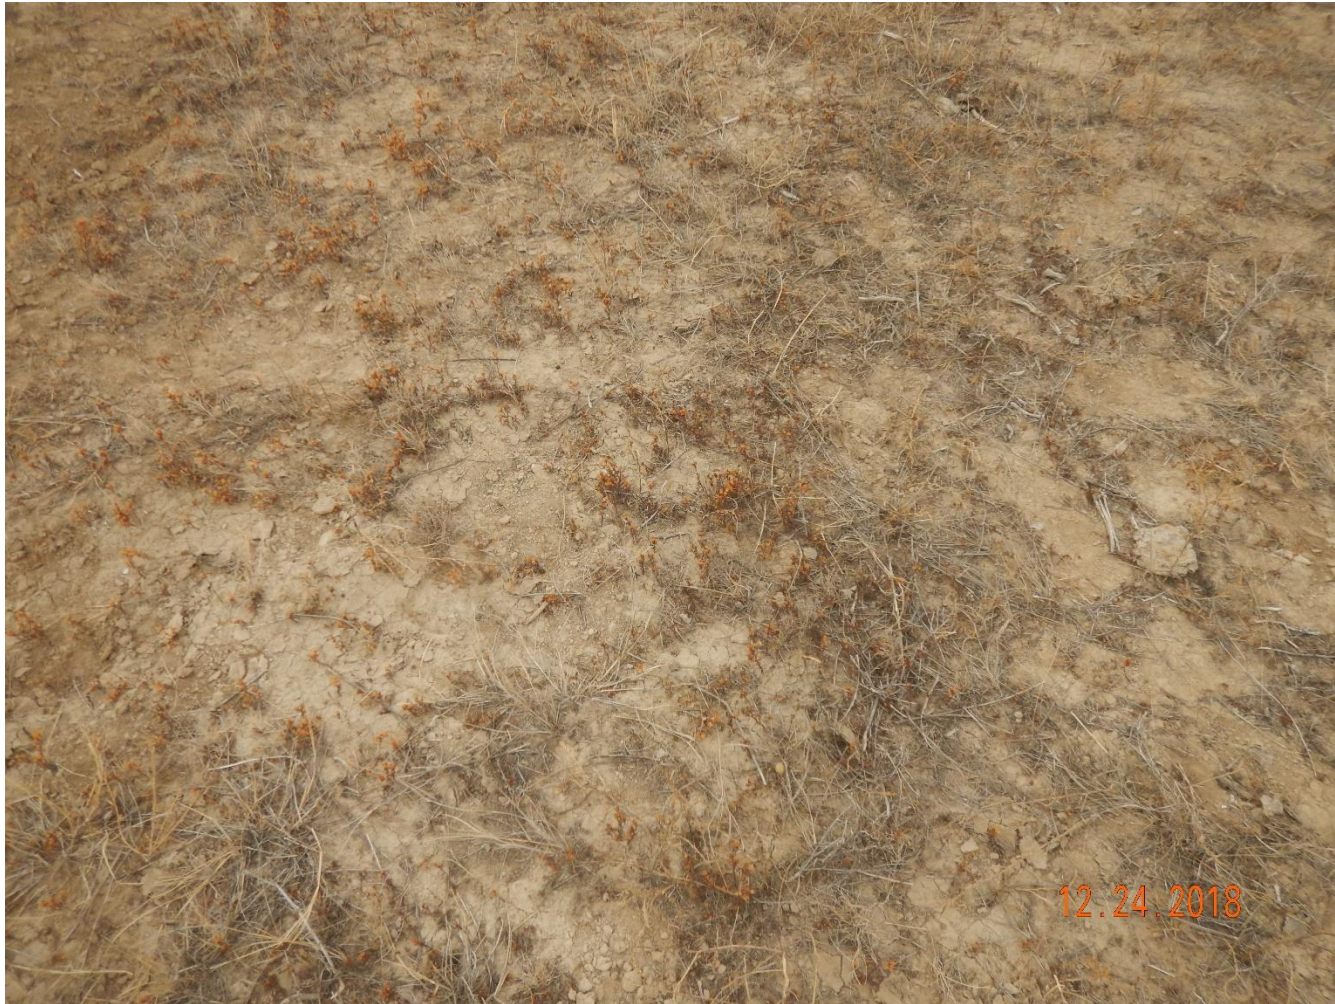
Photo 5: Continued from photo 4. Photo shows location/access road remains predominantly bare and exposed soil, or vegetated by undesirable weedy plant species.

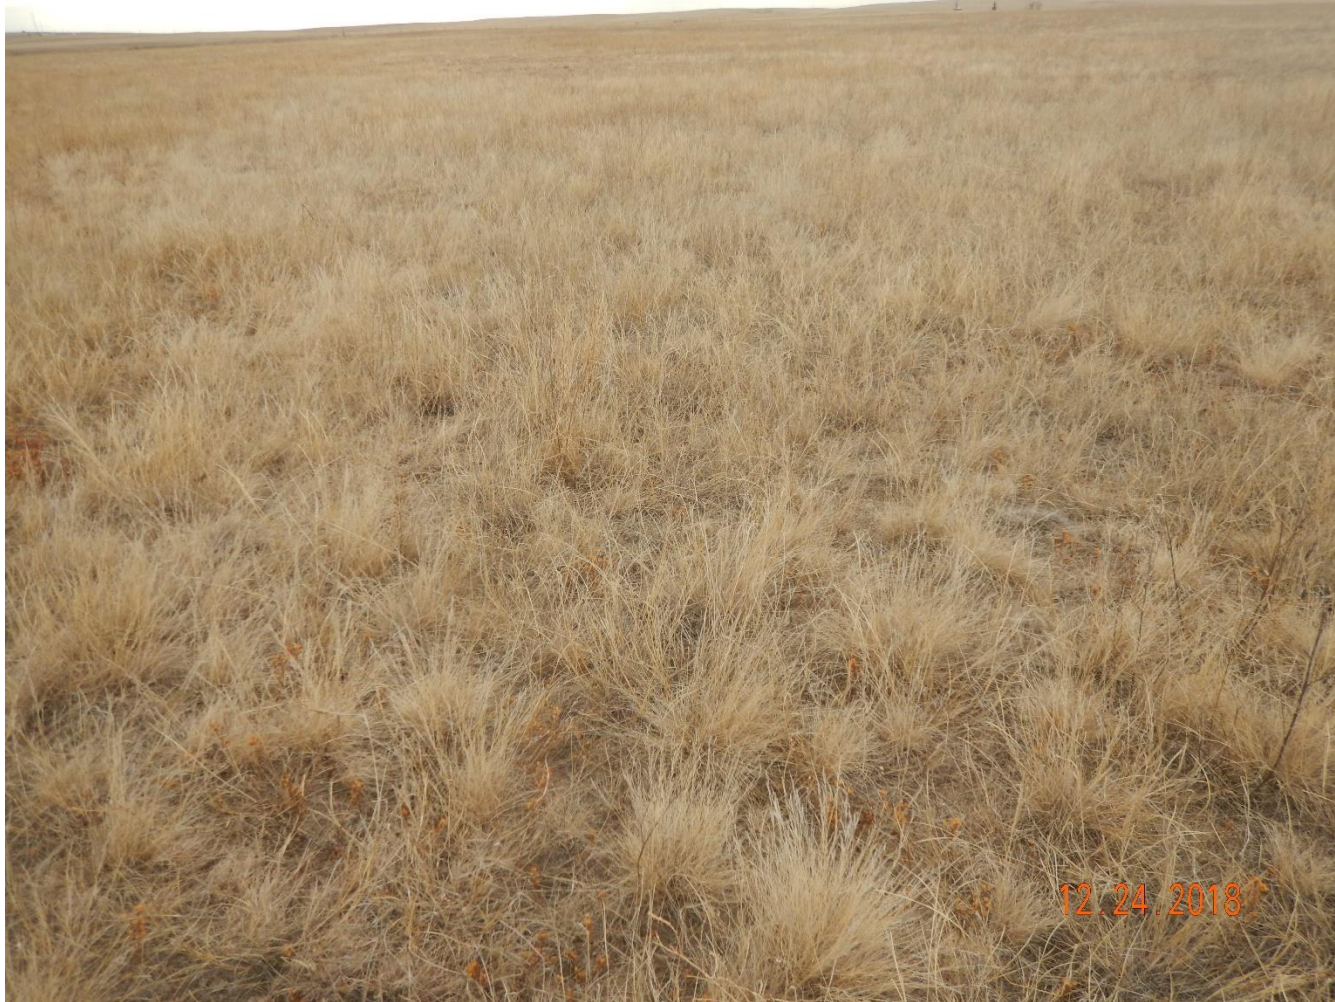
Photo 6: Photo taken from the adjacent reference area. Photo shows reference vegetation. Vegetation observed included Purple threeawn, Sand dropseed, Blue Grama Western wheat.
