Inspection Photos

Operator: PCR OPERATING LLC - 10657

Location ID: 313755

Inspection Doc. Number: 682504400

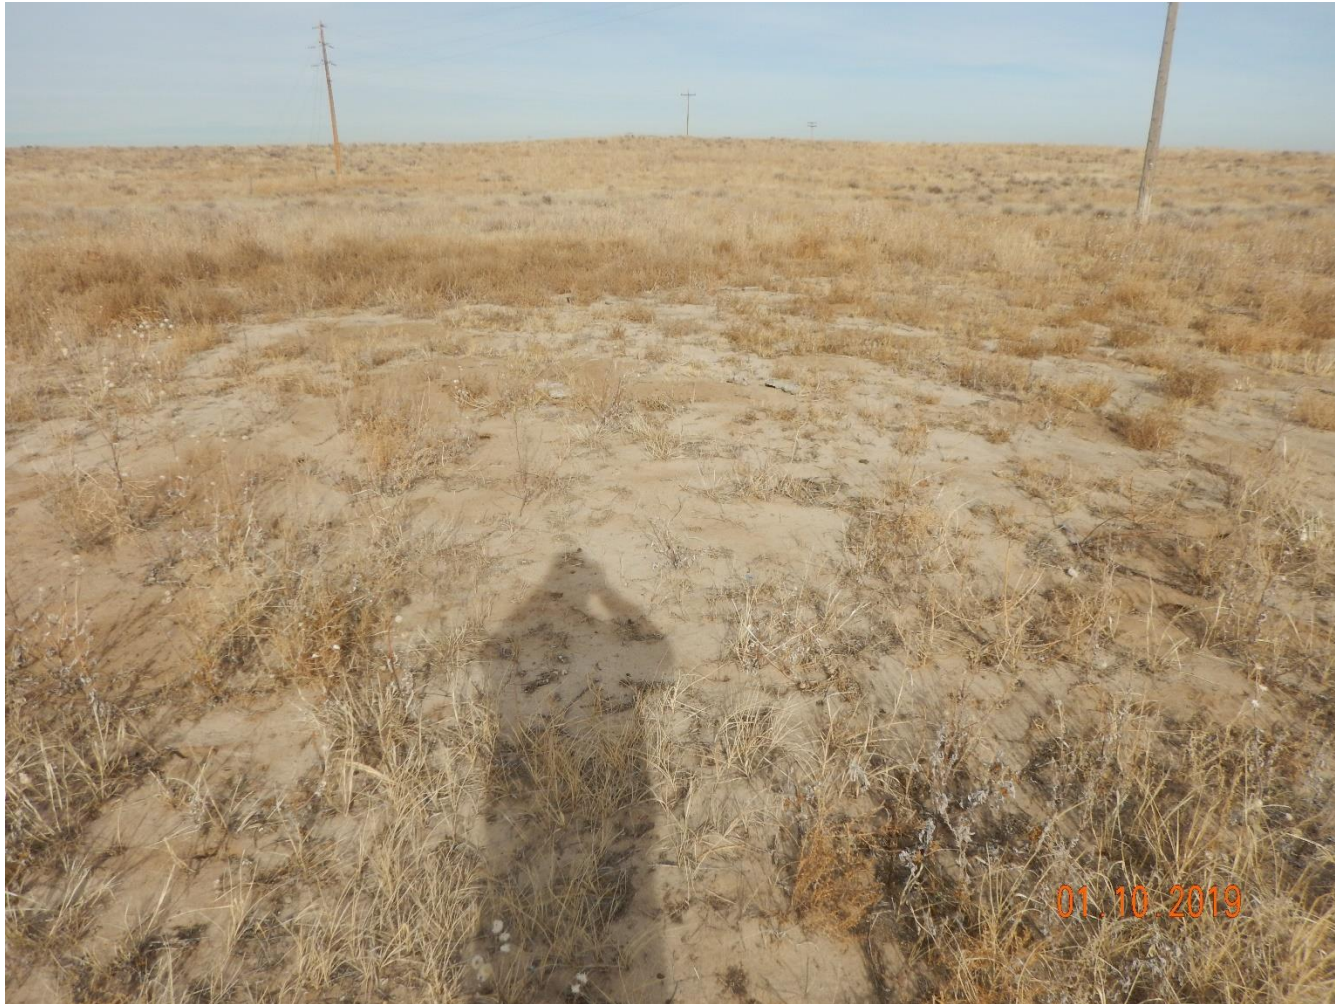
Photo 1: Photo taken from the west end of the location, facing east. Photo shows well location remains predominantly bare and exposed soil, or composed of undesirable weedy plant species. Unable to find evidence that reclamation work has been conducted.

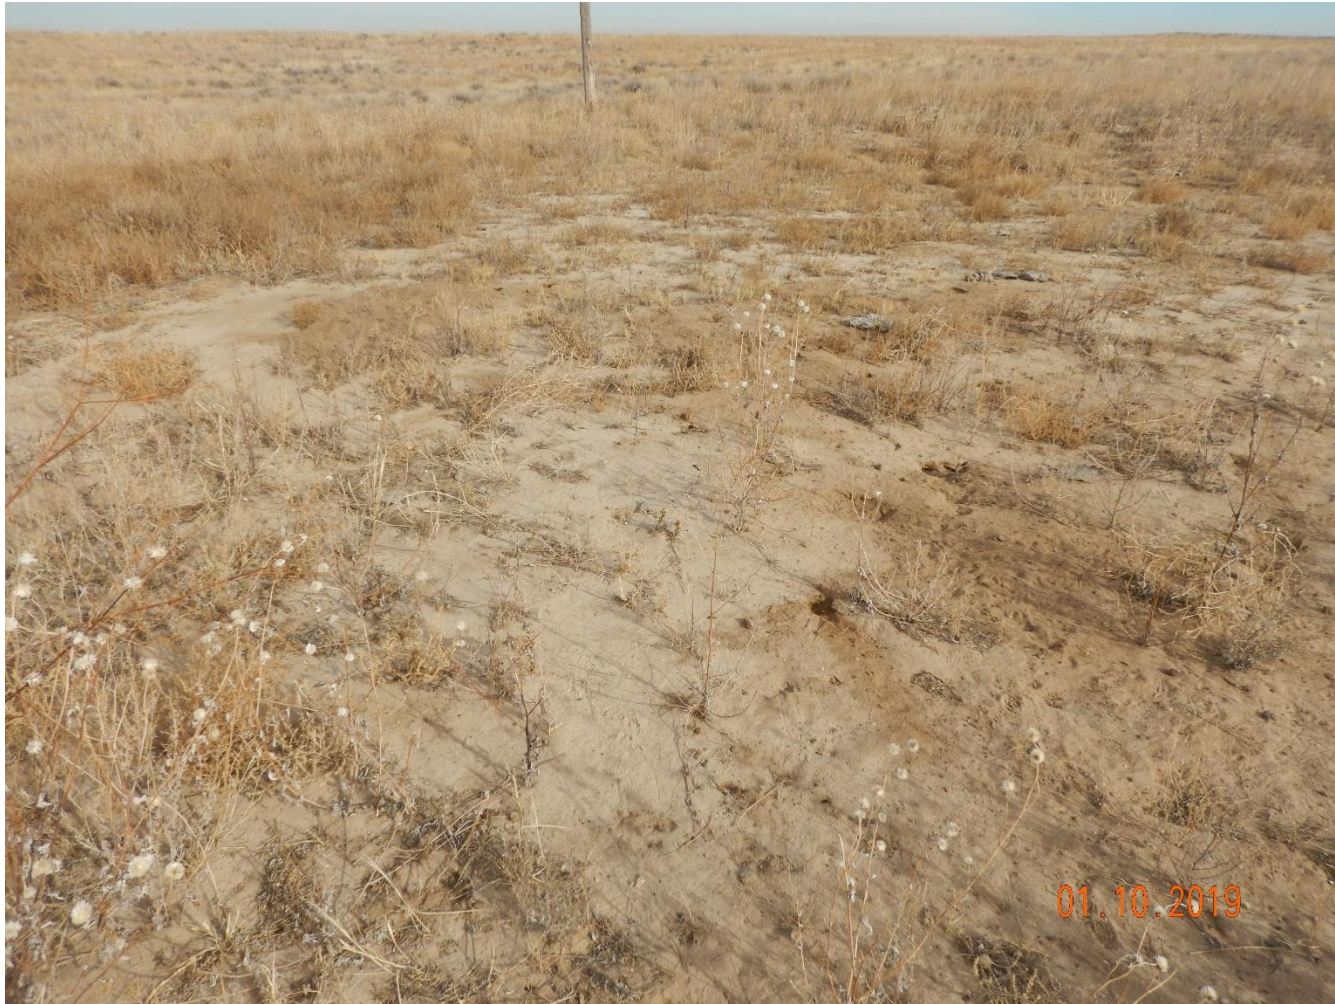
Photo 2: Photo taken from the location, facing east. See comments under photo 1

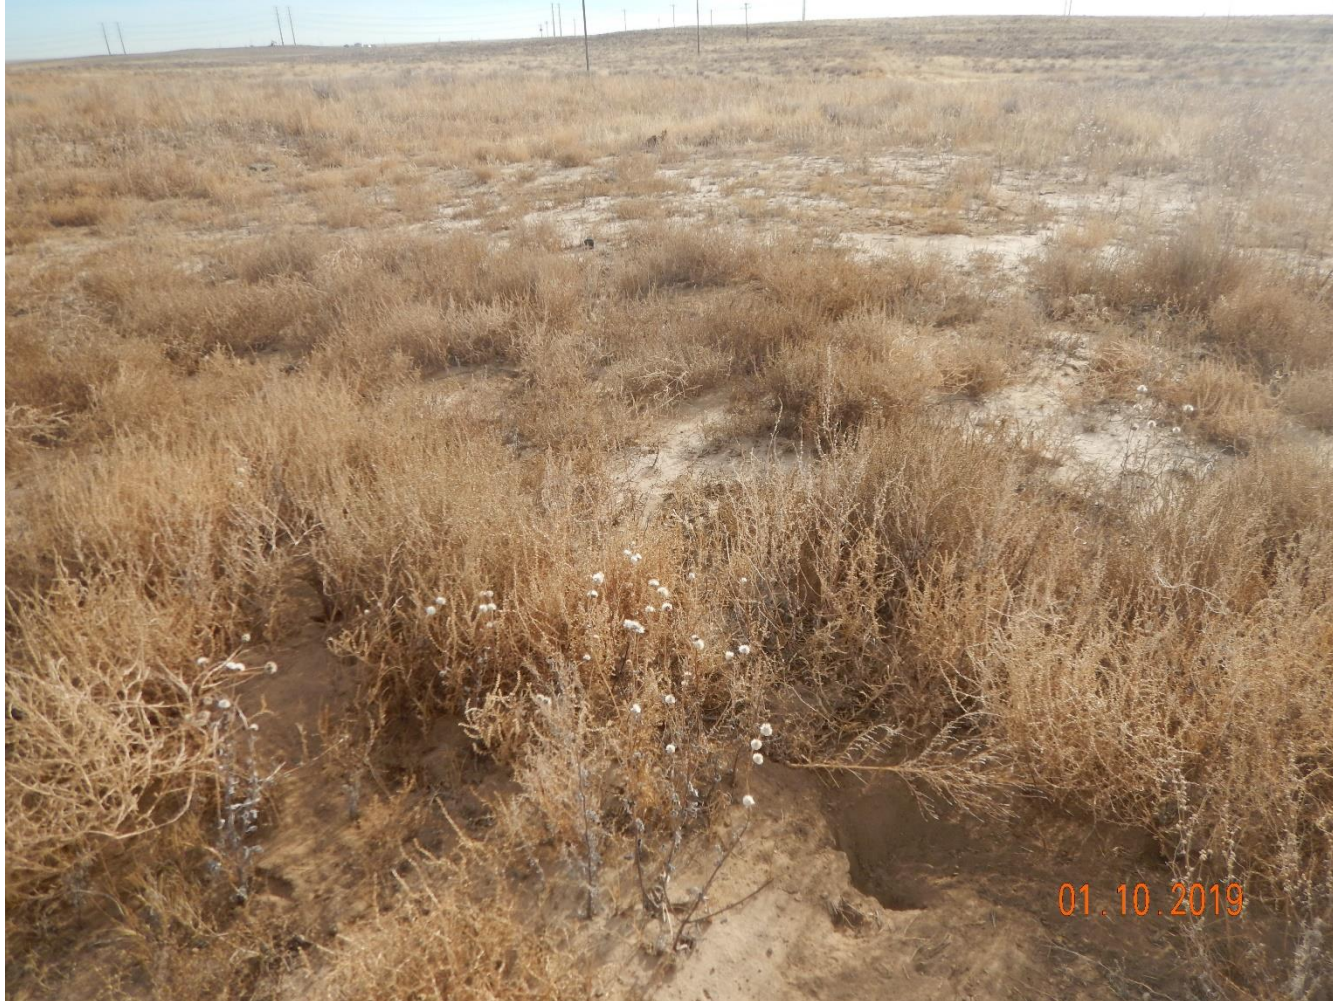
Photo 3: Photo taken from the north end of the location, facing south. See comments under photo 1.

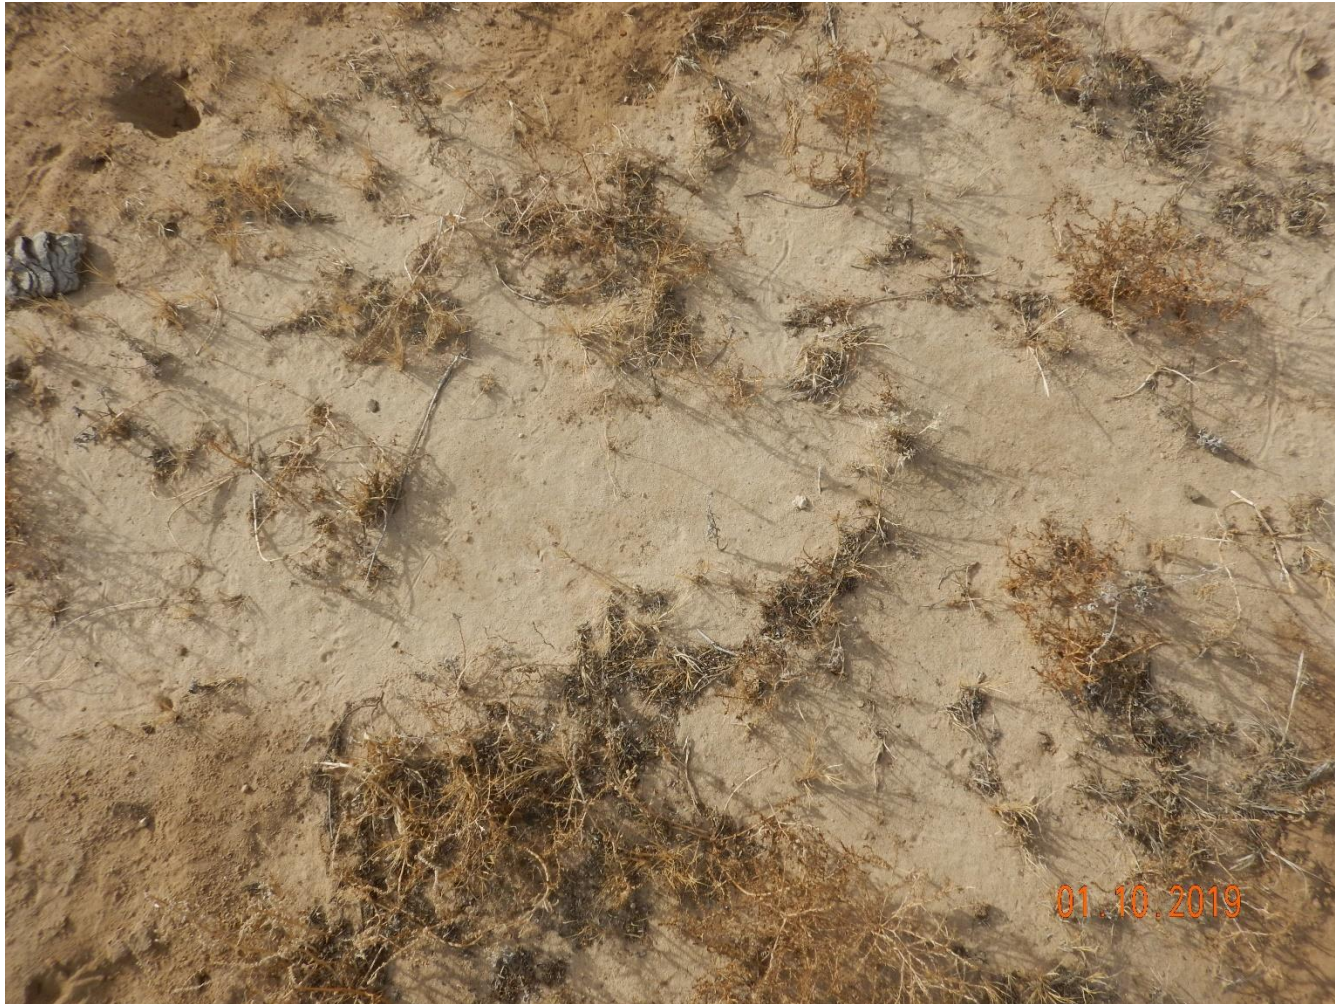
Photo 4: Photo taken from the well location. Photo shows well location remains predominantly bare and exposed soil or undesirable weedy plant species. Vegetation observed within photo Russian thistle.

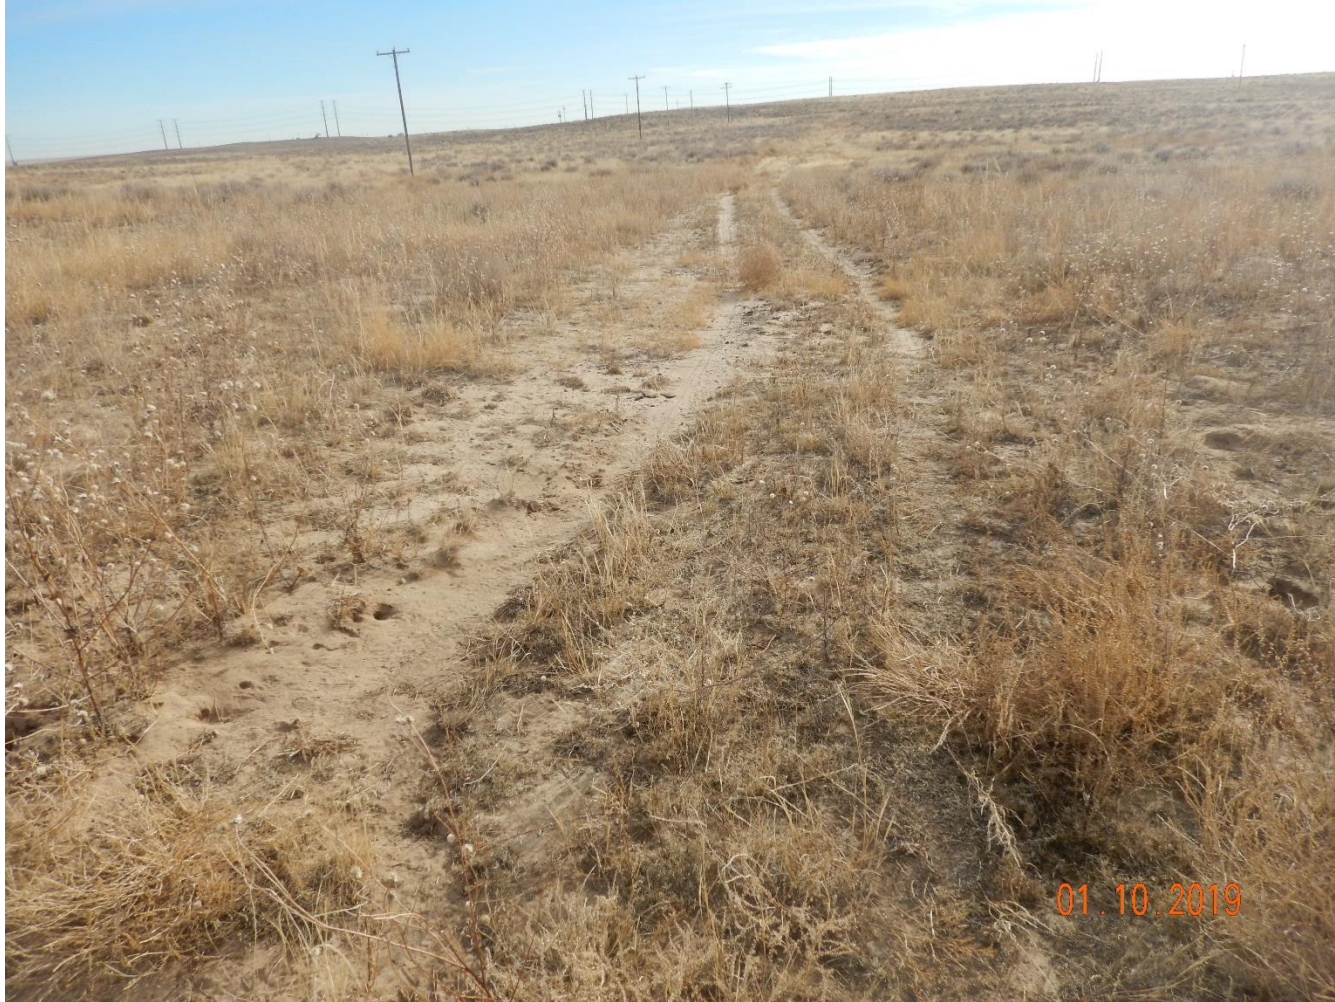
Photo 5: Photo taken from the west end of the location, facing south. Photo shows access road remains evident and predominantly bare and exposed soil or composed of undesirable weedy plant species.

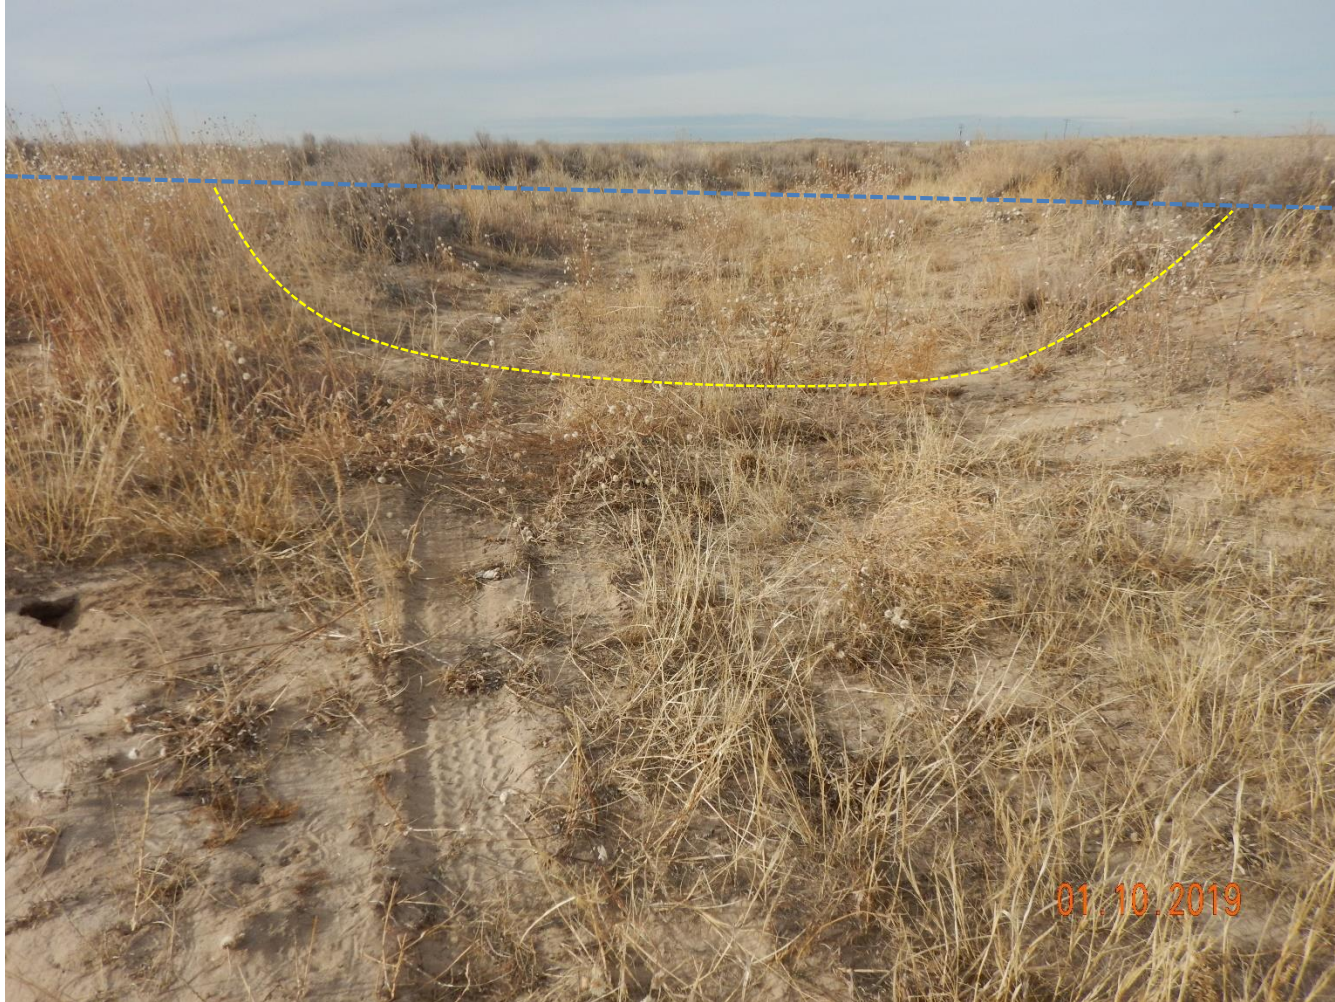
Photo 6: Photo taken from the access road, facing north. Photo shows access road (blue line) has not been recontoured/regraded to that of the adjacent reference area (yellow line)

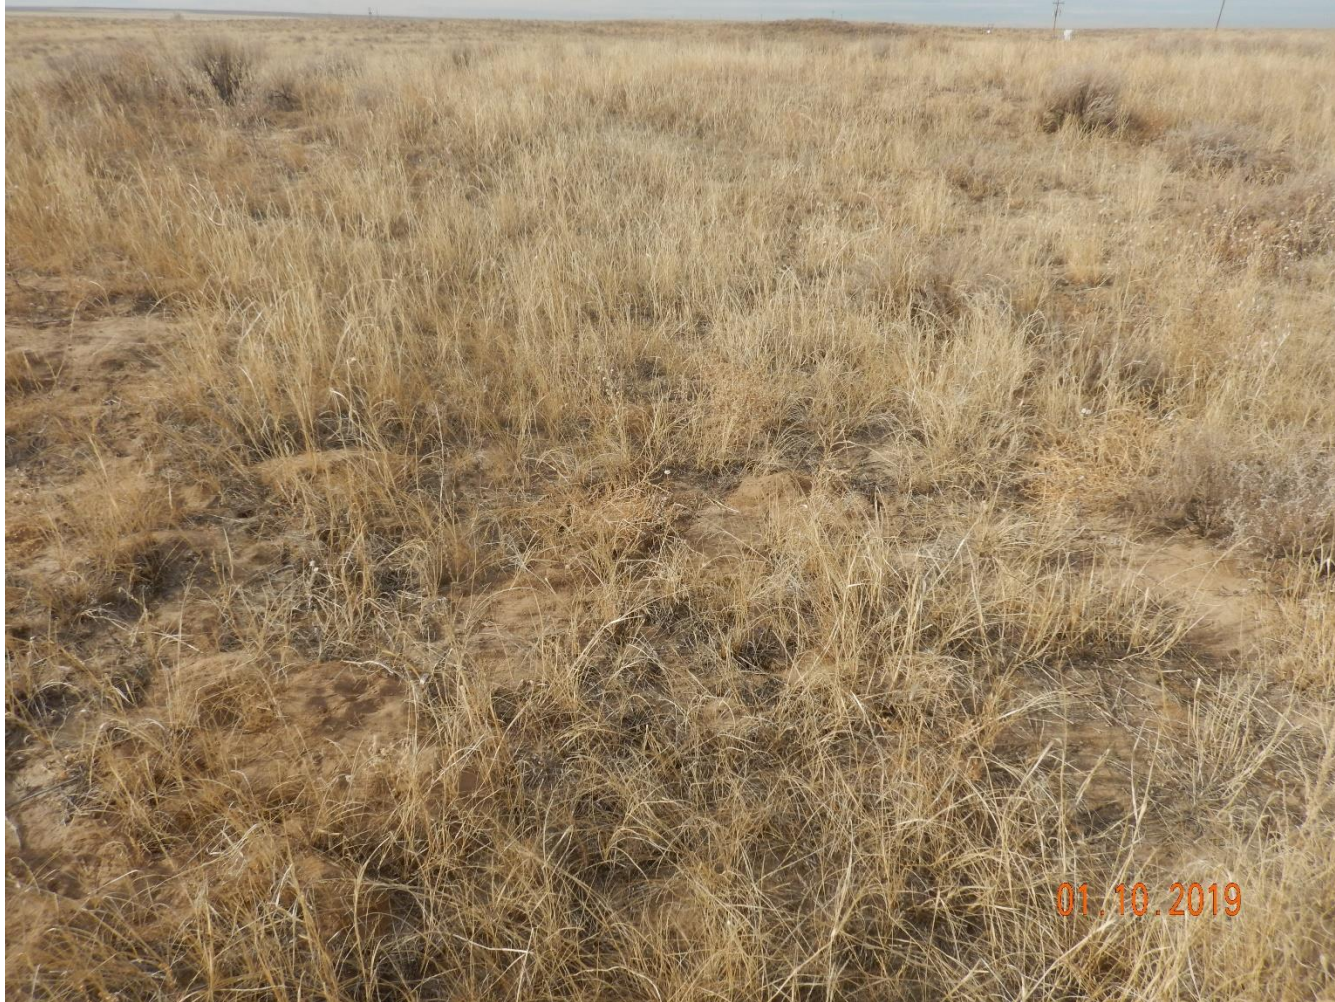
Photo 7: Photo taken from the adjacent reference area. Photo shows vegetation over reference. Vegetation observed predominantly Sand dropseed, blue grama, western wheatgrass, sand sage, etc...

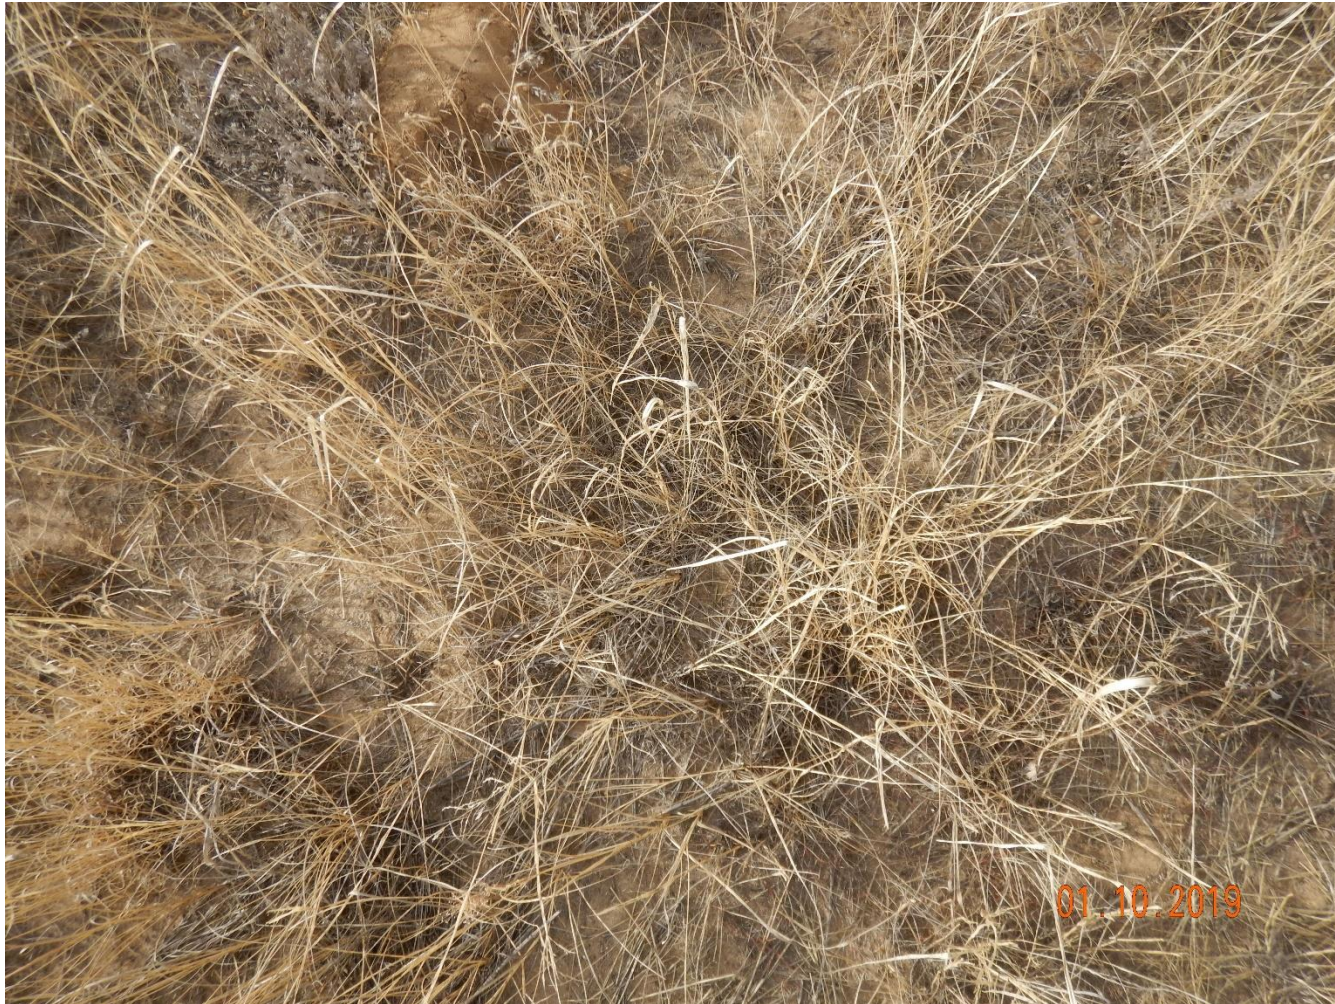
Photo 8: Photo taken from the adjacent reference area. Photo shows vegetation over reference. See comments under photo 7.
