Inspection Photos
Operator Name: Caerus Piceance LLC
Facility ID: 460722

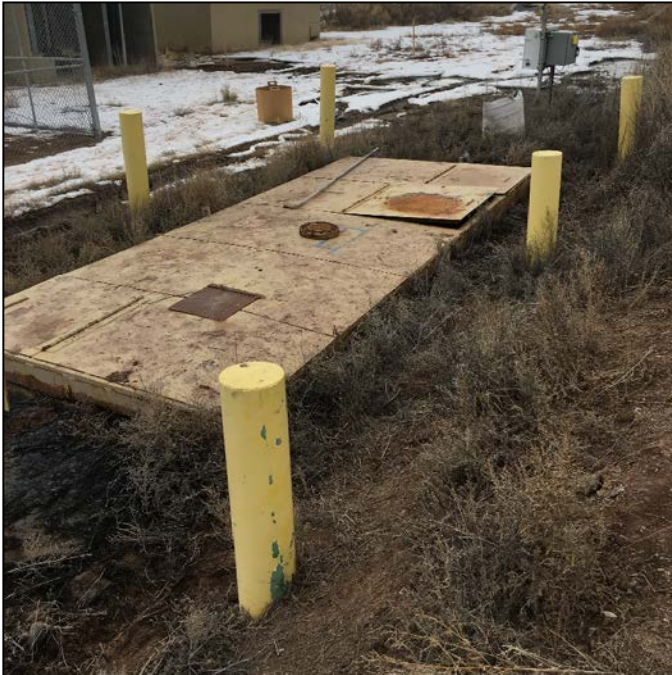
WC-4 Vault Point of release

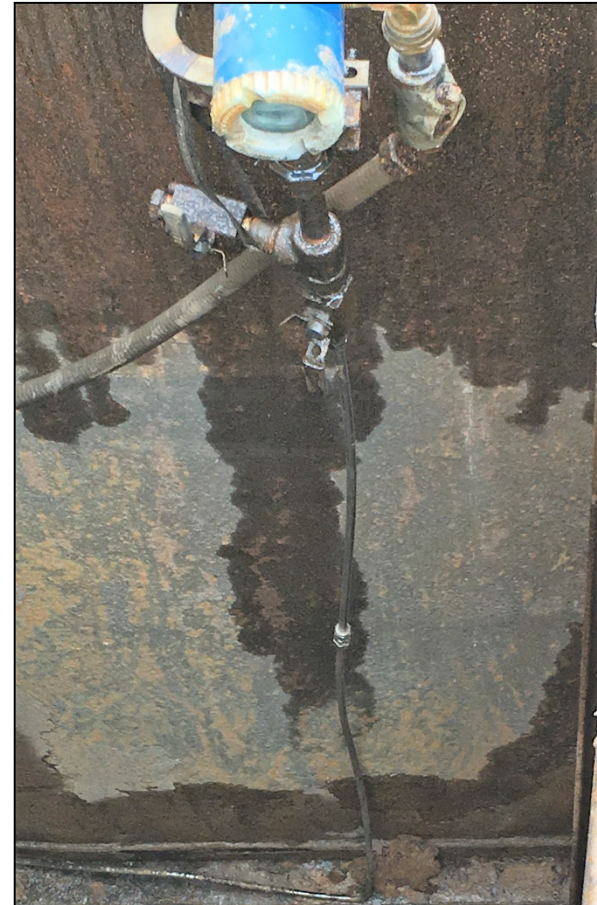
3/8" Stainless steel process piping that separated and was point of release. Line repaired in picture with coupler
