Inspection Photos

Operator: BAYHORSE PETROLEUM LLC - 10234

Location ID: 384906

Inspection Doc. Number: 682504426

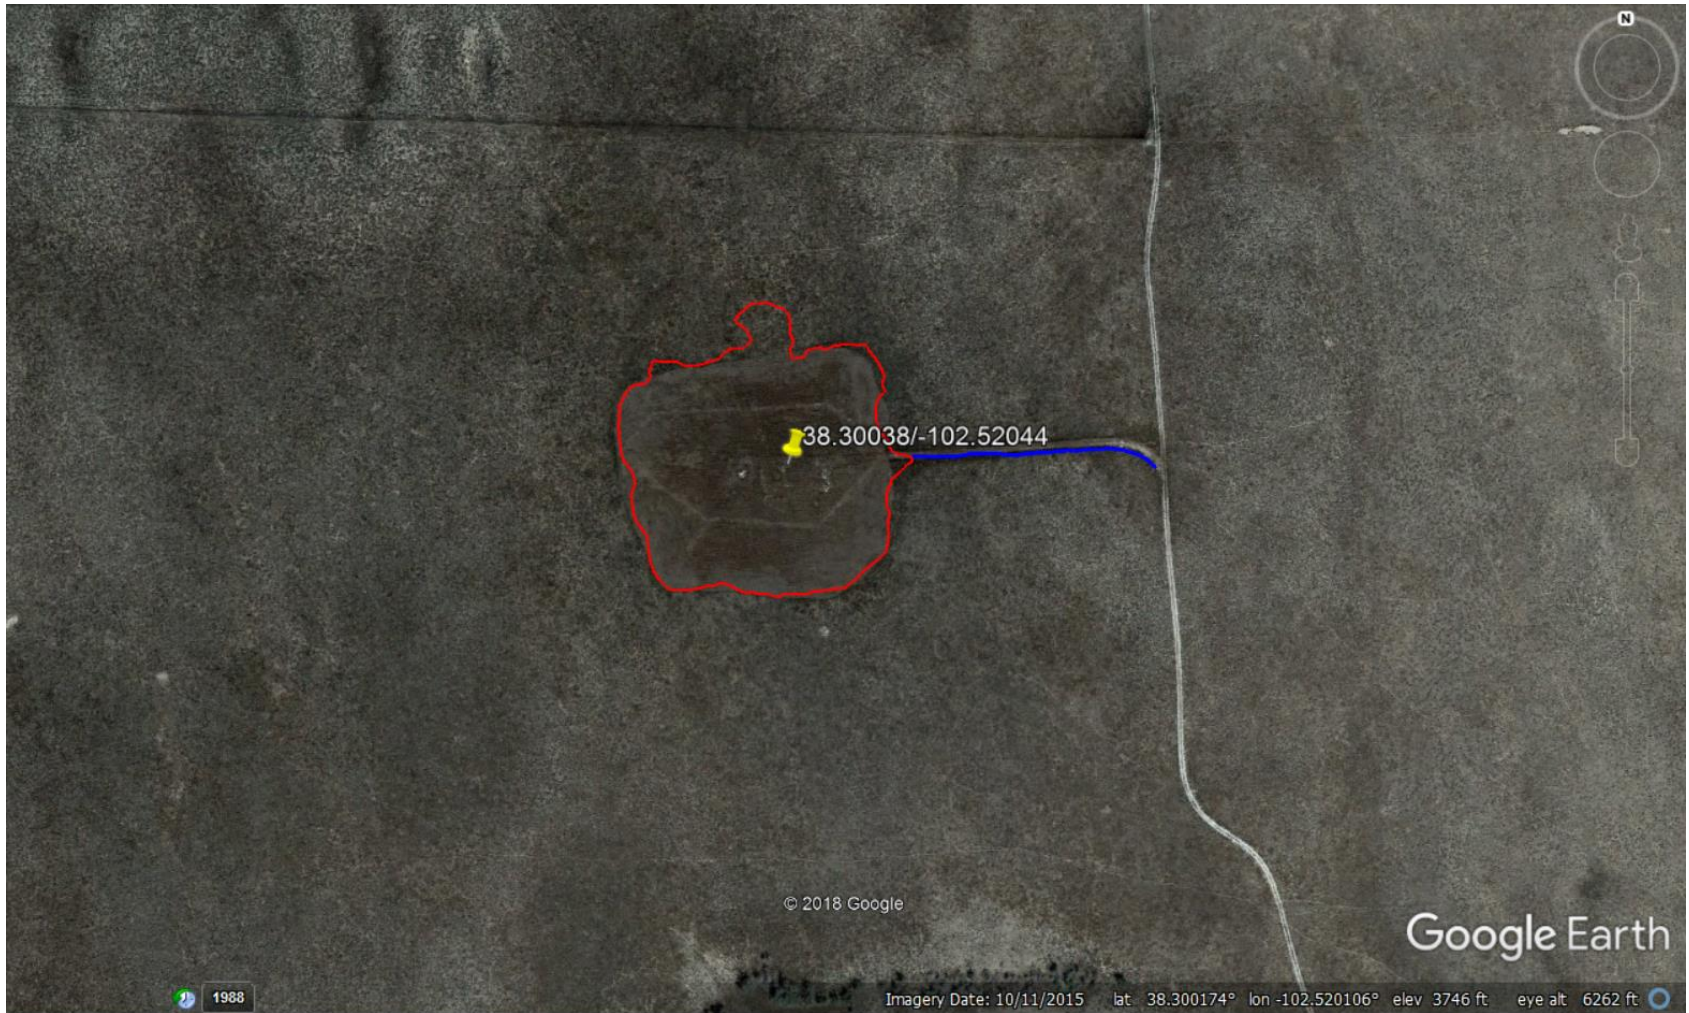
Photo 1: 2017 Google Earth aerial image. Photo shows areas of the location (red polygon, 4.11 acres) where vegetation has not achieved a uniform desirable perennial vegetative cover. Photo also shows access road (blue, 434 feet). Access road remains predominantly bare and exposed soil.

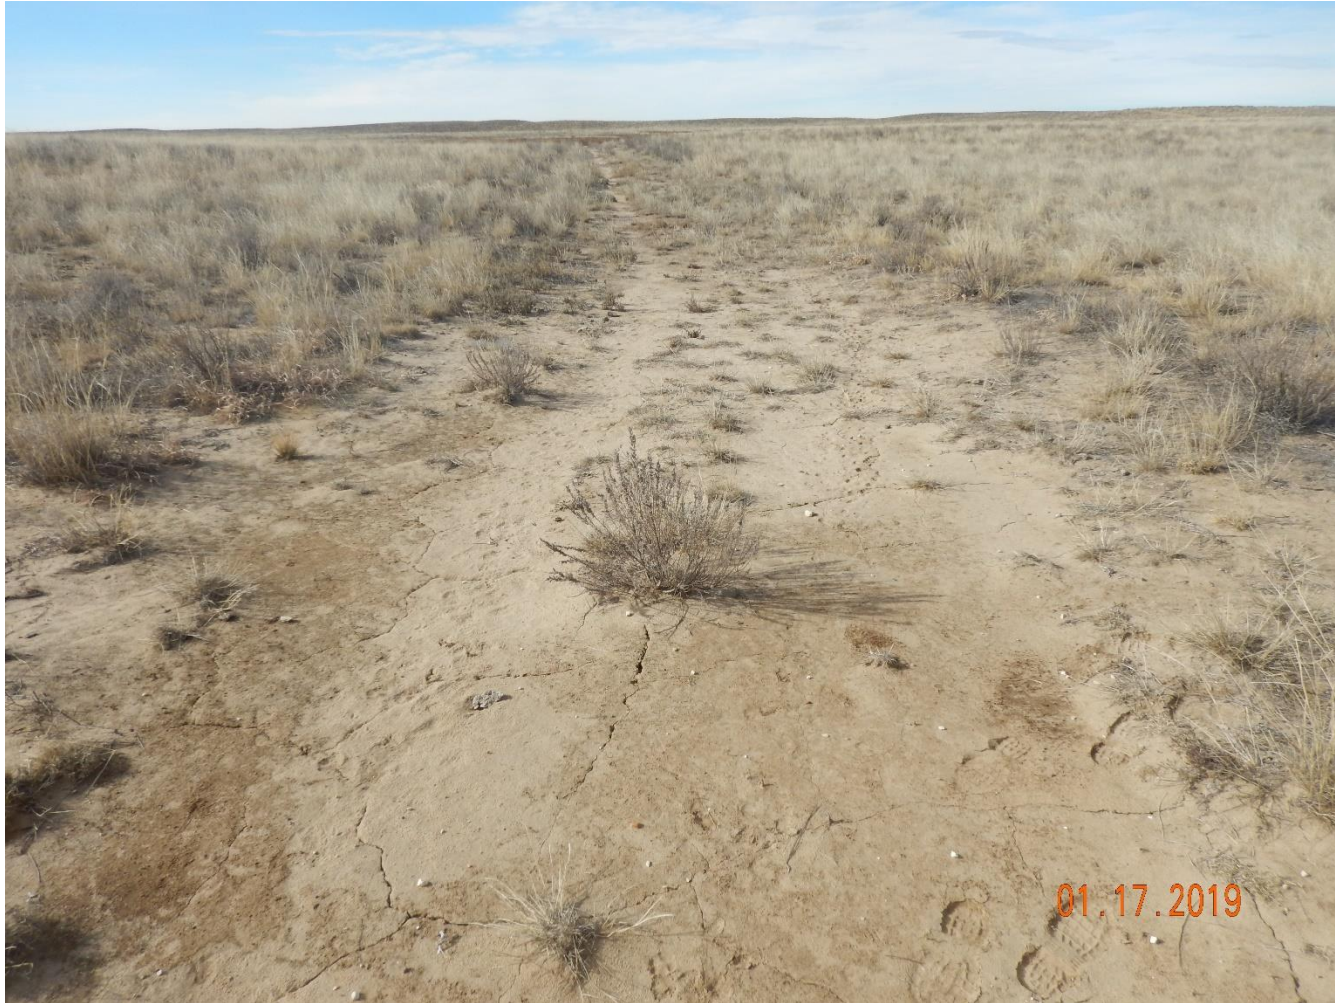
Photo 2: Photo taken from the access road east of the location, facing west. Photo shows access road remains predominantly bare and exposed soil.

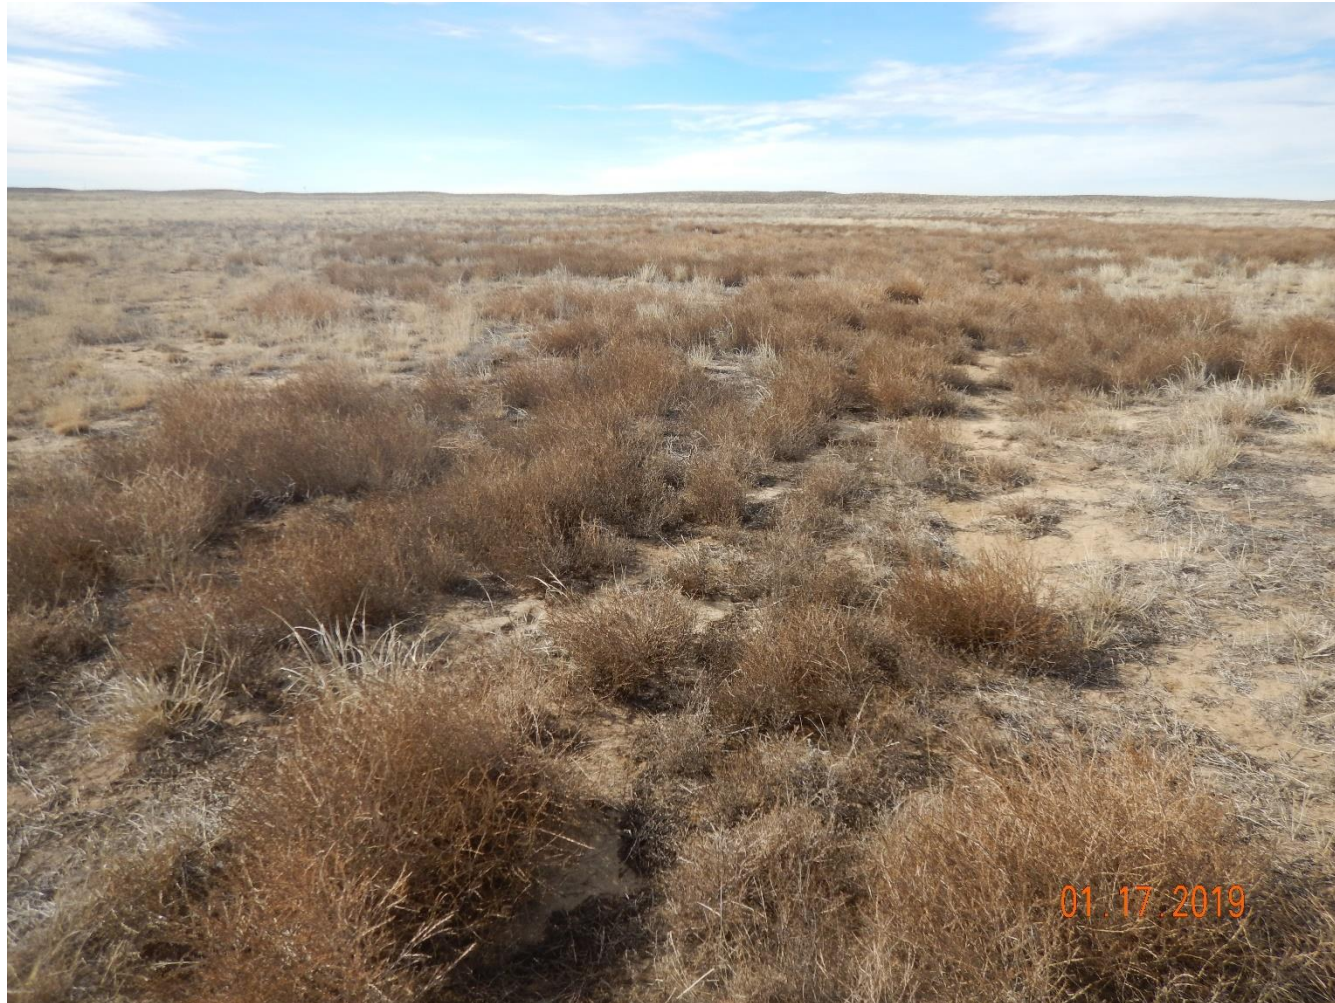
Photo 3: Photo taken from the access road on the east end of the location, facing west. Photo shows location remains predominantly undesirable weedy plant species (Russian thistle) or bare and exposed soils.

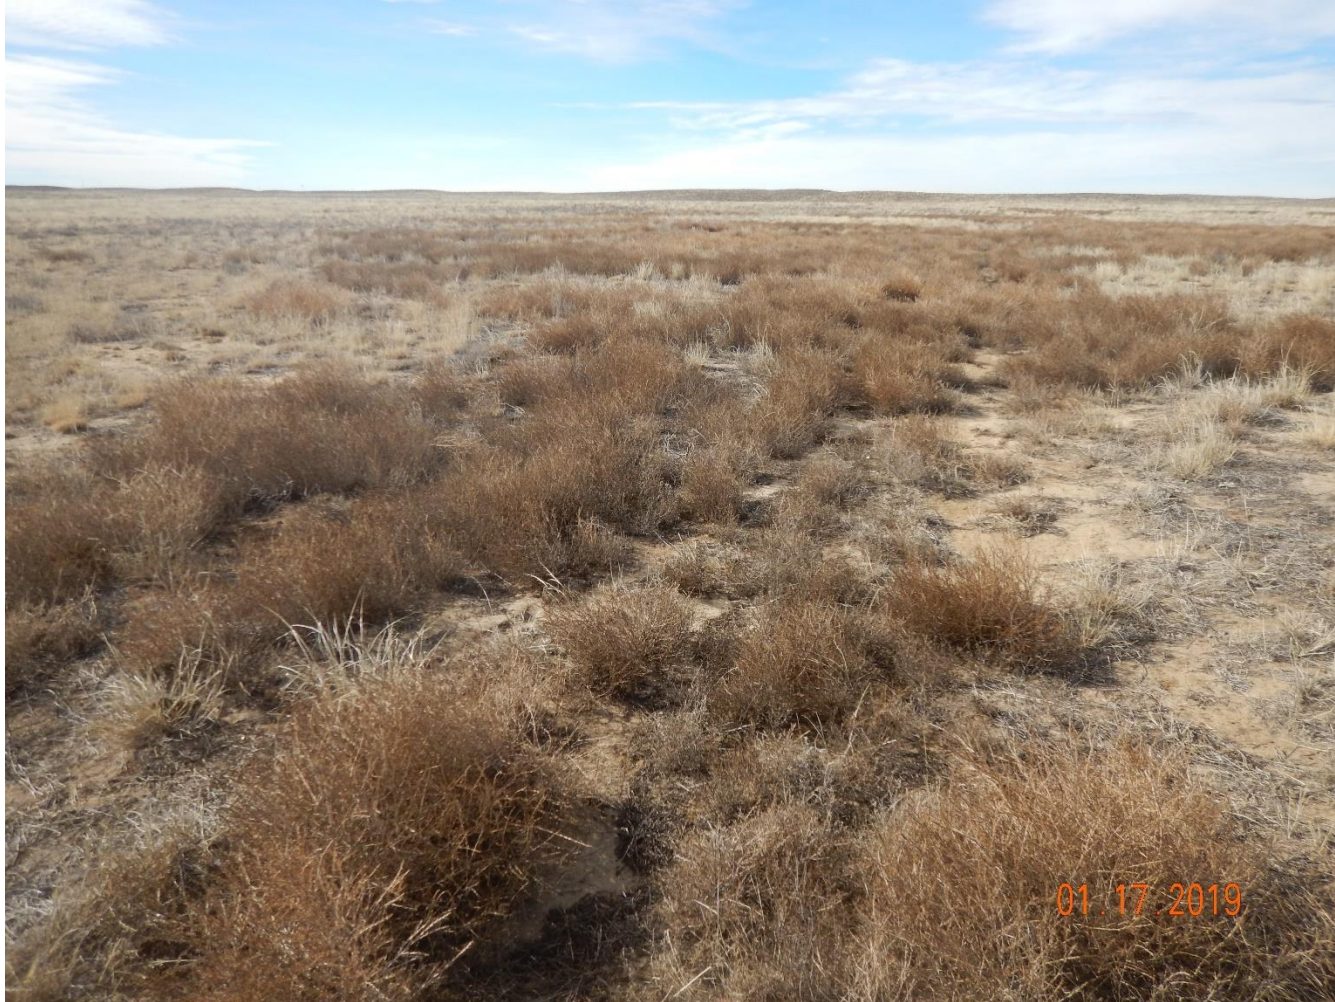
Photo 4: Photo taken from the access road on the east end of the location, facing west. Photo shows location remains predominantly undesirable weedy plant species (Russian thistle) or bare and exposed soils.

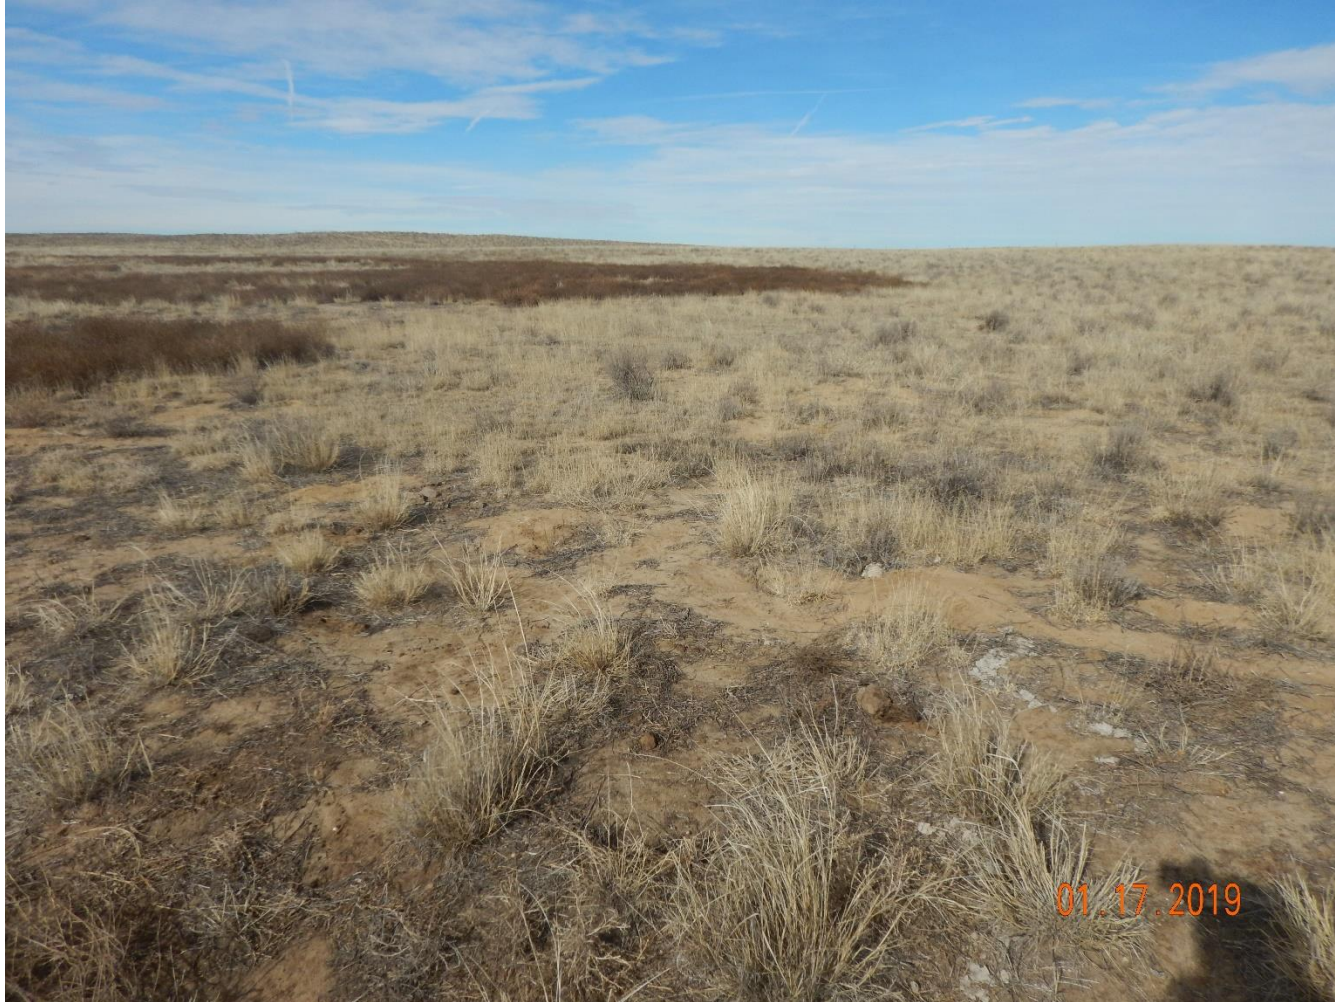
Photo 5: Photo taken from the access road on the east end of the location, facing northwest. Photo shows location remains predominantly undesirable weedy plant species (Russian thistle) or bare and exposed soils.

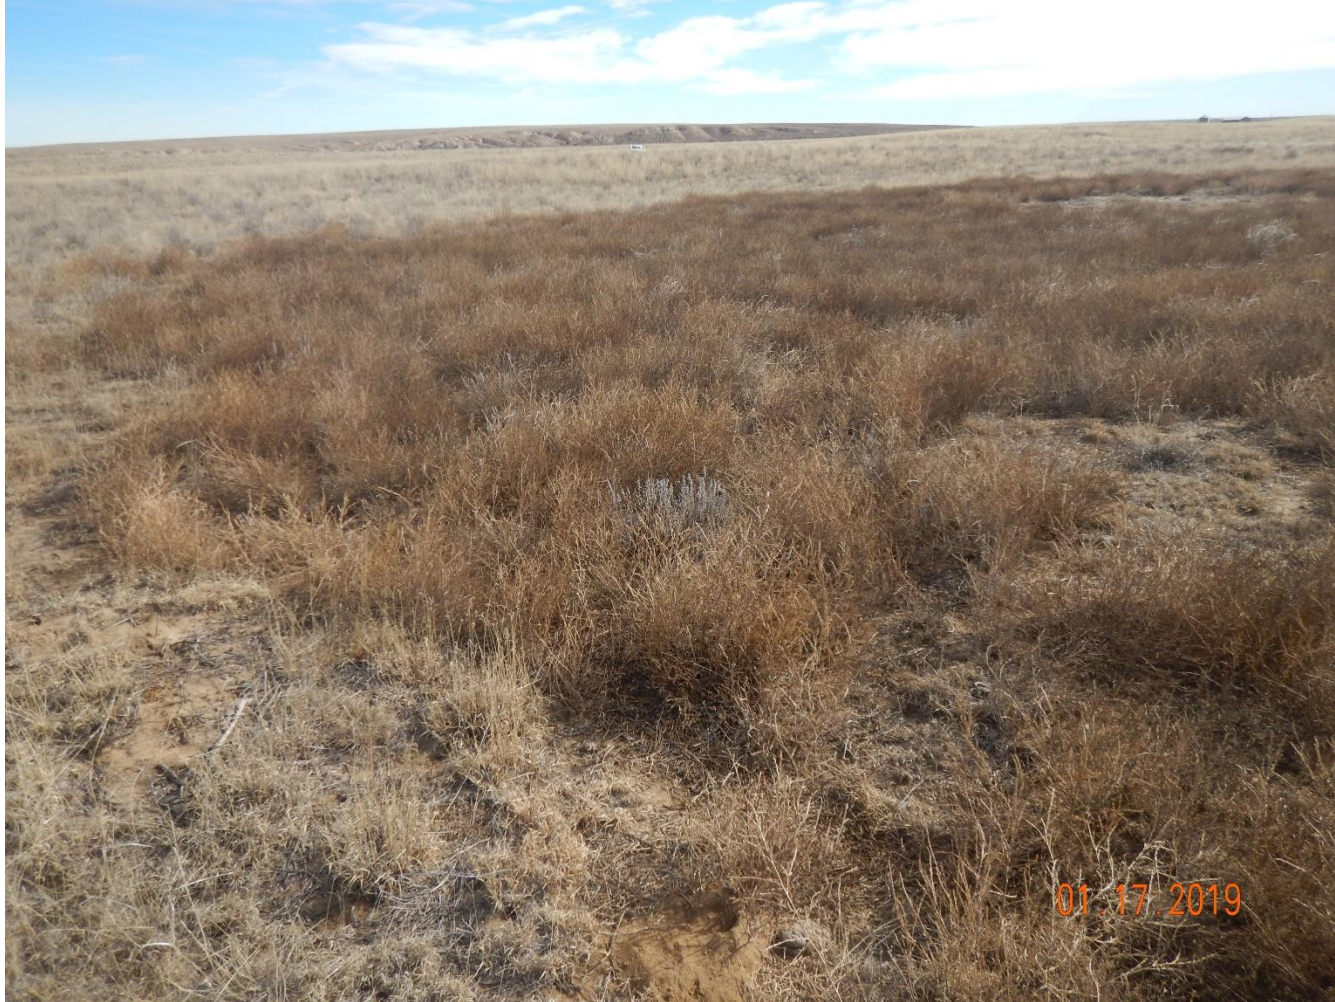
Photo 6: Photo taken from the north end of the location, facing east. See comments under photo 3.

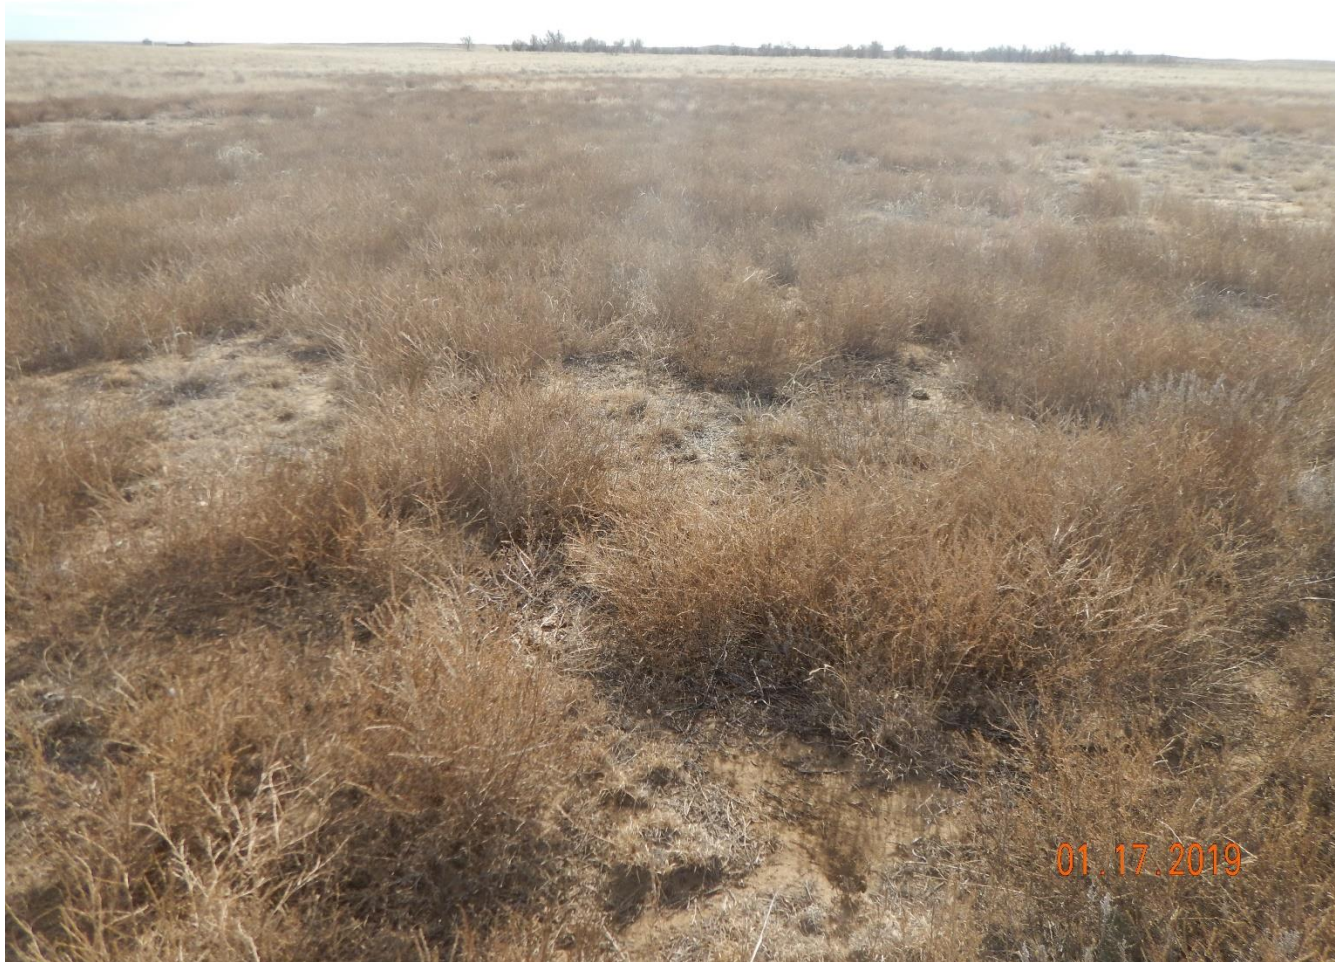
Photo 7: Photo taken from the north end of the location, facing south. See comments under photo 3.

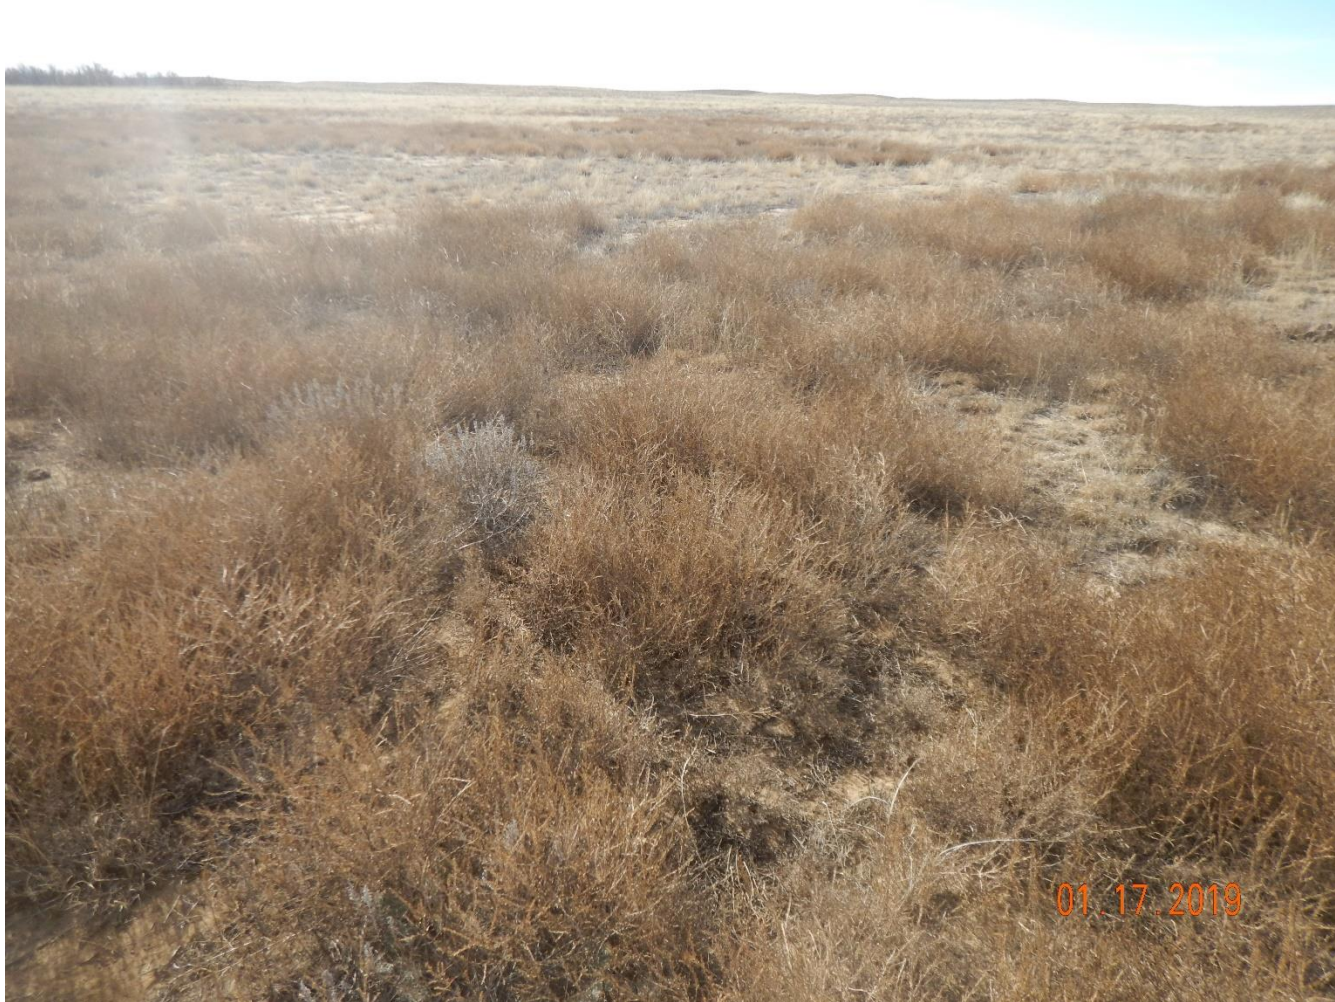
Photo 8: Photo taken from the north end of the location, facing southwest. See comments under photo 3.

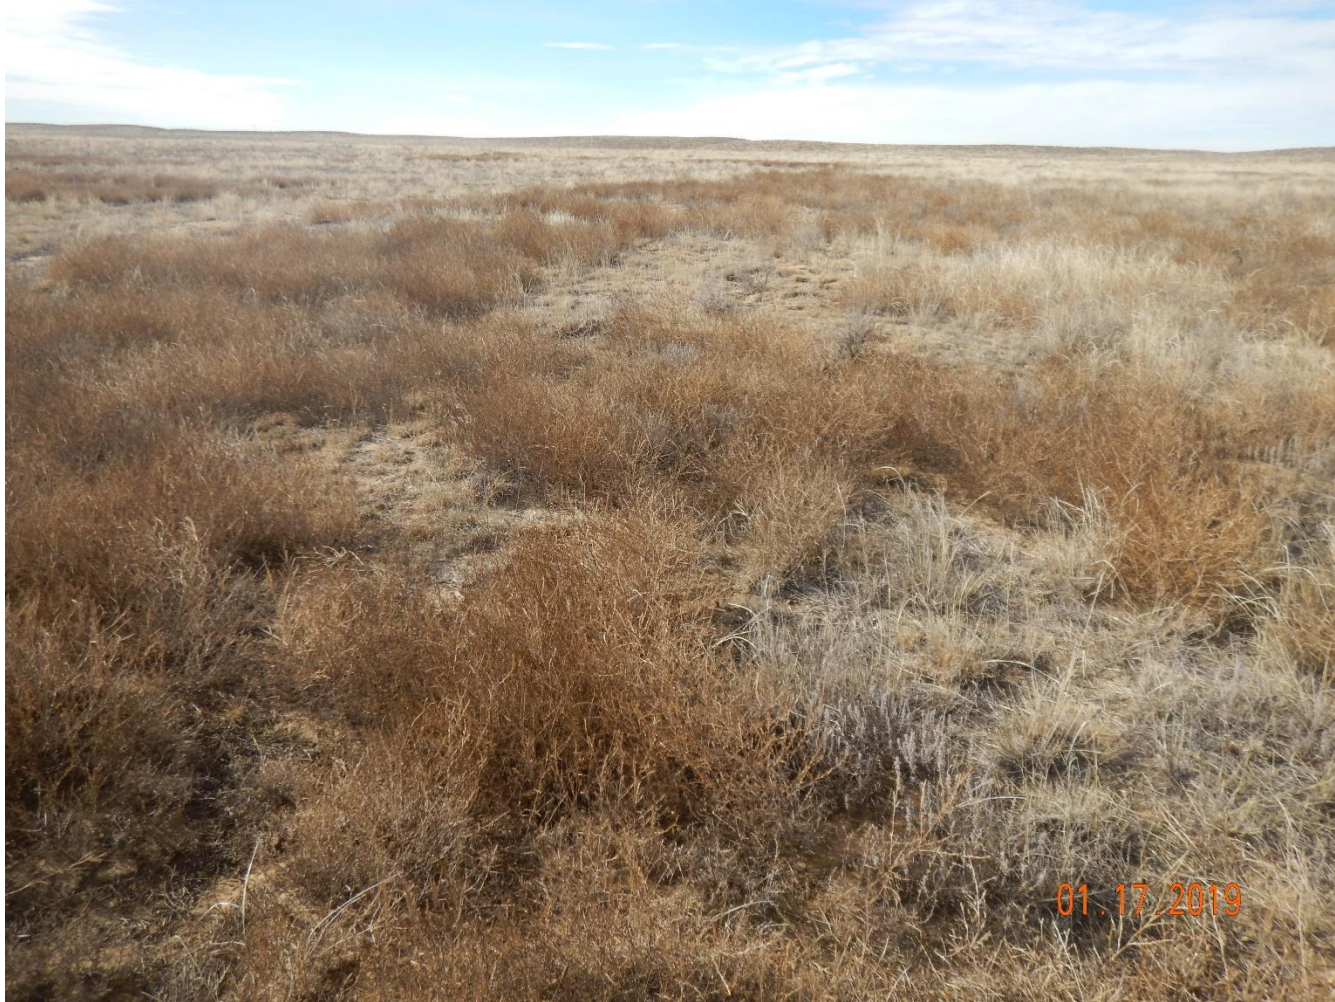
Photo 9: Photo taken from the north end of the location, facing west. See comments under photo 3.

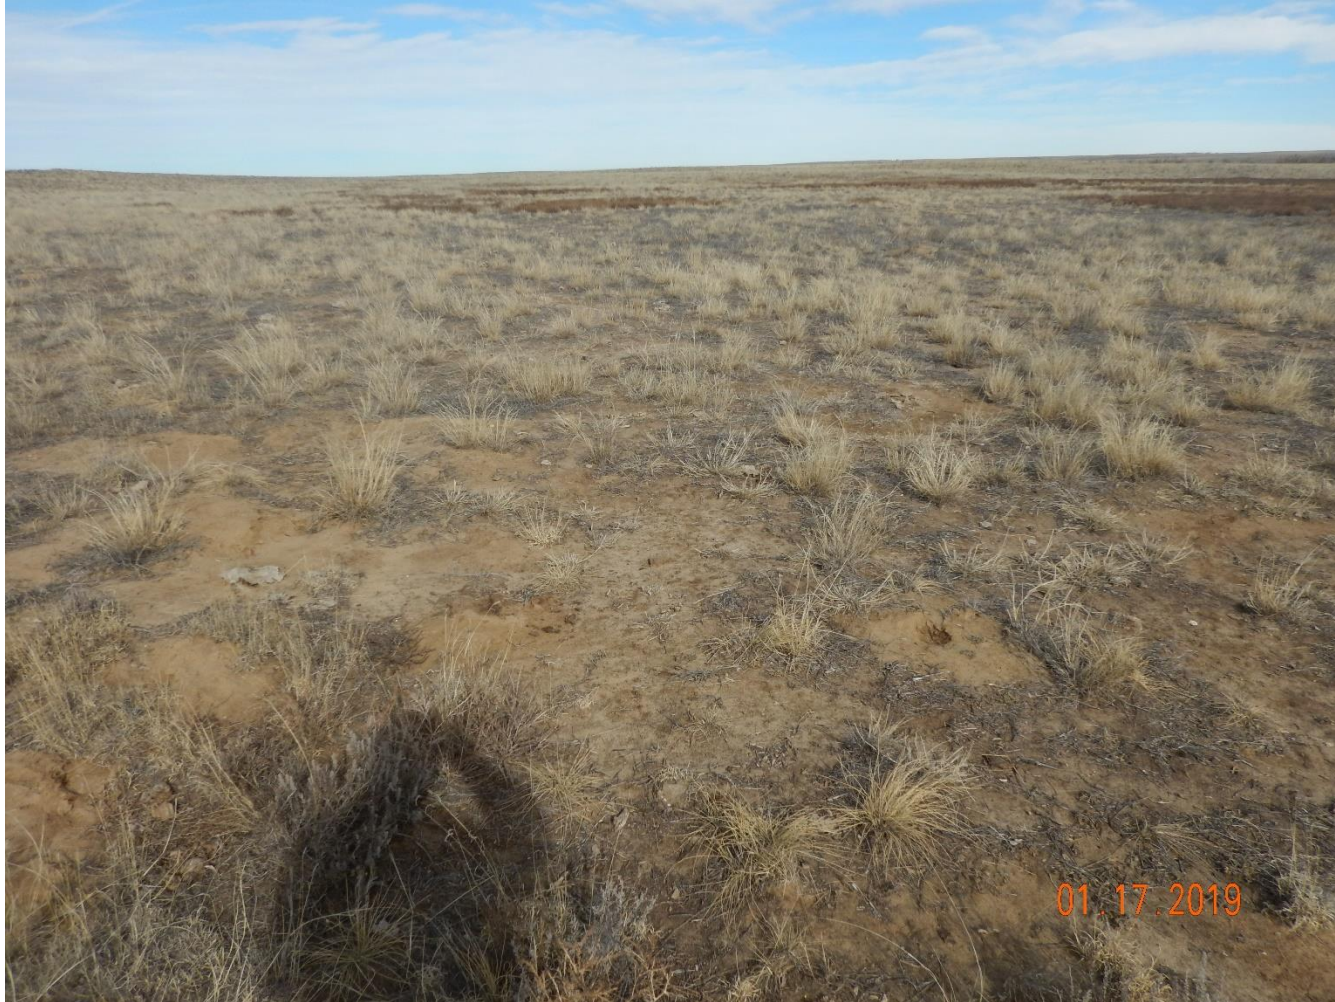
Photo 10: Photo taken from the southwest end of the location, facing northeast. See comments under photo 3. Vegetation observed in photo is sand dropseed. Desirable vegetation is sparse and not uniform.

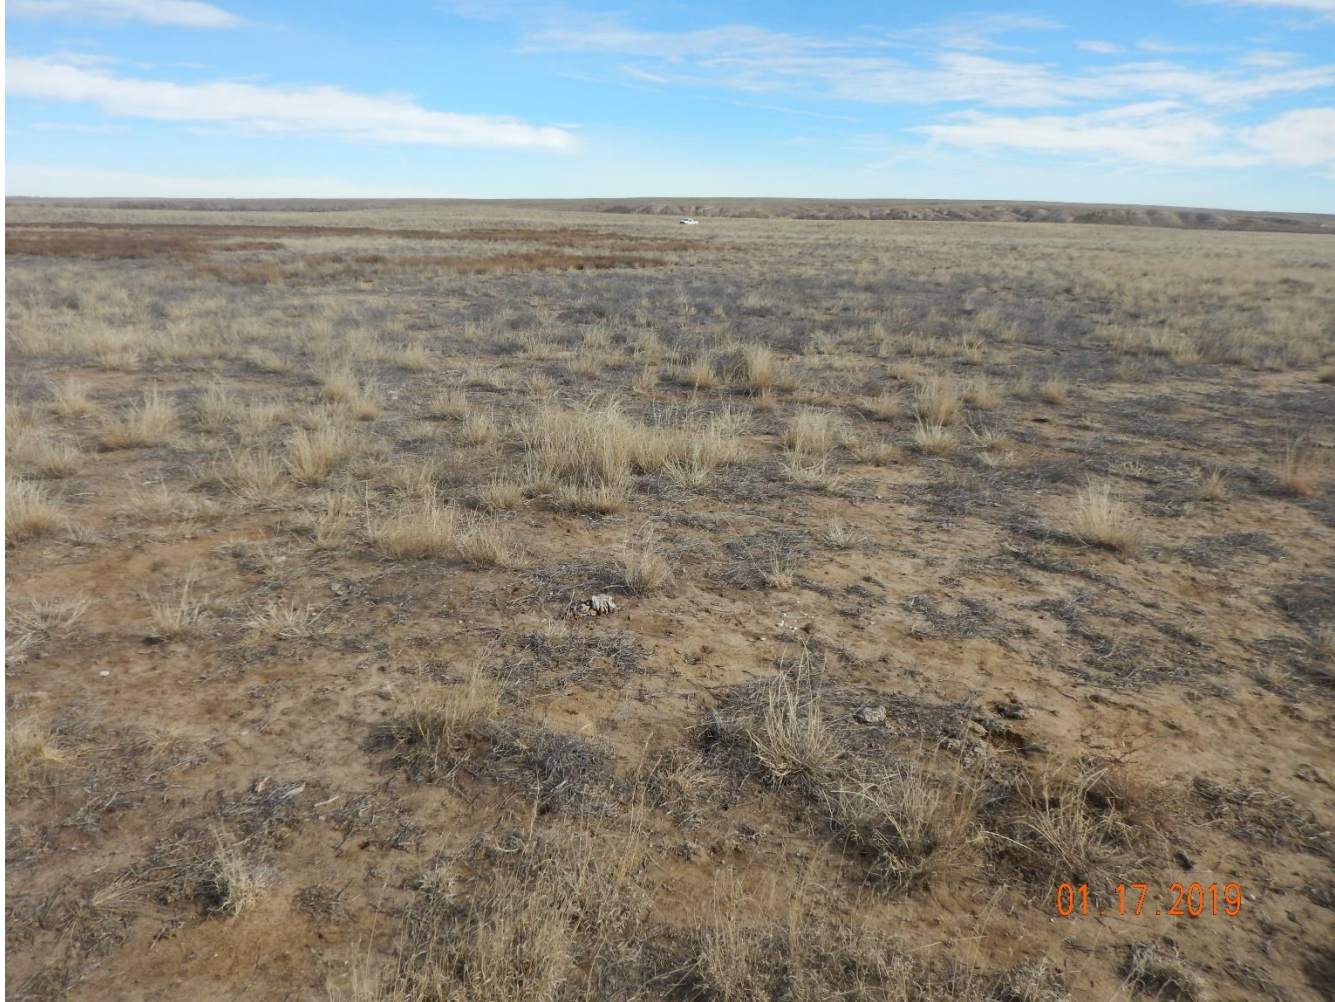
Photo 11: Photo taken from the southwest end of the location, facing east. See comments under photo 3. Vegetation observed in photo is sand dropseed. Desirable vegetation is sparse and not uniform.

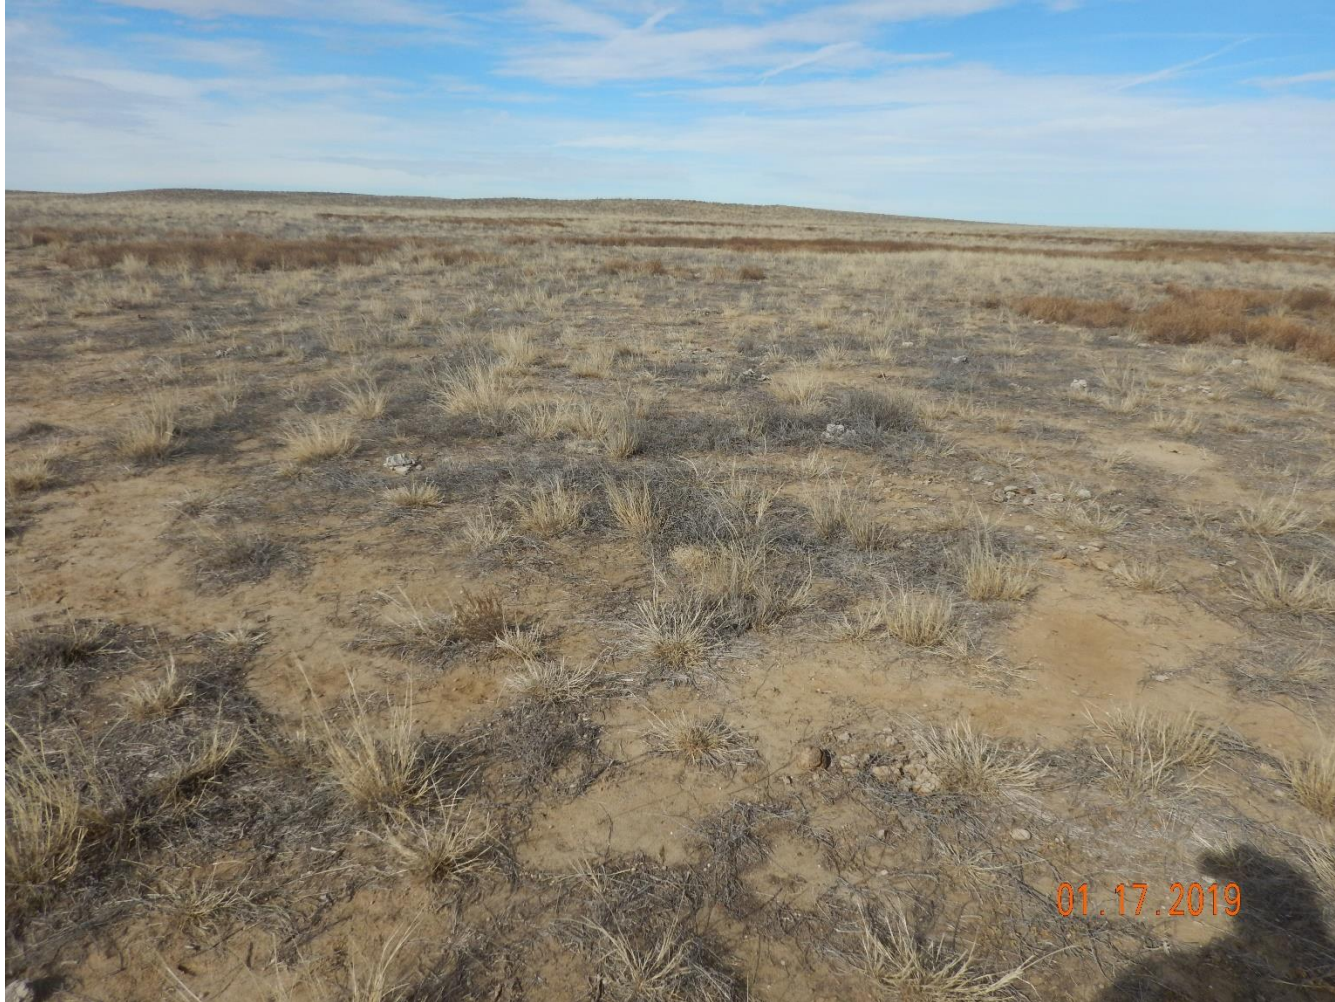
Photo 12: Photo taken from the south end of the location, facing northwest. See comments under photo 3.

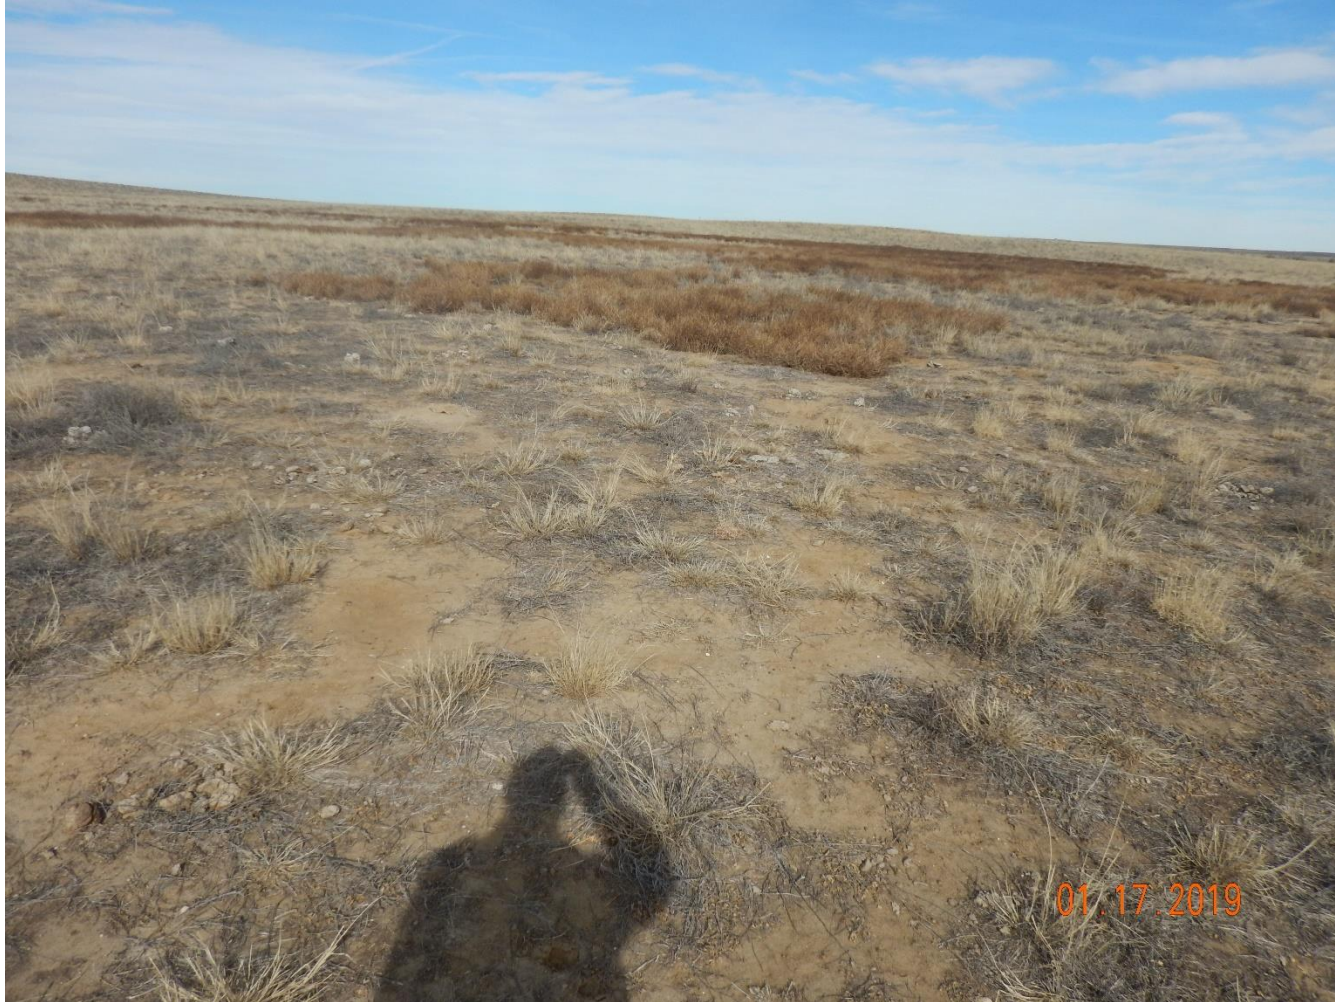
Photo 13: Photo taken from the south end of the location, facing north. See comments under photo 3.

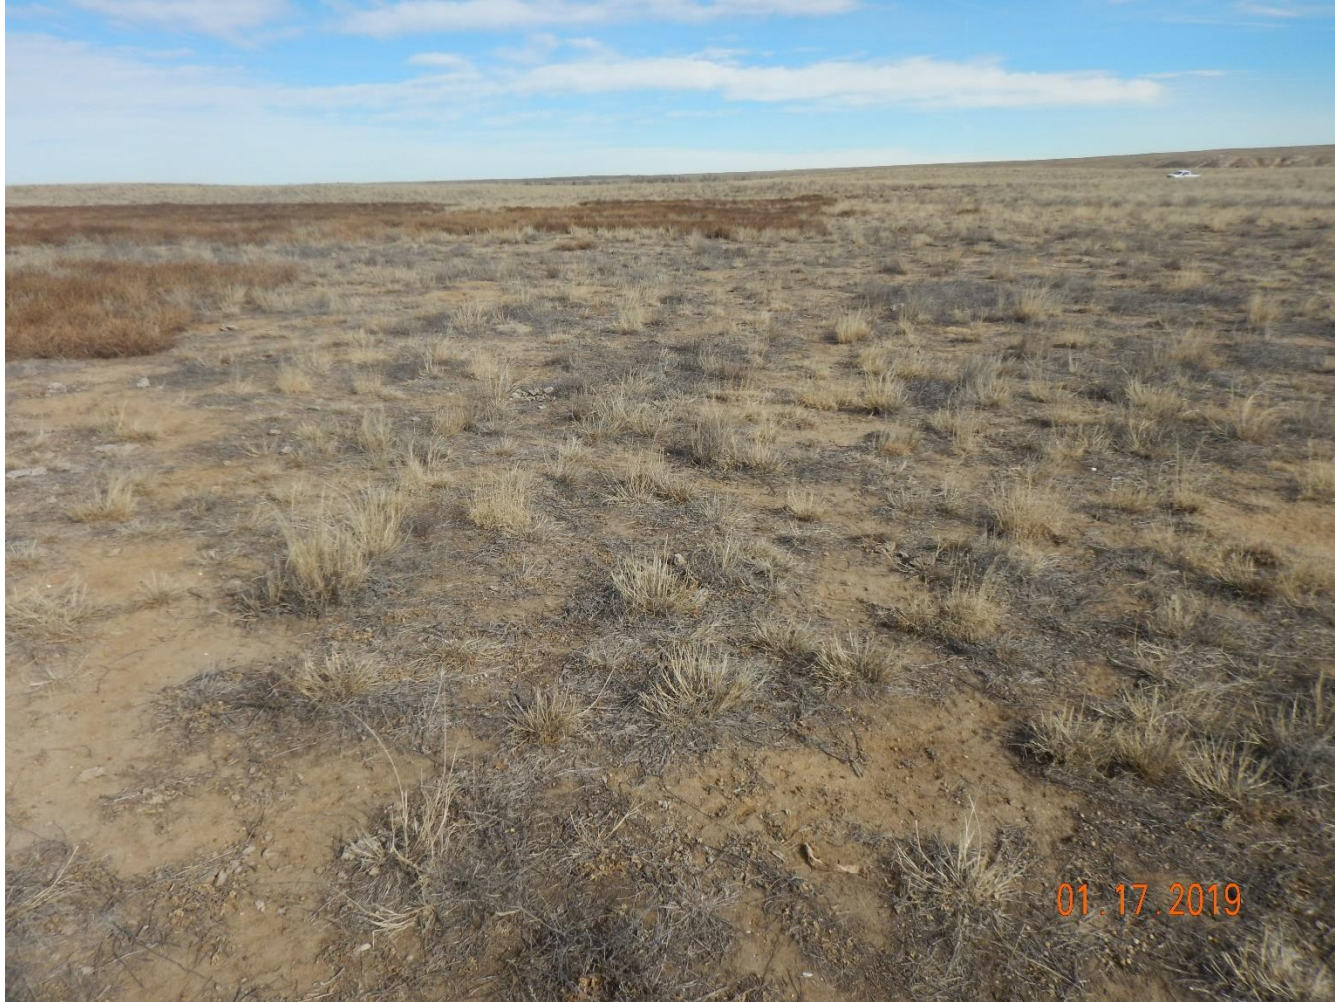
Photo 14: Photo taken from the south end of the location, facing northeast. See comments under photo 3.

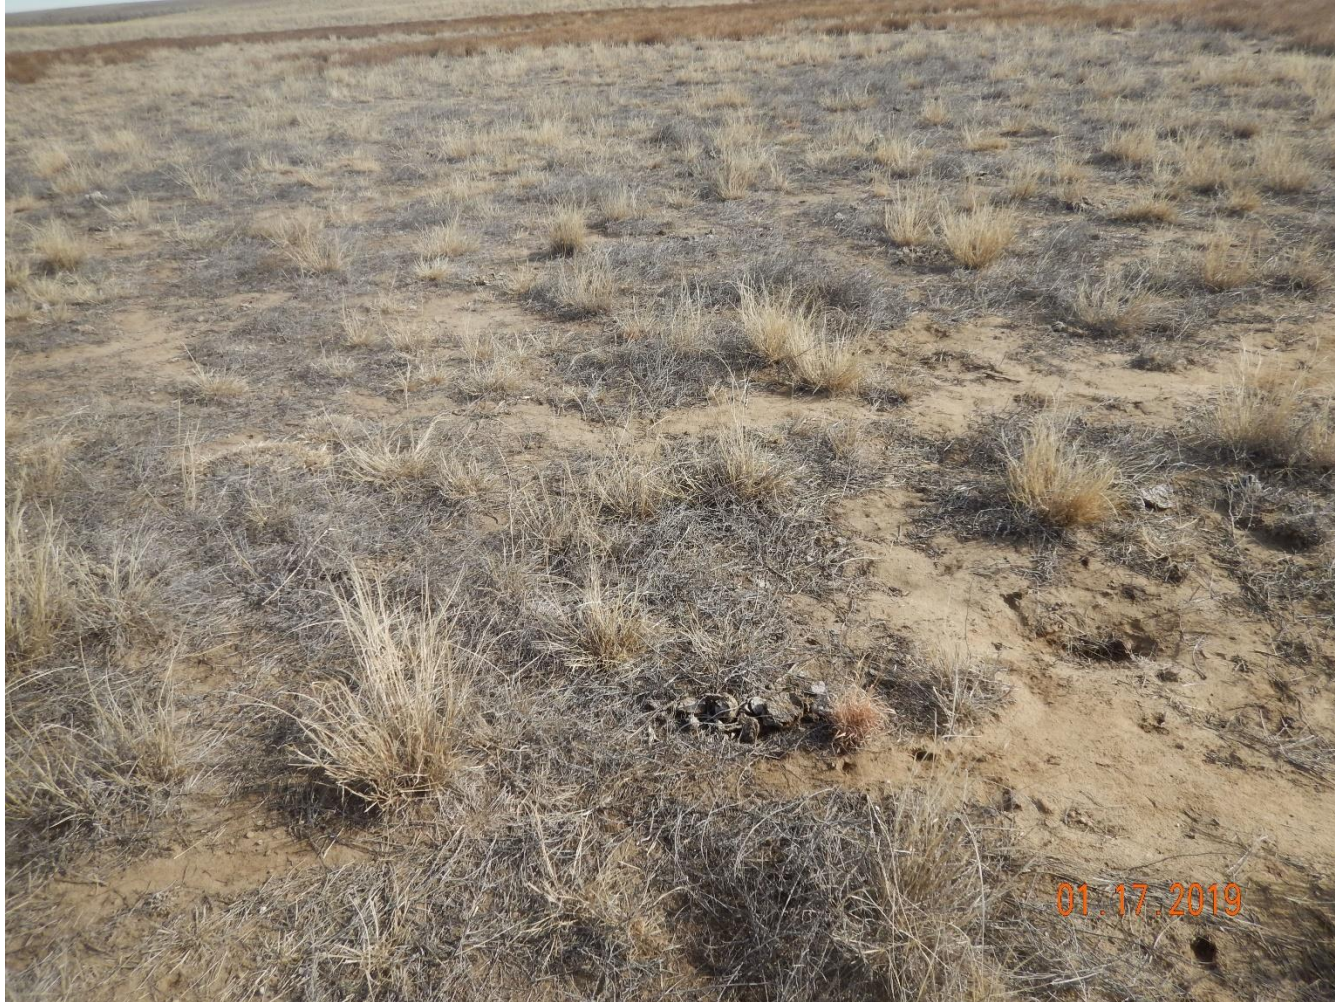
Photo 15: Photo taken from the central area of the location. Photo shows location remains predominantly bare and exposed soils or undesirable weedy plant species. Yellow colored vegetation seen in photo Sand Dropseed. Any desirable vegetation on location is sparse and not uniform.

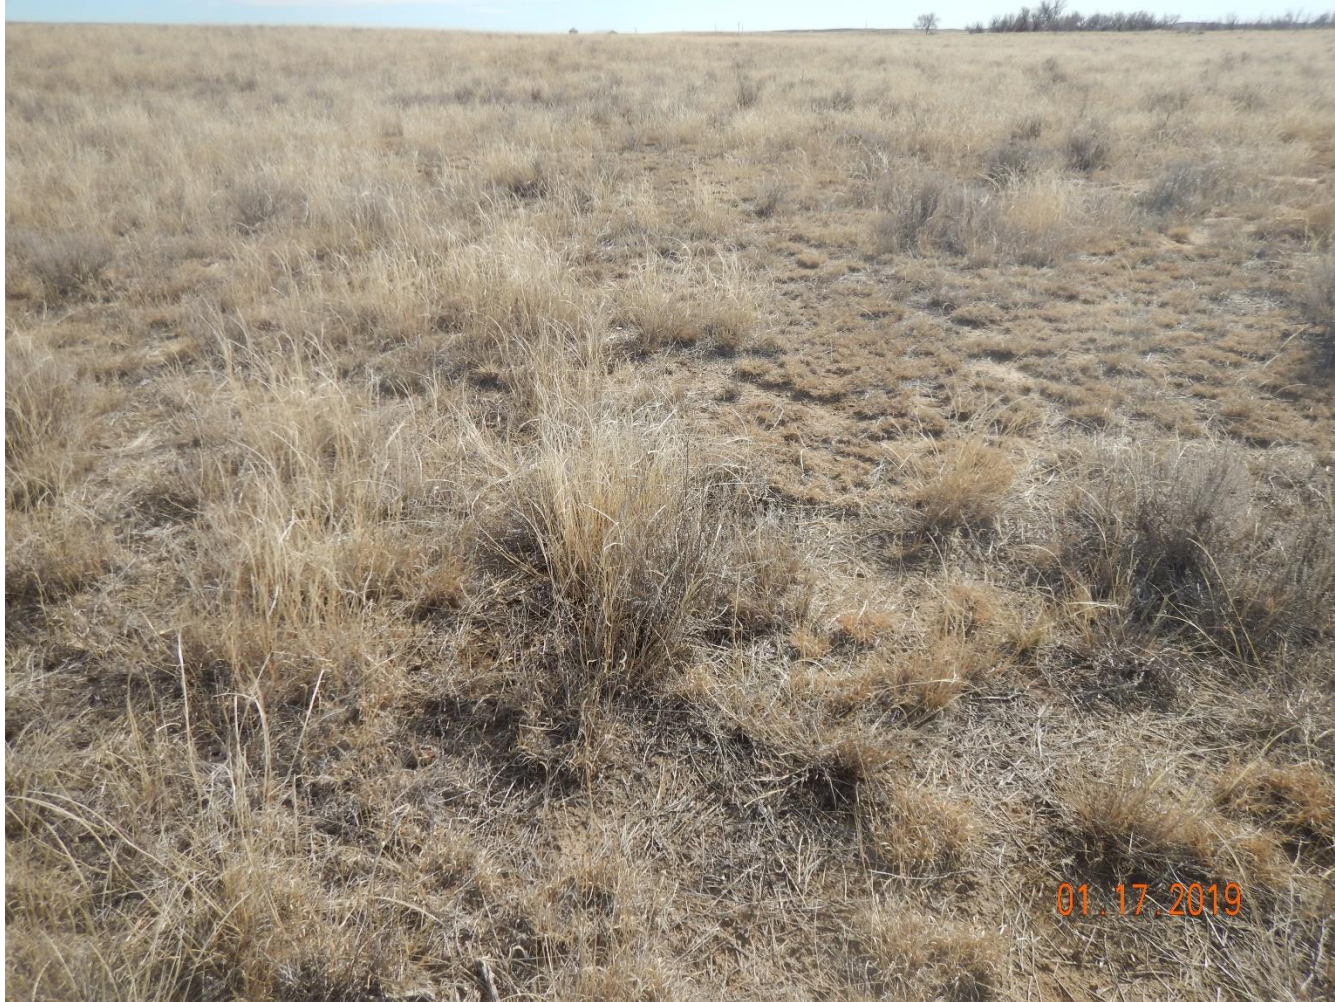
Photo 16: Photo taken from the adjacent reference area. Vegetation observed included Sand Draopseed, Blue grama, Western Wheatgrass, Sand Sage, Purple threeawn, etc... Photo shows location is not reflective of the reference areas.
