# Inspection Photos

Operator: BAYHORSE PETROLEUM LLC - 10234

Location ID: 440886

Inspection Doc. Number: 682504441

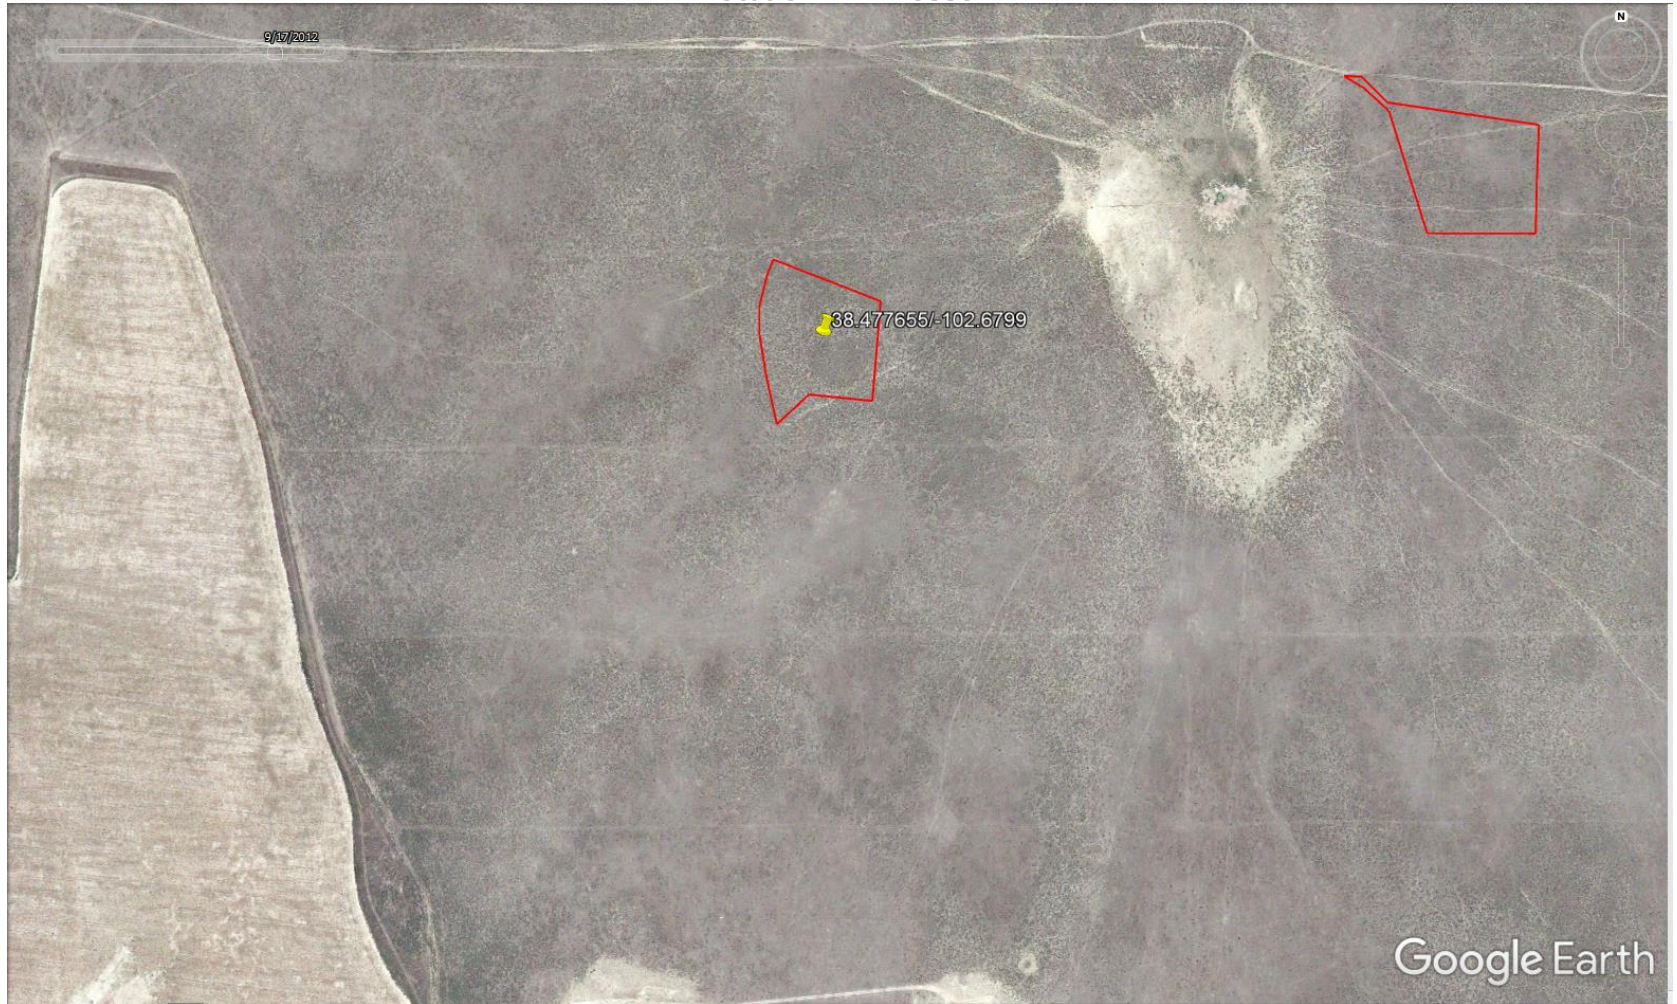
**Photo 1:** 2012 google earth aerial image. Photo shows area prior to oil and gas disturbance. Note access road did not pre-exist oil and gas location.

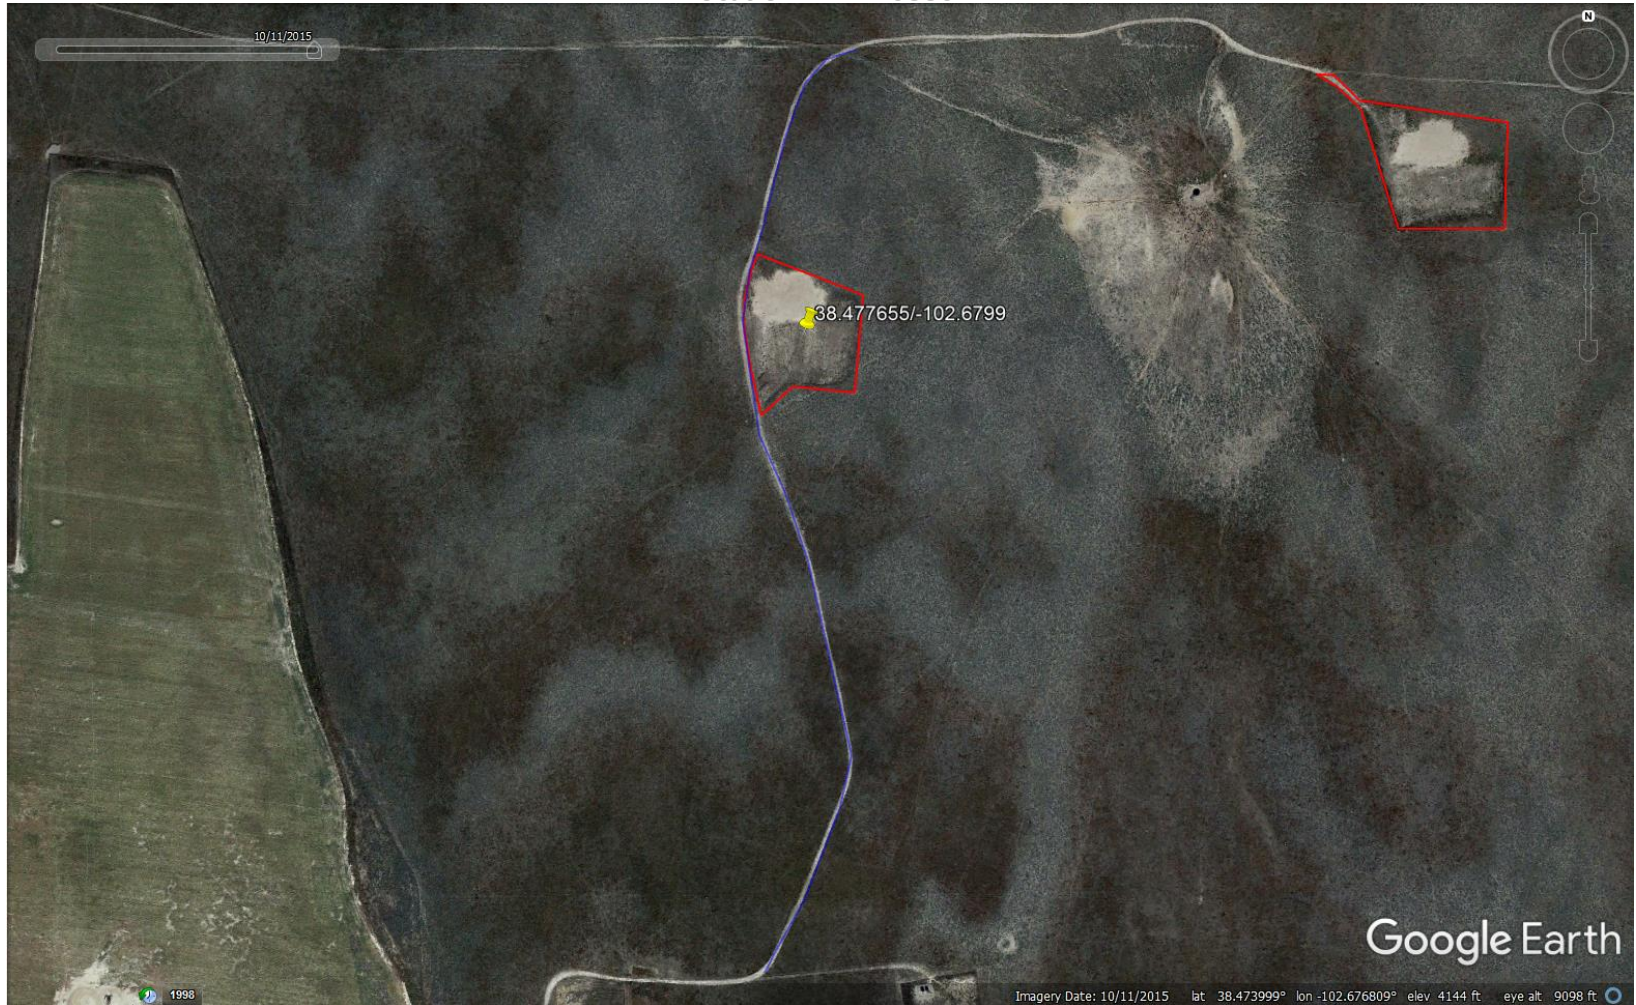
**Photo 1b:** 2015 google earth aerial image. Photo shows area of the location and access road disturbance mapped on the ground by inspector with a GPS. Mapped disturbance of location is ~3.78 acres, access road is ~3,500 by inspector.

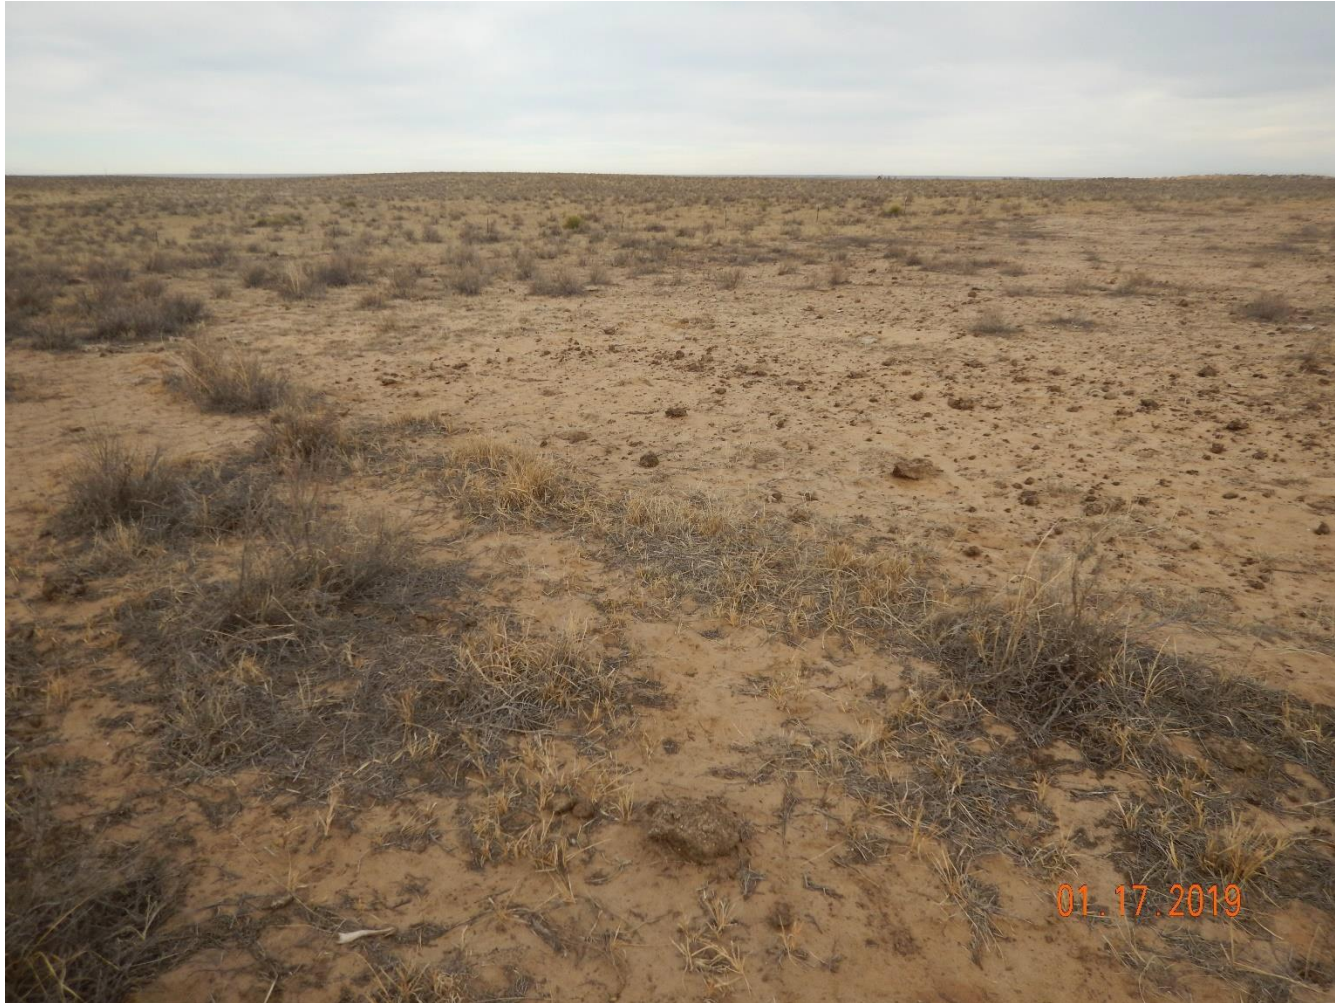
**Photo 2:** Photo taken from the west end of the location, facing north. Photo shows location remains predominantly bare and exposed soil. Desirable vegetative establishment does not appear to be progressing towards reclamation standards.

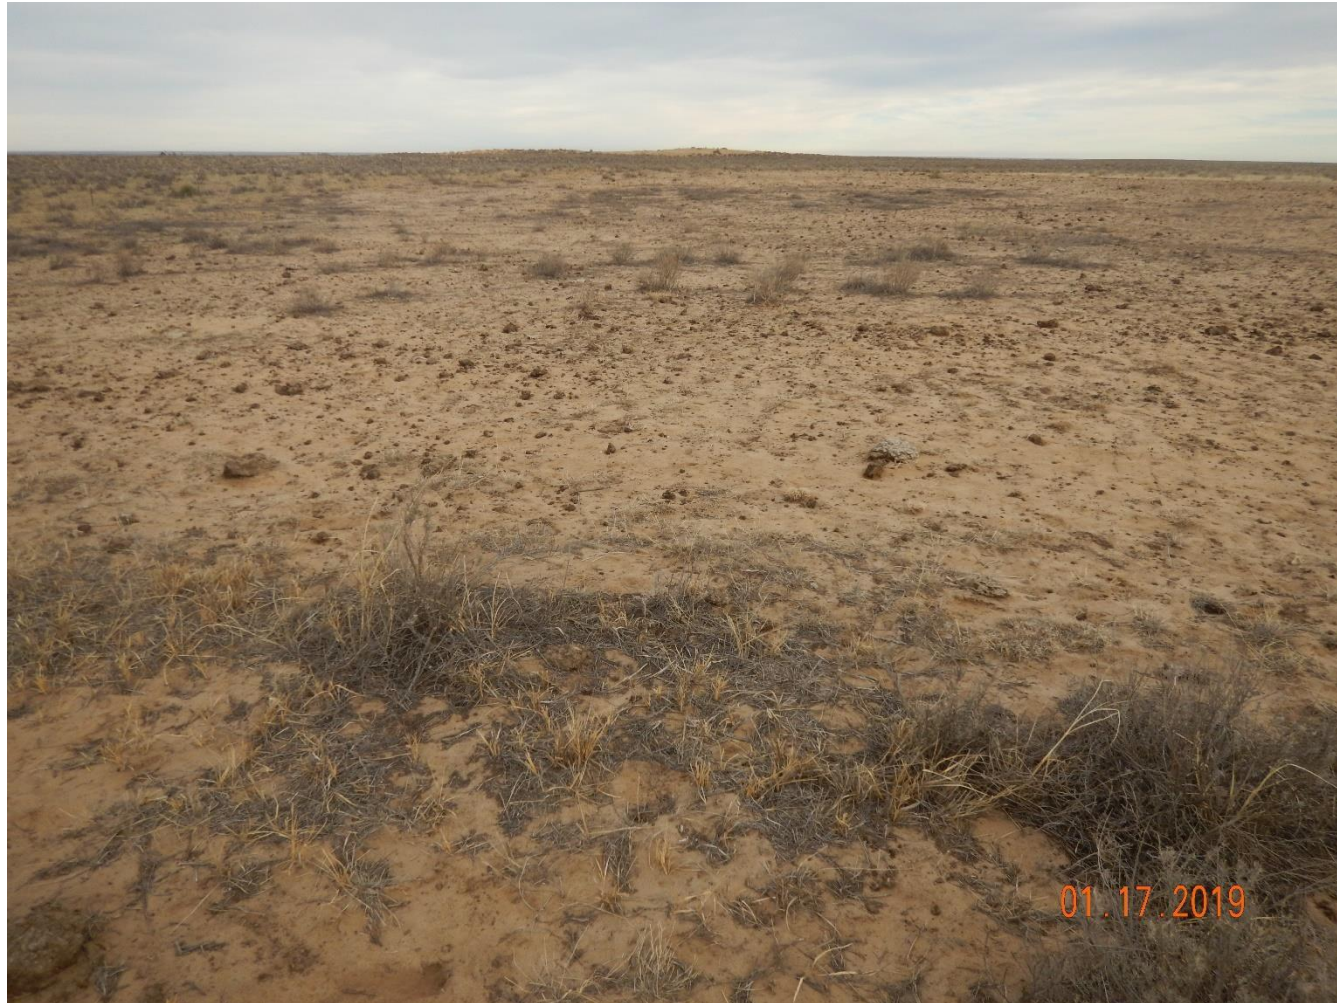
**Photo 3:** Photo taken from the west end of the location, facing northeast. See comments under photo 2

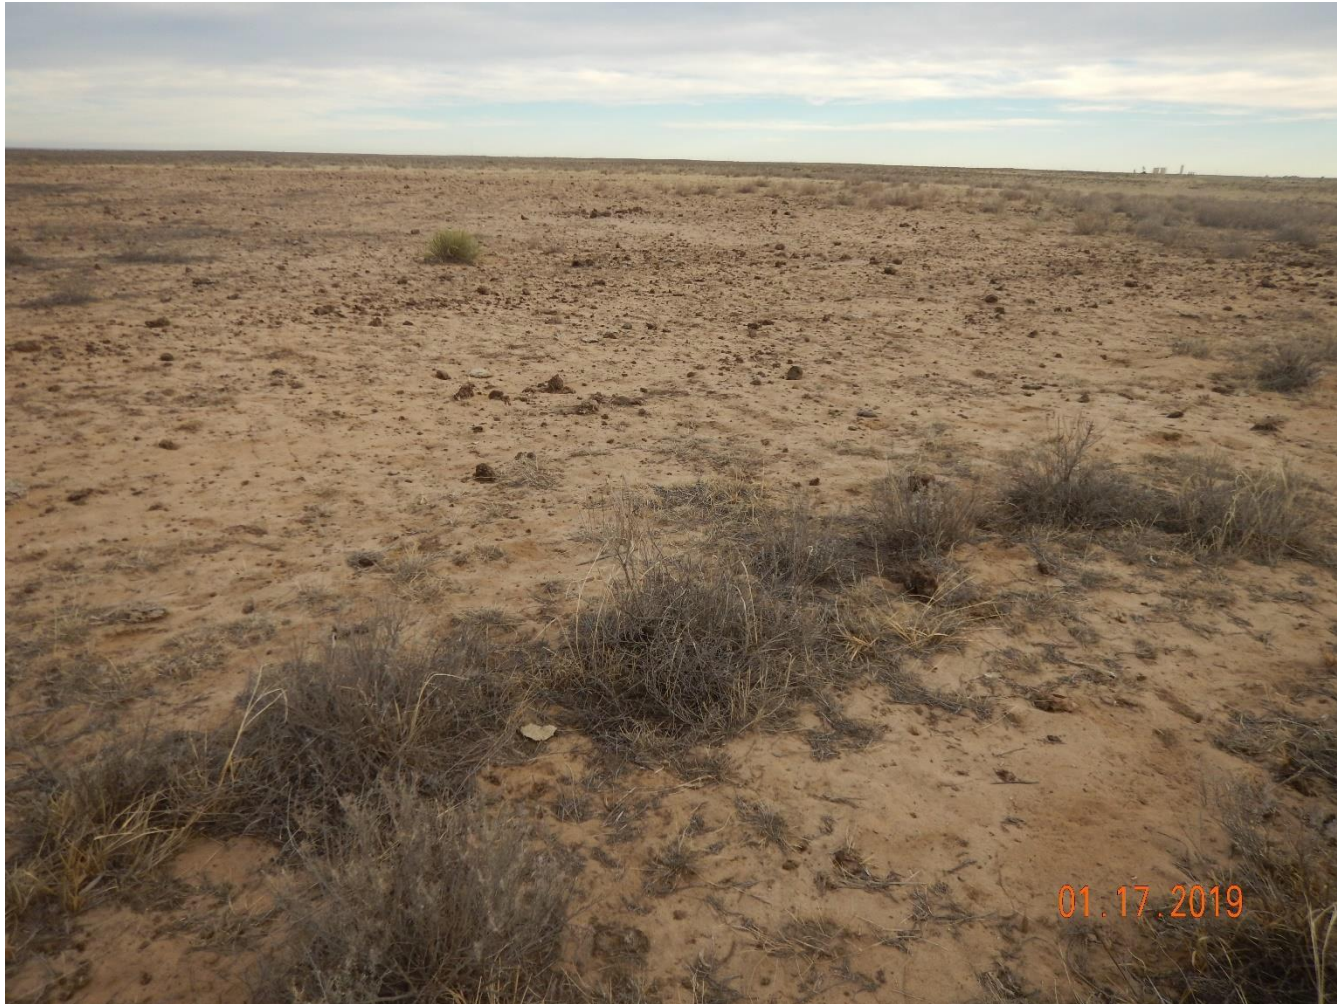
**Photo 4:** Photo taken from the west end of the location, facing southeast. See comments under photo 2

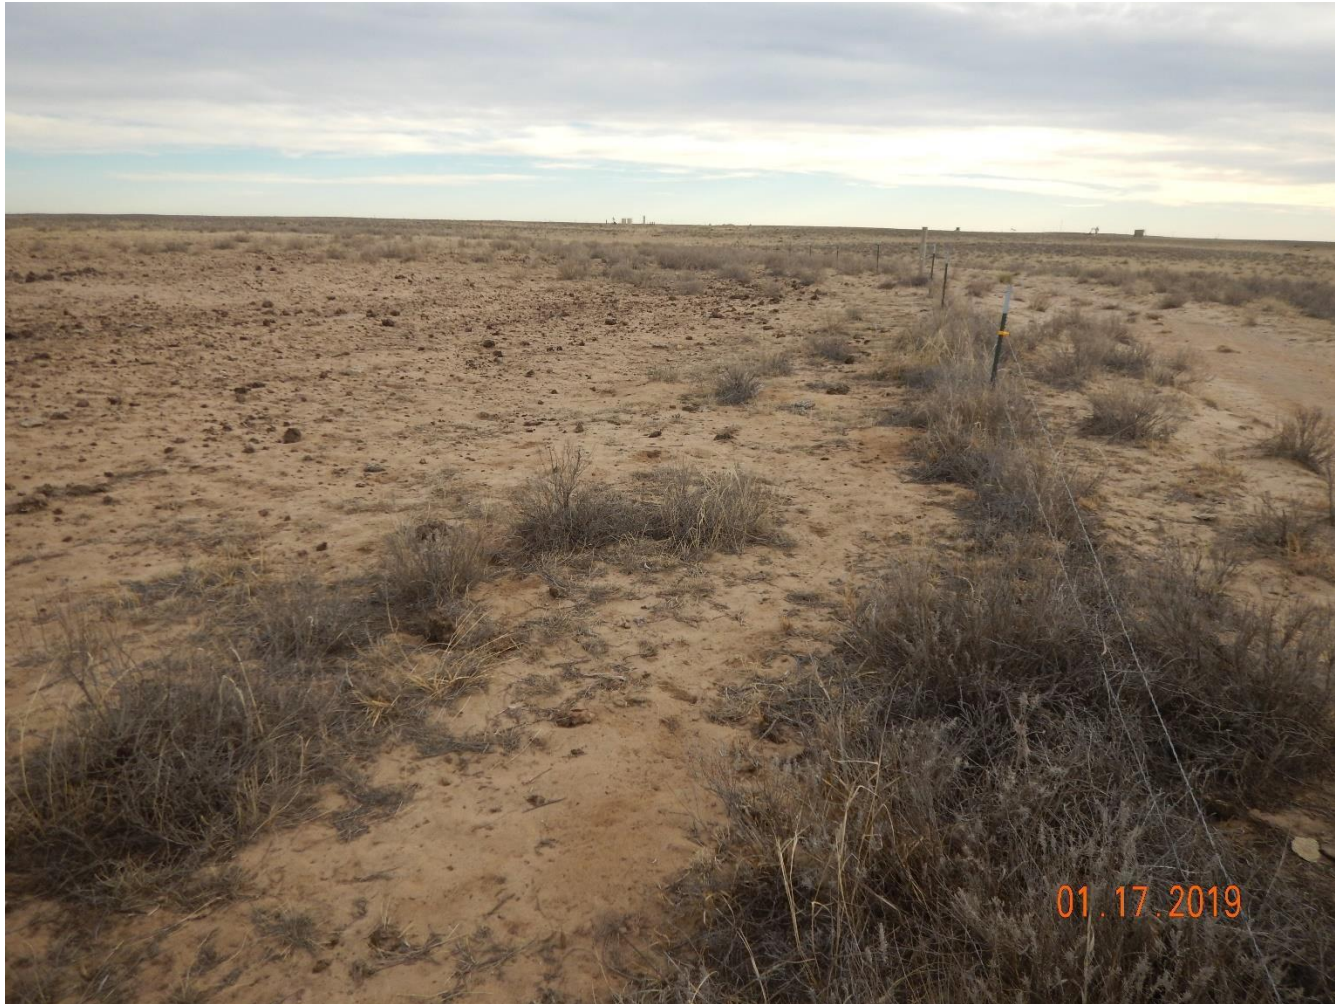
**Photo 5:** Photo taken from the west end of the location, facing south. See comments under photo 2

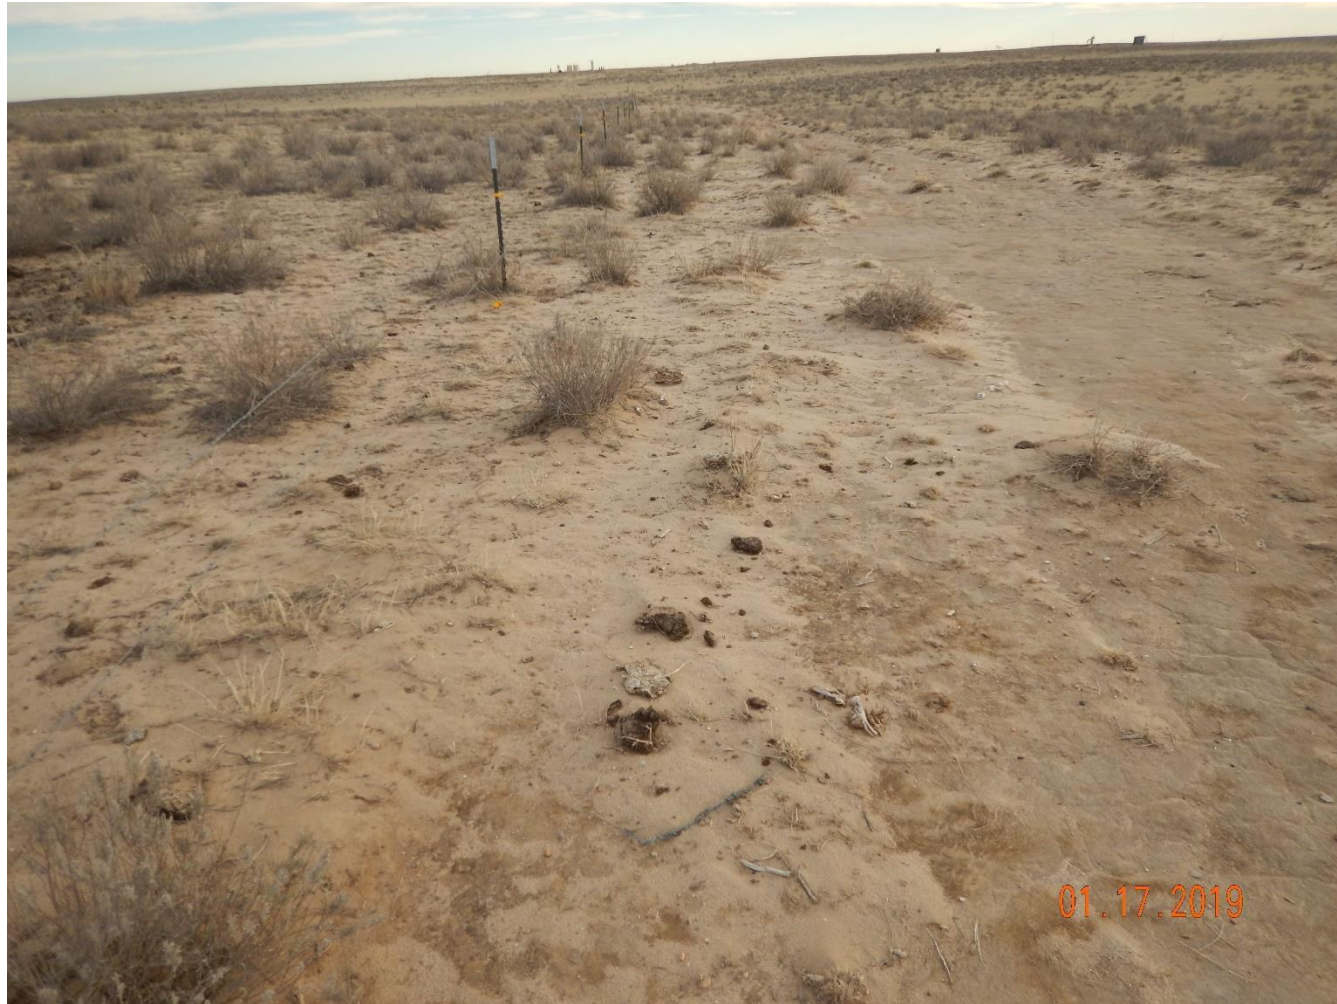
**Photo 6:** Photo taken from the access road, facing south. Photo shows access road remains and has not been reclaimed per 1004.a

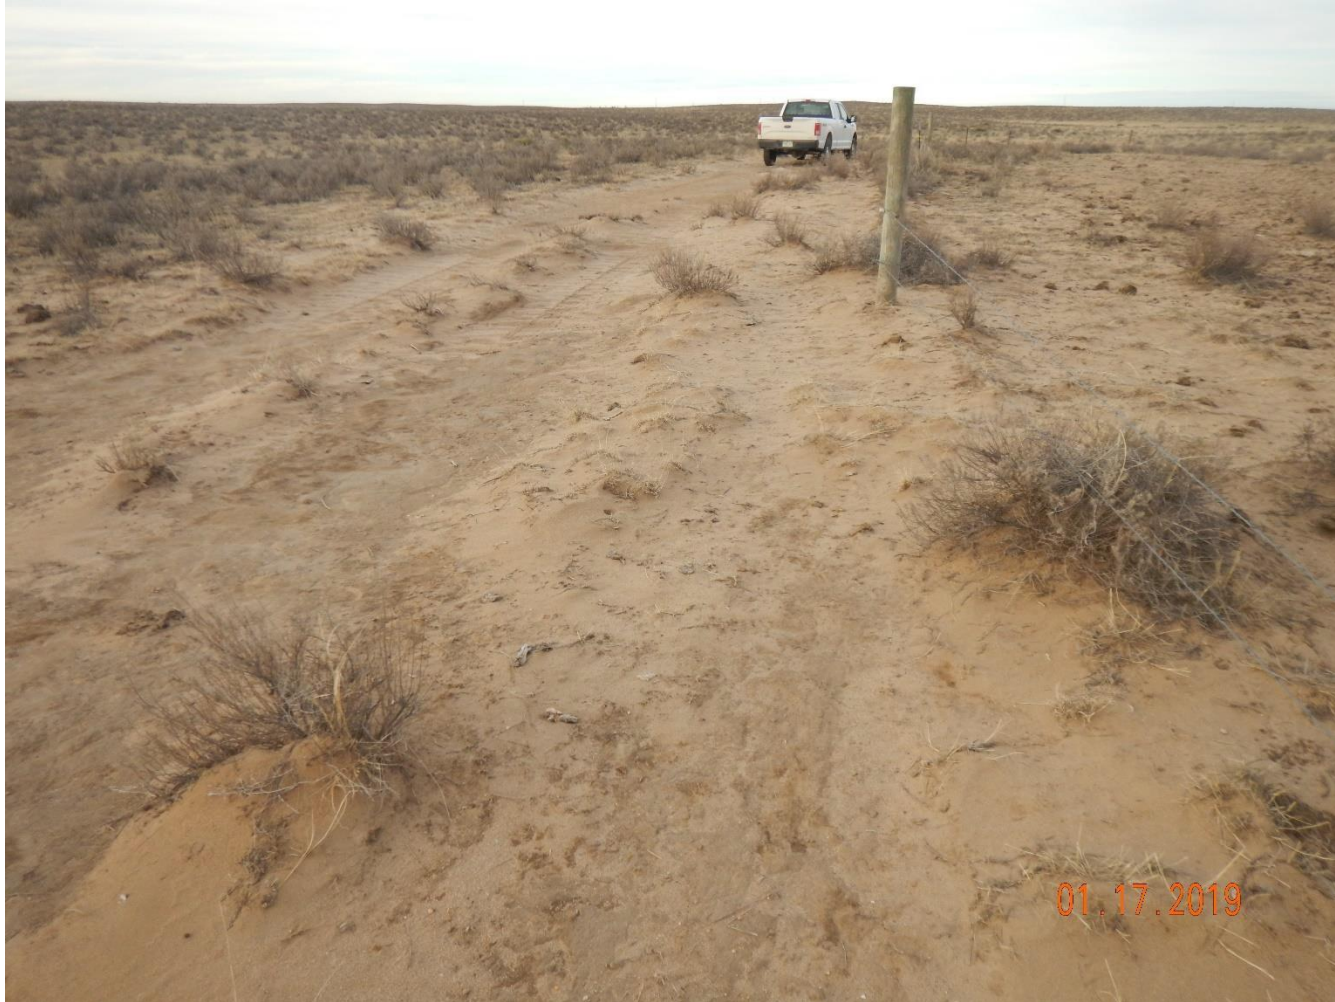
**Photo 7:** Photo taken from the access road, facing north. Photo shows access road remains and has not been reclaimed per 1004.a
