Interim Reclamation and Stormwater Inspection

Operator: VERDAD RESOURCES LLC - #10651

Location ID: 423984

Inspection Photos
Location Name: Pergamos /4-44-7-60
Location ID: 423984

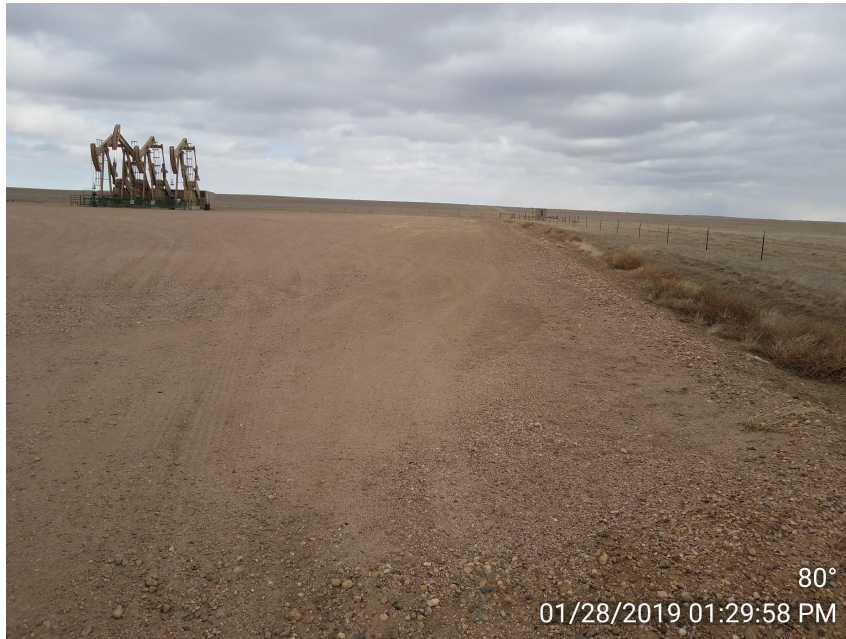
Photo 1. Photo taken from the entrance of the location, facing East. Photo illustrates the southern well pad. Operator has failed to perform interim reclamation.

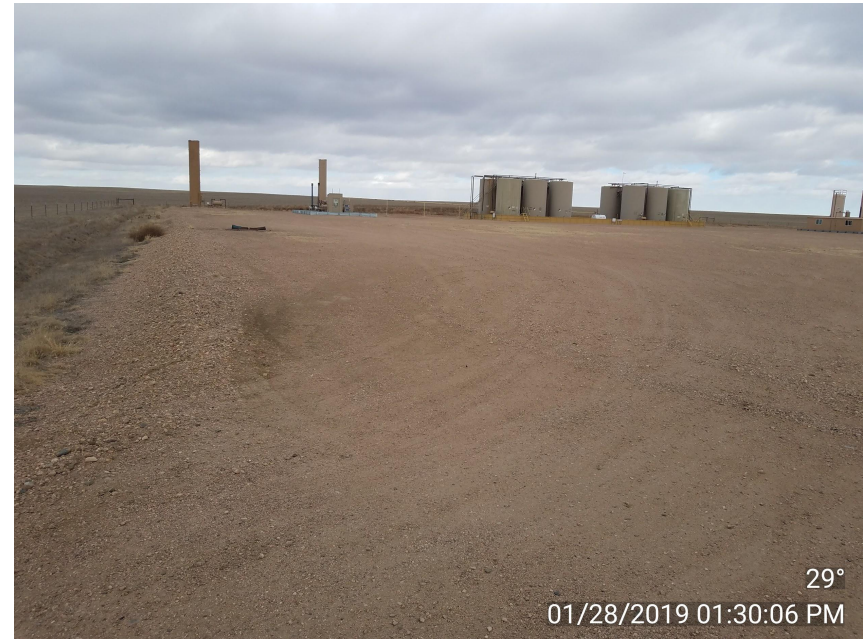
Photo 2. Photo taken from the entrance of the location, facing North. See comments under Photo 1.

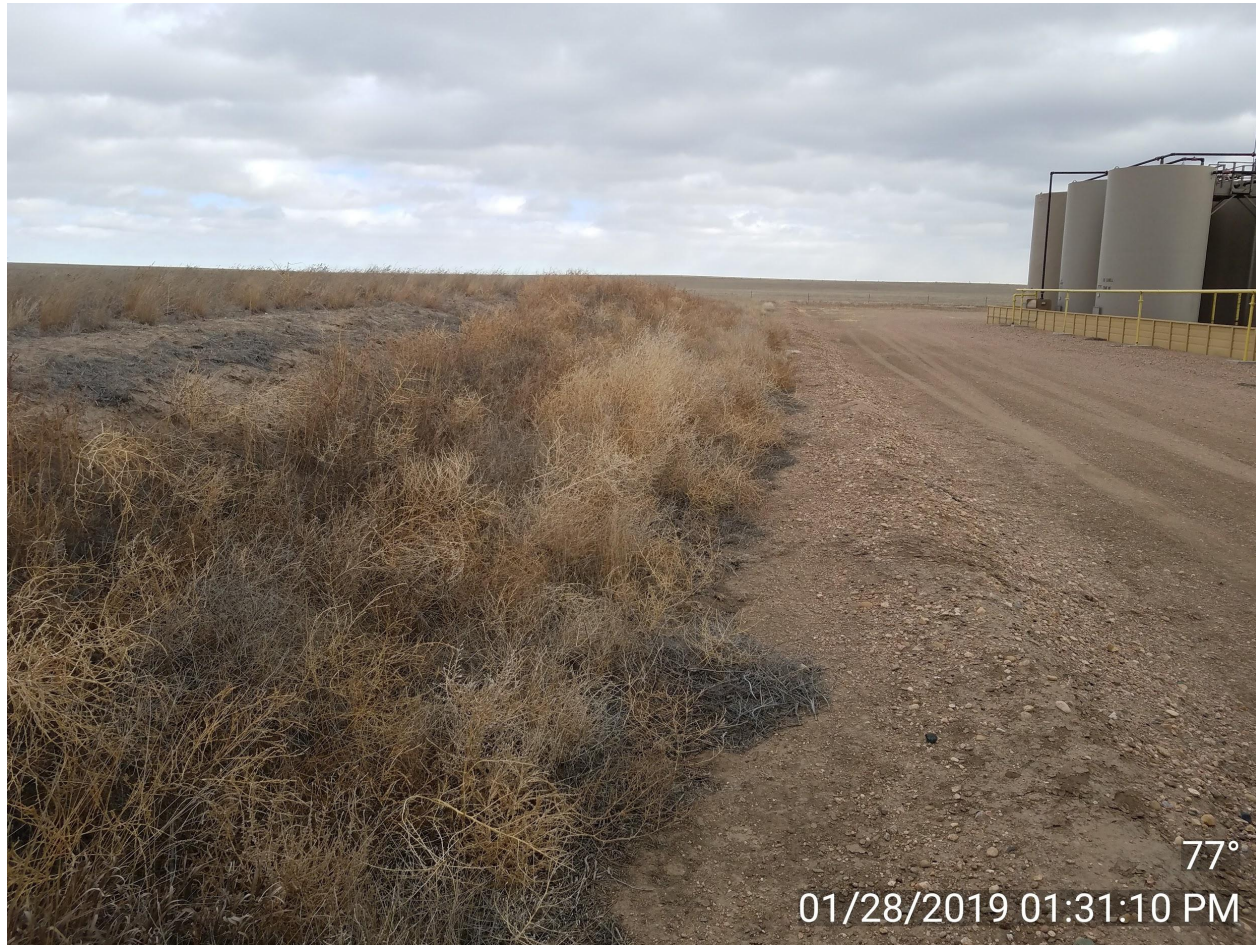
Photo 3. Photo taken from the northwestern well pad, facing East. Photo illustrates unmanaged weeds along the southern fill slope of the topsoil stockpile. Operator shall control weeds and weed debris per Rule 603.f. and comply with Rule 1002.c.
